Project 91592.00
23 August 2019
R.002. Rev1
MJB:plh

Preliminary Contamination Assessment - Summary
Proposed Residential and Clubhouse Development
40 King Street, Adamstown

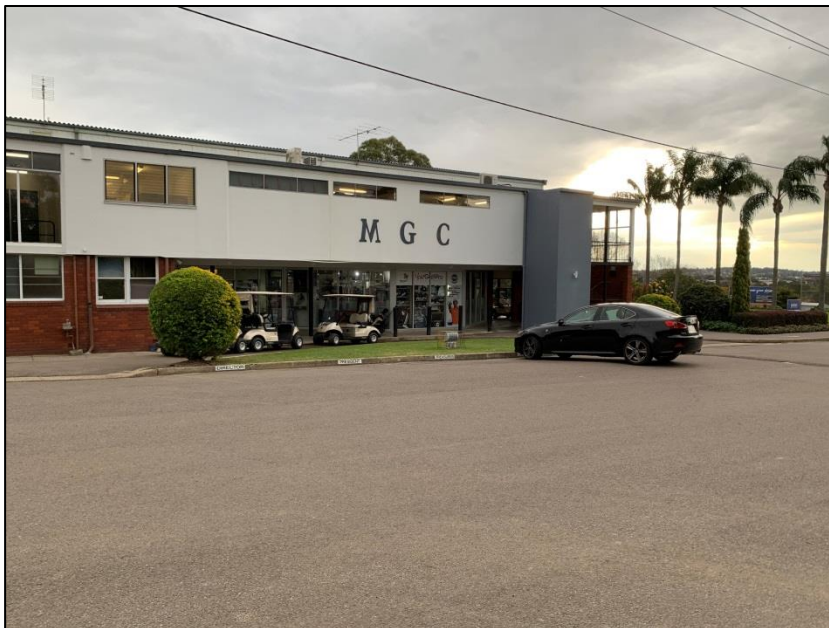
Figure 6: MGC Clubhouse and entrance driveway / carpark (looking northwest)

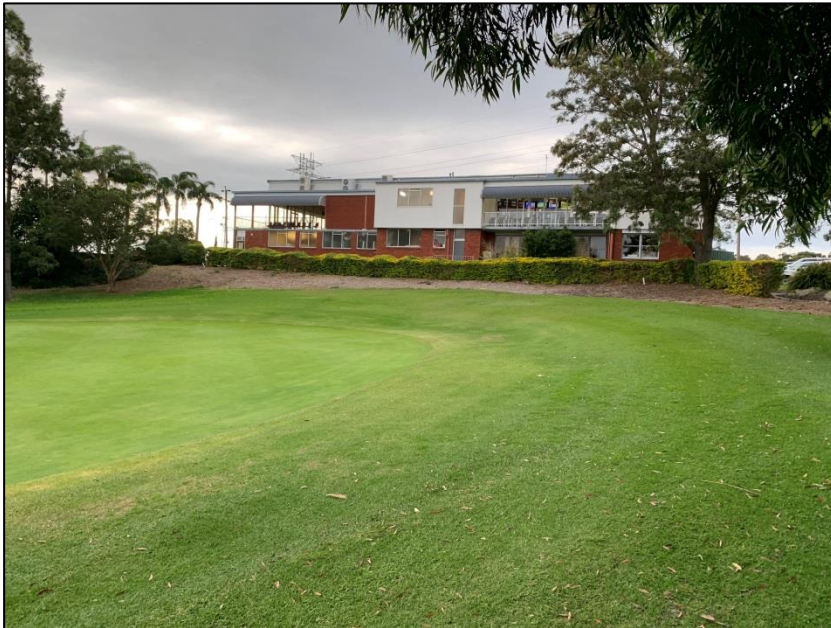
Figure 7: MGC Clubhouse with adjoining greens and associated fill embankments (looking east).

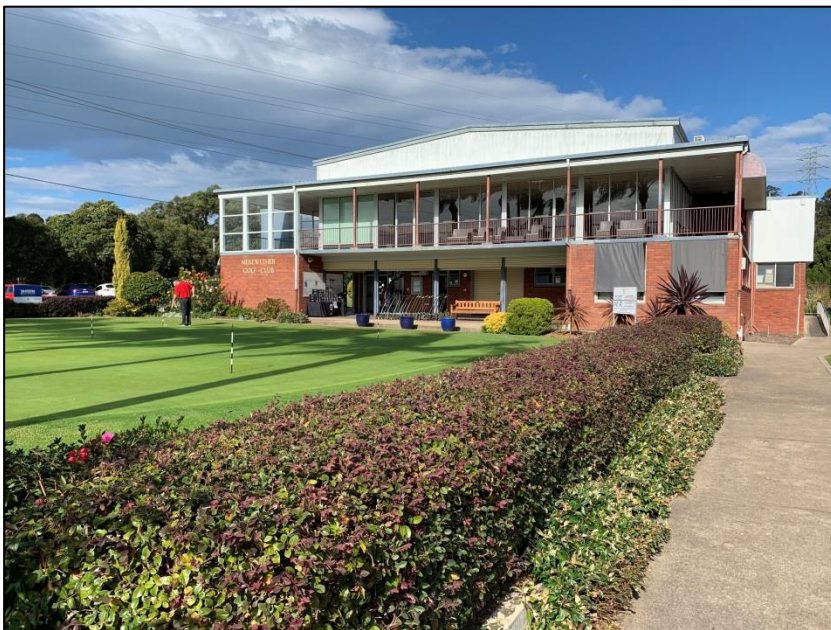
The clubhouse has a practice green at the northern end of the building (Figures 8 & 10) which appears to be partially filled.

Figure 8: MGC Clubhouse with practice green (looking south)

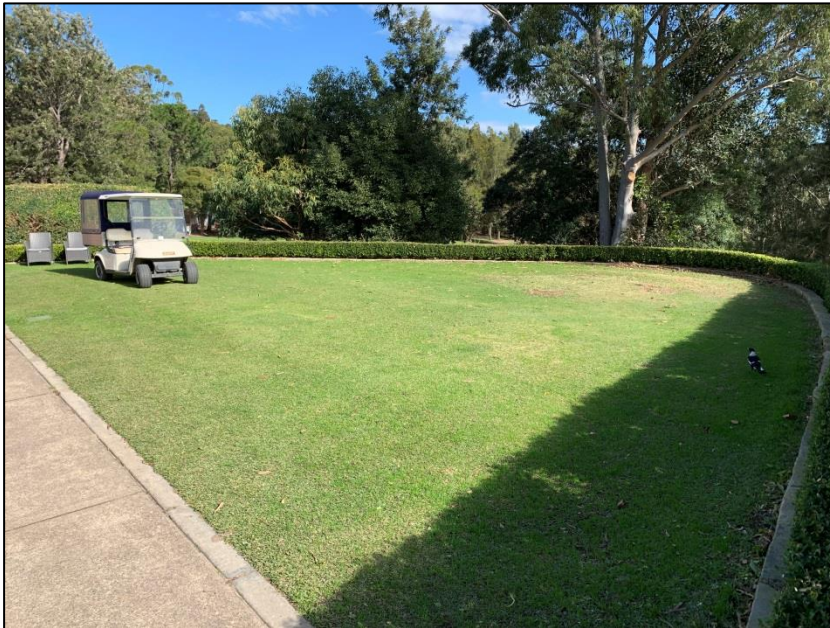
A raised garden bed to the west of this practice green (Figure 9 & 11) appears to comprise at least a few metres of filling. An adjoining garden bed to the west of the clubhouse (Figure 7) also appears to comprise recently imported fill materials.

Figure 9: Raised grassed / garden bed (former sand pit) west of practice green

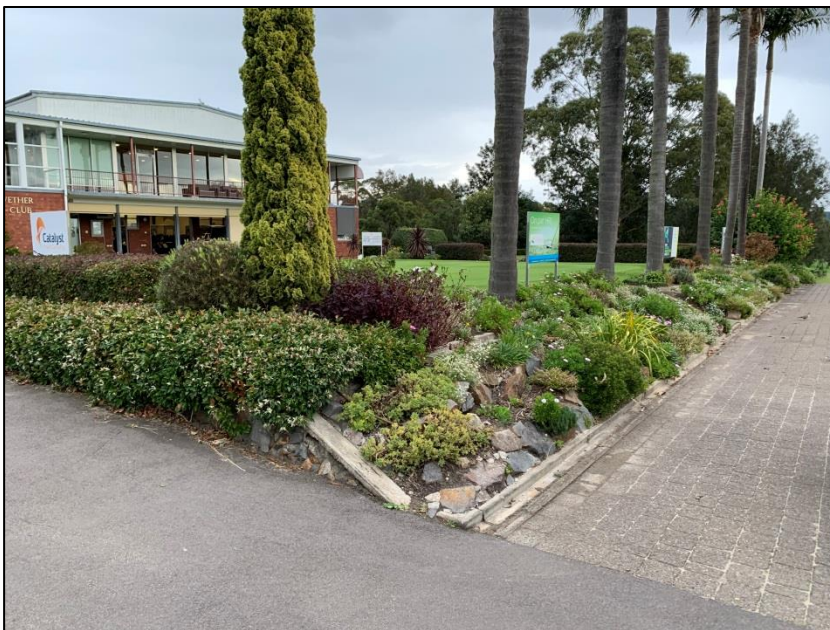
Figure 10: Clubhouse and practice green with paved and asphalt sealed pathways (looking south west)

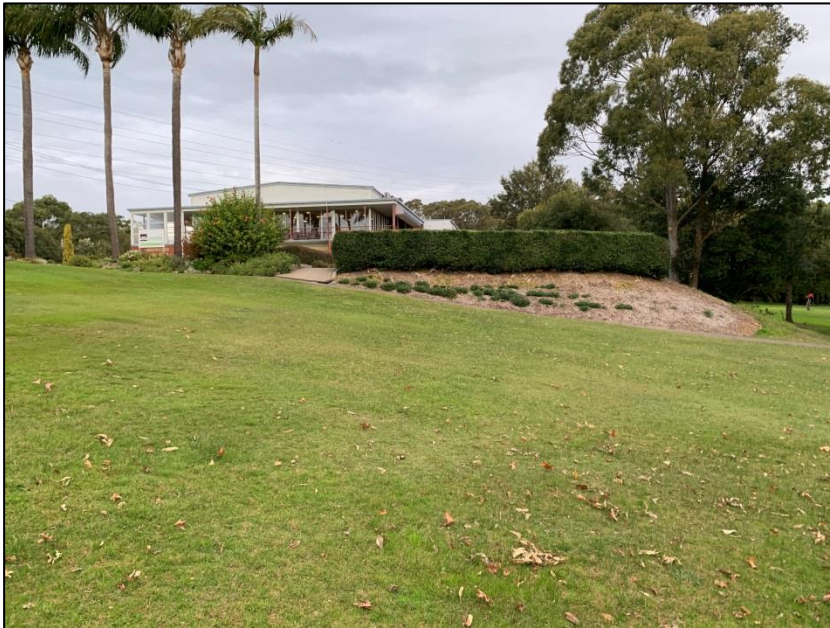
Figure 11: Raised fill embankment (looking south from 1st tee)

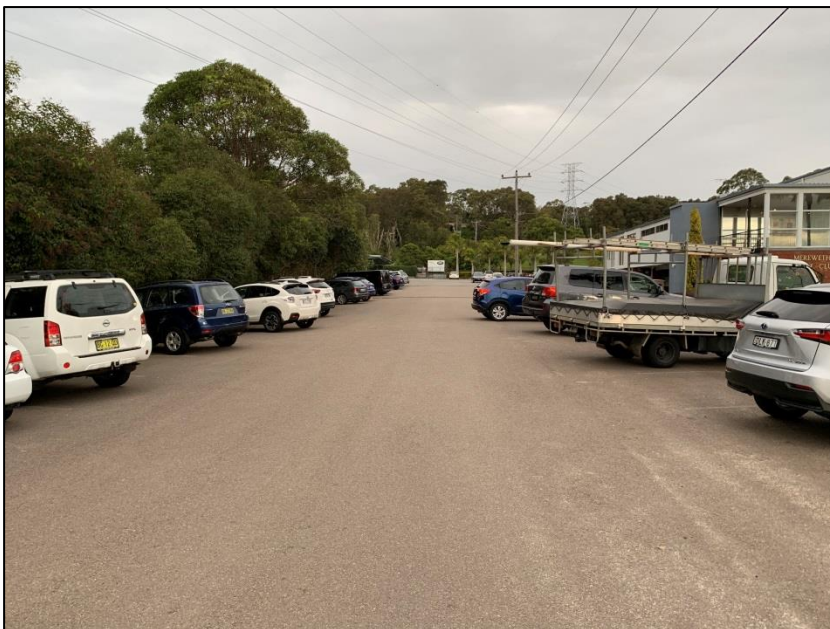
An asphalt sealed driveway and carpark is situated off King Street (Figure 12 & 17) and extends to the south of the clubhouse. The car park is patchy in some sections with exposed aggregate present.

Figure 12: Entrance driveway / carpark and Clubhouse (looking south)

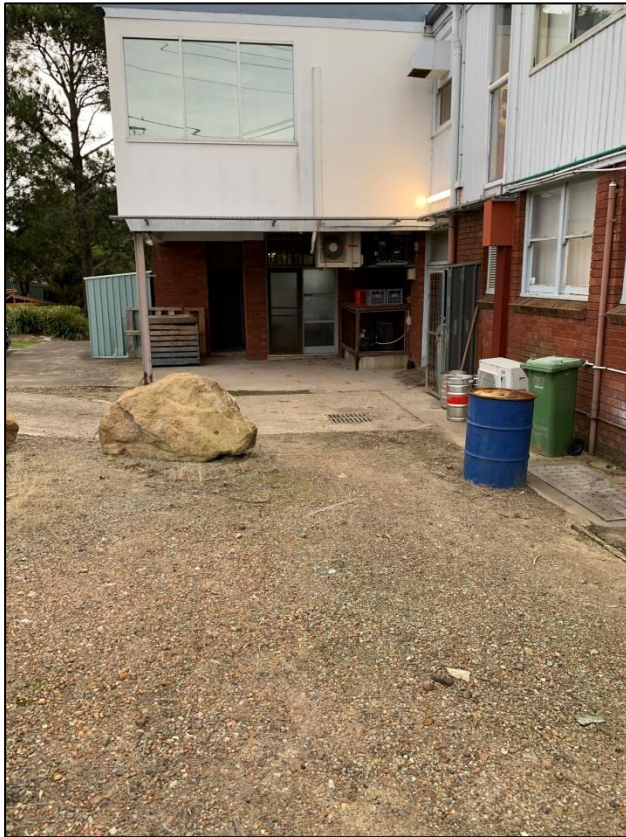
A rear entrance to the kitchen is present at the southern side of the building and contains gas bottles, kegs, compressor, possible sump, air conditioning units etc (Figure 13). The adjacent area comprises loose gravel fill materials.

Figure 13: Rear of Clubhouse with gas bottles, compressors, possible sump (looking west)

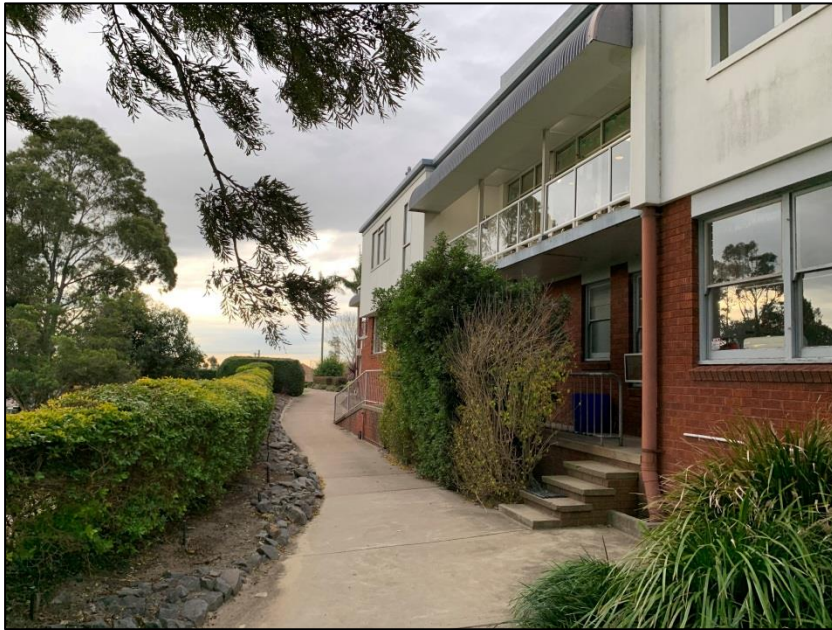
The western side of the clubhouse comprises a newer concrete path with adjoining raised garden bed (Figure 14).

Figure 14: Clubhouse with concrete path and raised garden beds (looking north)

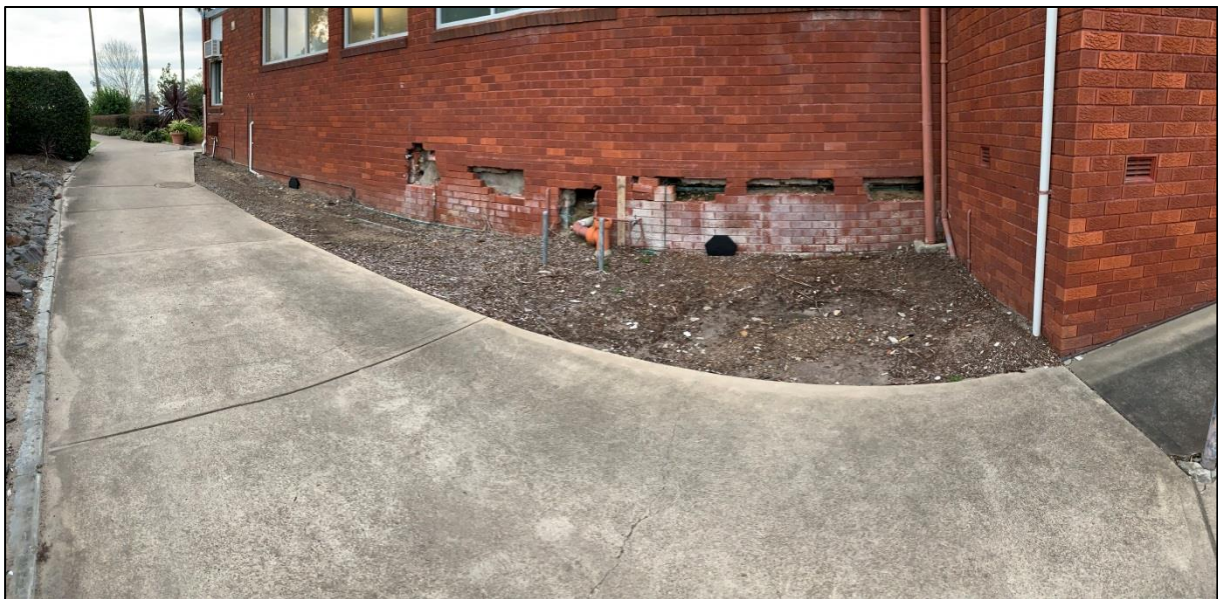
Demolition waste (including fragments of possible bonded asbestos containing materials (ACM)) were observed at the ground surface adjacent to the building (Figures 15 & 16) and were located at the base of a section of rendered wall which has been an addition at some point. Several holes had also been cut into the brick work exposing sandy fill materials.

Figure 15: Construction works / repairs to the western wall of clubhouse. Possible ACM at surface (looking north east)

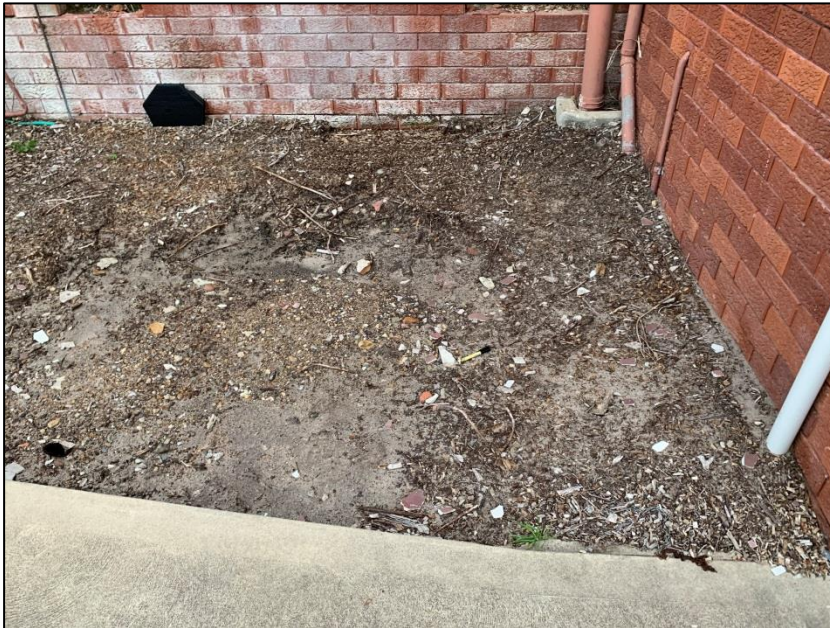
Figure 16: Possible ACM fragments at surface (fibro fragments)

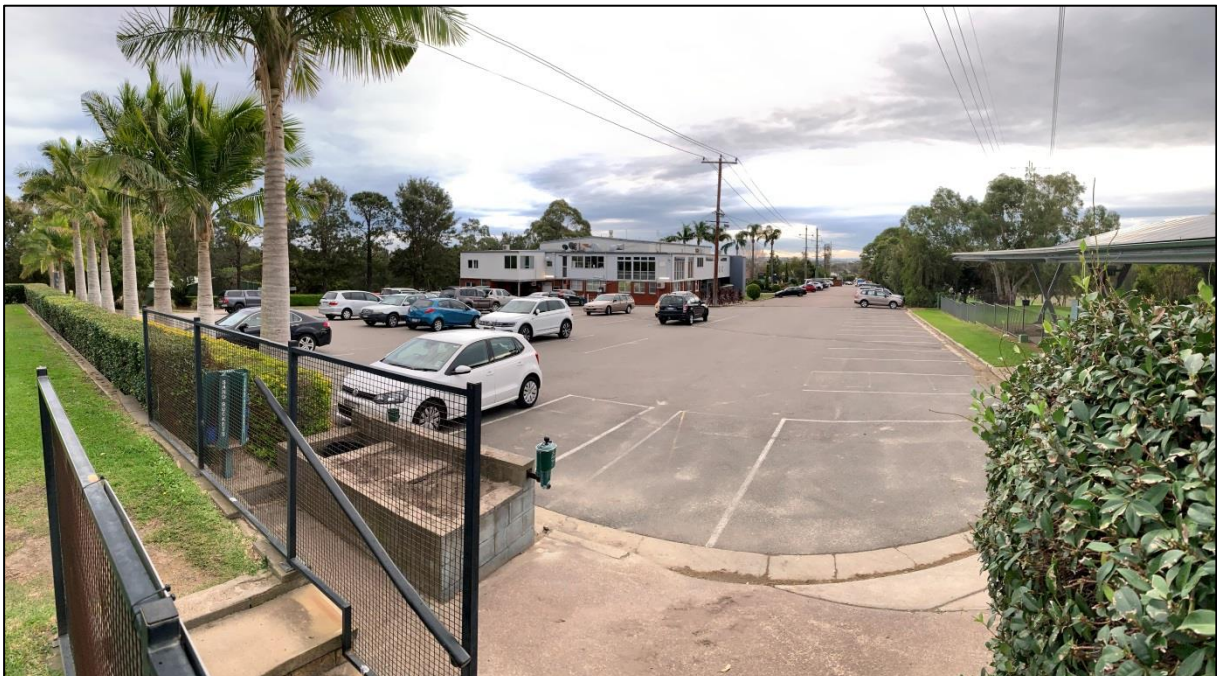
An approximately 1 m high retaining wall was situated at the southern end of the car park with granular fill materials evident where exposed. A shade shelter was situated to the east of this area and was adjacent to the 9th tee.

Figure 17: Carpark to south of clubhouse. Retaining wall with exposed fill evident in foreground (looking north)

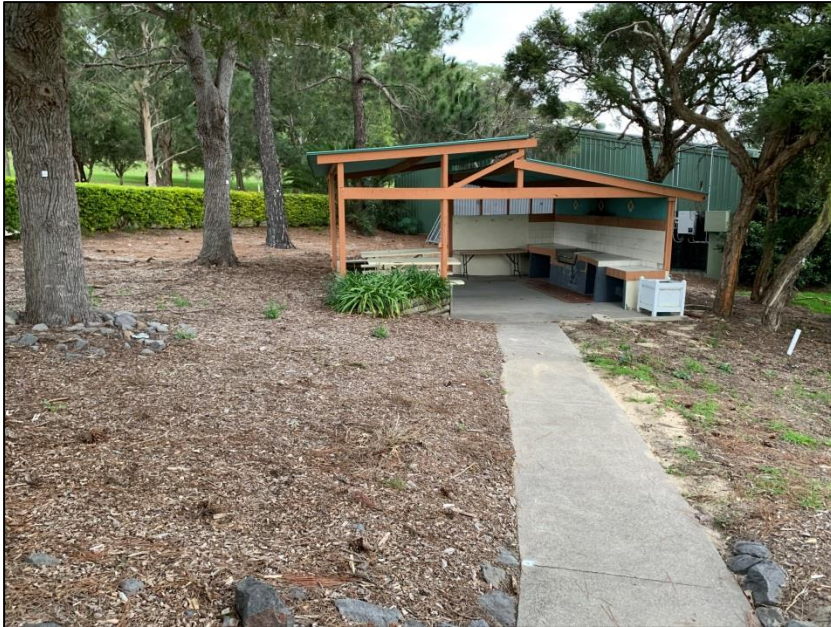
A BBQ area is situated to the south west of the clubhouse (Figure 18) which is adjacent to the cart shed. The cart shed is a metal clad shed with concrete floor and is used to house and recharge the golf carts (run on batteries). Raised garden beds are present on the southern side of the shed.

Figure 18: BBQ Area and golf cart shed to rear (looking south west)

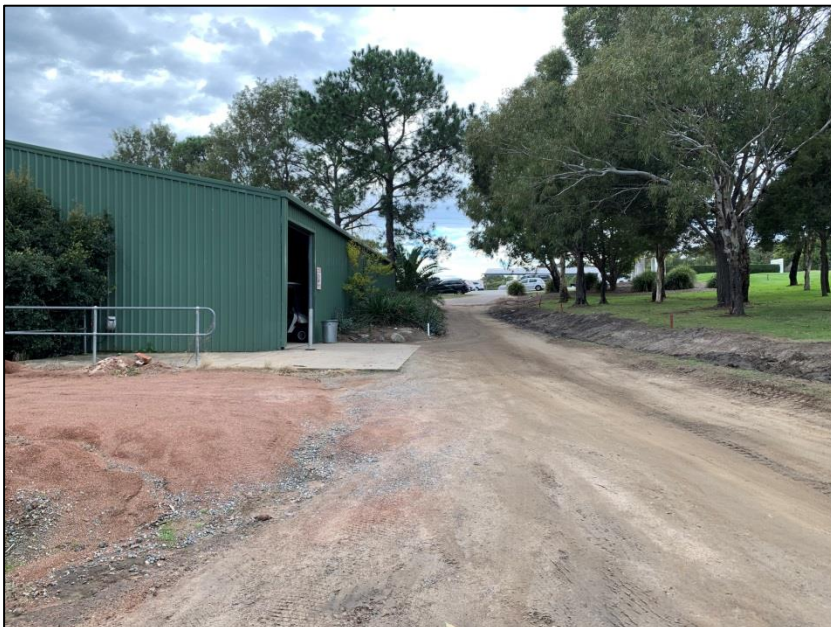
Figure 19: Golf cart shed, adjacent wash bay and gravel bay (looking east)

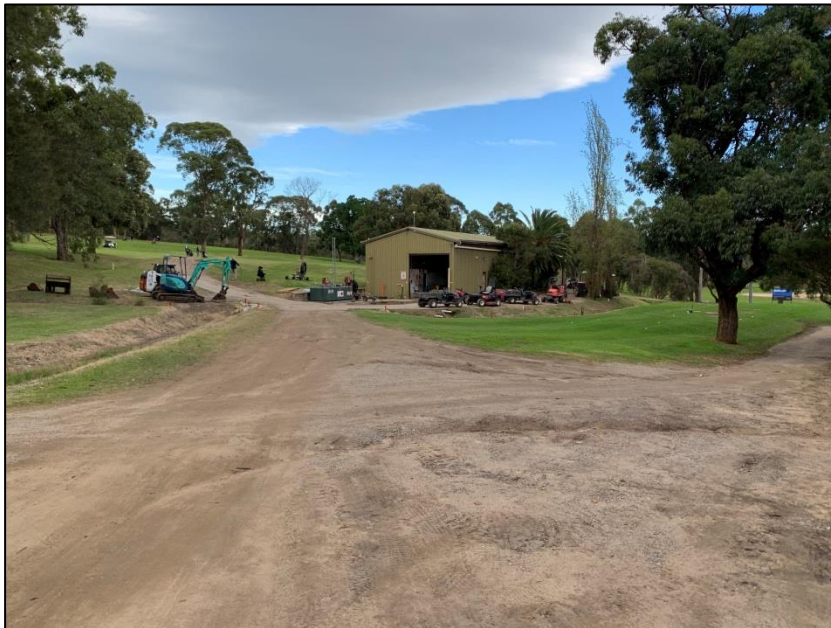
A greens keeper shed is located to the south west of the gold cart shed (Figures 20 to 28). The shed is metal clad with a concrete floor and has been cut into the natural batter (cut/fill). The front of the shed contains a concrete slab with sump (full of water at the time of the inspection) with an adjacent above ground fuel storage tank housing diesel and ULP (Figure 21).

Figure 20: Greens keeper shed and adjacent creek (looking south west)

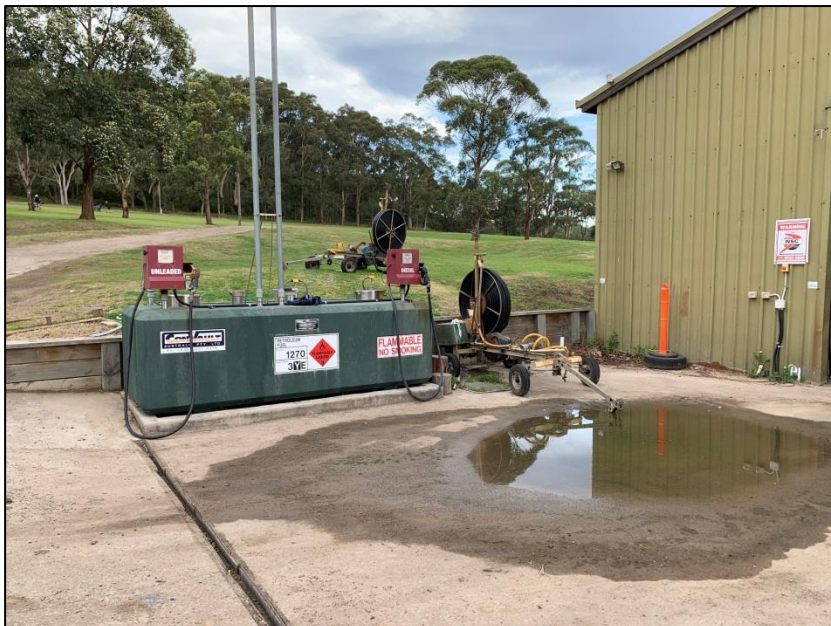
Figure 21: AGST with adjacent sump (full water)

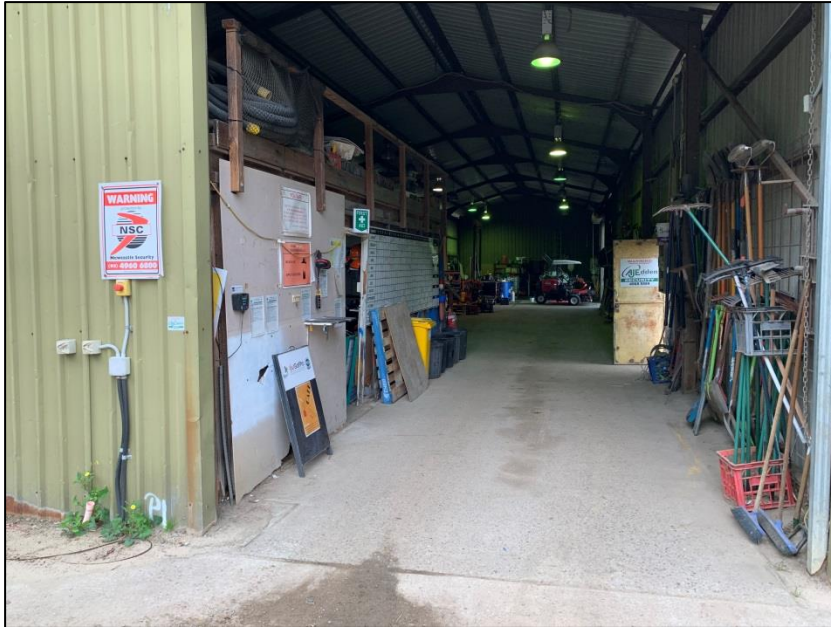
Figure 22: Entrance to Greens keeper shed (looking west)

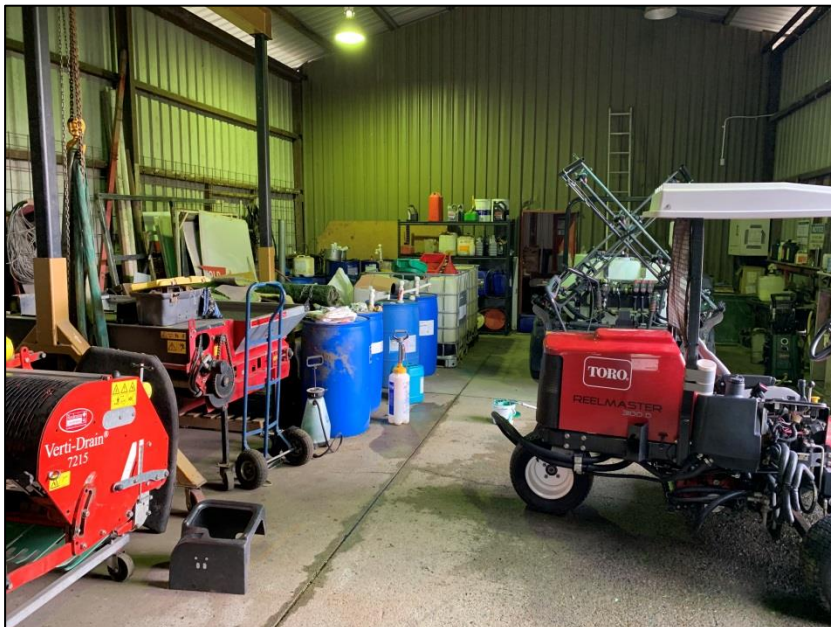
The shed itself houses machinery, parts, tools and a range of pesticides, herbicides, fertilisers, oils etc. The chemicals are stored on crates and in bunded areas, however, the condition of some containers / bags were in a poor state and residues and spills are evident across the concrete floor.

Figure 23: Machinery (including boom spray), oils, chemicals, pesticides stored in shed over concrete floor (looking west)

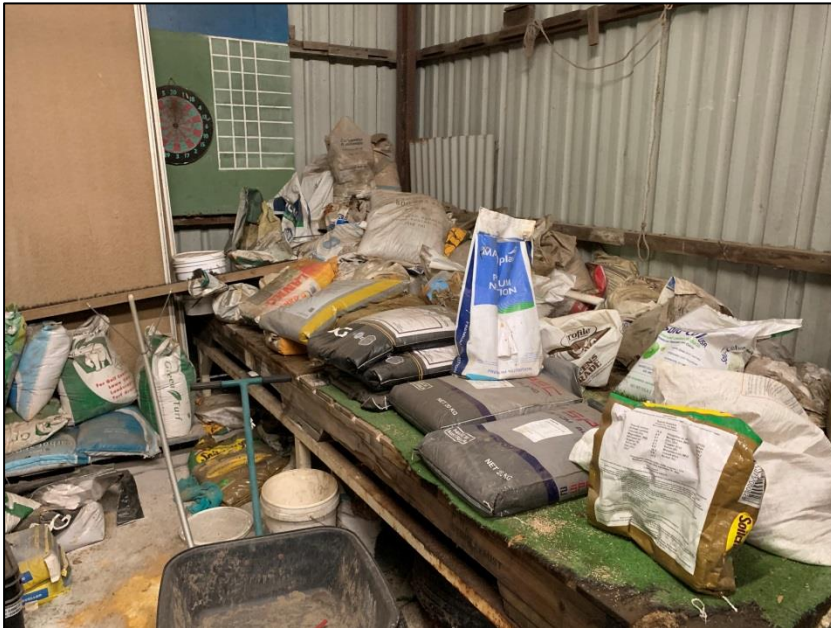
Figure 24: Stored chemicals within chemical store (looking south west)

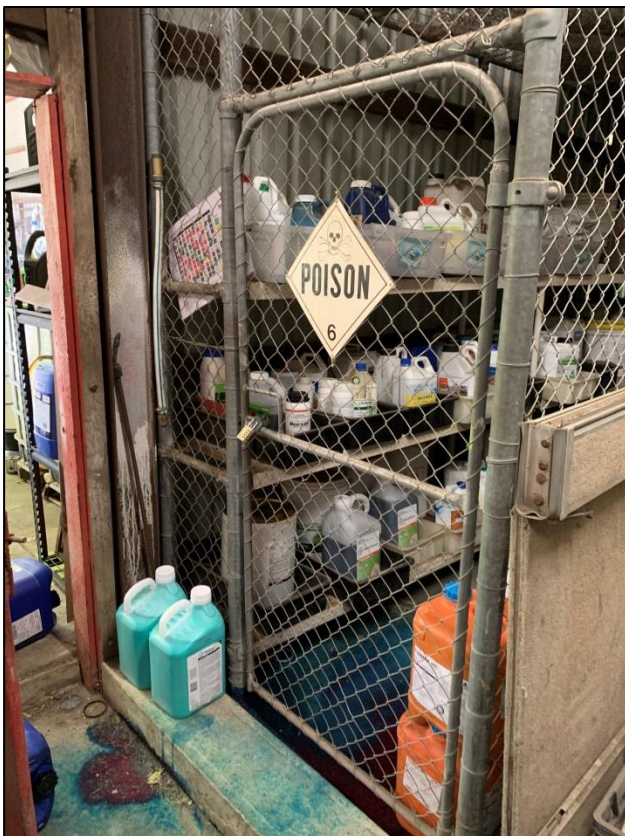
Figure 25: Pesticide storage area within chemical store with shallow concrete bund. Some spilled residues across floor (looking south east)

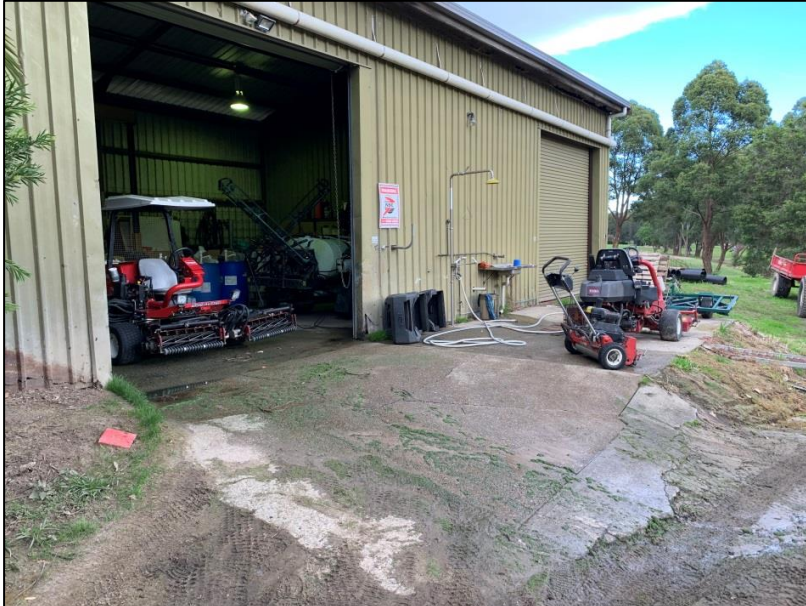
A servicing and wash bay area is situated at the western end of the shed. The area drains directly into the creek / drain running along the side of the shed which flows down to the west and would eventually discharge into the stormwater channel north of the 1st fairway. The drain was observed to contain algae and organic residues and grass clippings.

Figure 26: Northern side of shed with wash down area (looking south west)

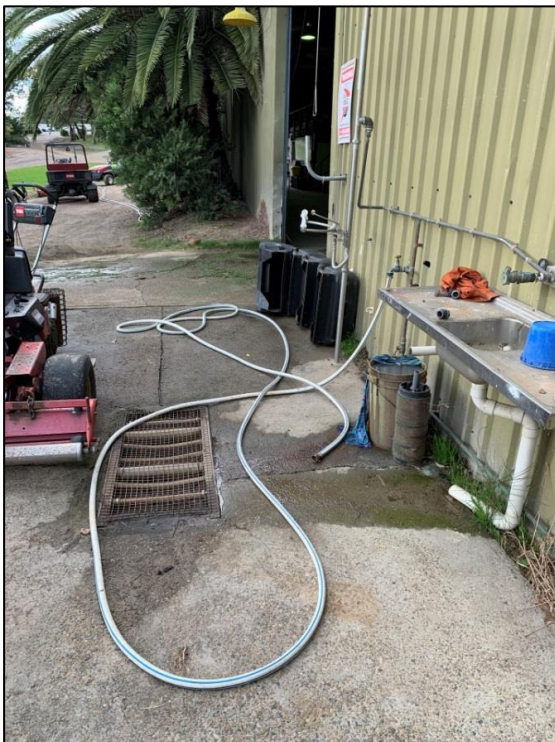
Figure 27: Wash down area with drain in centre (looking south east)

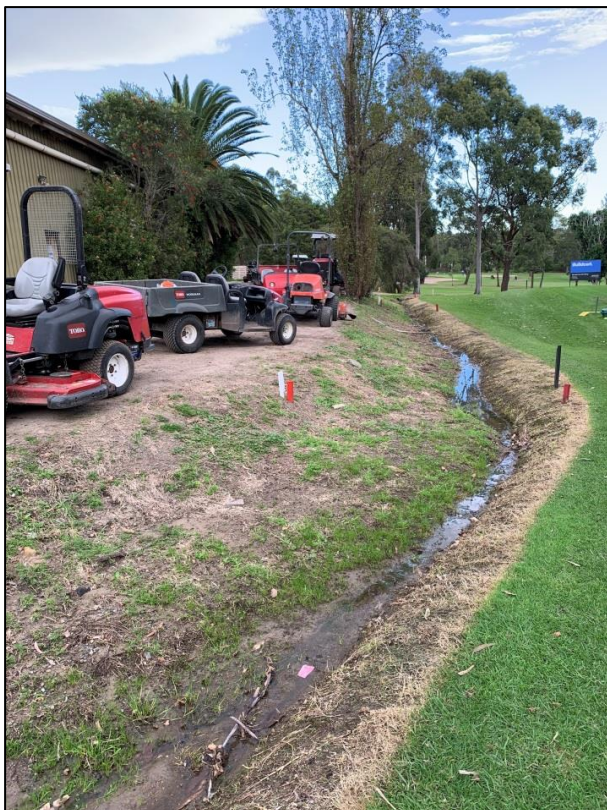
Figure 28: Open drain / creek to north greens keeper shed (looking west). Distressed grass possible indicating pesticides application.

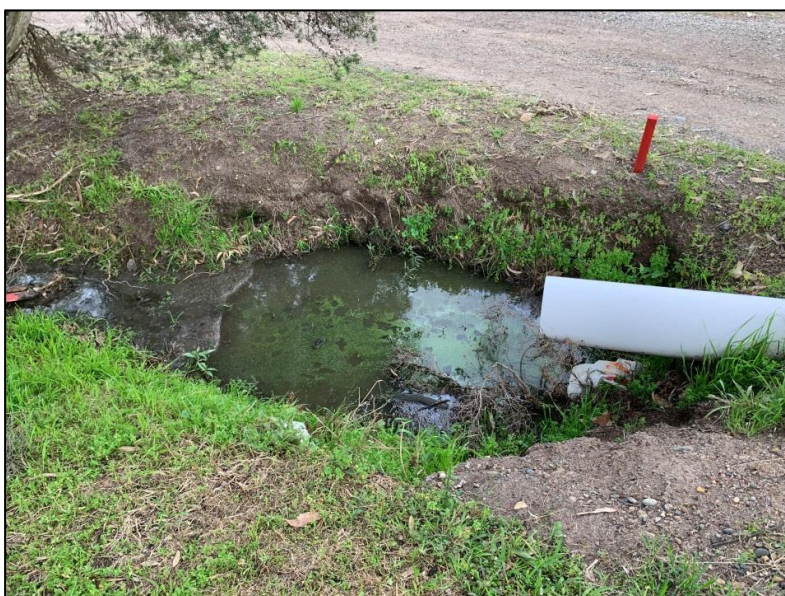
Figure 29: Drain / creek downslope of wash down area (algae and organic residues evident at surface)

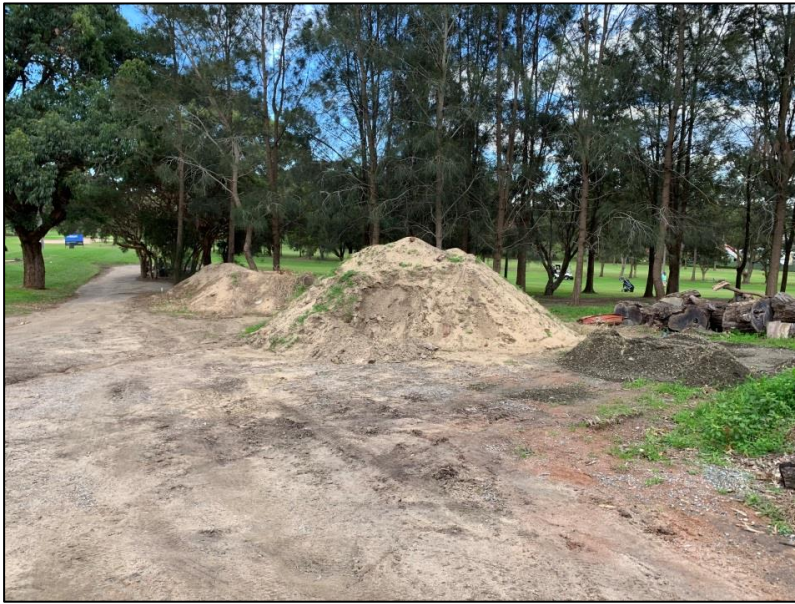
A localised soil stockpiling area was present to the west of the cart shed (Figure 30). The area comprised several stockpiles of gravel and sand. The stockpiles all contained building wastes including brick and concrete and other deleterious materials. Some green waste was also stockpiled here.

Figure 30: Soil stockpile area between cart shed and greens keeper shed

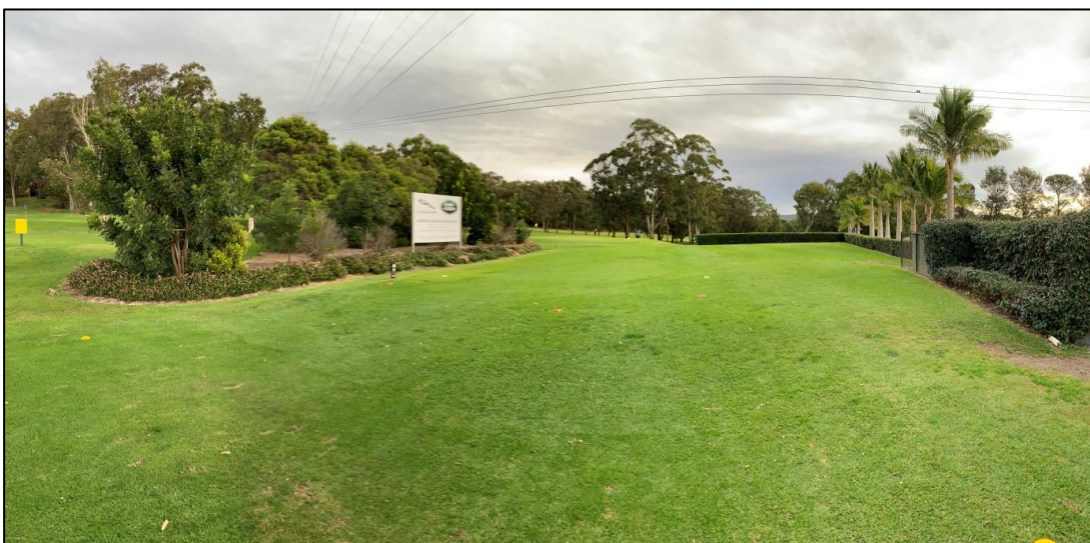
The surrounding golf course has numerous fill bunds, filled garden beds and raised areas. While these are largely associated with greens, and tee off platforms there is also a number of earth mounds across the site. Where not covered by vegetation, some of these were observed to comprise granular fill material with anthropogenic inclusions including concrete and brick etc.

Figure 31: 9th Tee with filled area adjacent to a retaining wall and filled garden bed to south

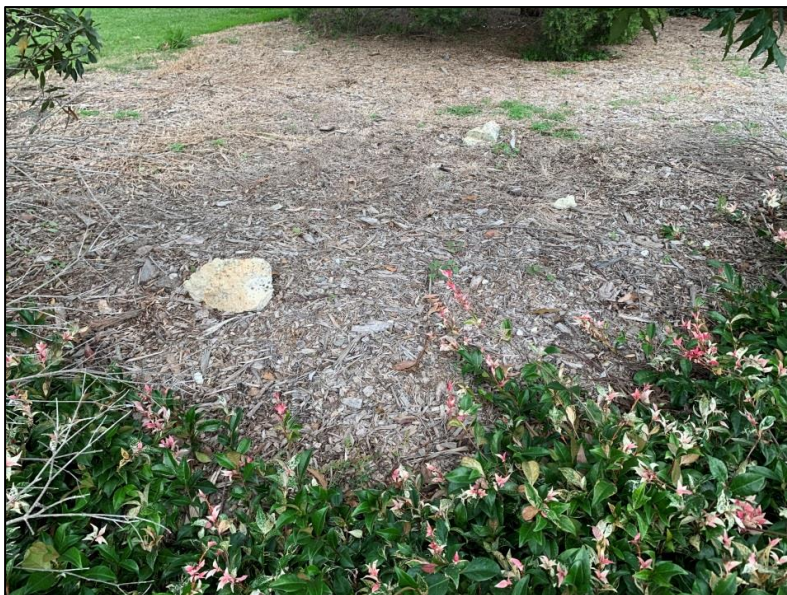
Figure 32: Exposed concrete fragments in recently completed garden bed (looking south west)

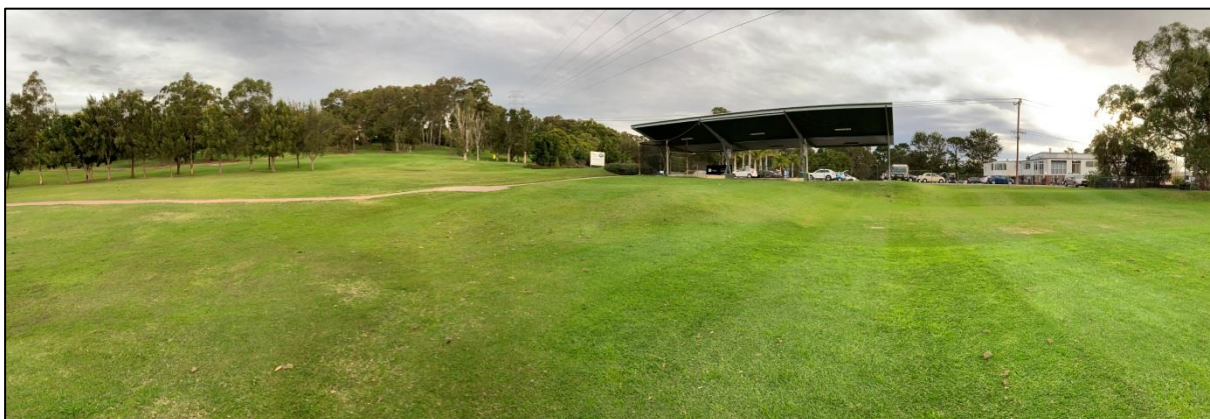
Figure 33: Looking towards the shade shelter and car park. Benching evident (looking west)

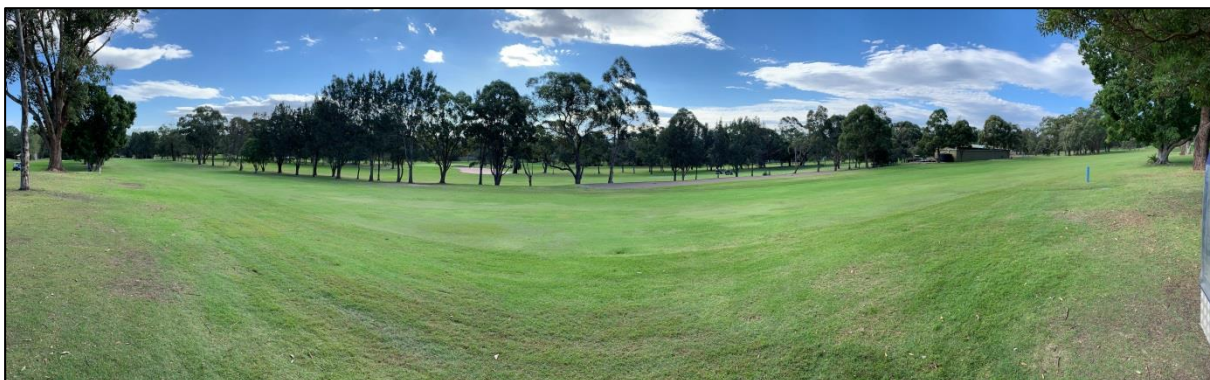
Figure 34: Panoramic view of fairway to the south west of the greens keeper shed

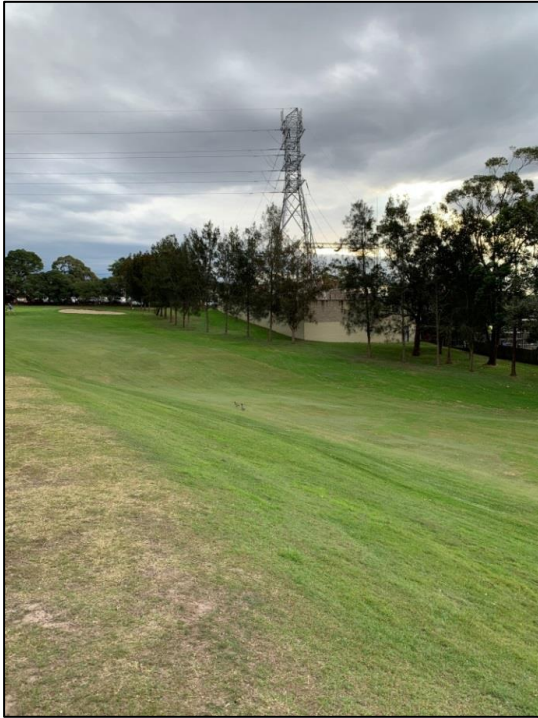
An electrical substation is located to the north of the site, east of the MGC entrance car park. The substation has a concrete floor, sloped steeply with the natural land surface to the north east corner of the bunded area. Stormwater feeds into a pit just outside the compound in the golf course and appears to flow to the east through the golf course to the east of the site.

Figure 66: Electrical Substation north of 8th fairway (looking north west)

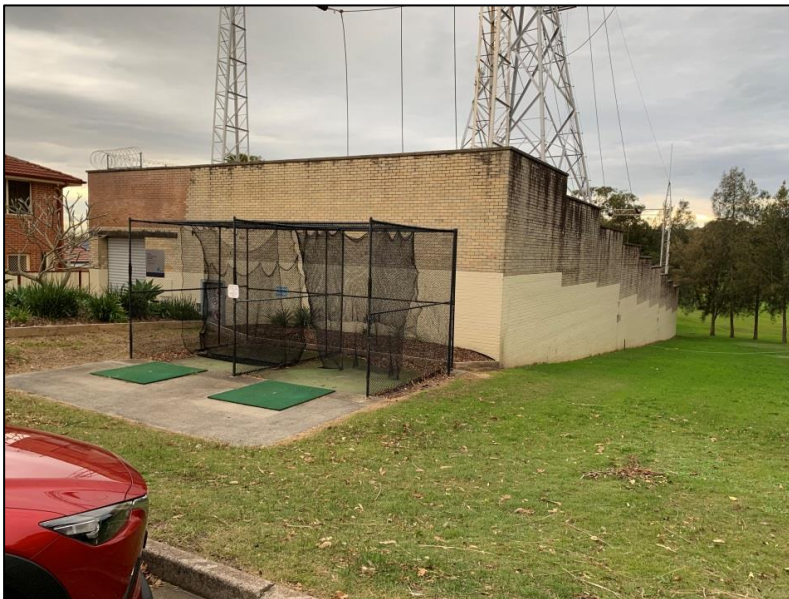
Figure 67: Electrical substation and practice nets adjacent to entrance to MGC (looking north east)

- The electrical substation on the northern site boundary which drains onto the golf course to the east of the substation may be a source of PCB, heavy metals and hydrocarbons. Surface water is collected in pits which appears to be discharged to the golf course east of the substation (ie to east of proposed development footprint);
