Slope Risk Assessment Report

Patyegarang Project

Reference No. 30012988
Prepared for Metropolitan Local Aboriginal Land Council
14 July 2023

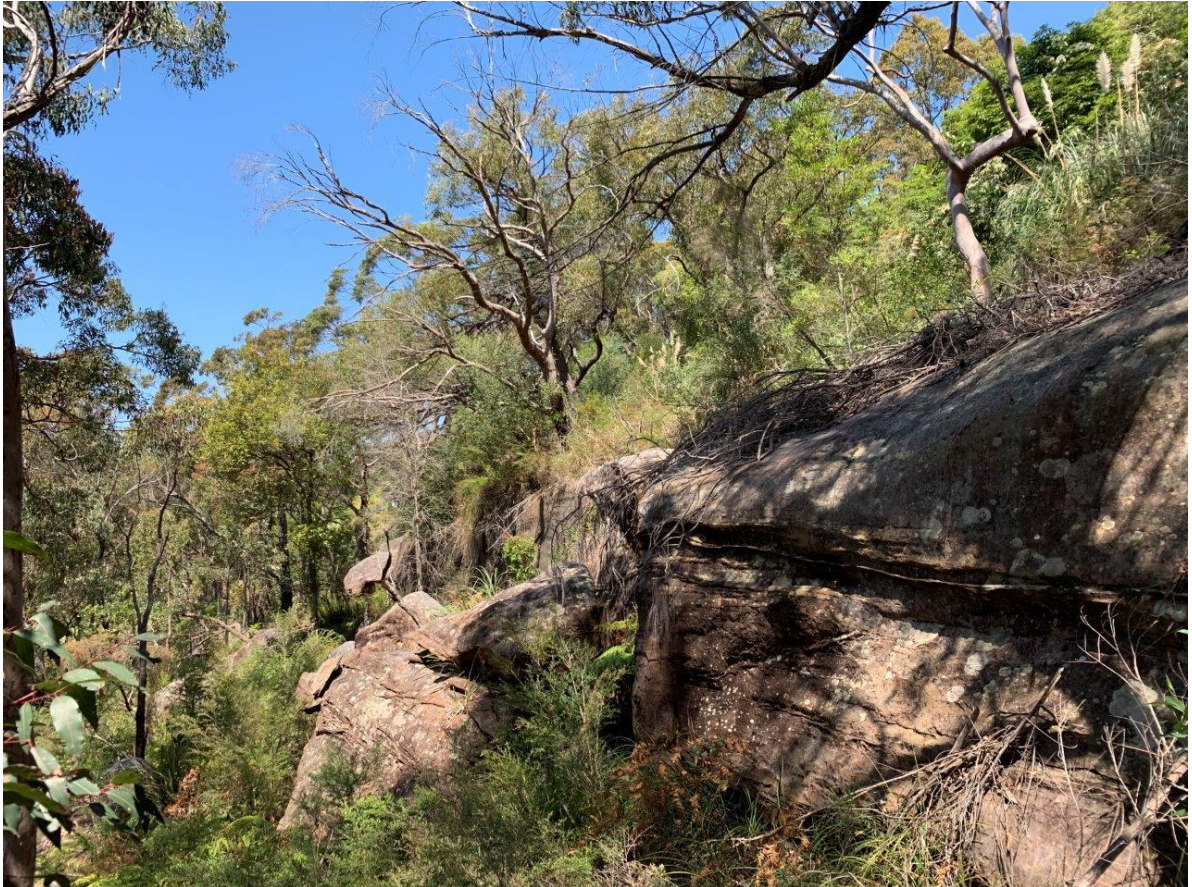
Photograph 5: View looking south along crest of precipice, large fallen blocks up to 2.5m observed

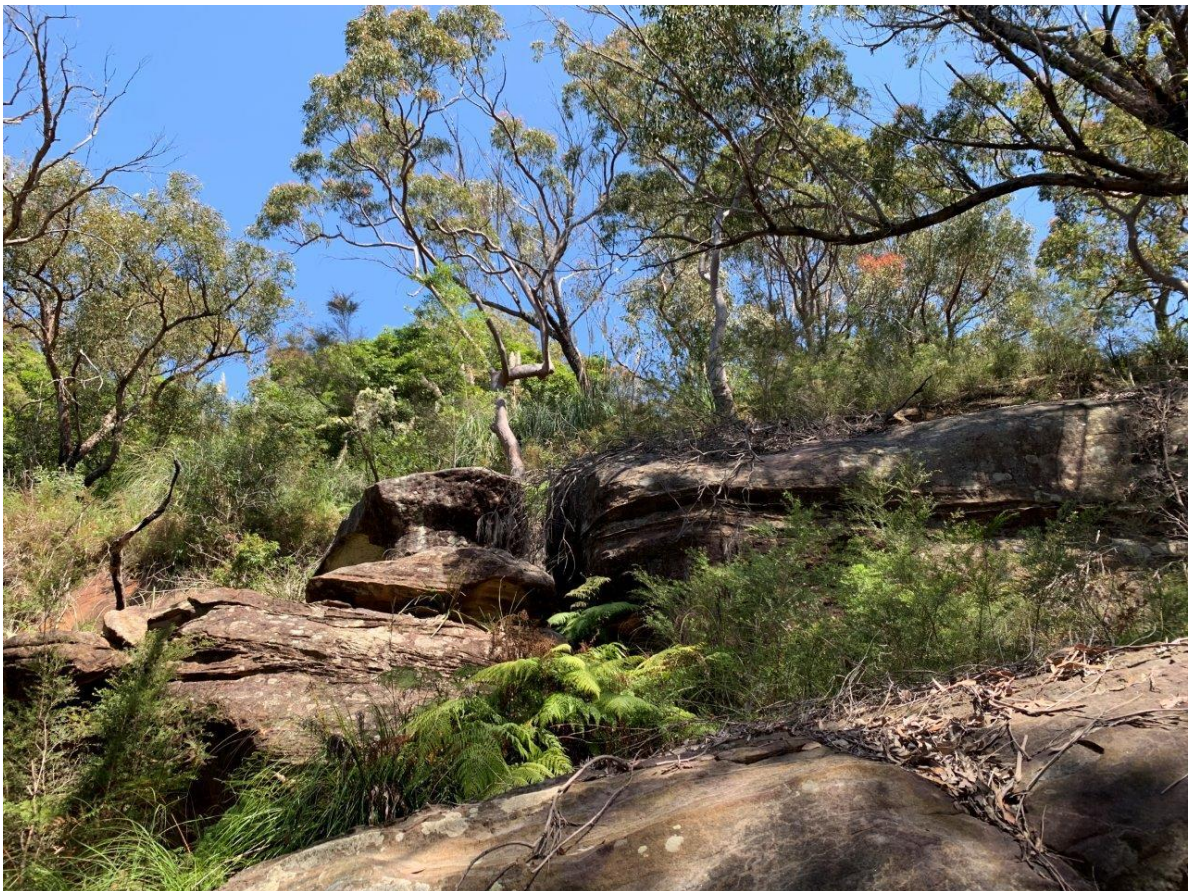
Photograph 6: View looking west, loose blocks on slope crest up to 0.8m

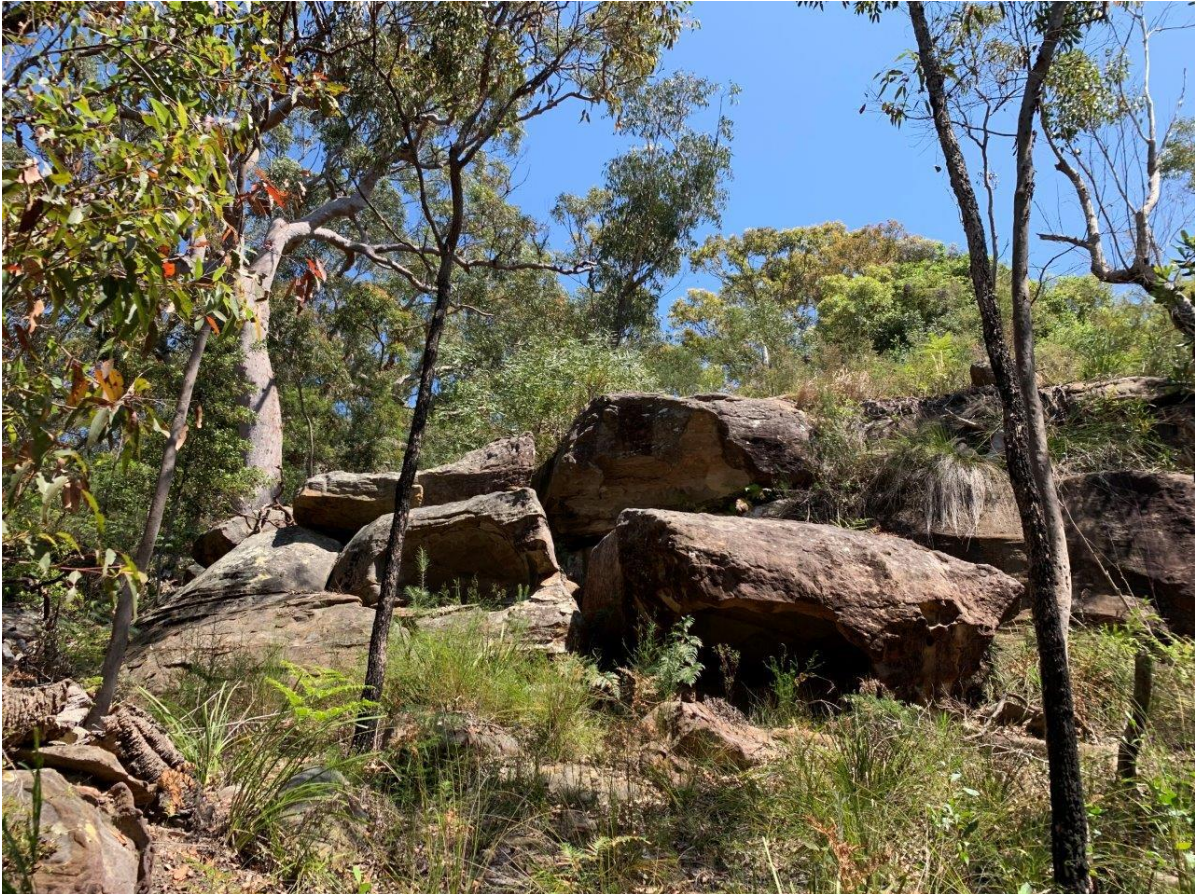
Photograph 7: View looking west, large overhangs up to 1.5m at crest

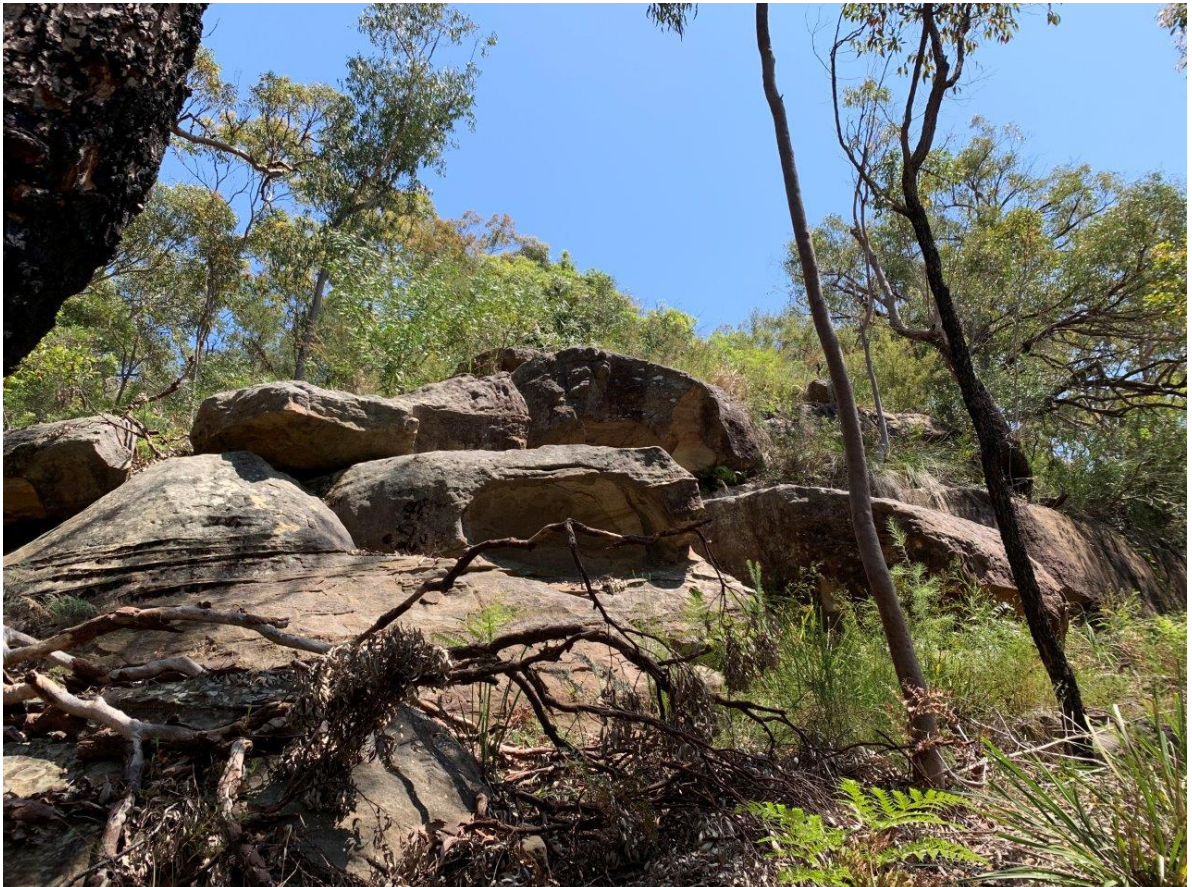
Photograph 10: View looking north-west, overhangs and loose blocks observed

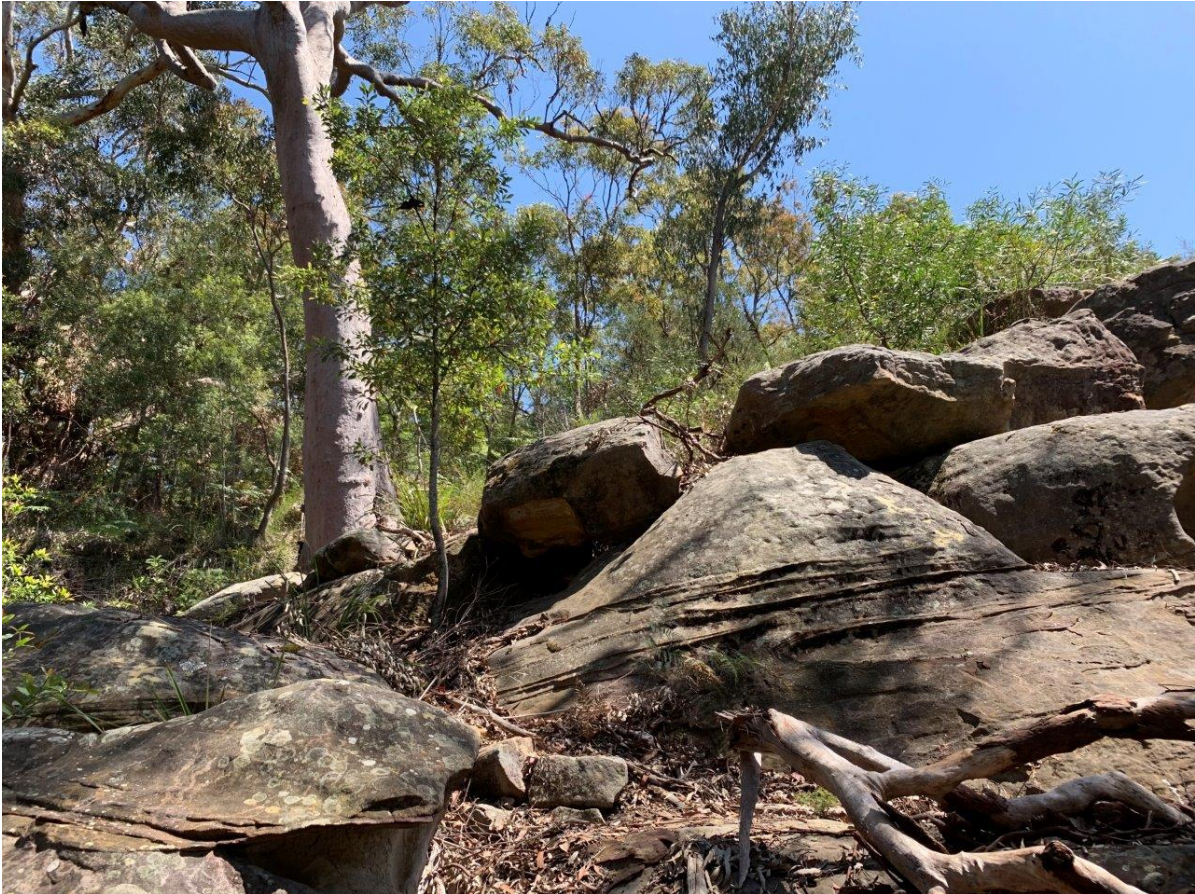
Photograph 11: View of loose blocks up to 0.8m at crest

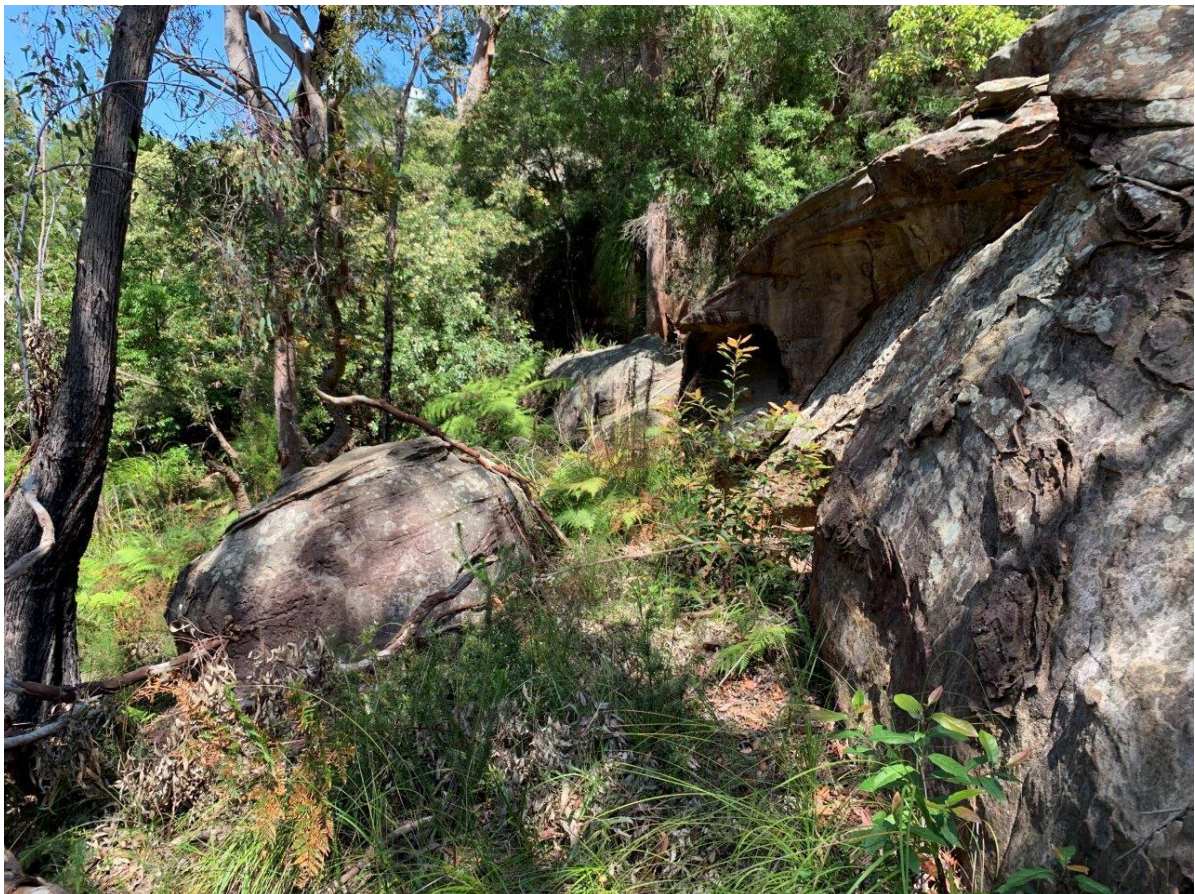
Photograph 12: View looking south-west, previous large failures observed suspect translational slide mechanism

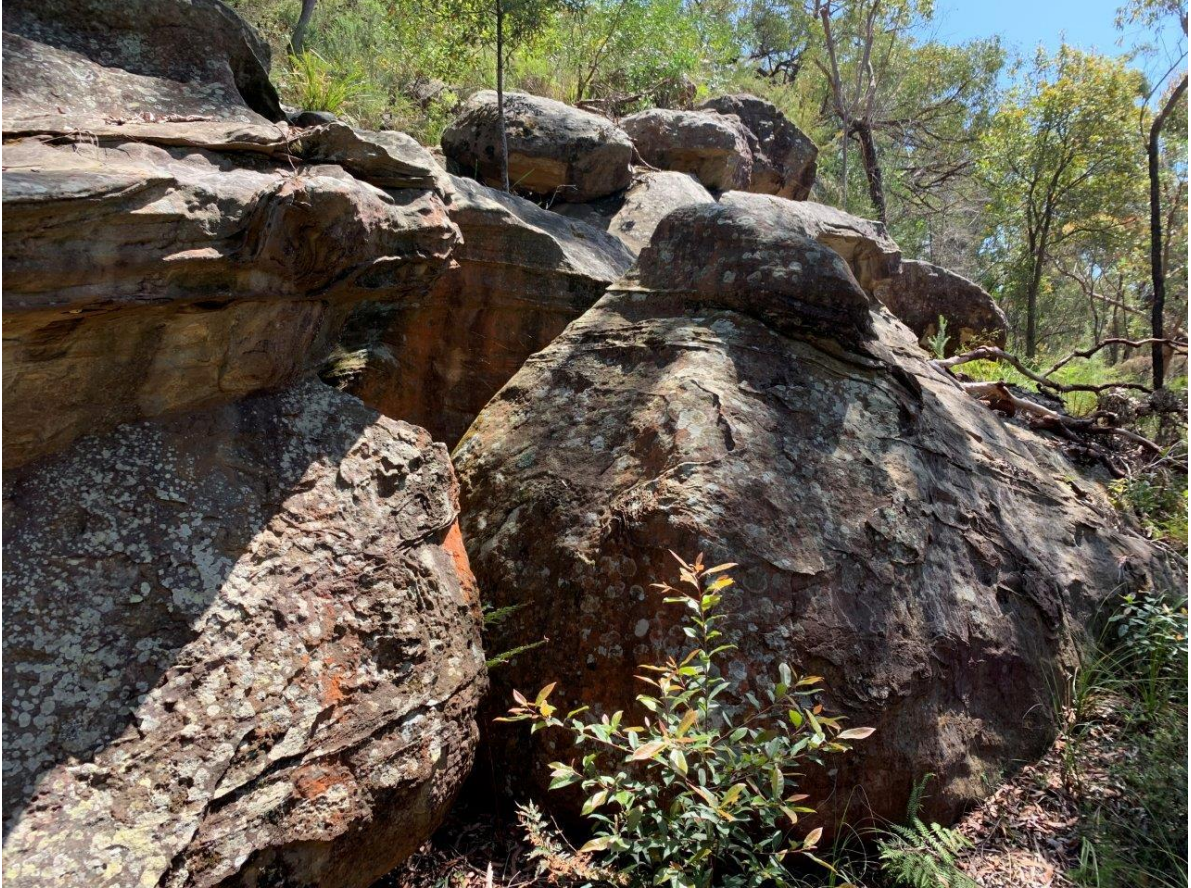
Photograph 13: View looking north along crest, large loose blocks observed

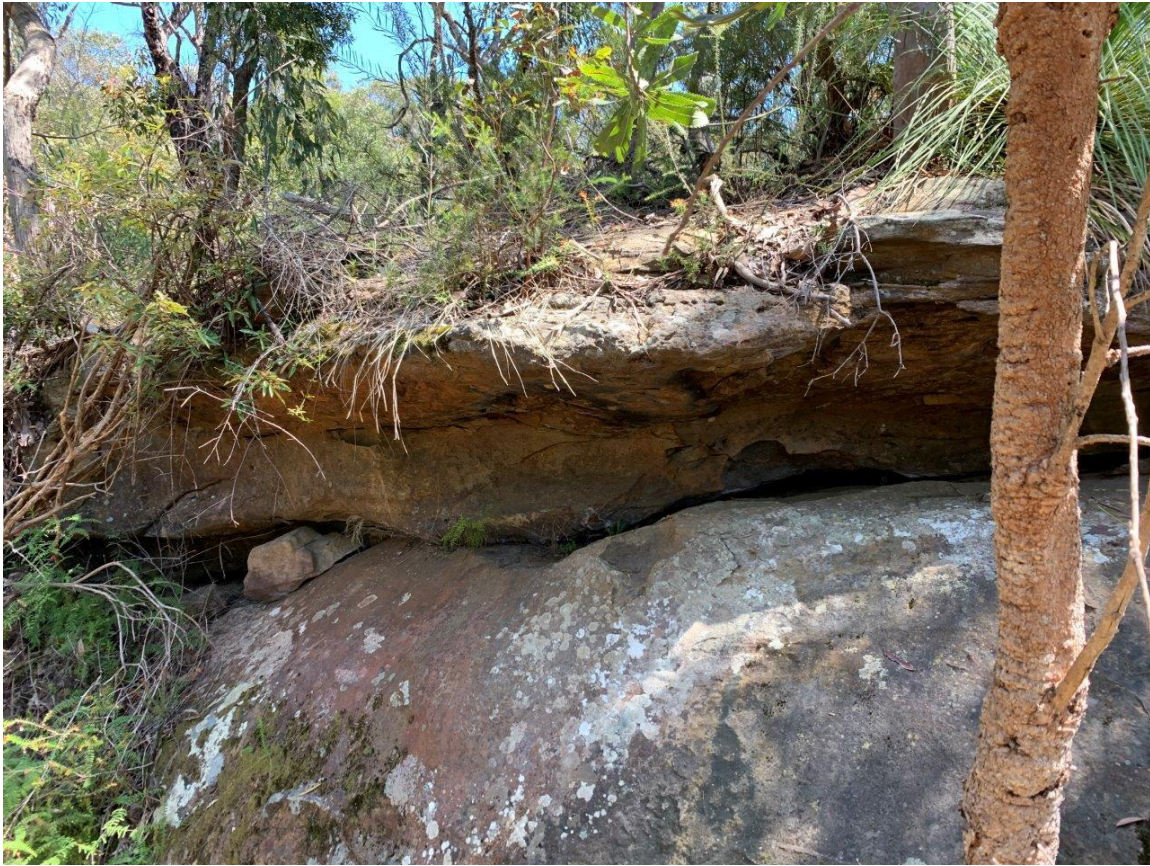
Photograph 1: Looking south, overhangs up to 0.8m observed

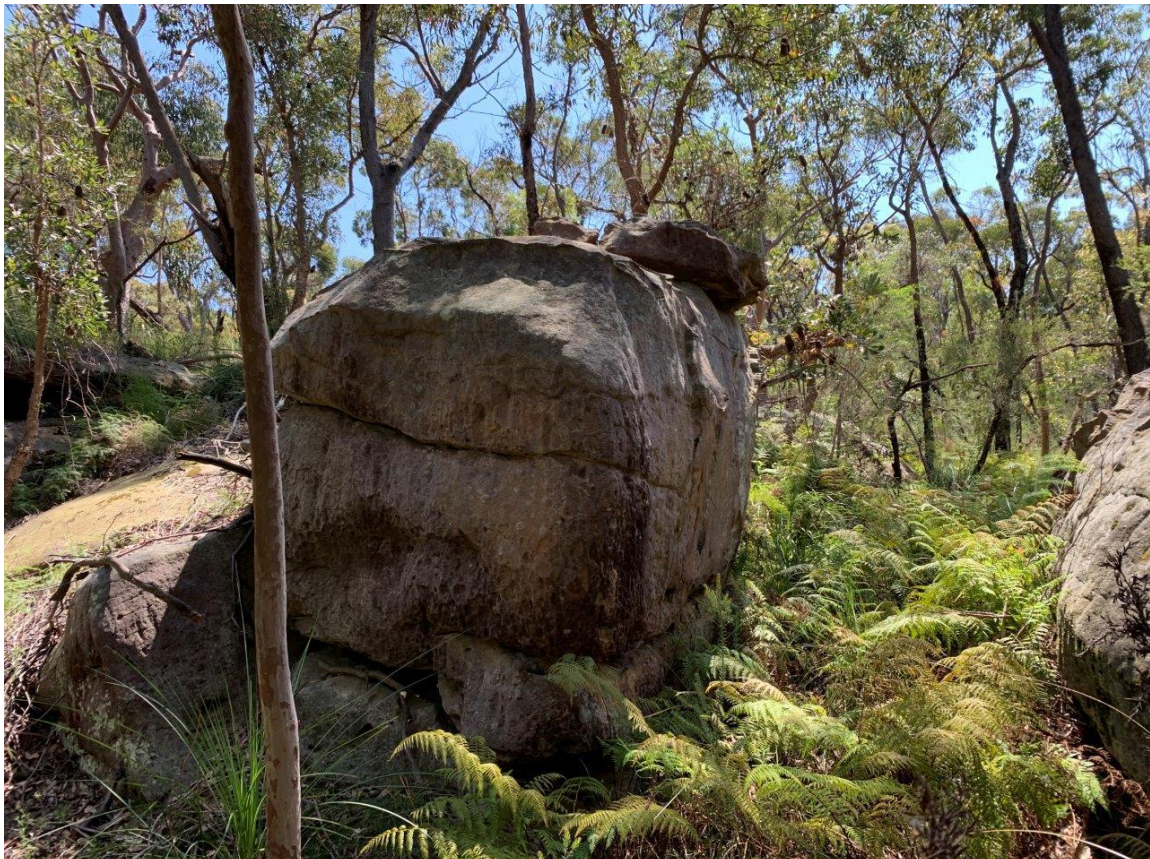
Photograph 2: View looking north-west, large boulder on slope with smaller loose block balancing on top

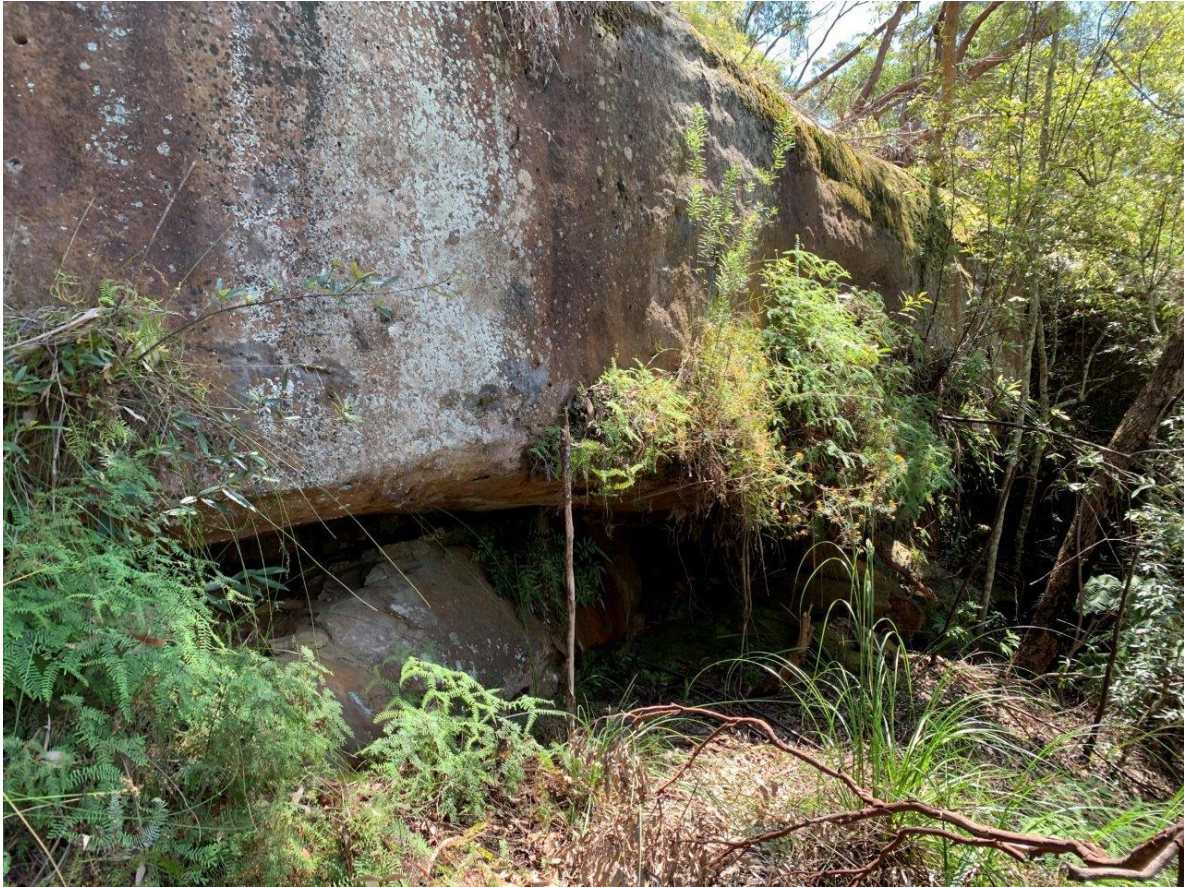
Photograph 3: View looking north-west, large sandstone bed with up to 2.5m undercut

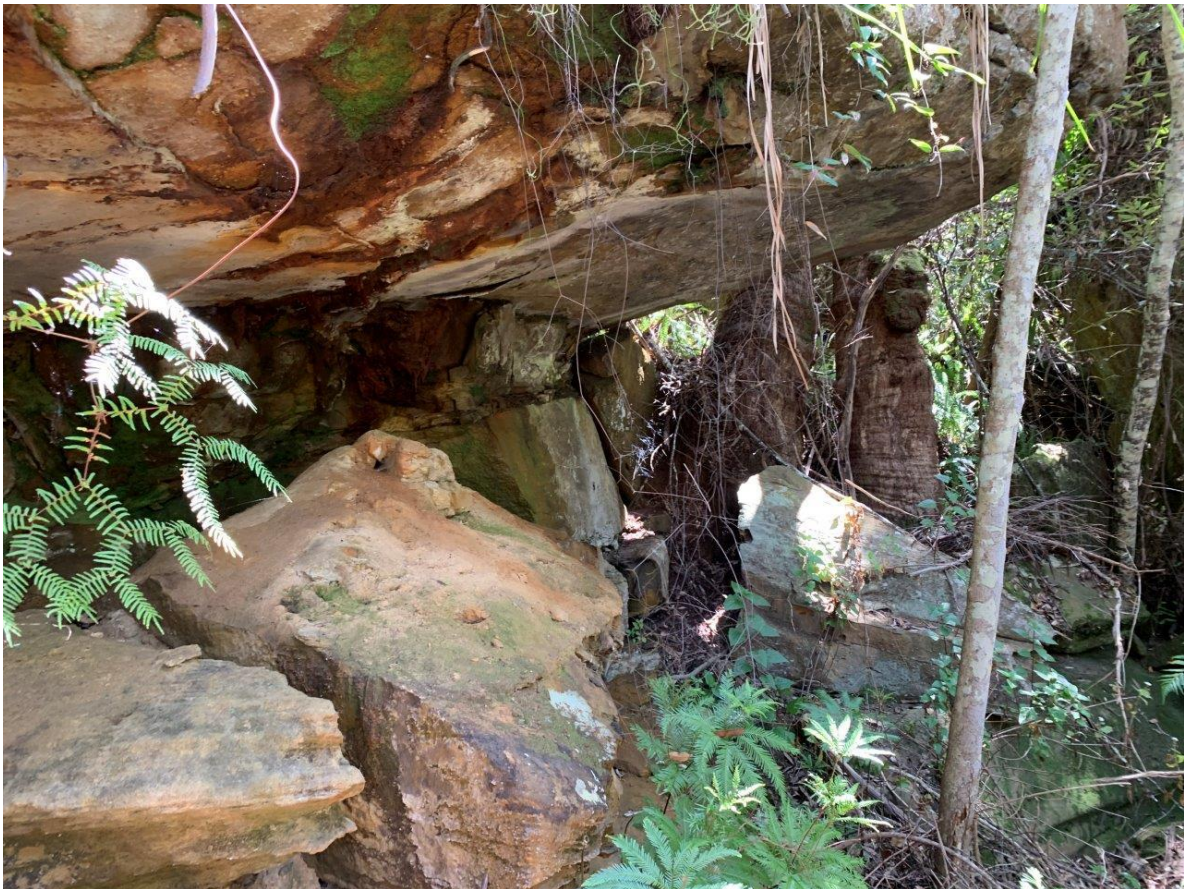
Photograph 4: View underneath large sandstone bed, loose fallen blocks underneath

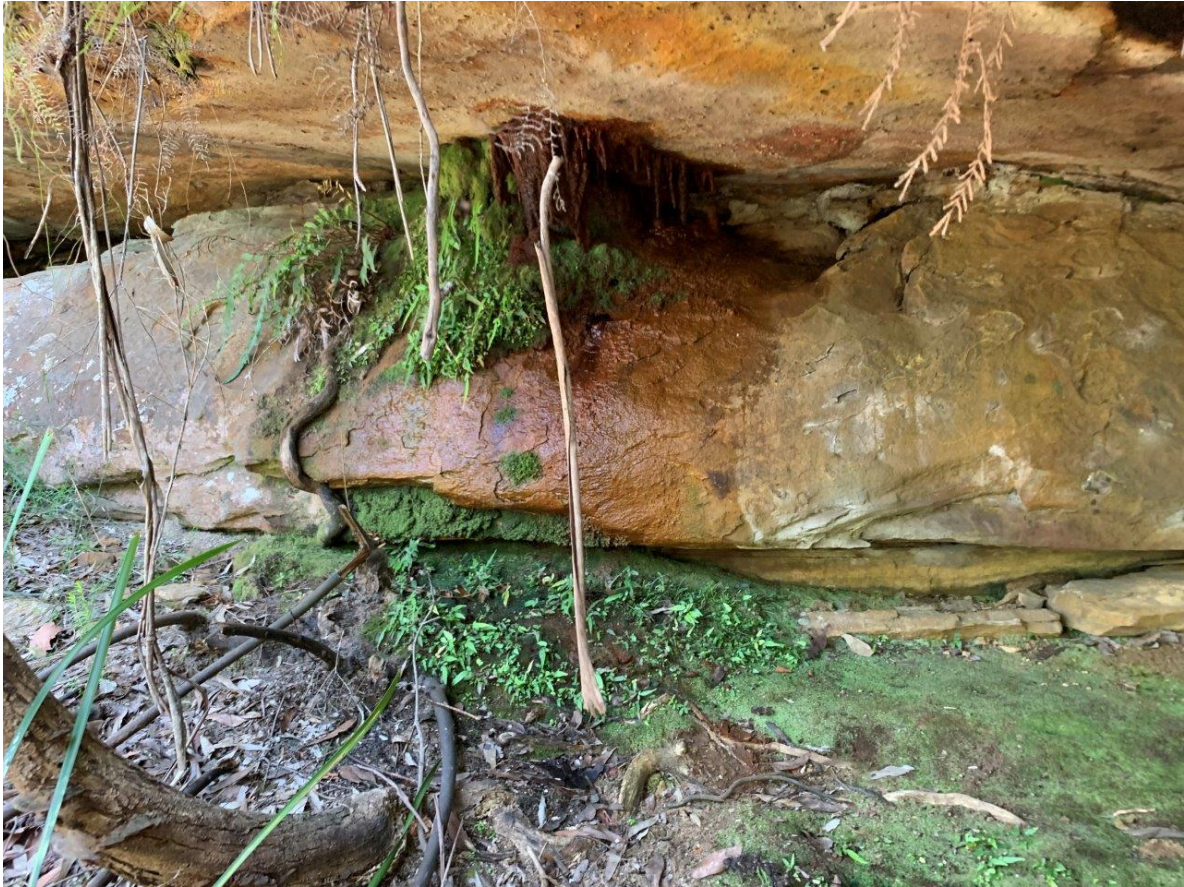
Photograph 5: View underneath undercut sandstone bed, water seepage observed

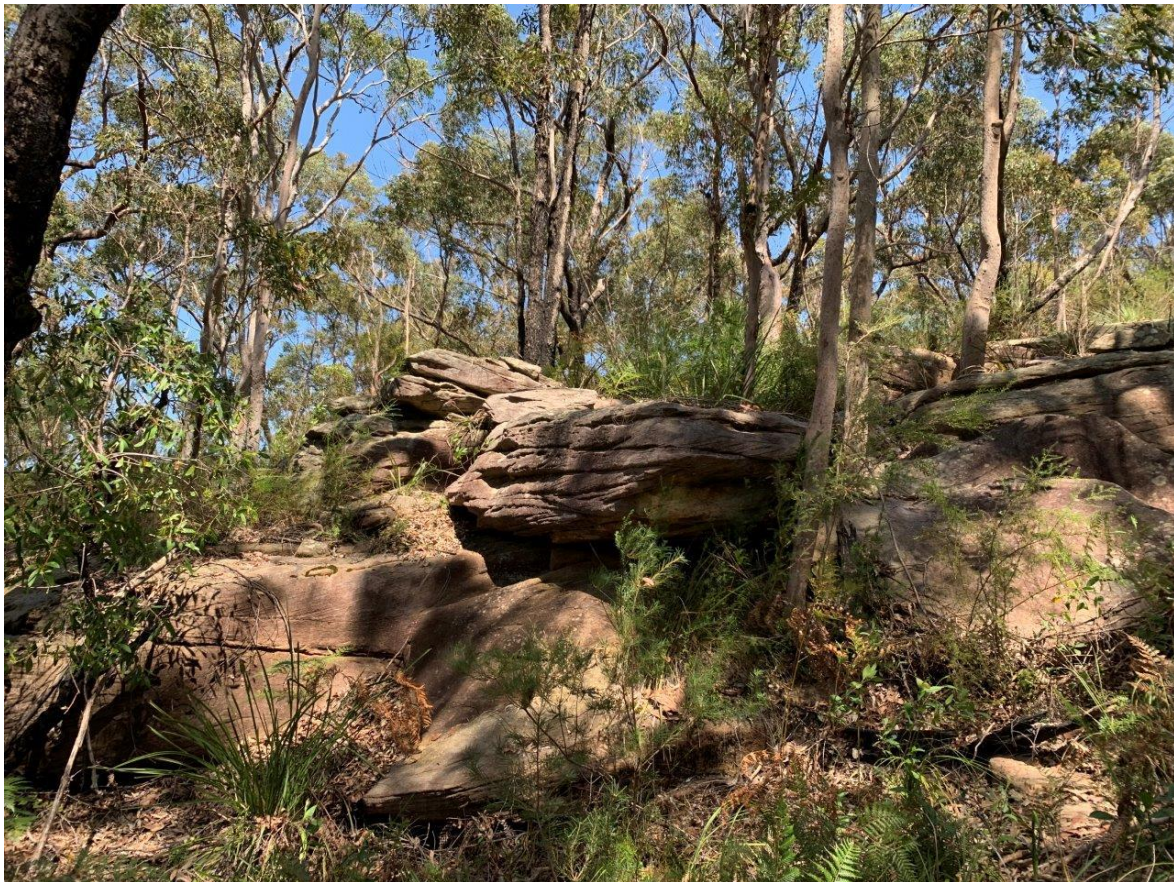
Photograph 10: View looking south-west, loose undercut blocks on slope

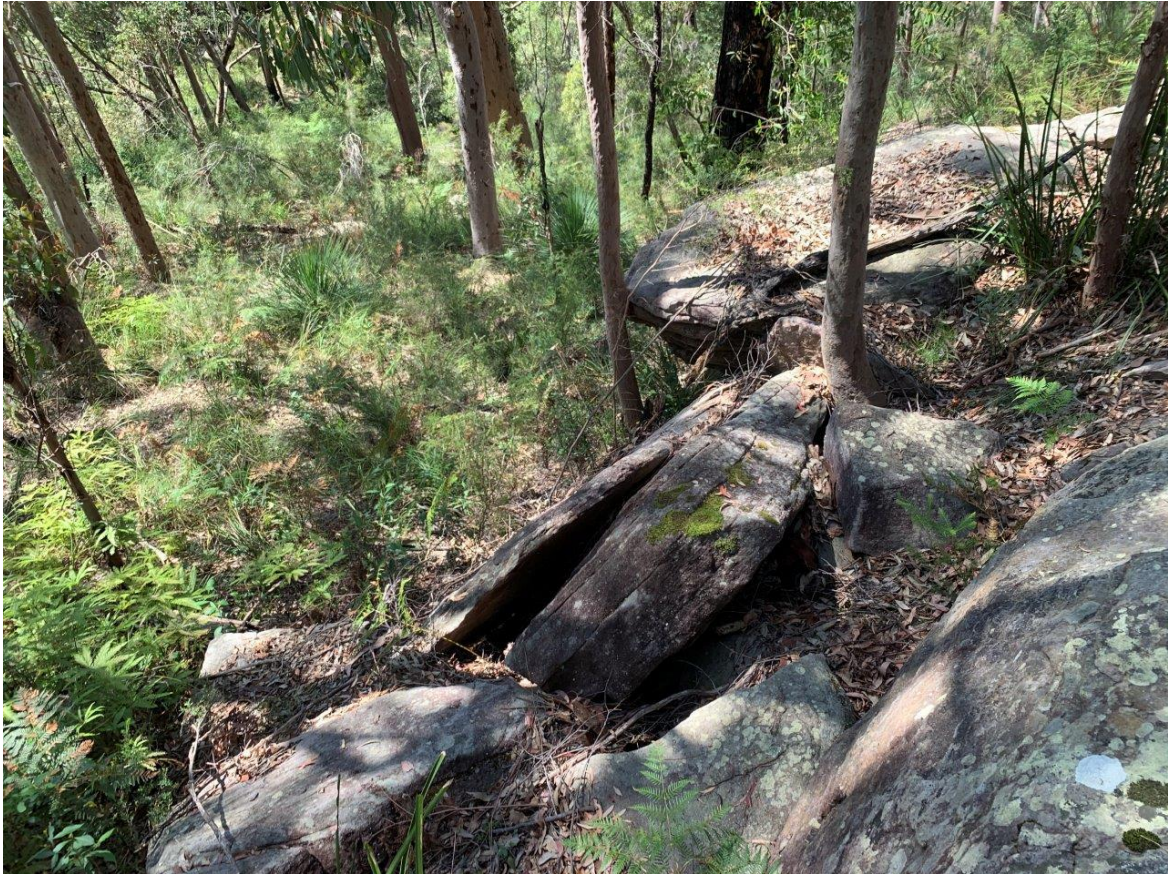
Photograph 11: View looking east, previous fallen blocks at toe, up to 0.6m

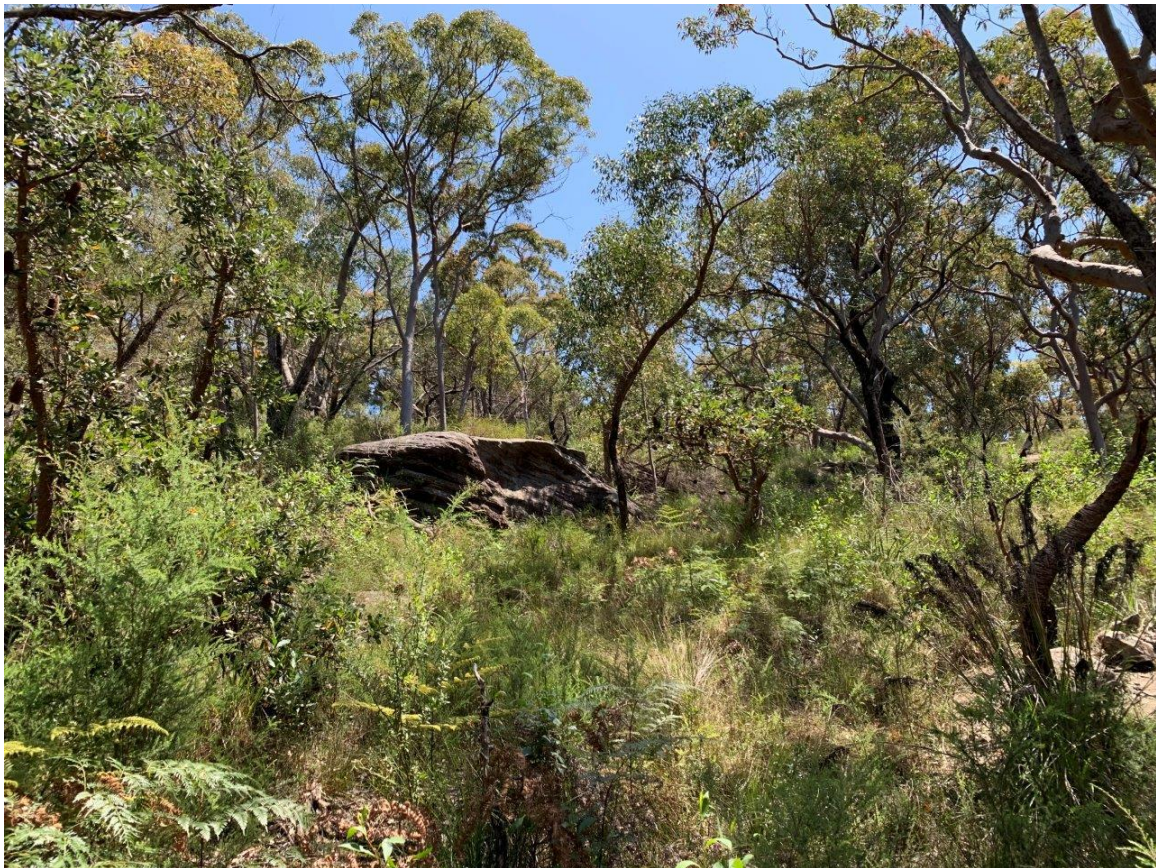
Photograph 12: View looking west, loose sandstone blocks on slope

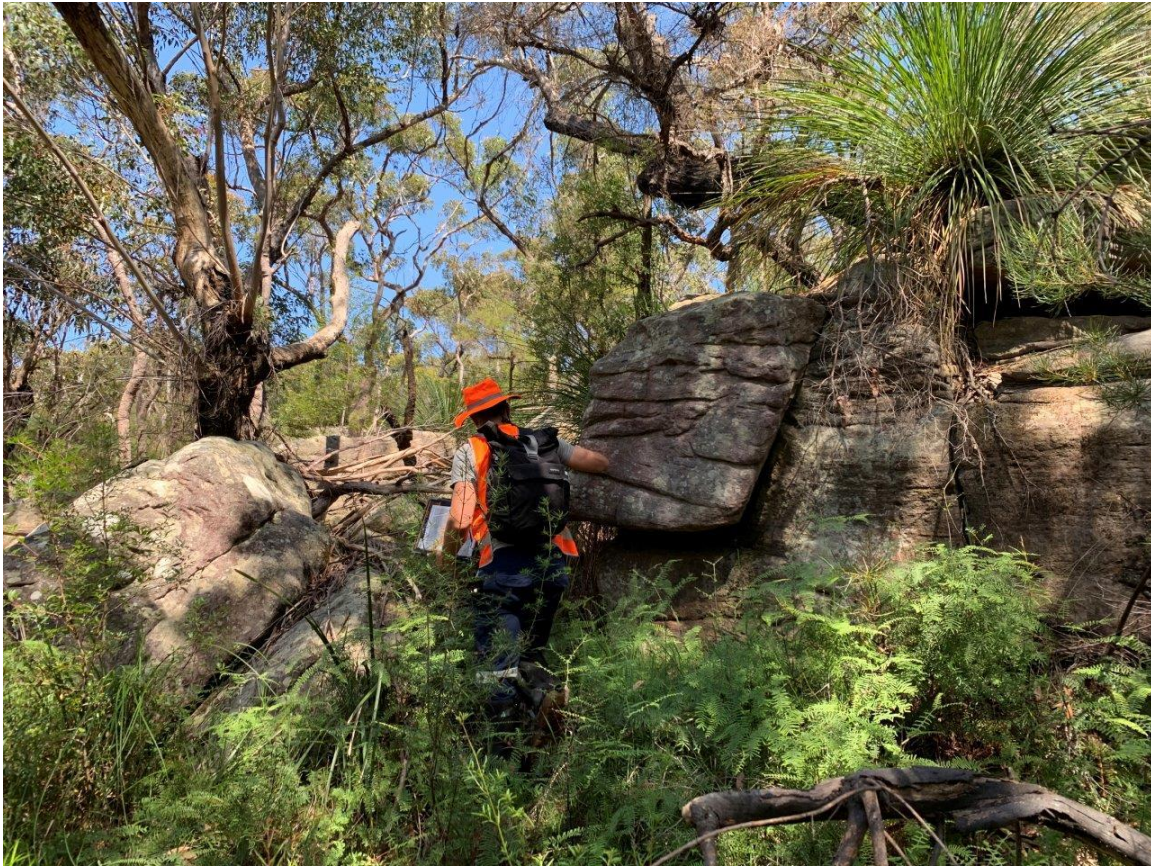
Photograph 1: View looking west, loose undercut block up to 1m

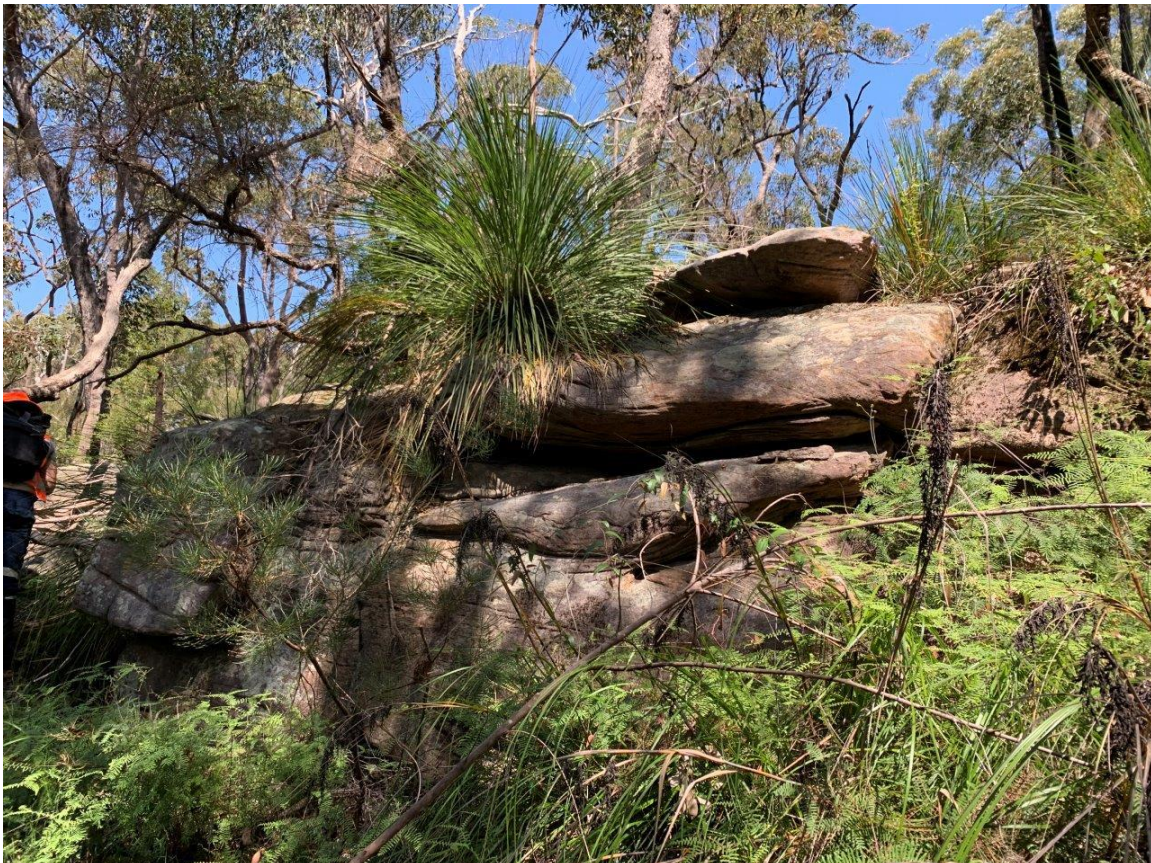
Photograph 2: View looking west, view undercut sandstone beds

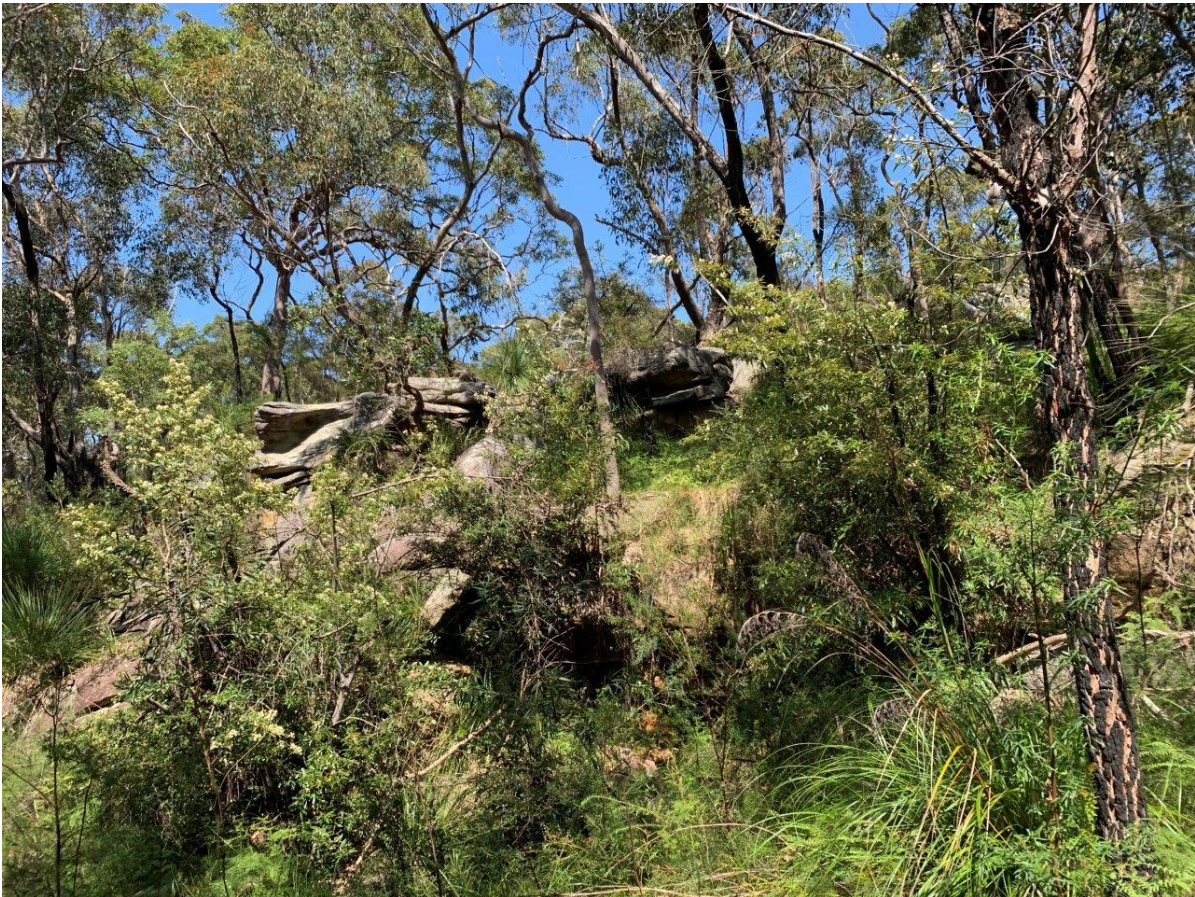
Photograph 4: View looking south towards slope crest, overhangs and loose blocks observed

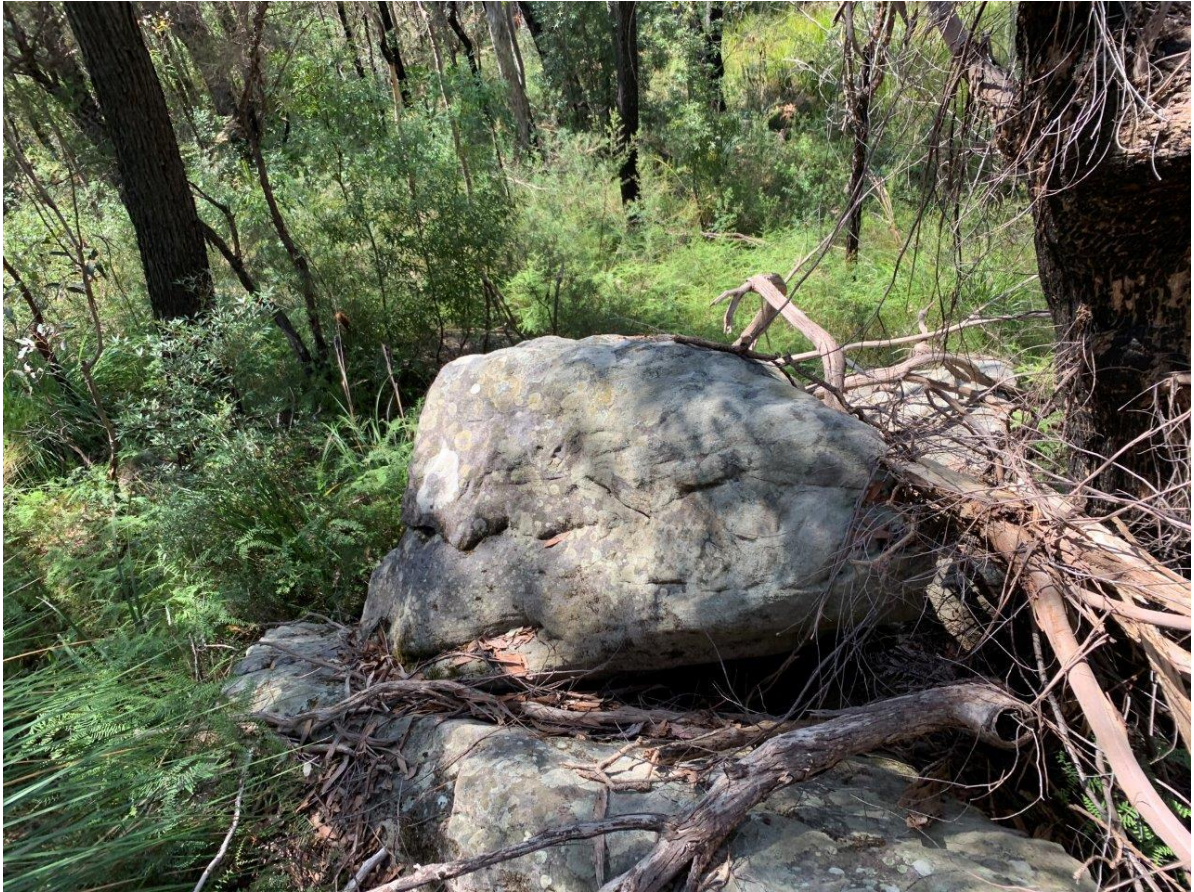
Photograph 5: View of large fallen block on slope

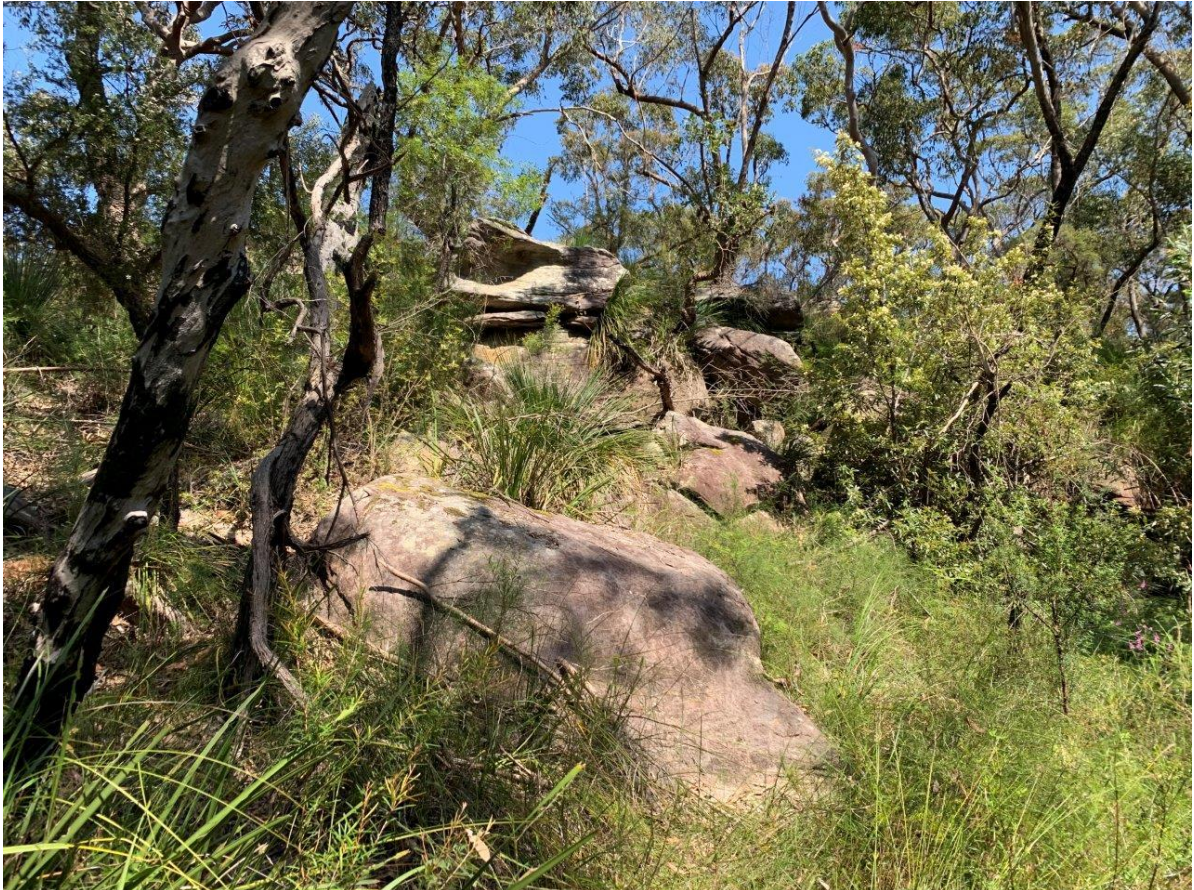
Photograph 6: View looking west towards crest of precipice, overhangs and undercut blocks observed

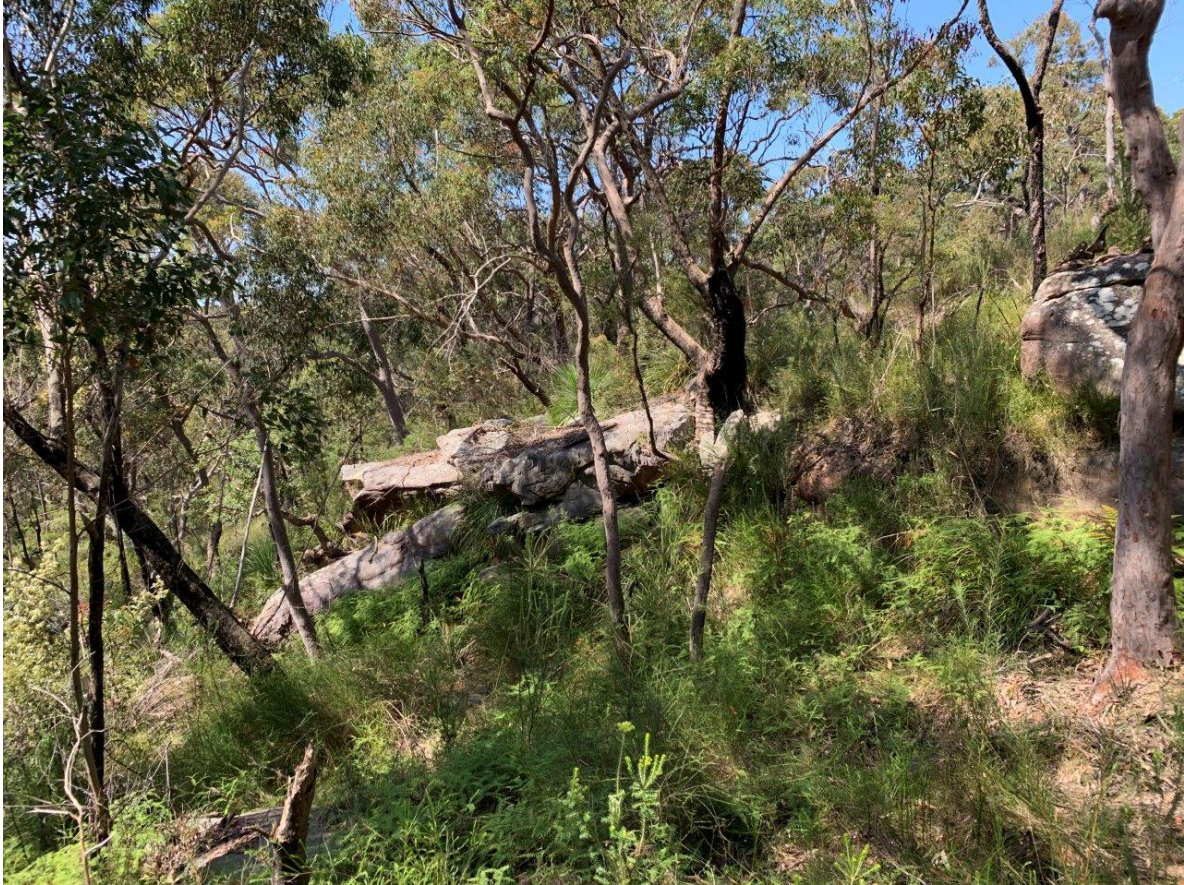
Photograph 7: View looking south along crest, loose blocks along crest

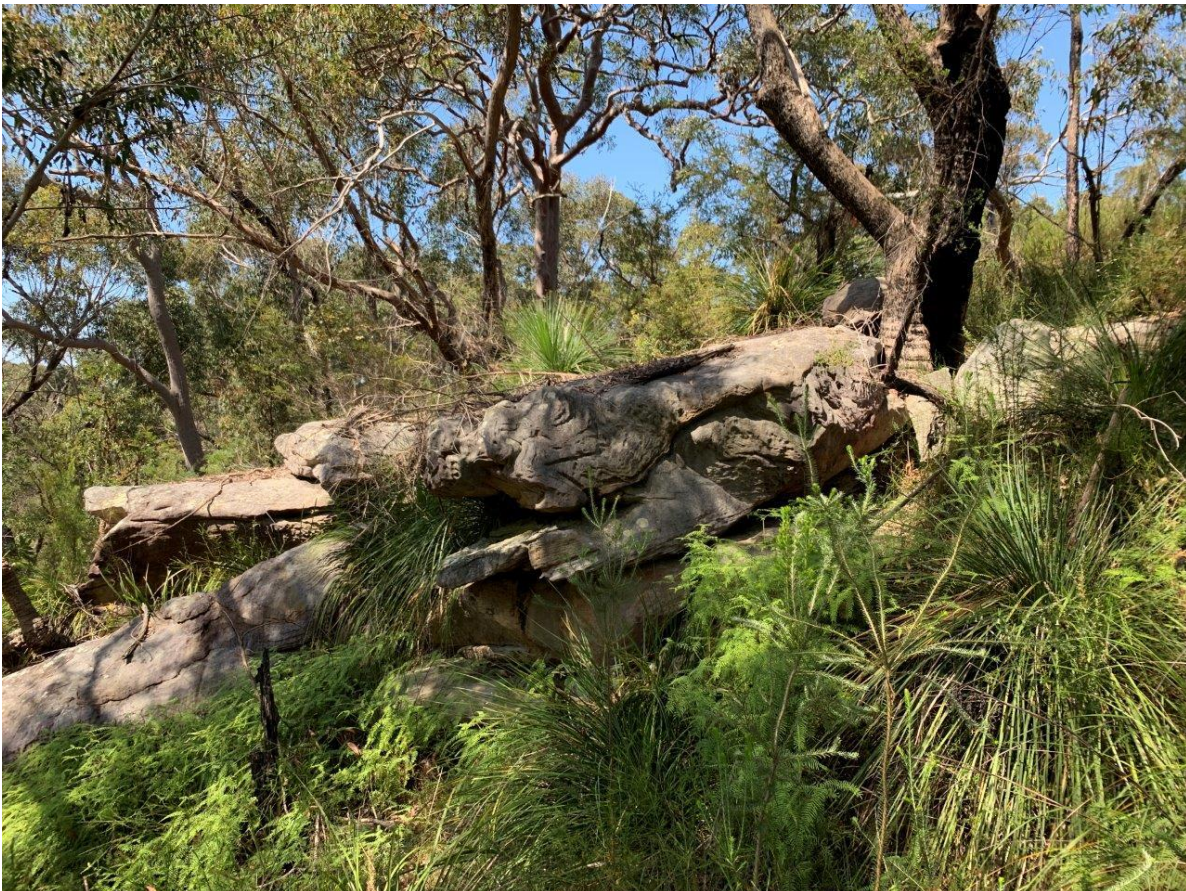
Photograph 8: View of loose block at crest, approximately 2m x 0.5m
