Slope Risk Assessment Report

Patyegarang Project

Reference No. 30012988
Prepared for Metropolitan Local Aboriginal Land Council
14 July 2023

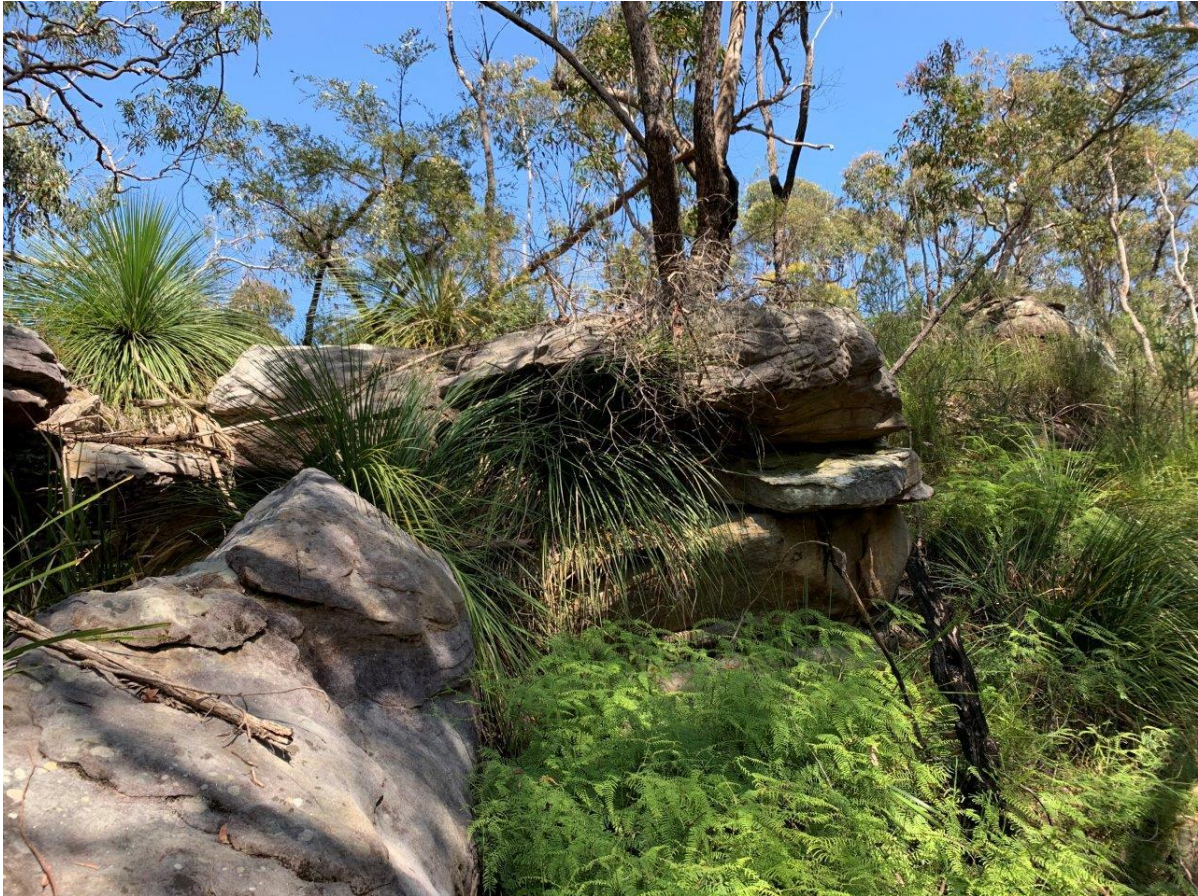
Photograph 9: View looking west, loose blocks and overhangs at crest

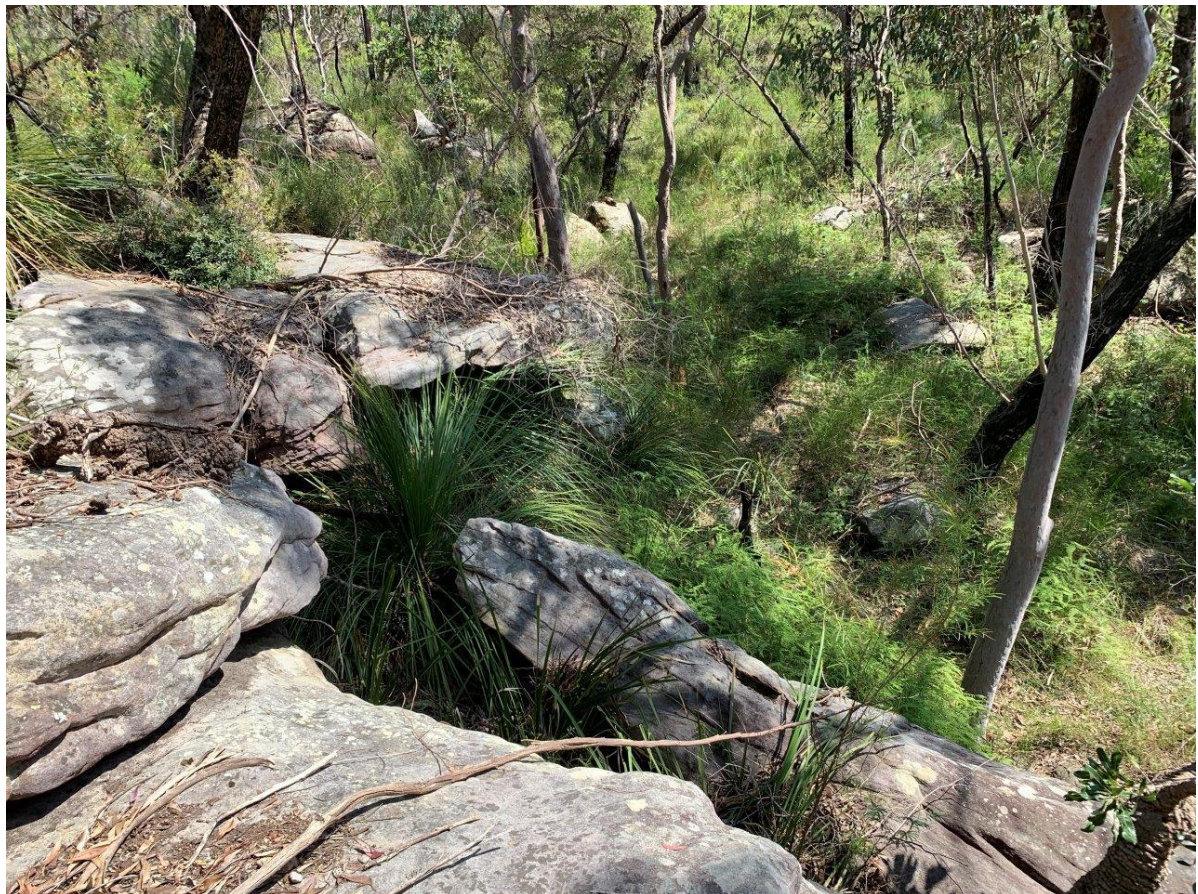
Photograph 10: View looking north, previous large fallen blocks from overhangs

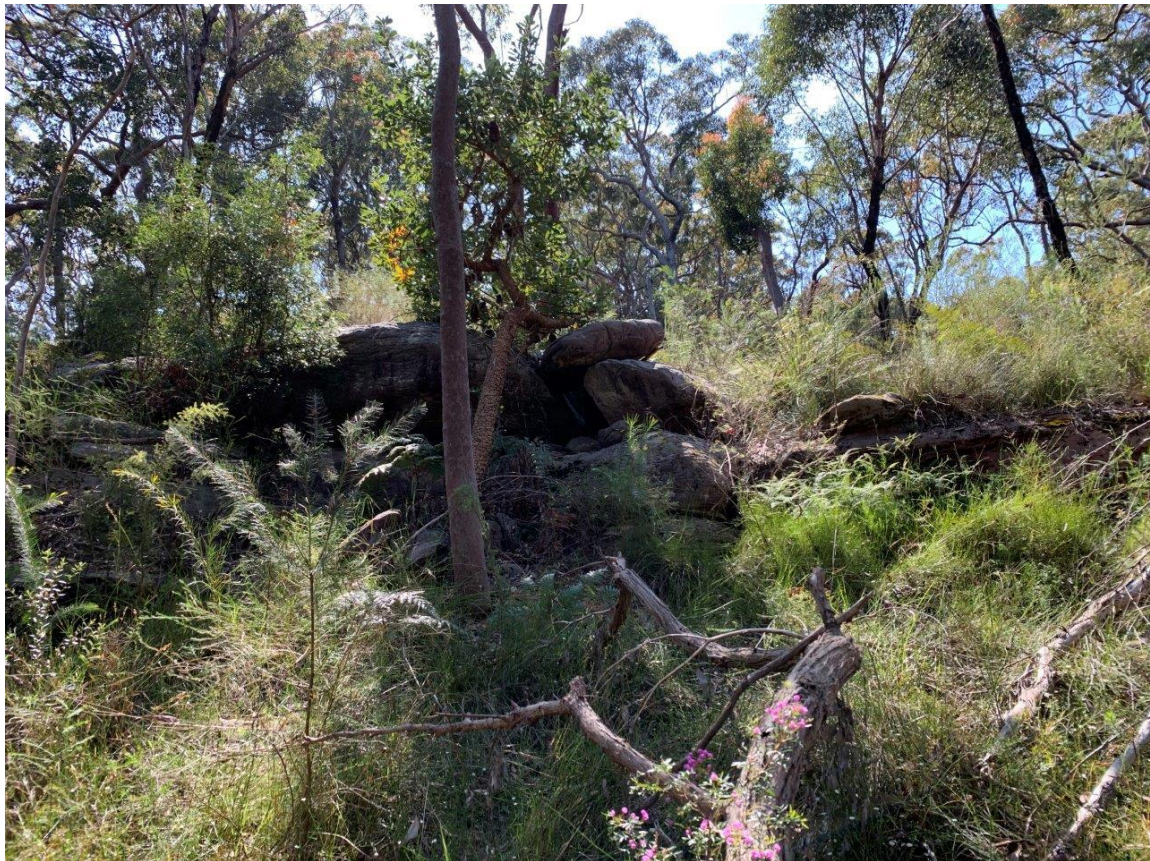
Photograph 2: View looking east, loose boulders and block at crest

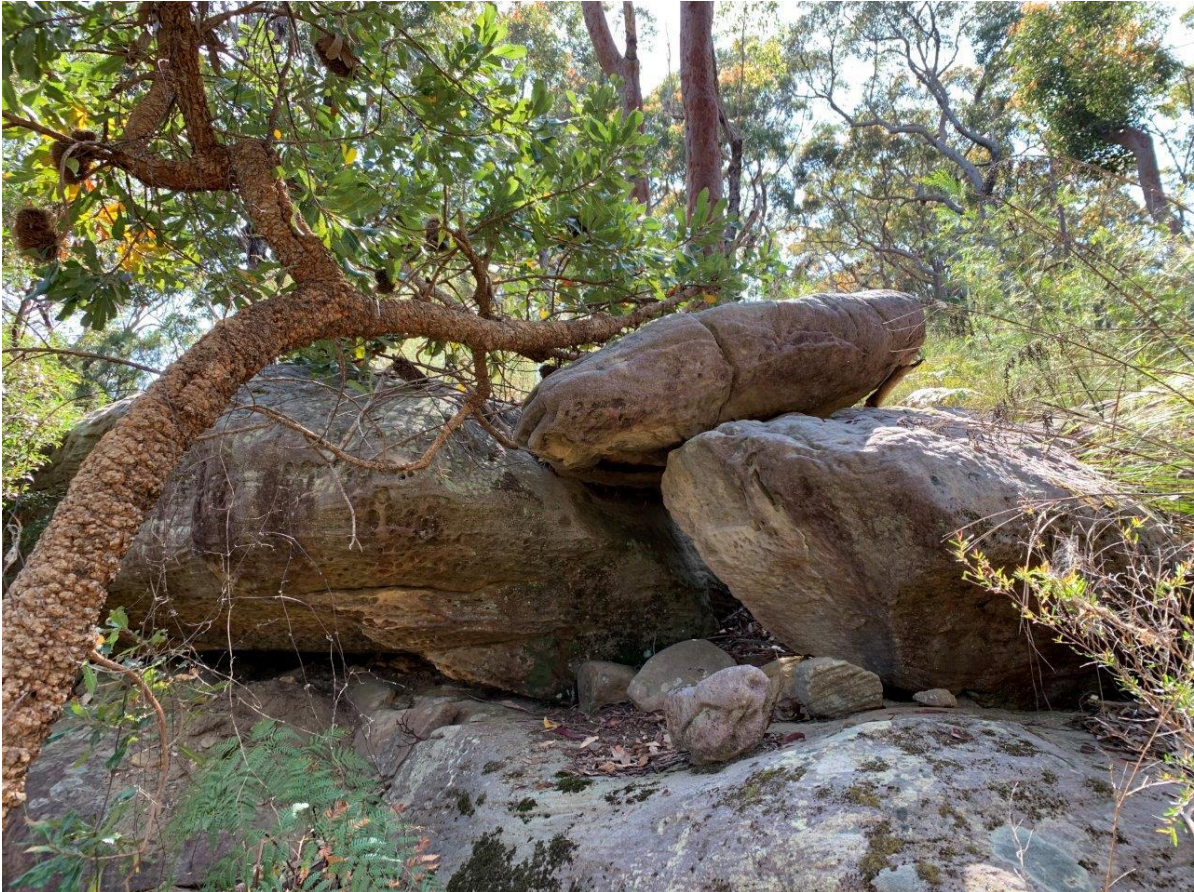
Photograph 3: View of loose undercut blocks at crest

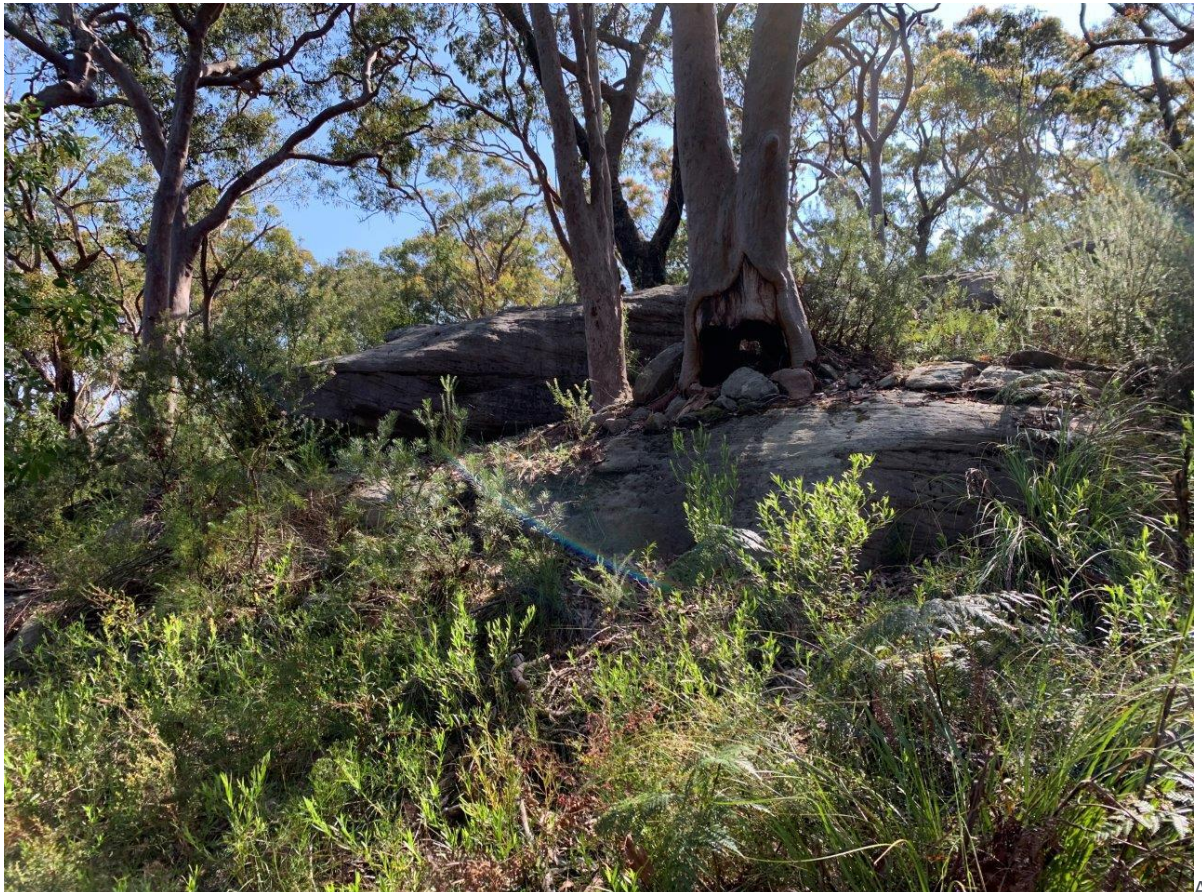
Photograph 4: View of hollow mature tree and undercut blocks at crest

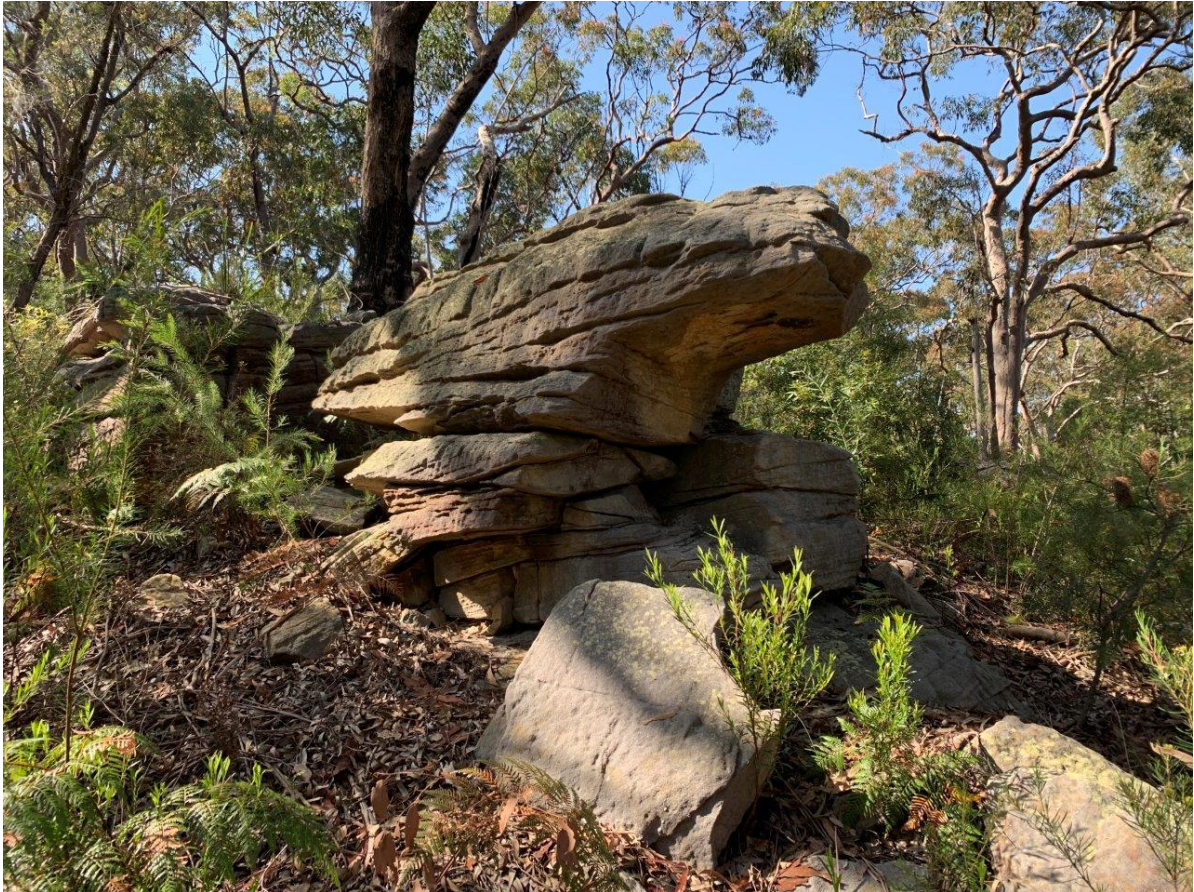
Photograph 5: View looking south-east, view of large block (~0.8m x 2m) potential topple failure

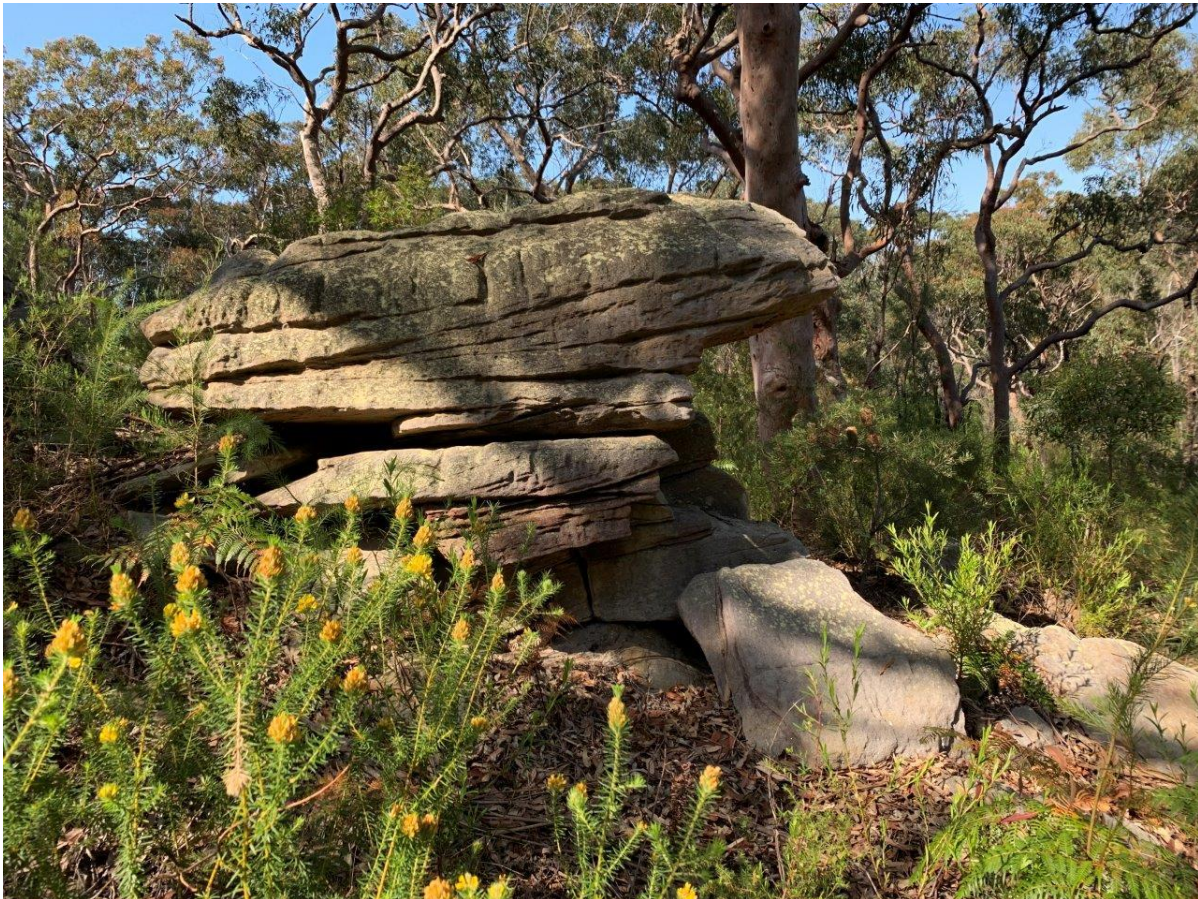
Photograph 6: View of overhangs and loose blocks on slope

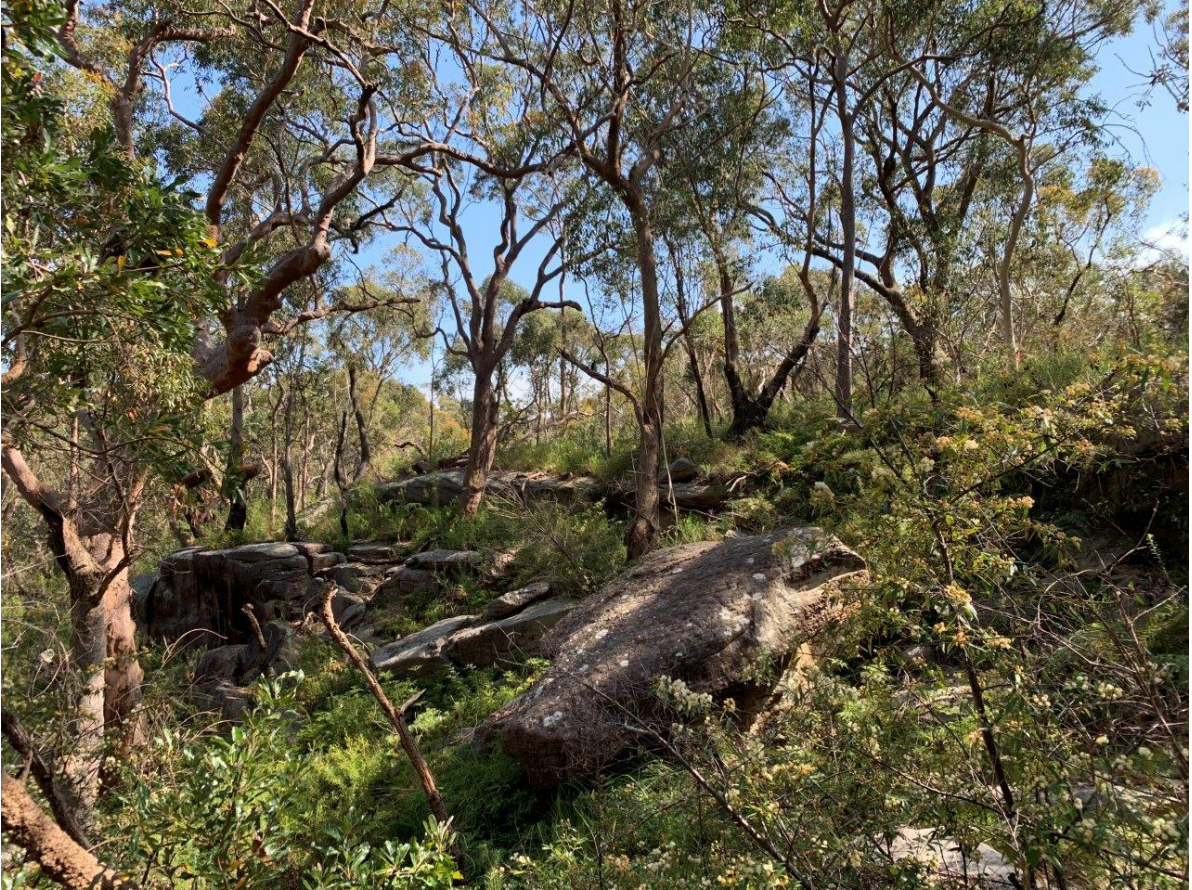
Photograph 7: View looking north-east, large previous falls/topple failures

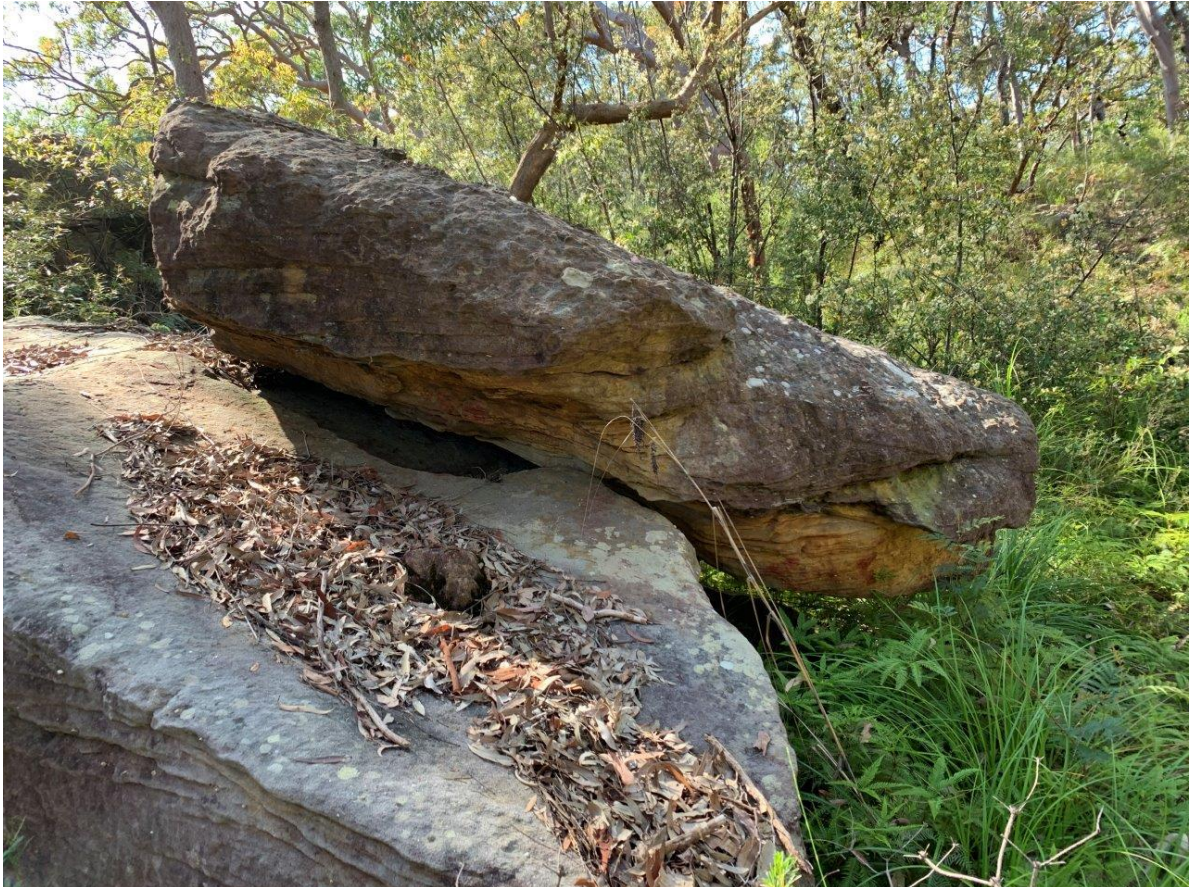
Photograph 8: View of previous large fall/topple, 1.5m x 5m

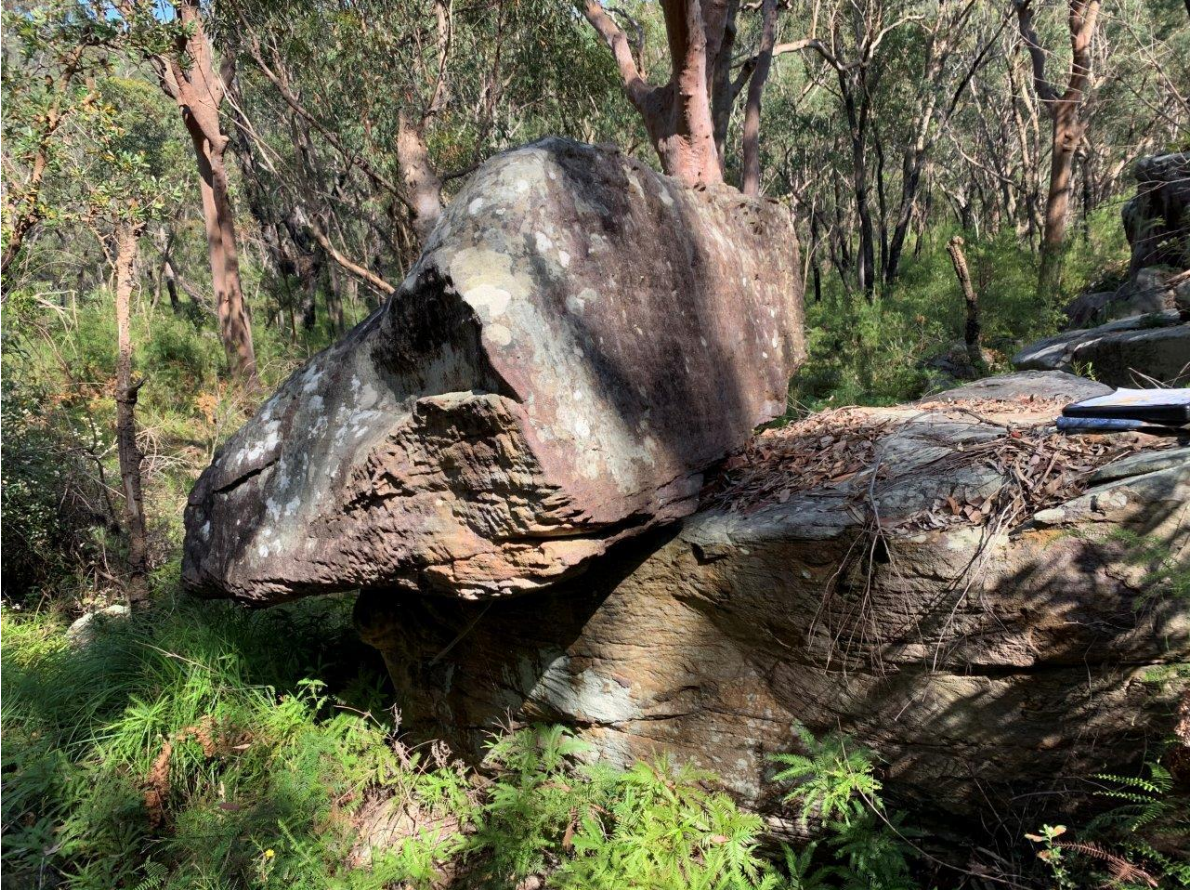
Photograph 9: View looking west of previous large failure

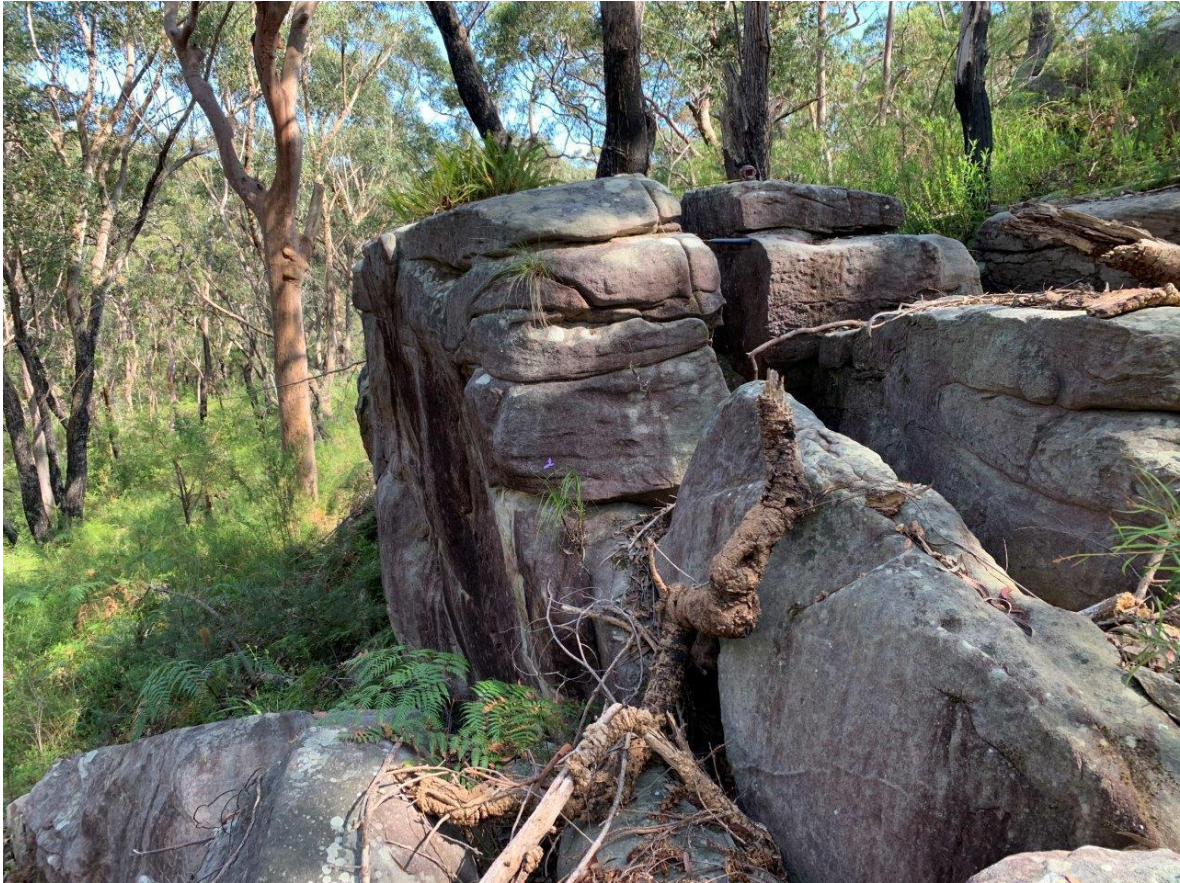
Photograph 11: View looking north along ~4.3m high sandstone precipice, large void observed behind face

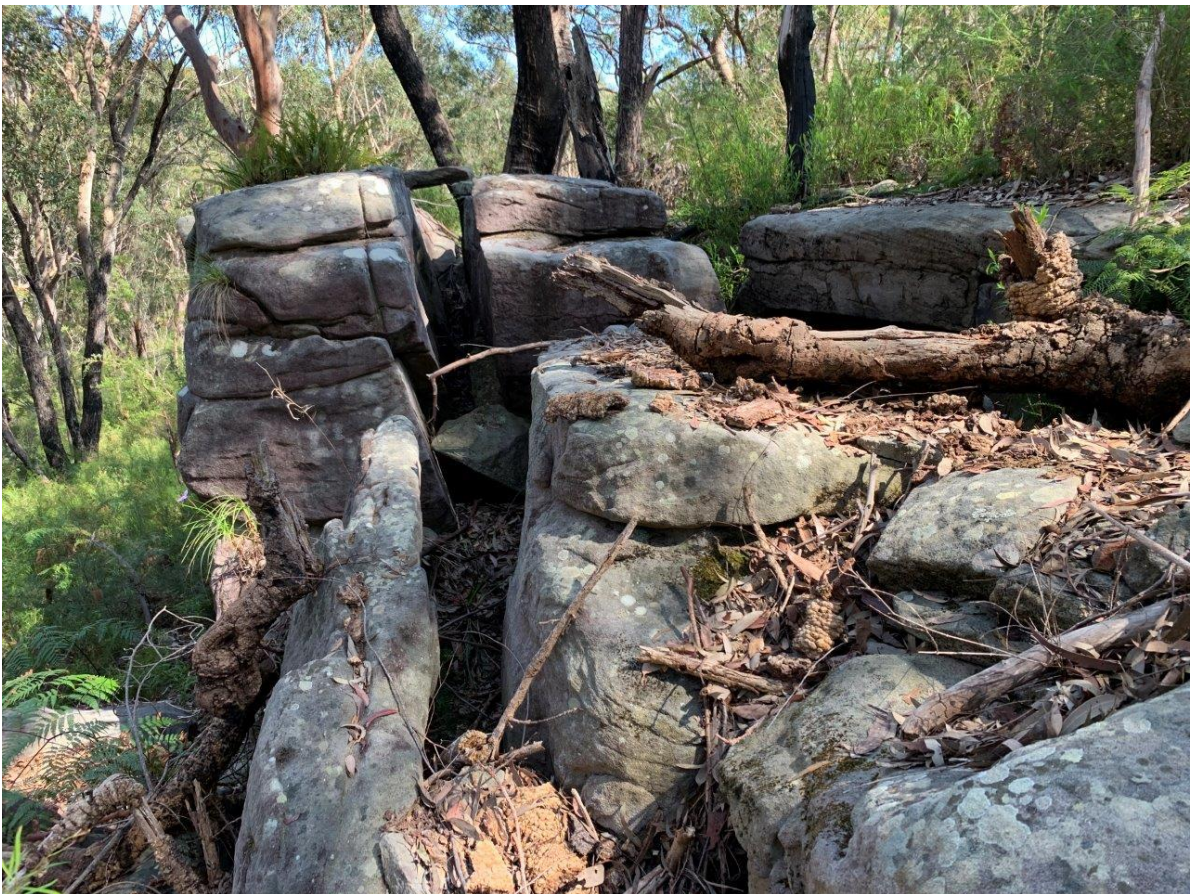
Photograph 12: View of large void approximately 0.35m wide and 1.3m deep, vegetation debris blocking truth depth

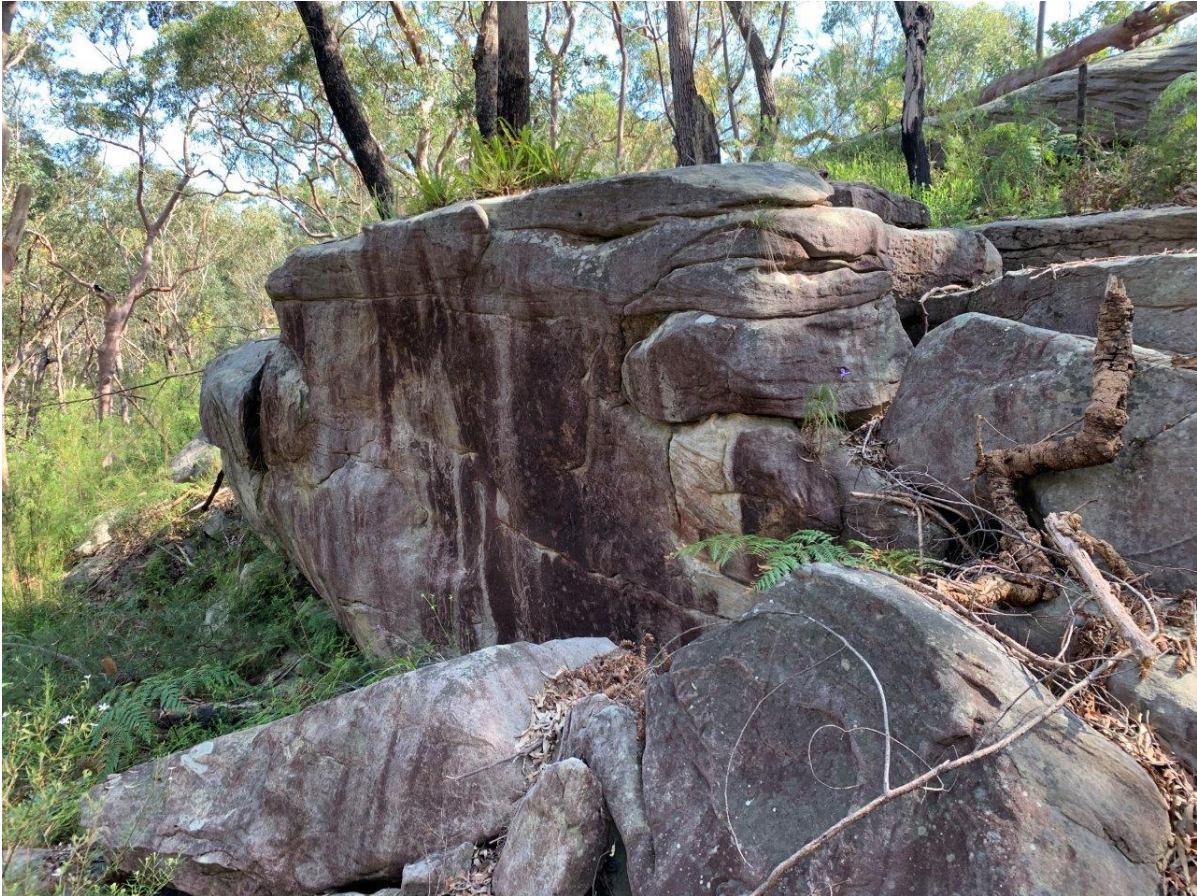
Photograph 13: View looking north-east at face of precipice, high potential of topple failure with large void behind face

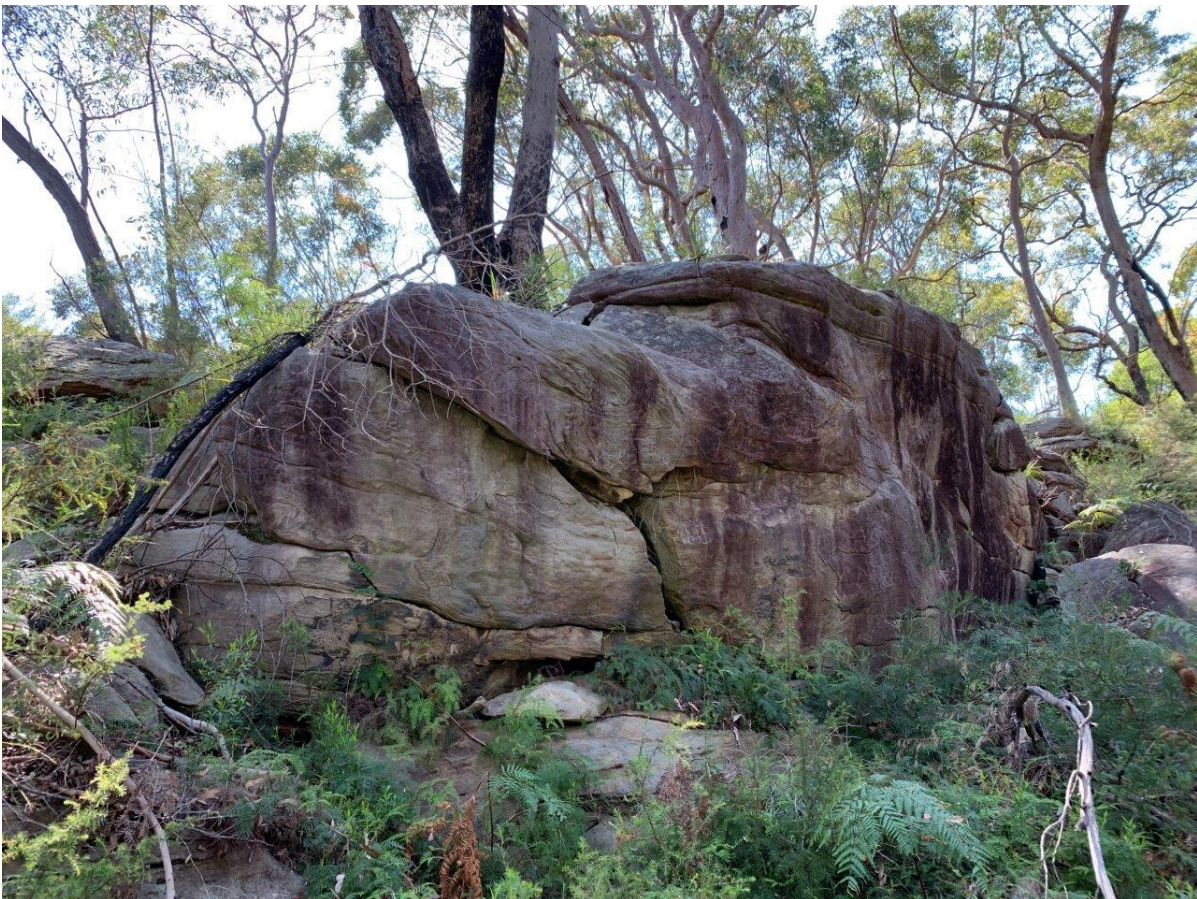
Photograph 14: View looking south-east at cracks within sandstone precipice

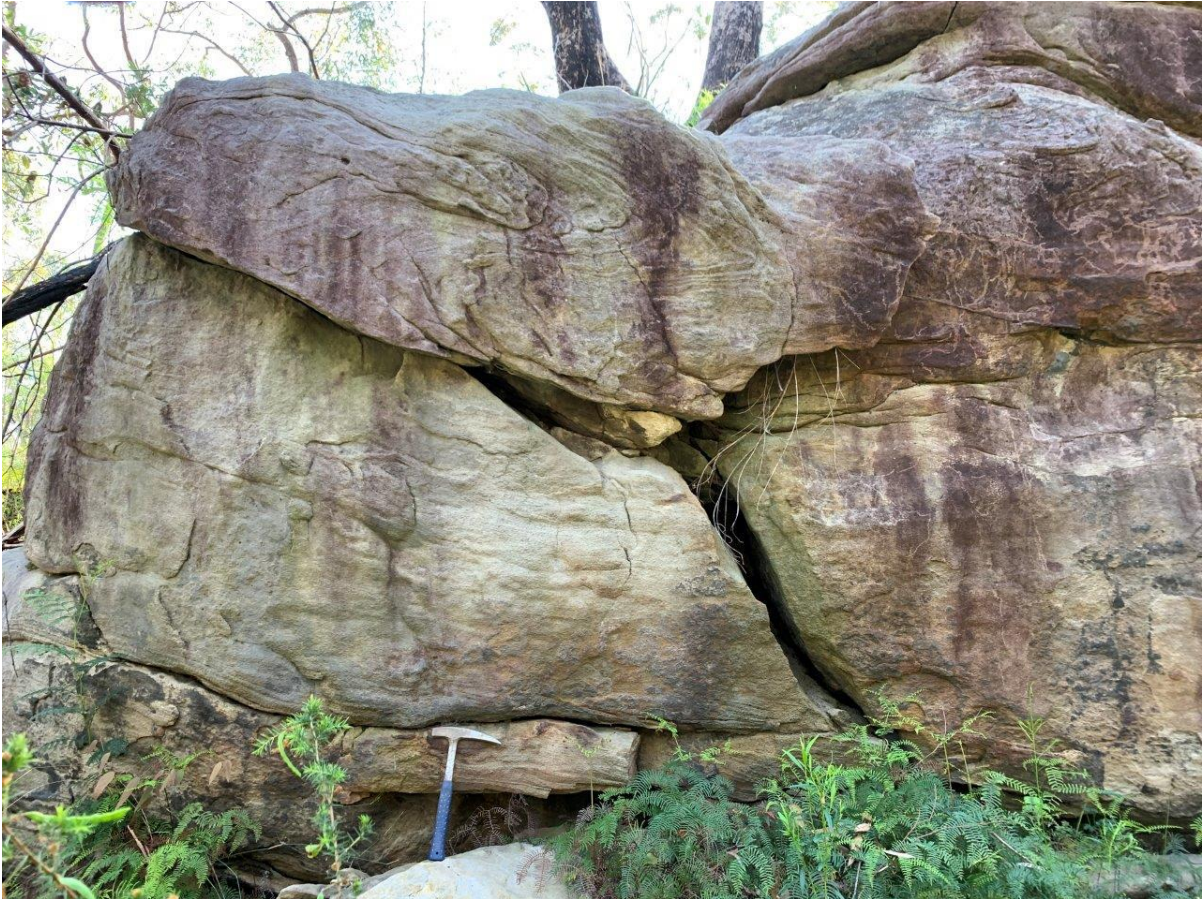
Photograph 15: View of open cracks within sandstone face, potential of fall/topple

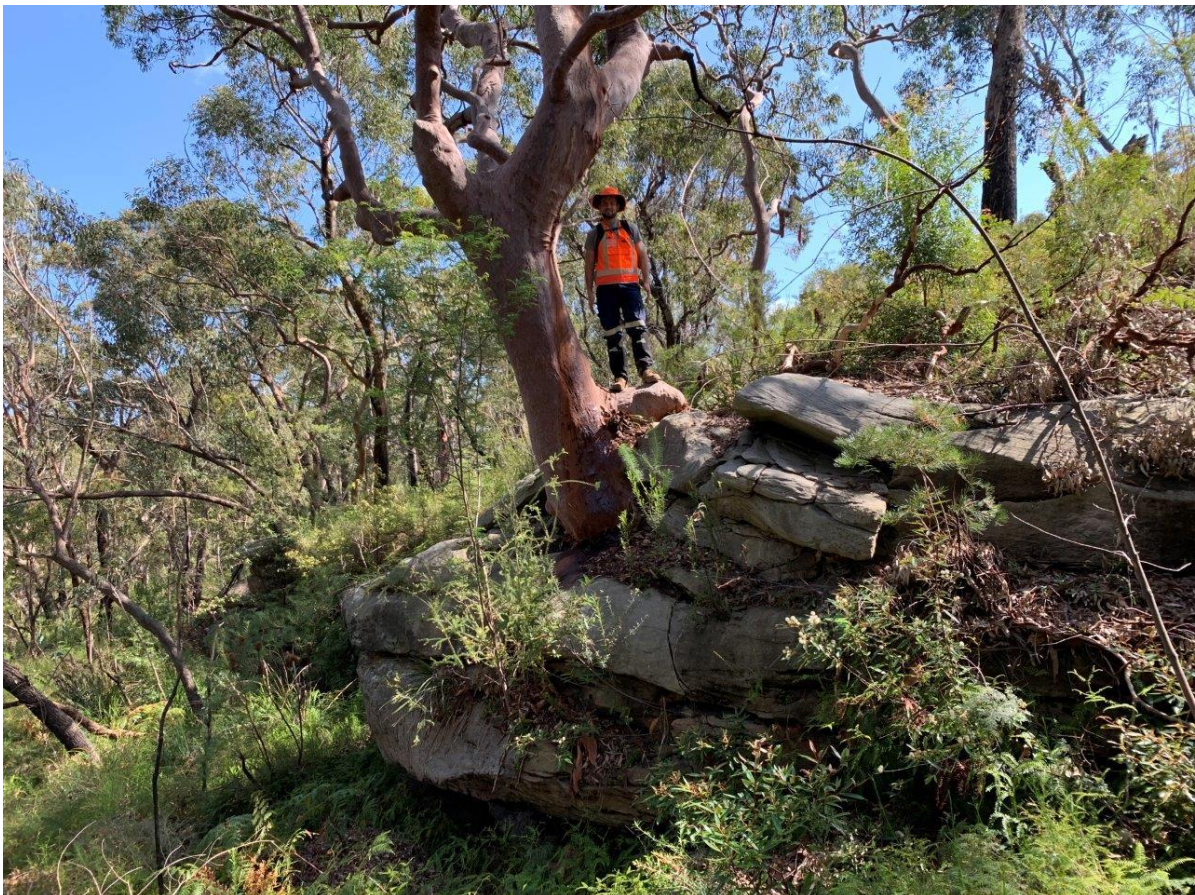
Photograph 16: View looking north, mature tree at crest, loose undercut blocks at crest

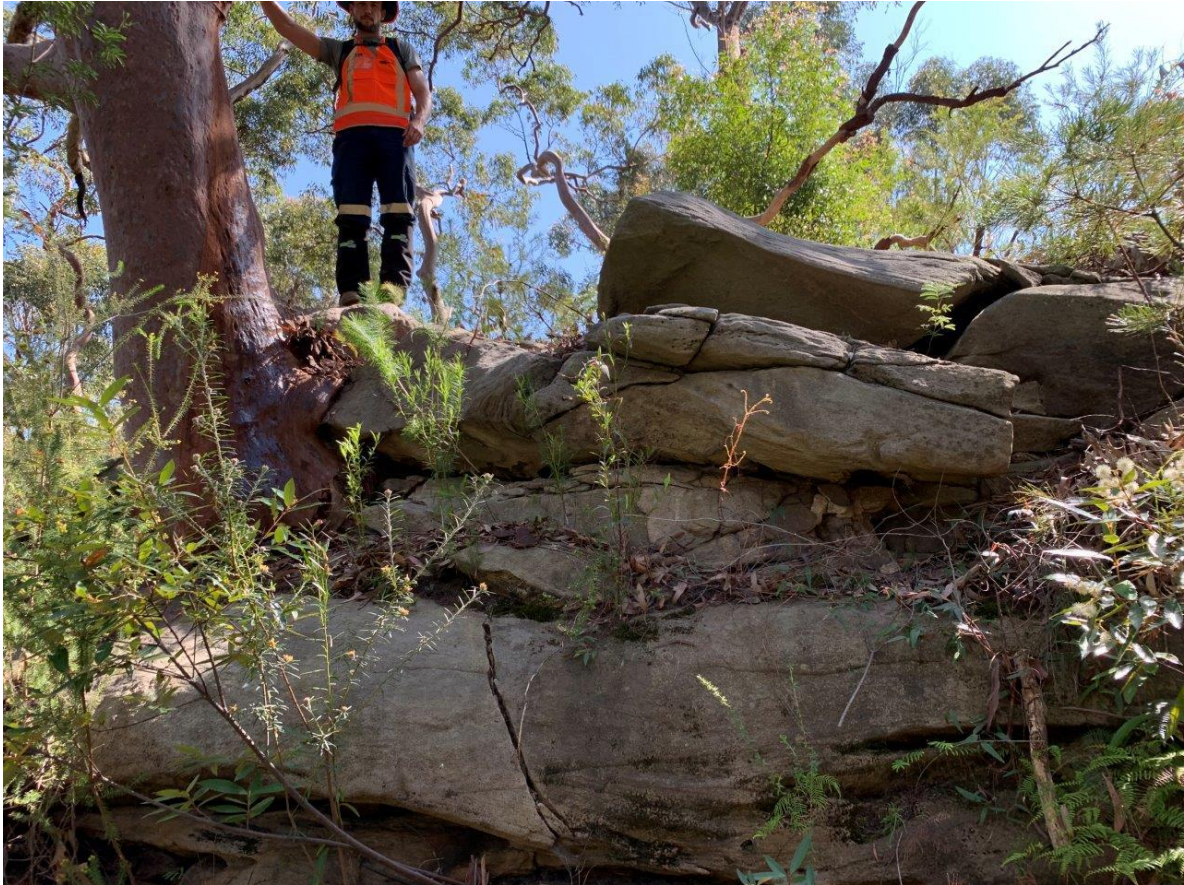
Photograph 17: View looking east, cracking observed within sandstone precipice, potential root jacking from mature tree

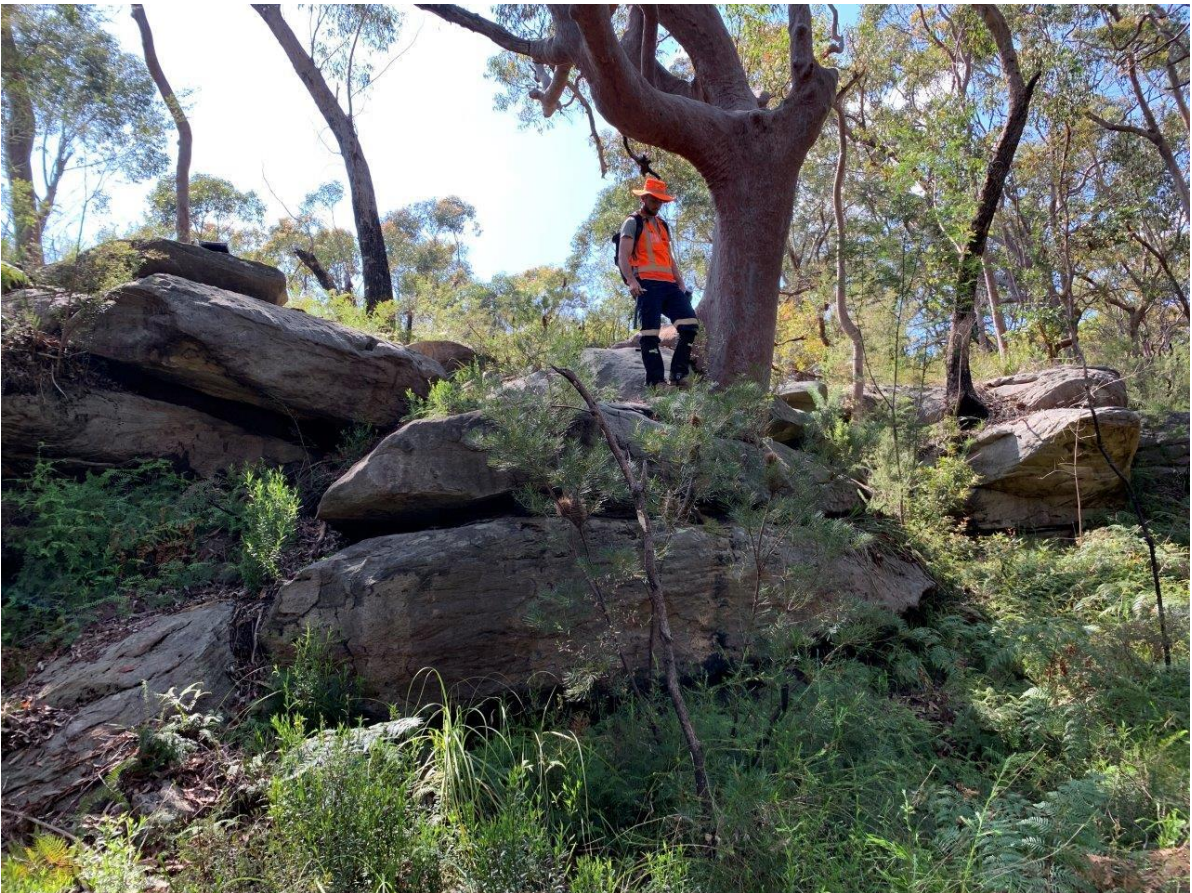
Photograph 18: View of large undercut sandstone beds

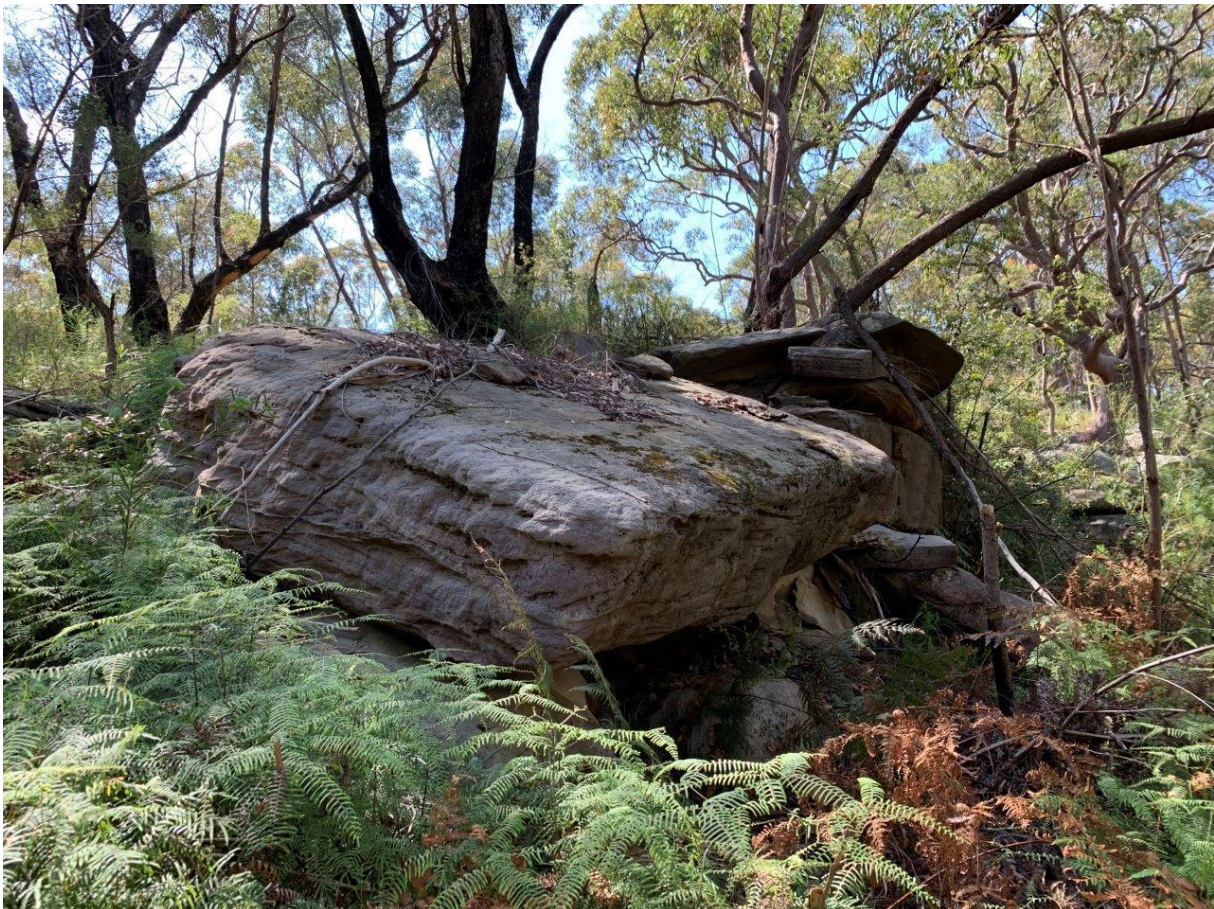
Photograph 20: View looking south-east, previous failure of large sandstone bed up to 1.5m thick

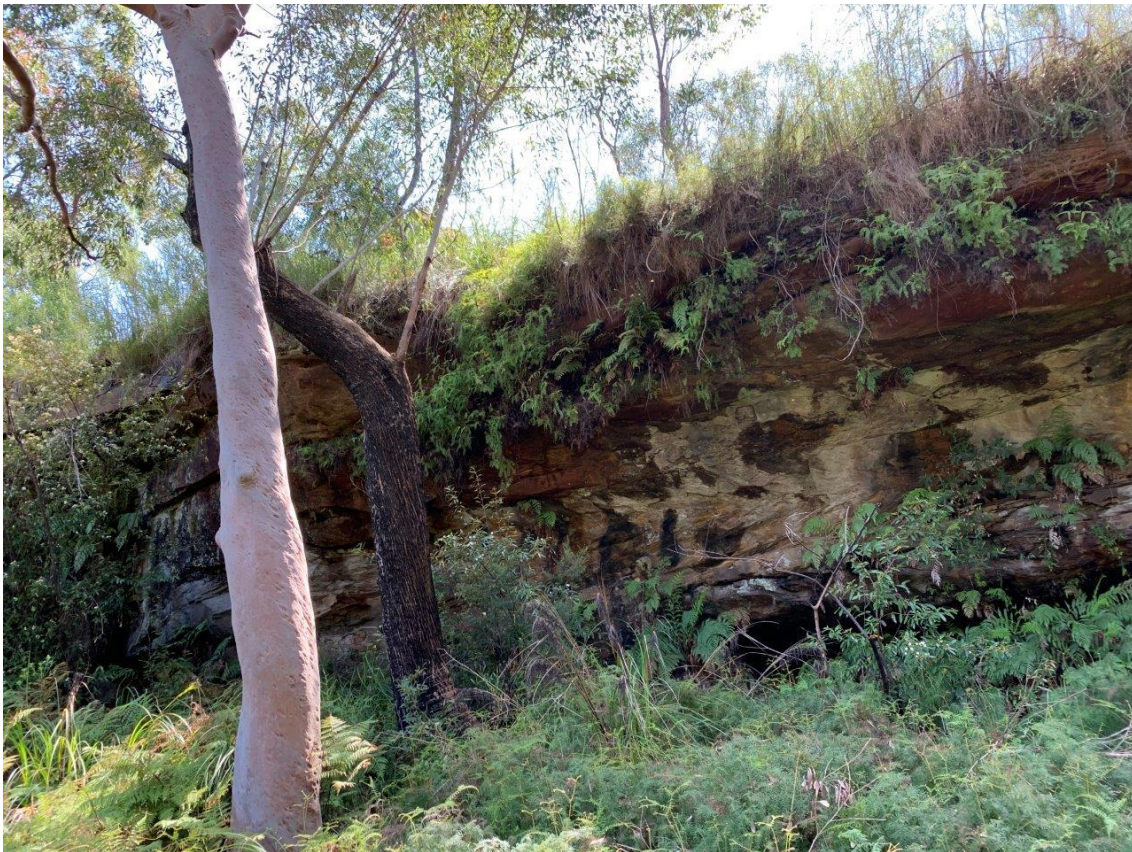
Photograph 22: View of sandstone precipice $\sim 12\text{m}$ height, overhangs up to 2.5m observed

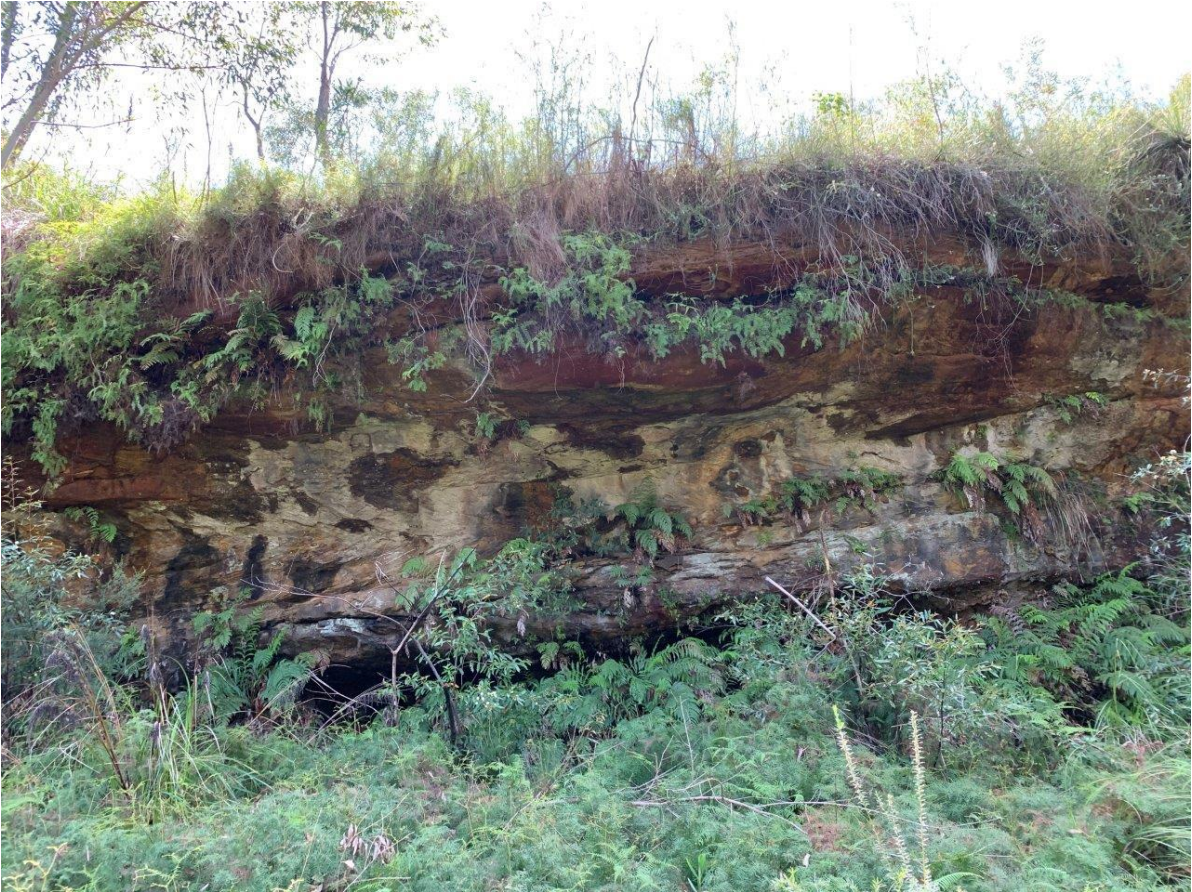
Photograph 23: View of high sandstone precipice with overhangs
