Slope Risk Assessment Report

Patyegarang Project

Reference No. 30012988
Prepared for Metropolitan Local Aboriginal Land Council
14 July 2023

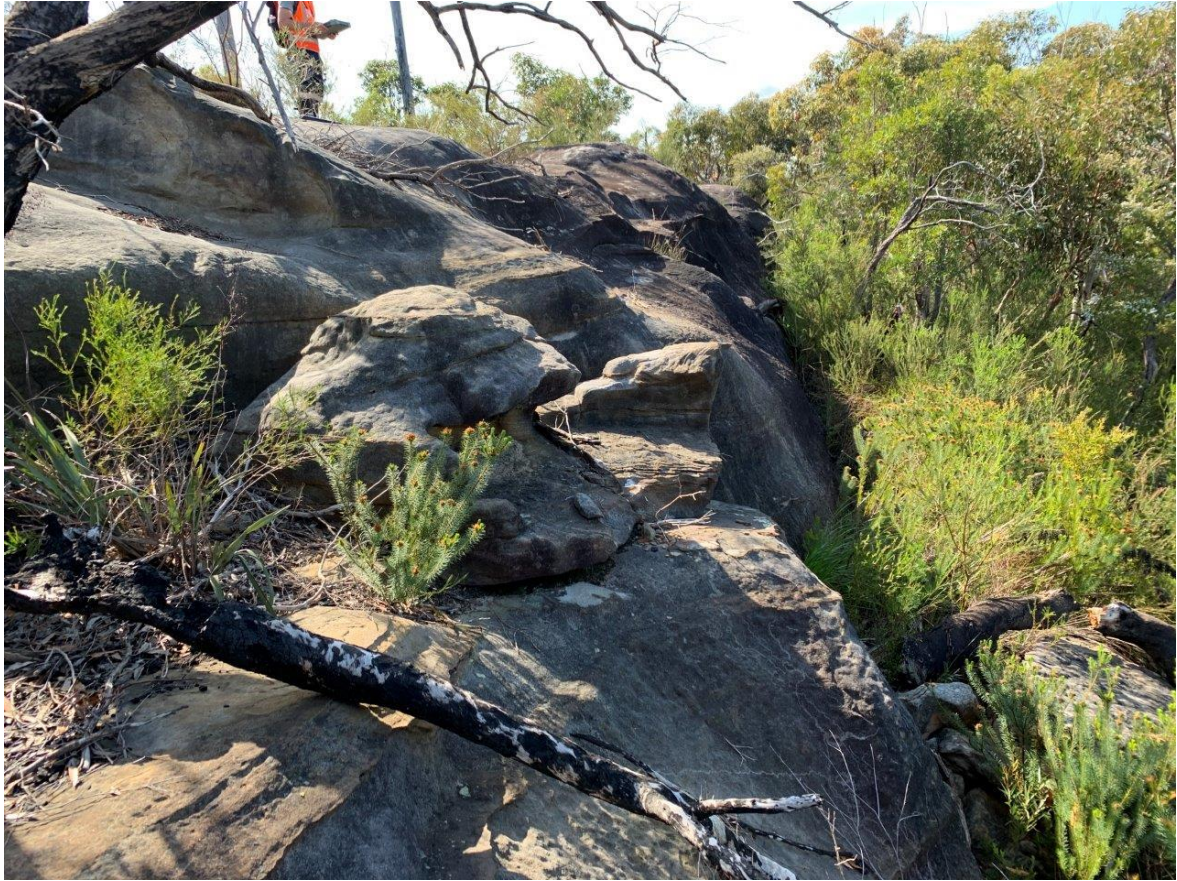
Photograph 3: View of loose blocks near crest of sandstone precipice

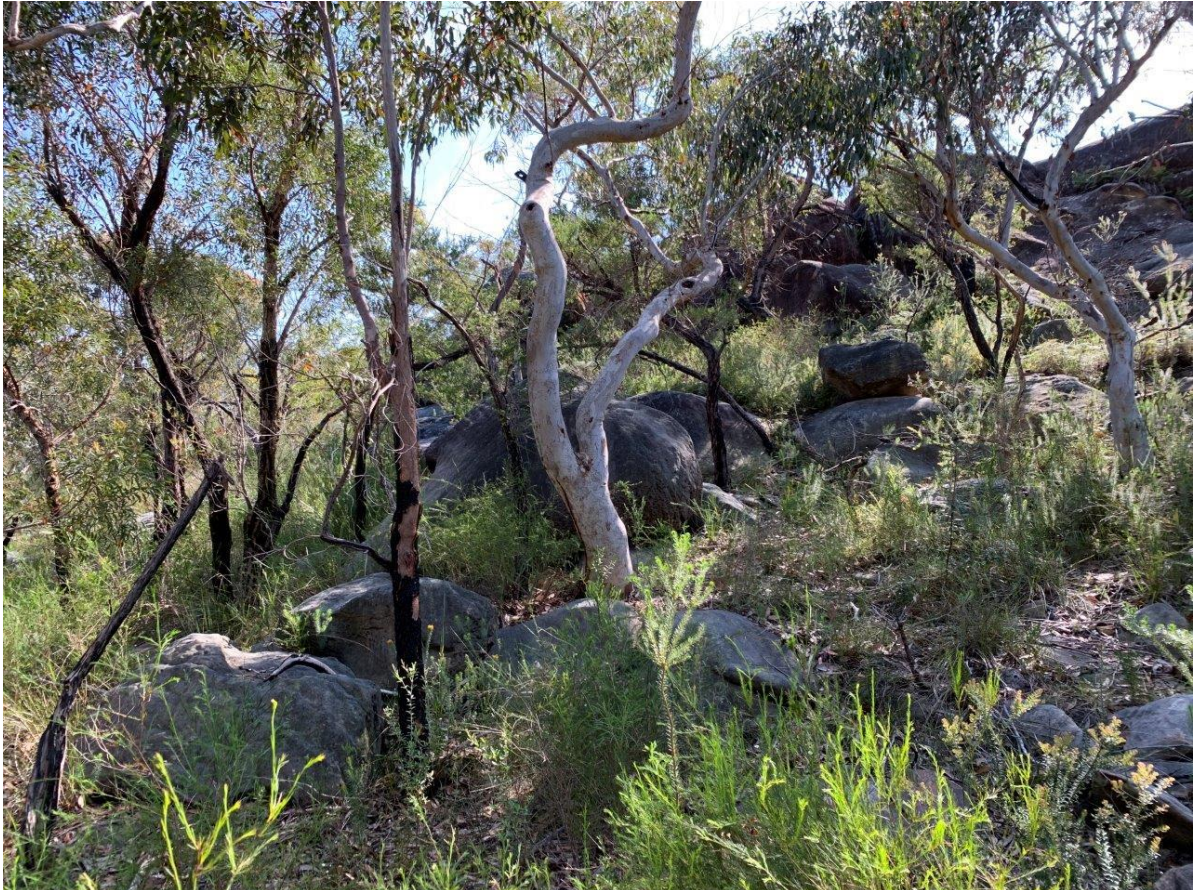
Photograph 6: View looking east upslope, loose boulders up to 2m on slope

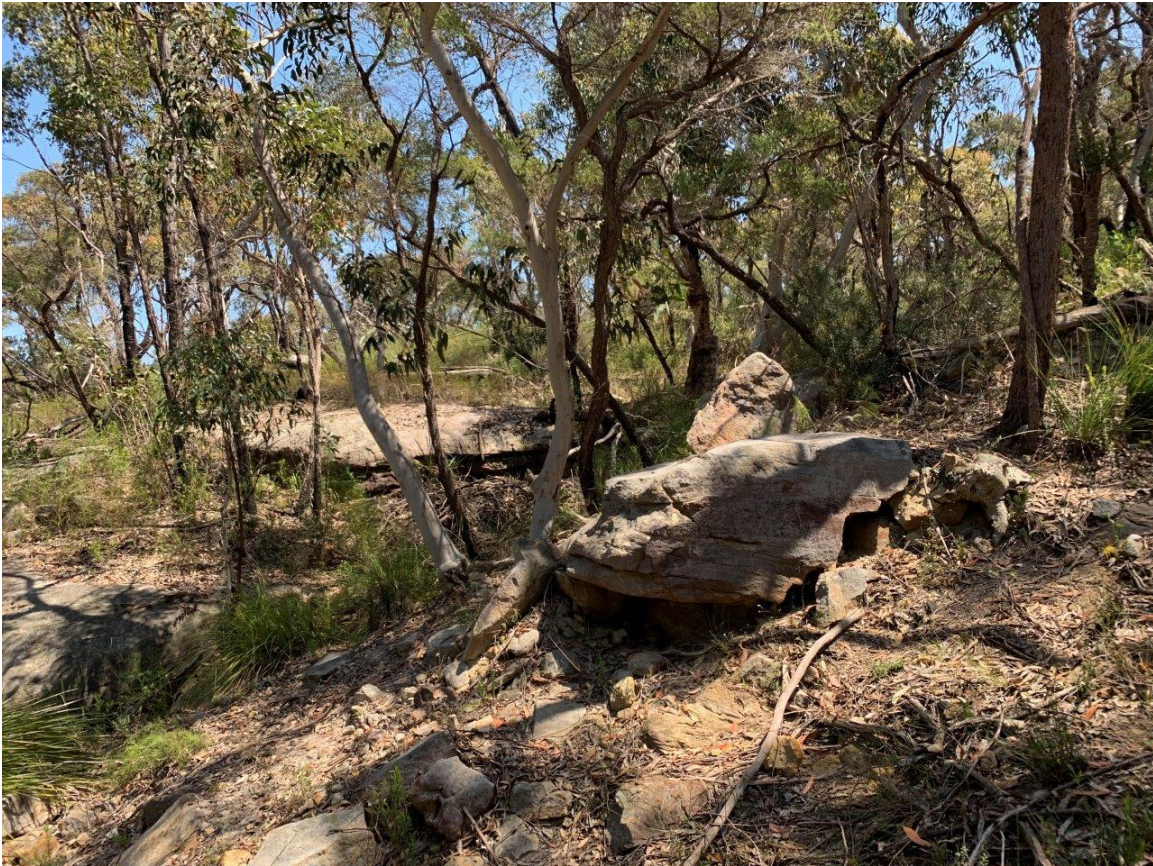
Photograph 1: View looking west, loose blocks on slope

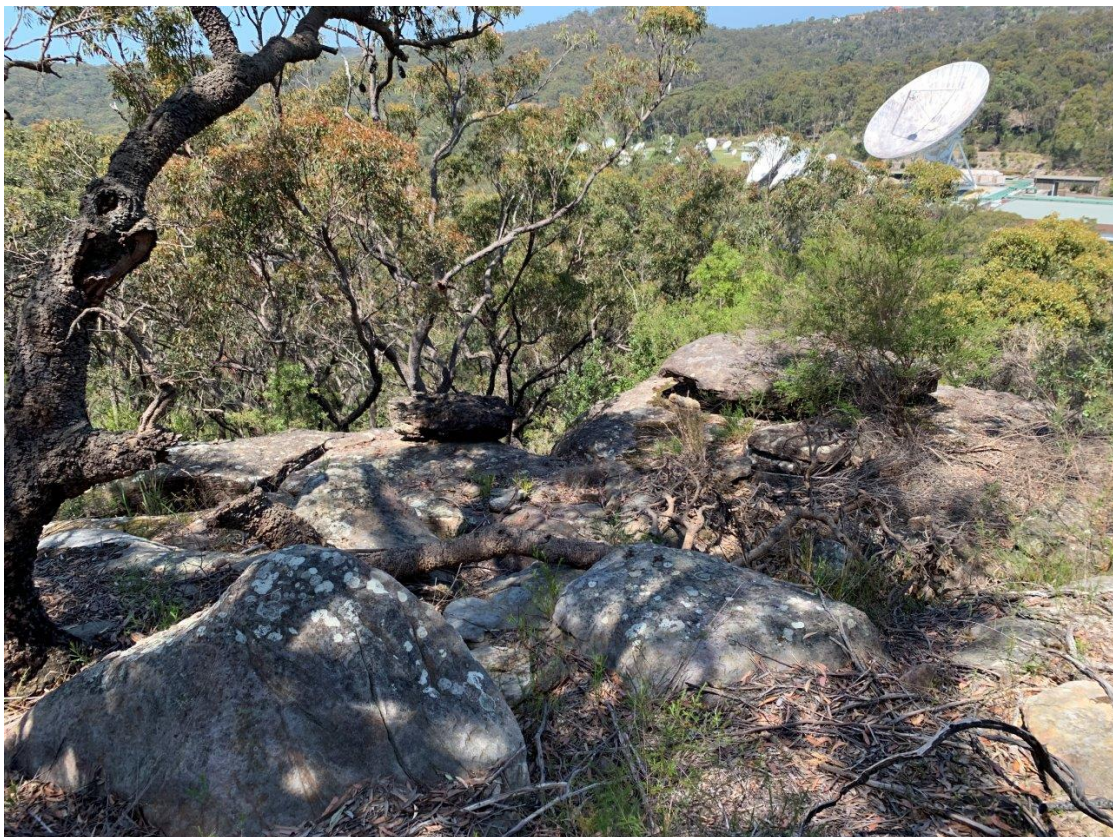
Photograph 4: View looking south, loose blocks along crest, Telstra satellite station noted in background

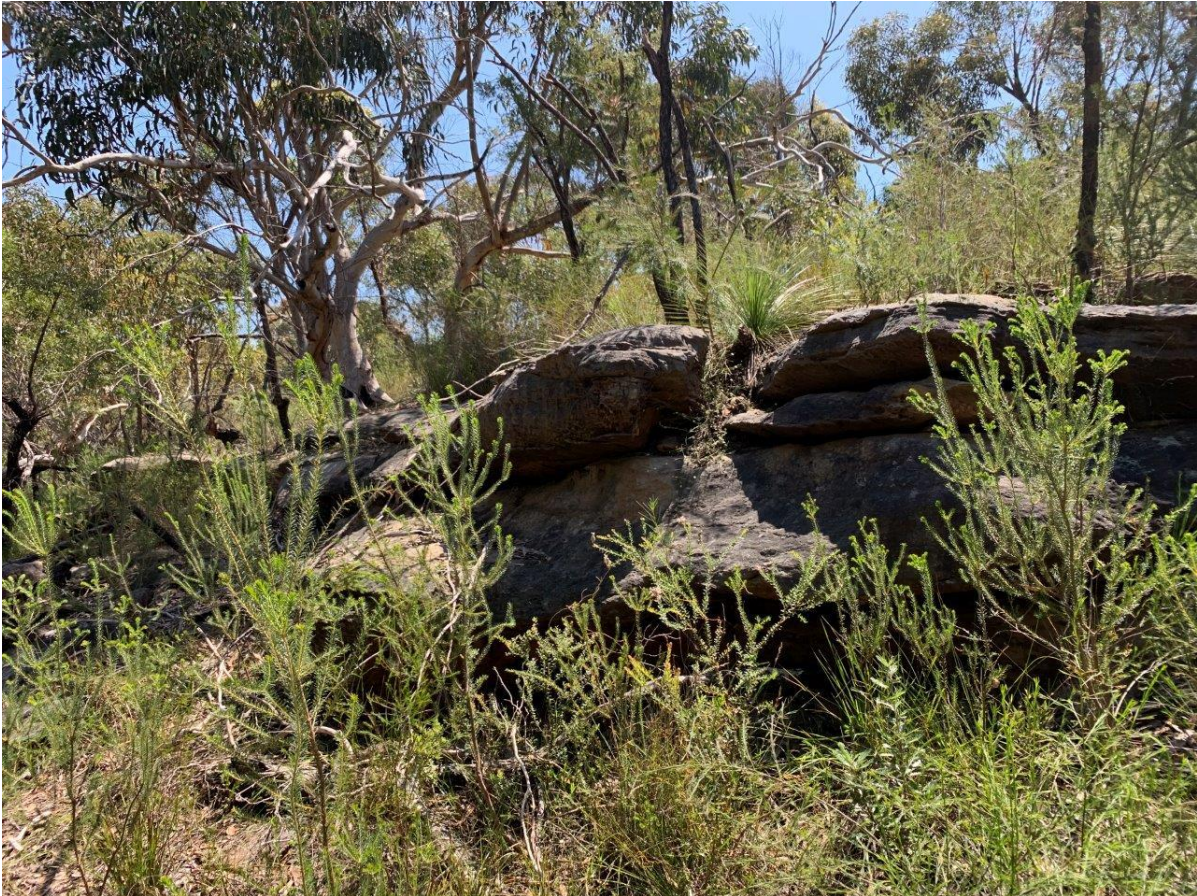
Photograph 5: View of overhangs along precipices up to 2m height

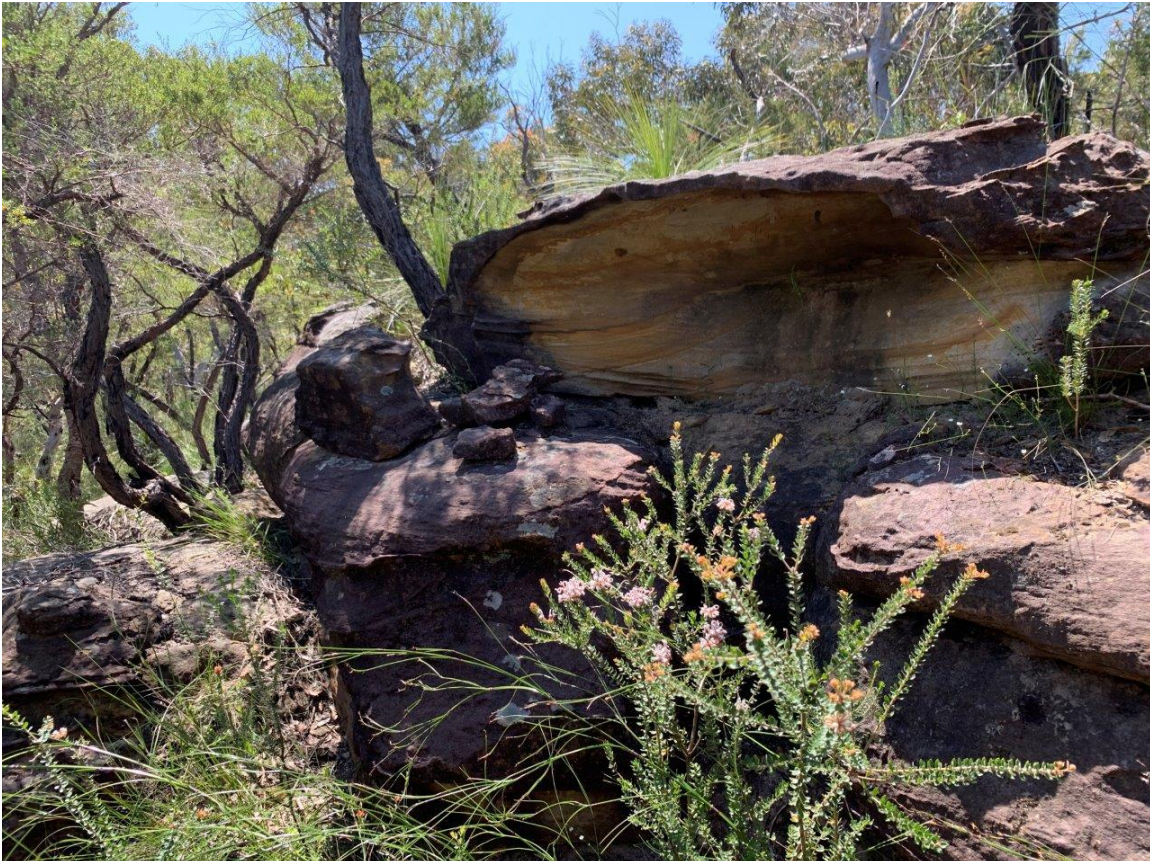
Photograph 2: View of overhangs and loose blocks at crest

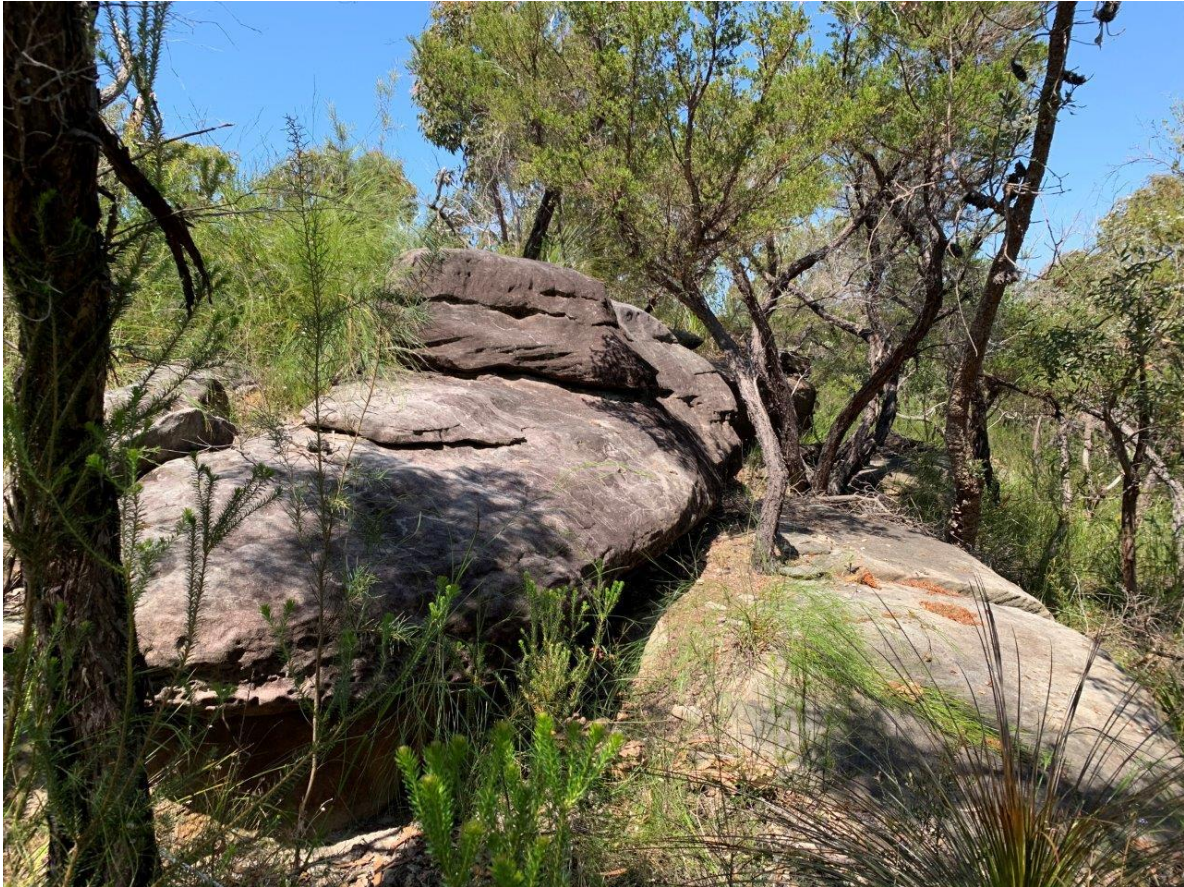
Photograph 3: View looking south, undercutting of large sandstone bed caused by erosion and weathering of weaker beds

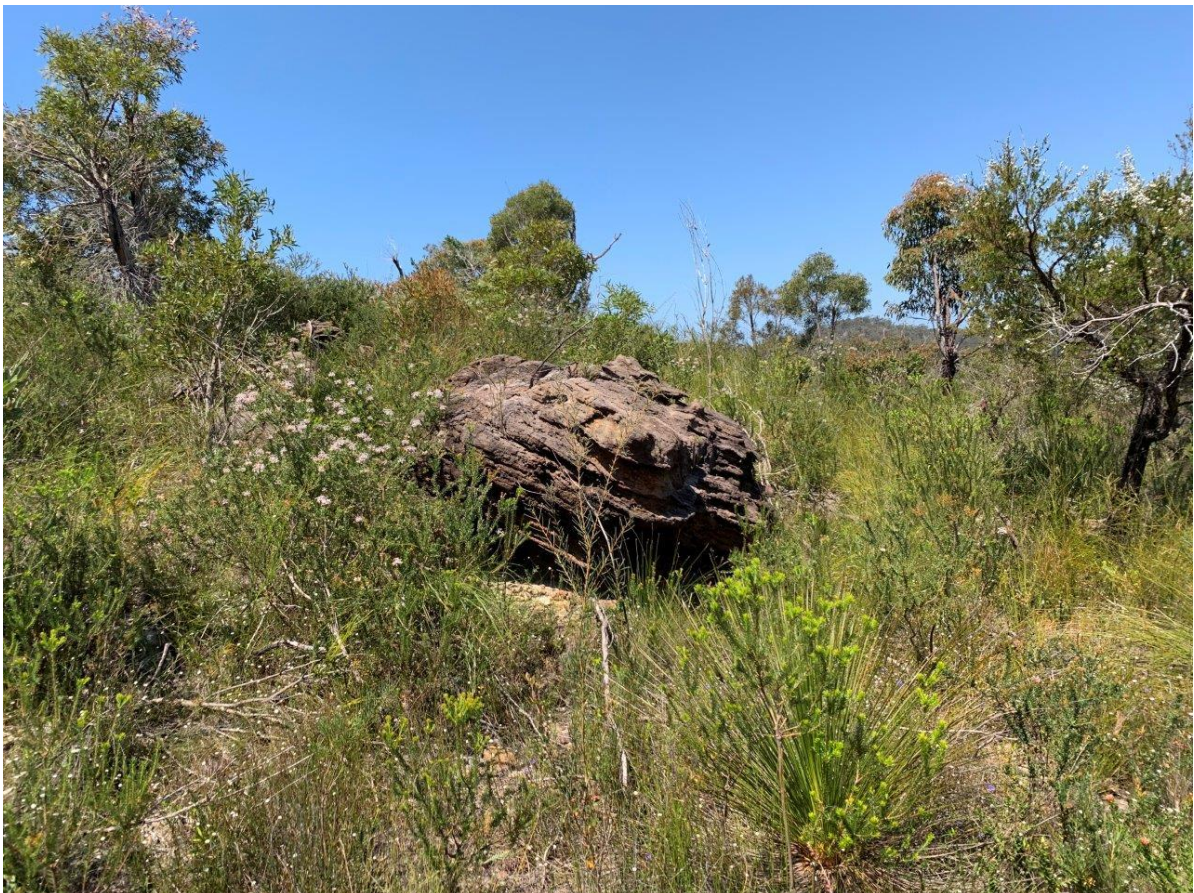
Photograph 4: View of loose boulders on slope

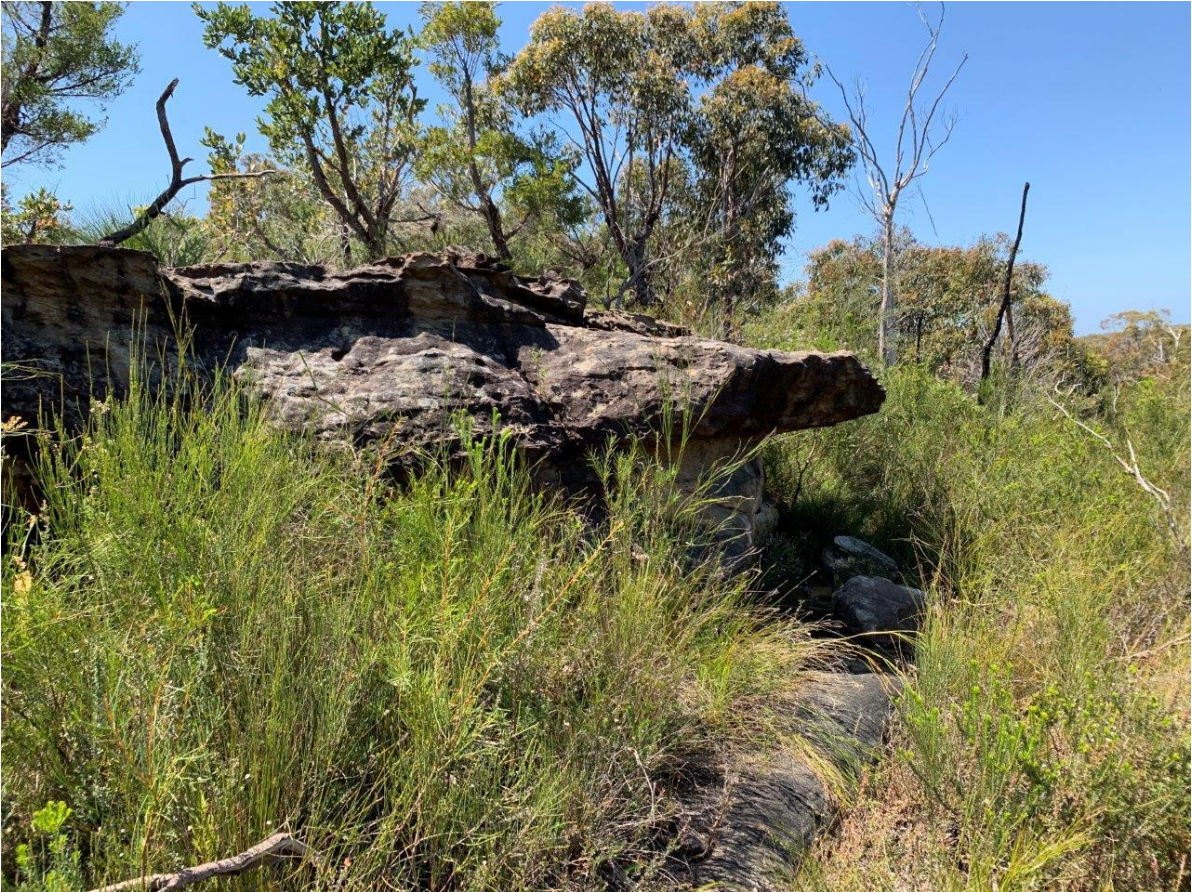
Photograph 5: View looking east, overhangs up to 1m observed in precipices up to 1.5m height

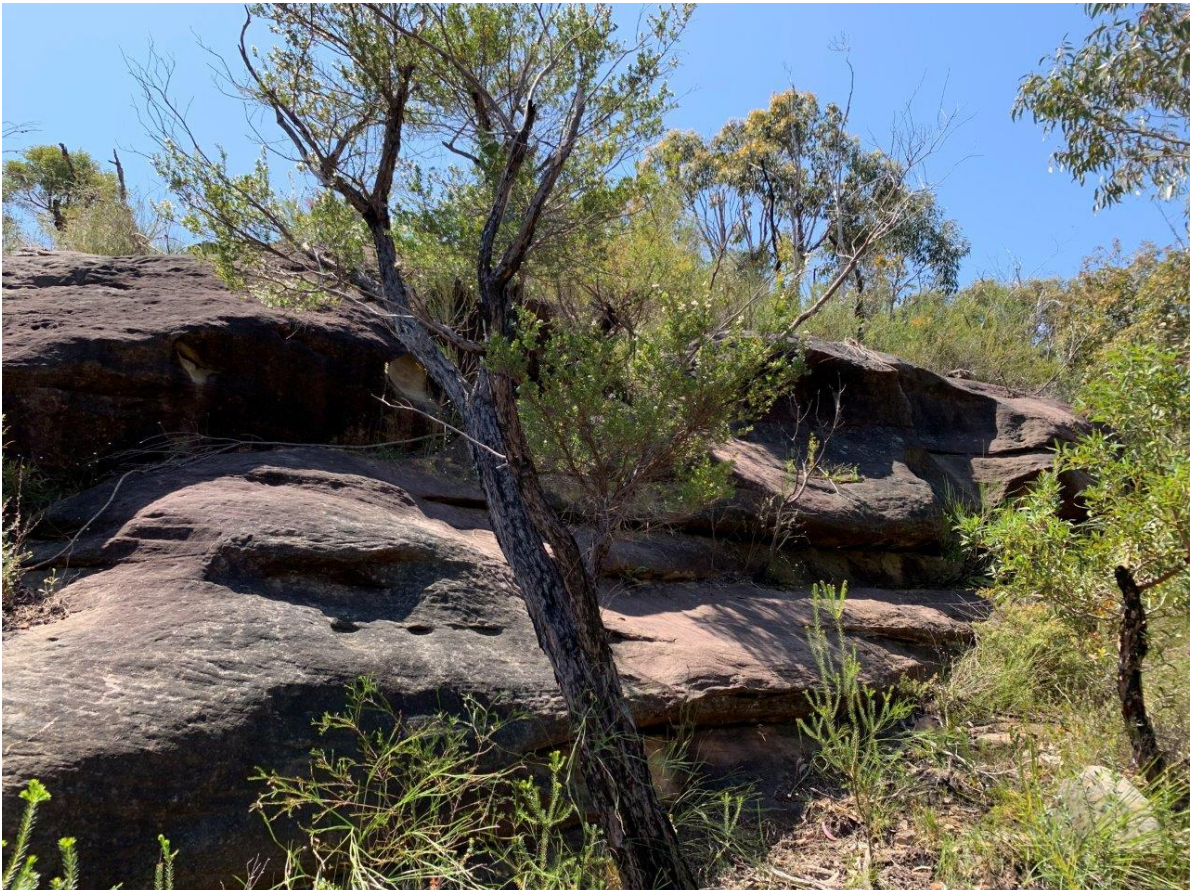
Photograph 6: View looking north-east, minor overhangs up to 0.5m observed through sandstone precipice

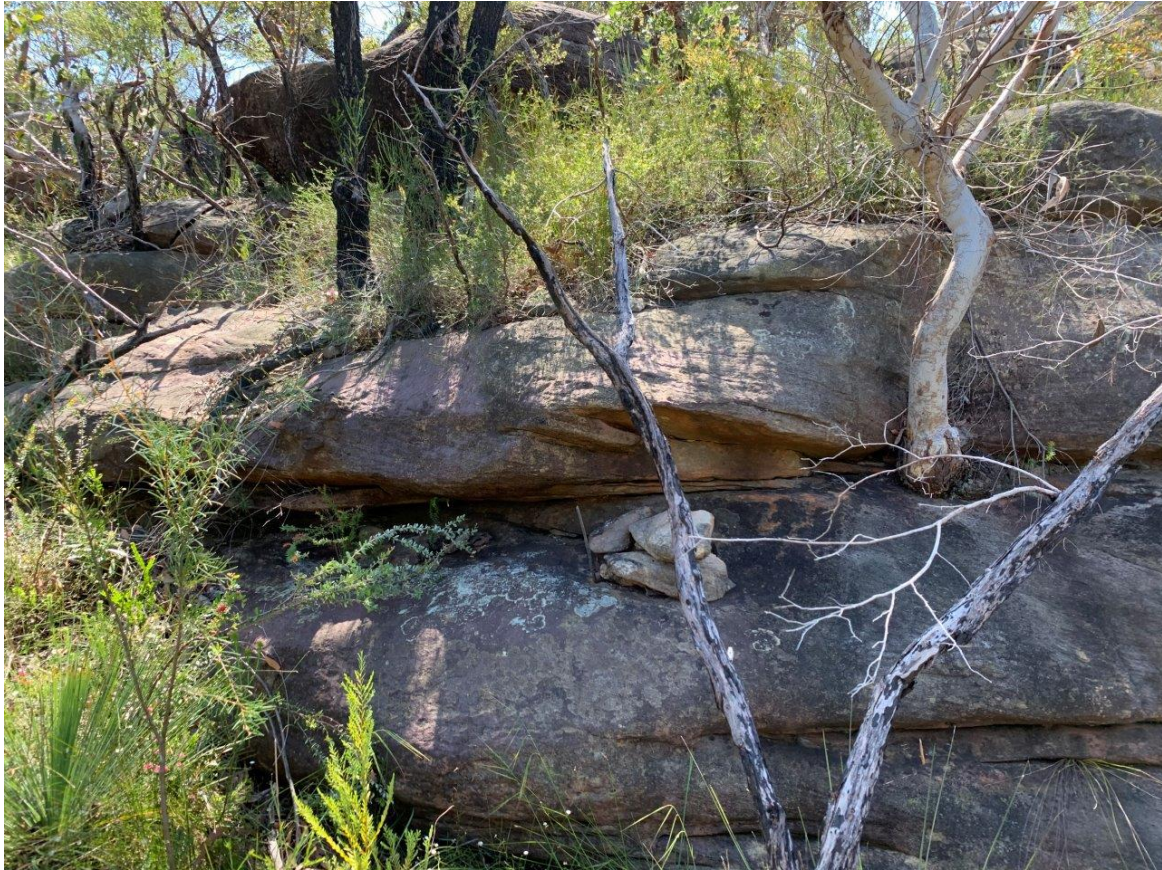
Photograph 7: Overhangs up to 0.5m observed

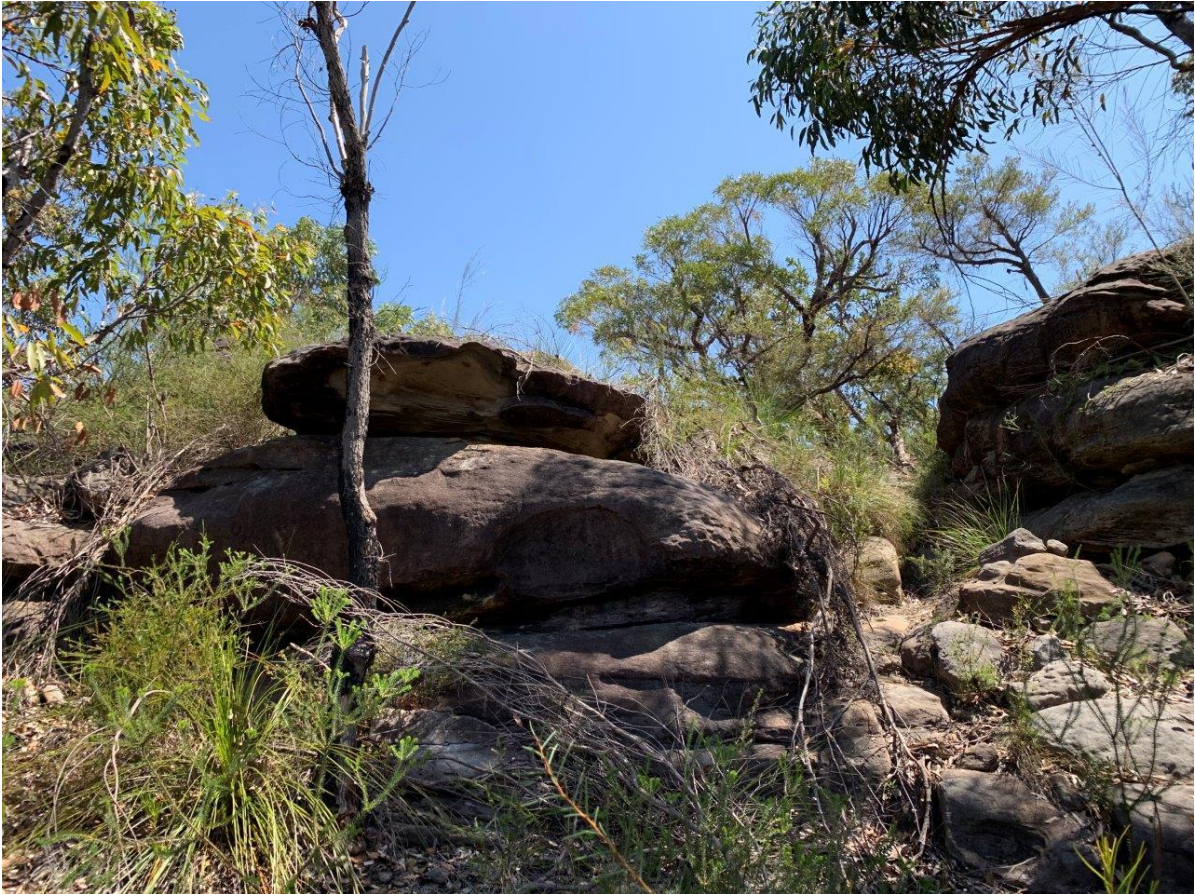
Photograph 3: View looking west, overhangs of loose blocks along crest

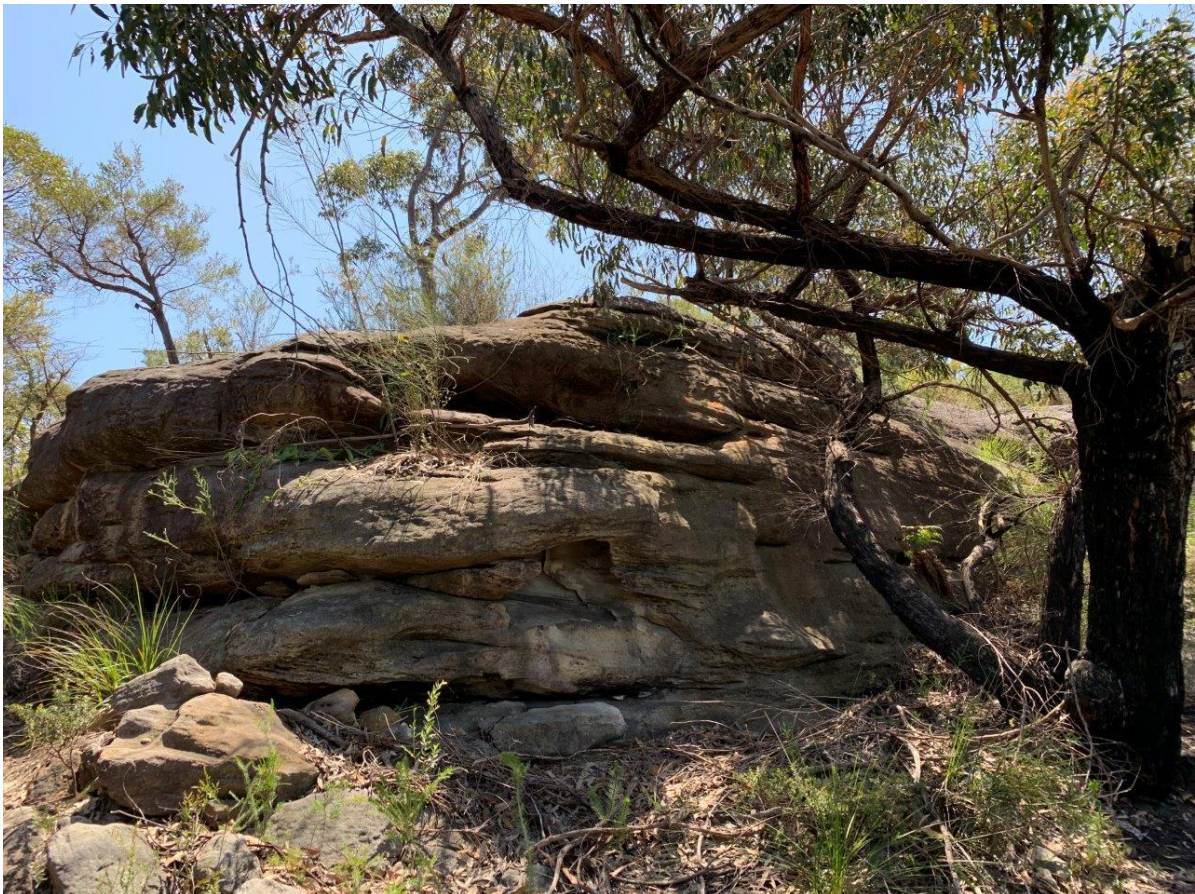
Photograph 4: View looking west, overhangs up to 0.8m observed

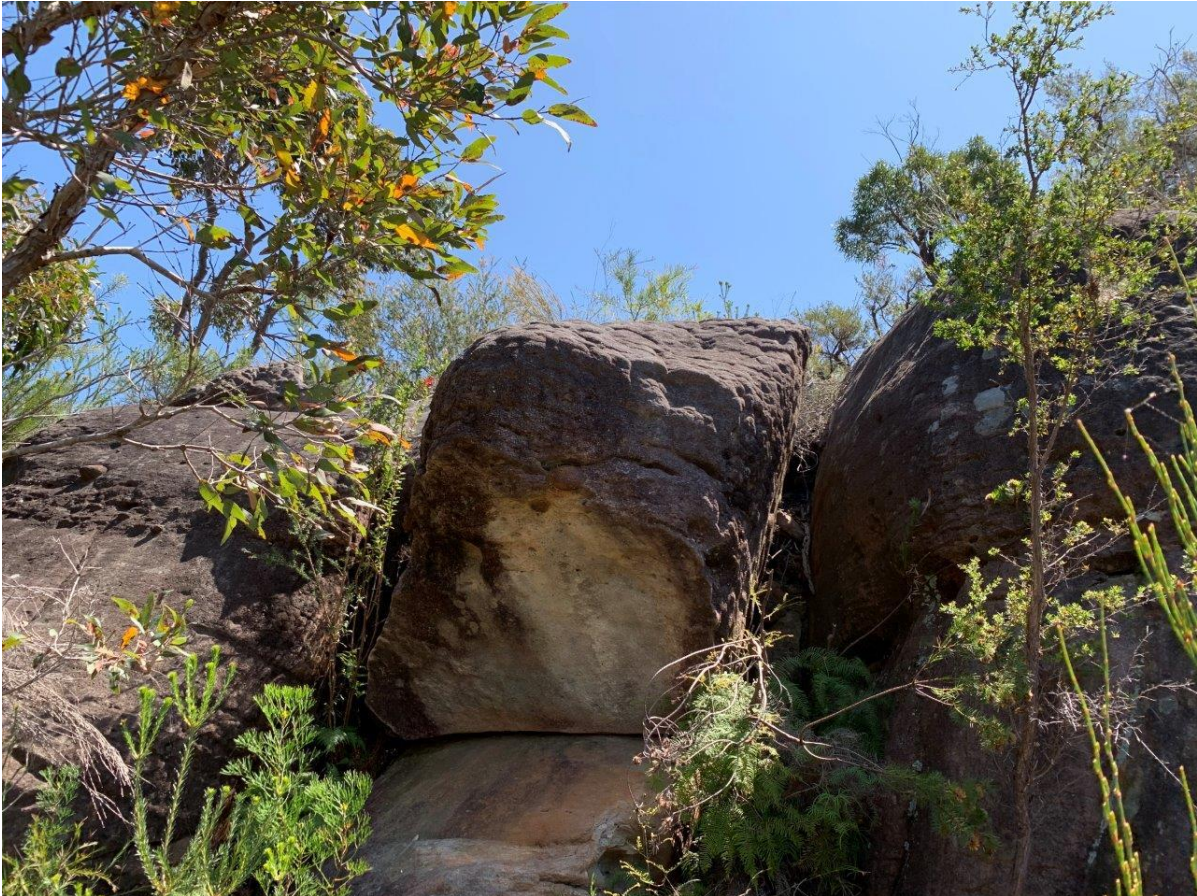
Photograph 5: View looking west, large loose block (~1m x 1.5m) at crest, potential slide failure

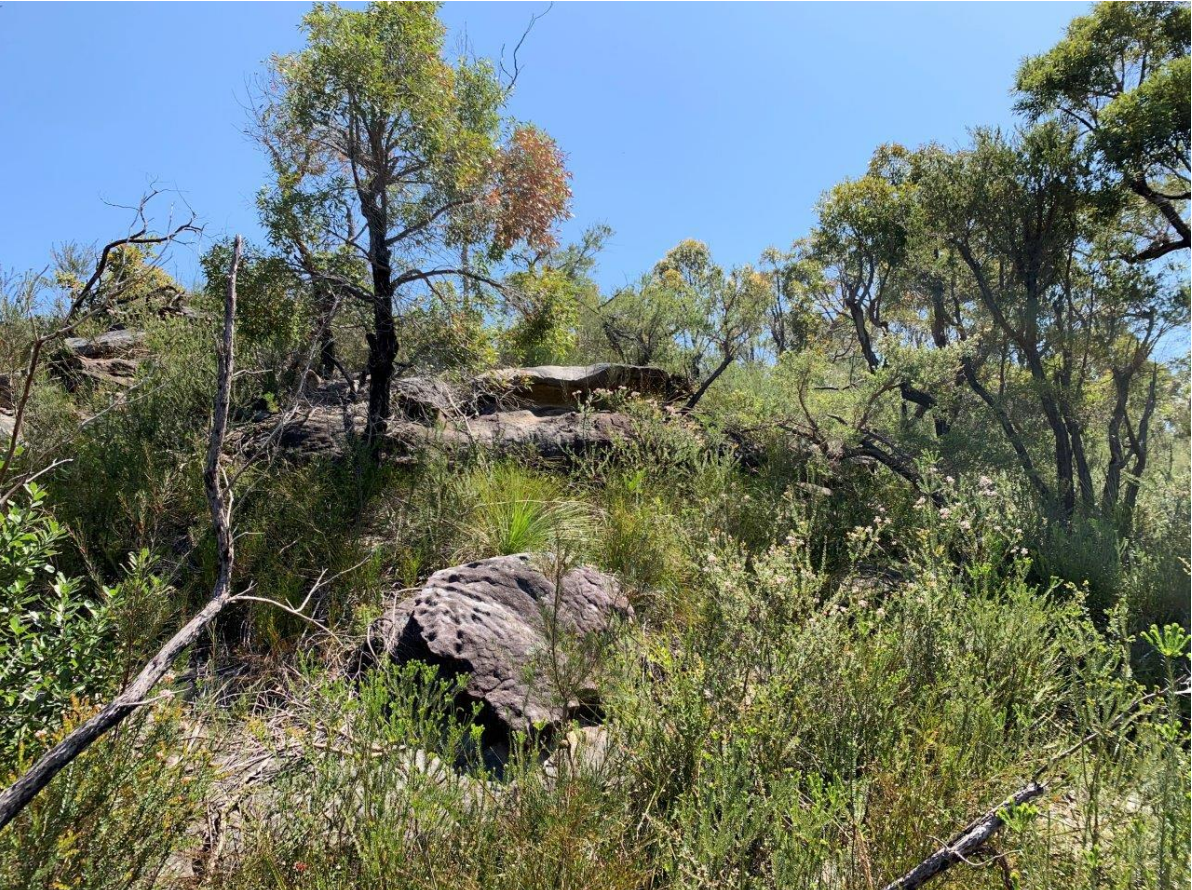
Photograph 8: View looking north toward sandstone precipice up to 2.5m high, overhangs up to 1m observed

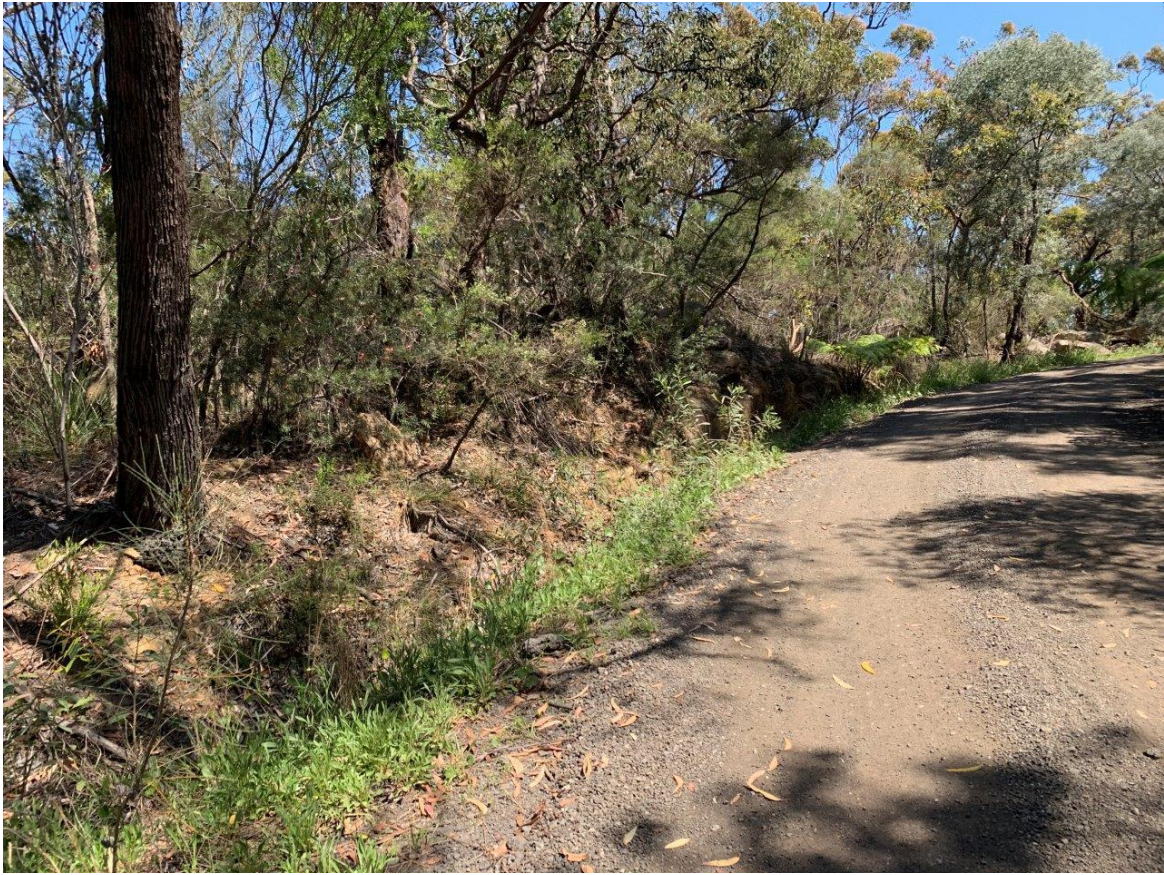
Photograph 1: View looking west along Slippery Dip Road, cutting up to 1.5m

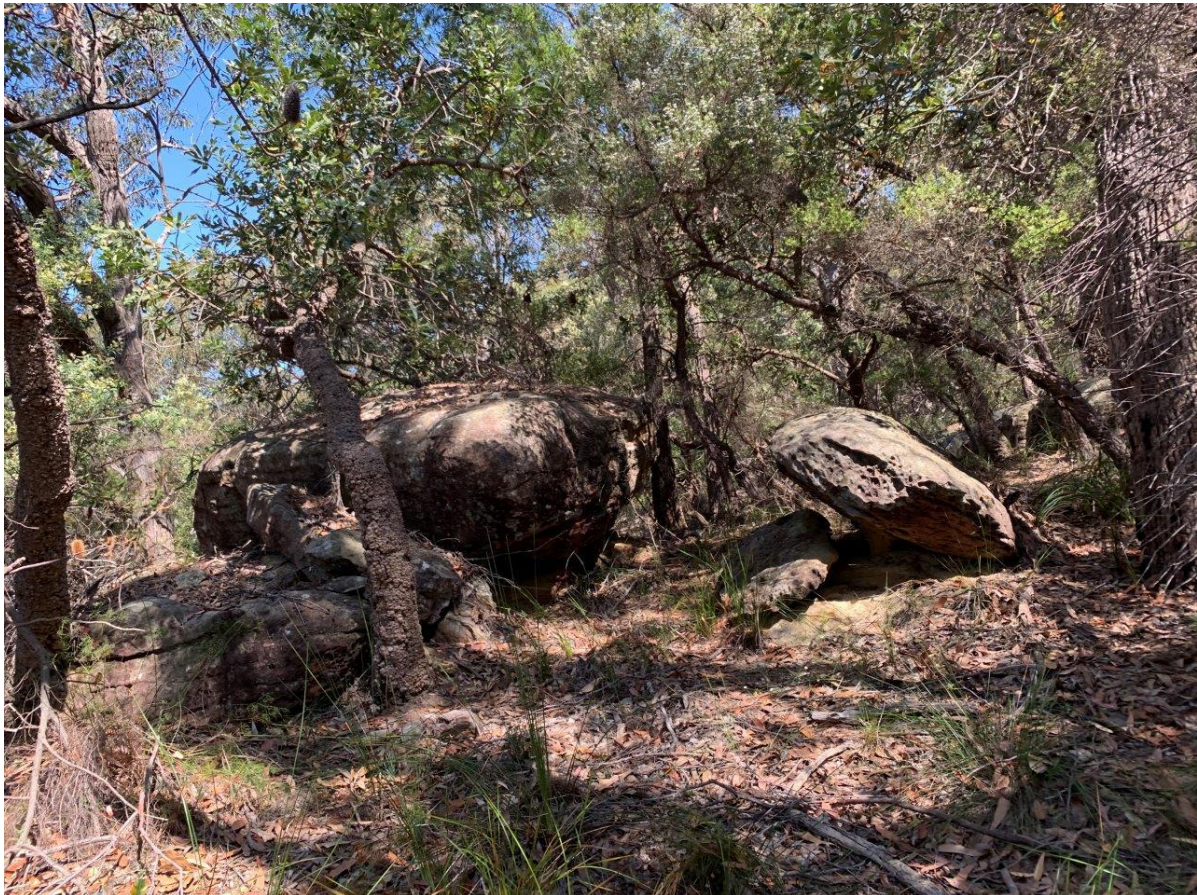
Photograph 4: View looking south-east, large loose blocks on slope

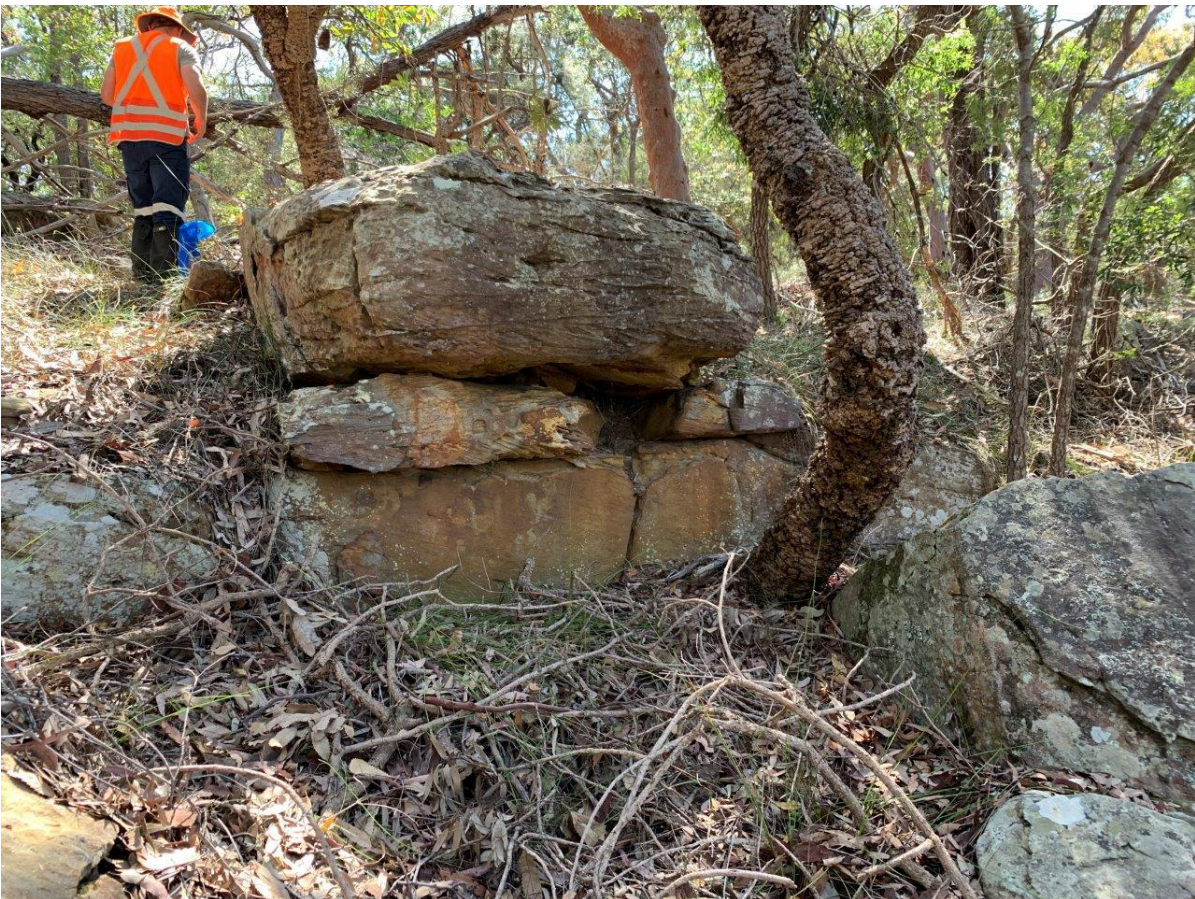
Photograph 8: View looking north, loose undercut block on slope
