Geotechnical Report

Our Ref: GF1404-Br

Date: 25 November 2022

**Re: Short-term Groundwater Monitoring Programme for Proposed Boarding House
71-73 Thomas Street, Parramatta, NSW 2150**

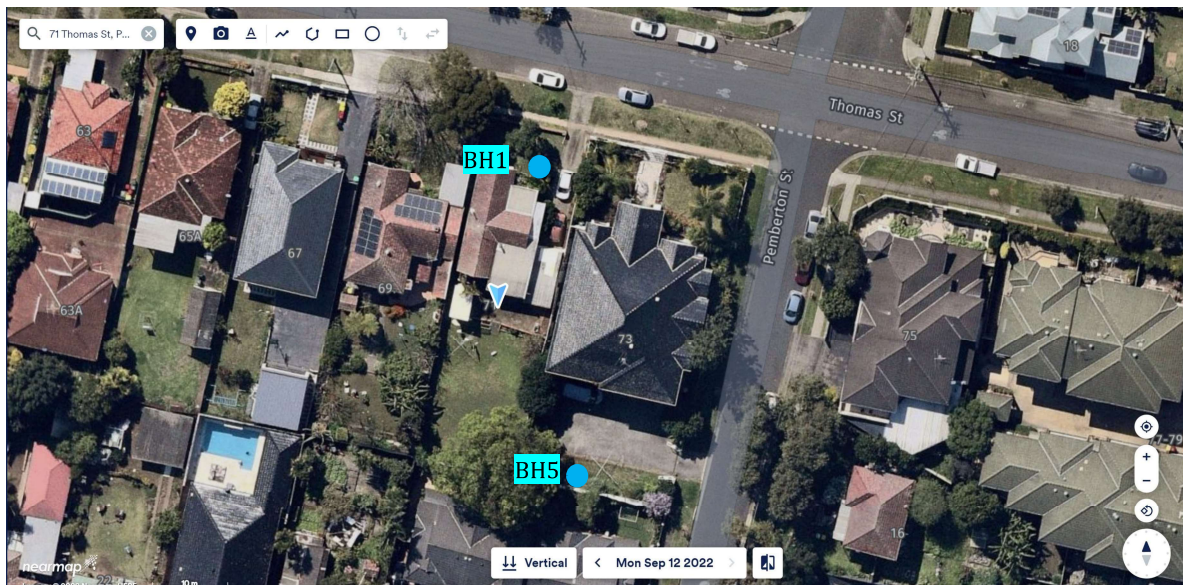
Photo 1: Approximate Well Locations

A Geotechnical Engineer from Geofirst Pty Ltd visited the site on 16 November 2022 to install two groundwater monitoring wells into the previous machine-drilled boreholes (BH1 – Well 1 and BH5 – Well 2) to depths of 3.45m (Well 1) and 2.8m (Well 2) below the existing grade.

Following the installation of the wells, tap water was used to clean out mud and debris inside the boreholes. All water was pumped out using an electrical pump to the bottom of the wells after the completion of the well installations. The approximate well locations are shown in the following aerial image (Photo 1).
