Residential Site Investigation Report

Site Address: 1 Warratah Avenue and 50 Frost Street, Orange NSW 2800

Client: NSW Land and Housing Corporation, Locked Bag 4009, Ashfield NSW
2131

(Our Reference: 36151-GR01_A)

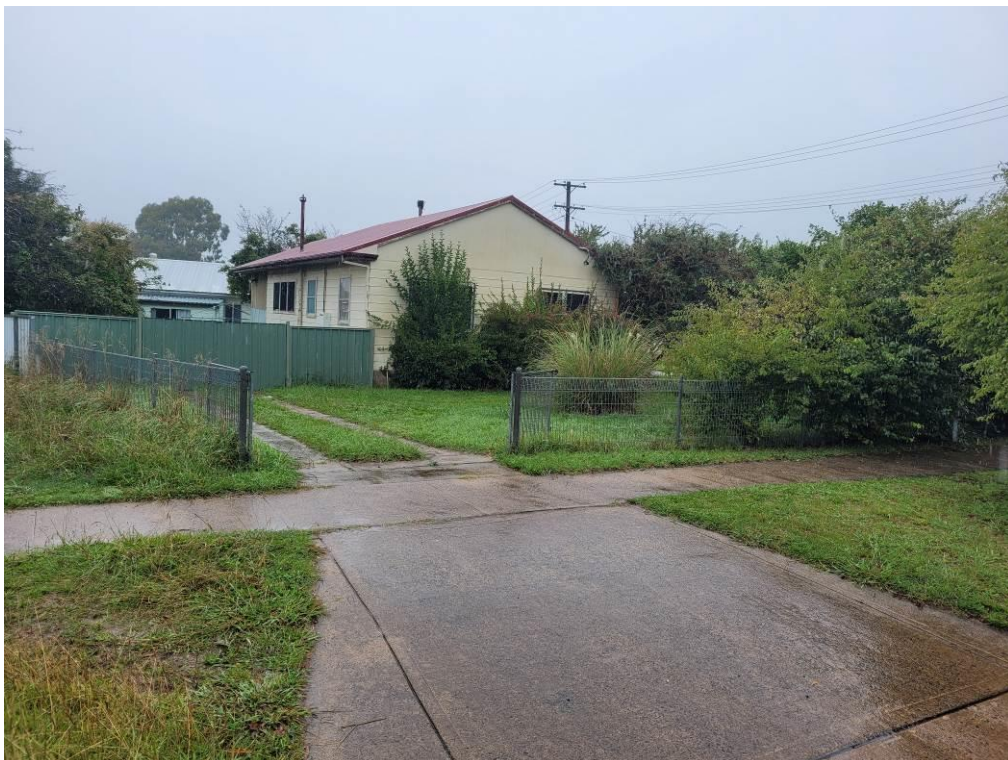
Plate 1 – East facing view.

The site is relatively flat. The block has existing dwelling on block with existing buildings and established houses surrounding the area.

Any trees noted to be within the building zone, should be removed and the excavation remaining should be backfilled with natural material and reinstated in layers to a minimum of 95% Standard Maximum Dry Density.
