HAZARDOUS MATERIALS SURVEY REPORT (HAZMAT)

HYAMS BEACH RFS ROSE ST, HYAMS BEACH, NSW 2540 LOT 78-79 DP 755907

Shoalhaven City Council ENRS1872 28th May 2021

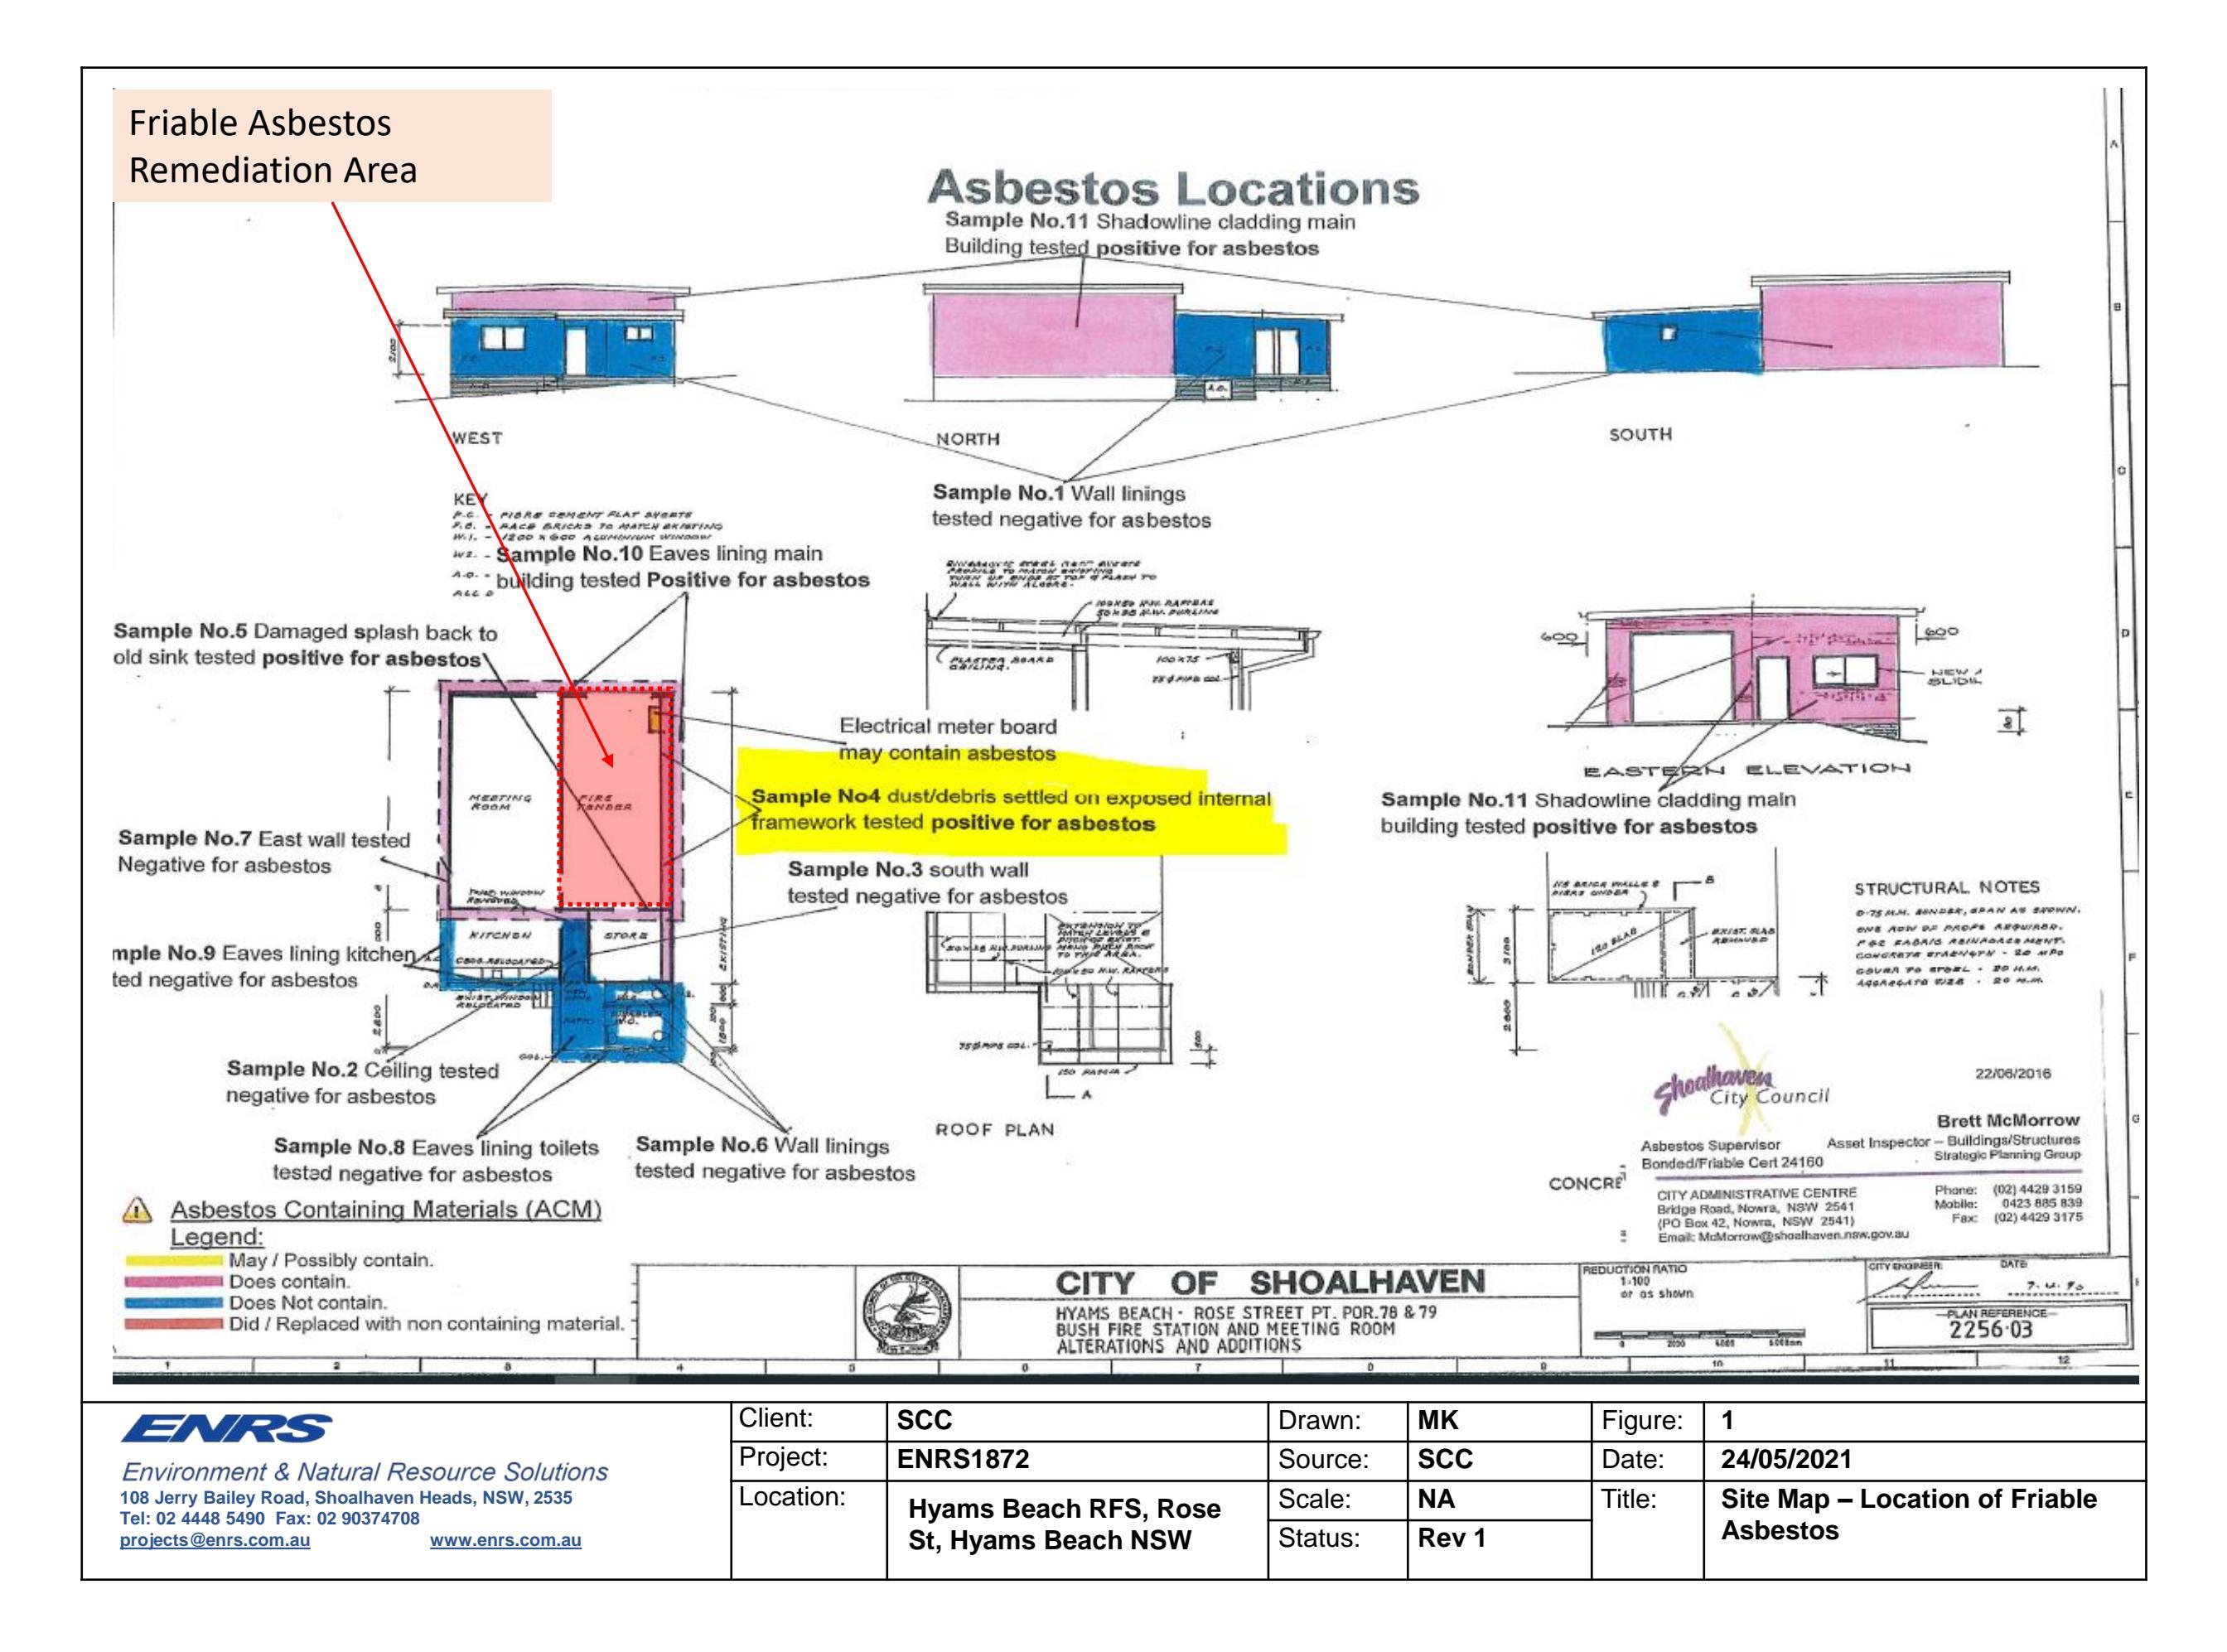
FIGURES

- Friable asbestos in building dust within Fire Tender Room (garage) (refer to Figure 1). Required to be remediated by a Class A licenced removal contractor supported by air monitoring and clearance certificate prior to any further building access or ongoing works;
- > Non-Friable (bonded) asbestos containing materials;
- ➢ PCB's;
- ➢ SMF; and
- > Hazardous Chemicals.
