Arboricultural Assessment and Tree Protection Plan

Commissioned by: Land and Housing Corporation / Department of Planning and Environment Site: 189 Riverside Drive, Airds 2560 Within: Campbelltown City Council Date of Inspection: 12 September 2022 Version: 1.2

Vertical Tree Management & Consultancy Pty Ltd

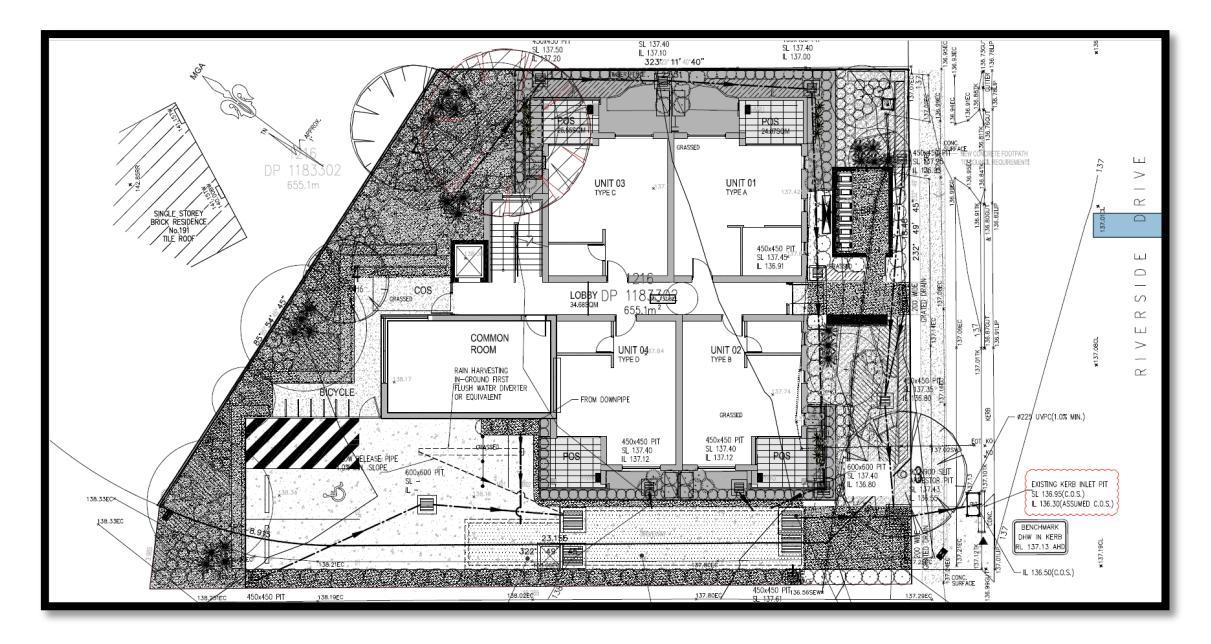
Figure 4. Stormwater and drainage plan shows there will minimal disturbance to the trees in the adjacent allotment 84 DP 609357
