# **Arboricultural Impact Assessment Report**

## **Seniors housing development, NSW Land & Housing Corporation**

**3 Cooke Avenue & 1, 3 and 5 Deegan Drive,  
Alstonville**

**Date: 21 August 2023**

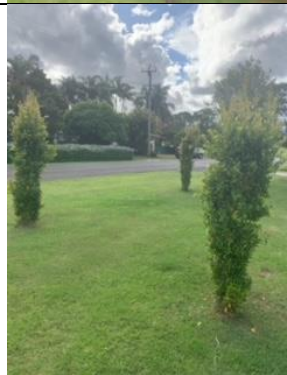
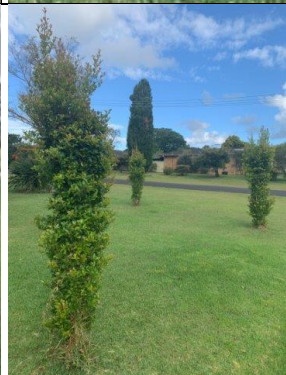
T56 to T58 Brush Cherry (x3) <i>Syzygium australe</i> Planted; native rainforest shrub or small tree species TRV Low	Average of 3 5 6 2 0.5	Average of 3 Juvenile Fair Fair	Average of 3 2.0 1.5	REMOVE T56 for construction RETAIN T57 & T58, install TPZ fence Major T56 TPZ encroachment 1.2m inside the SRZ for concrete path construction. T57 & T58 no substantial impact expected Upright, Heavily pruned/ trained to a columnar form, Highly exposed plantings, Low volume deadwood

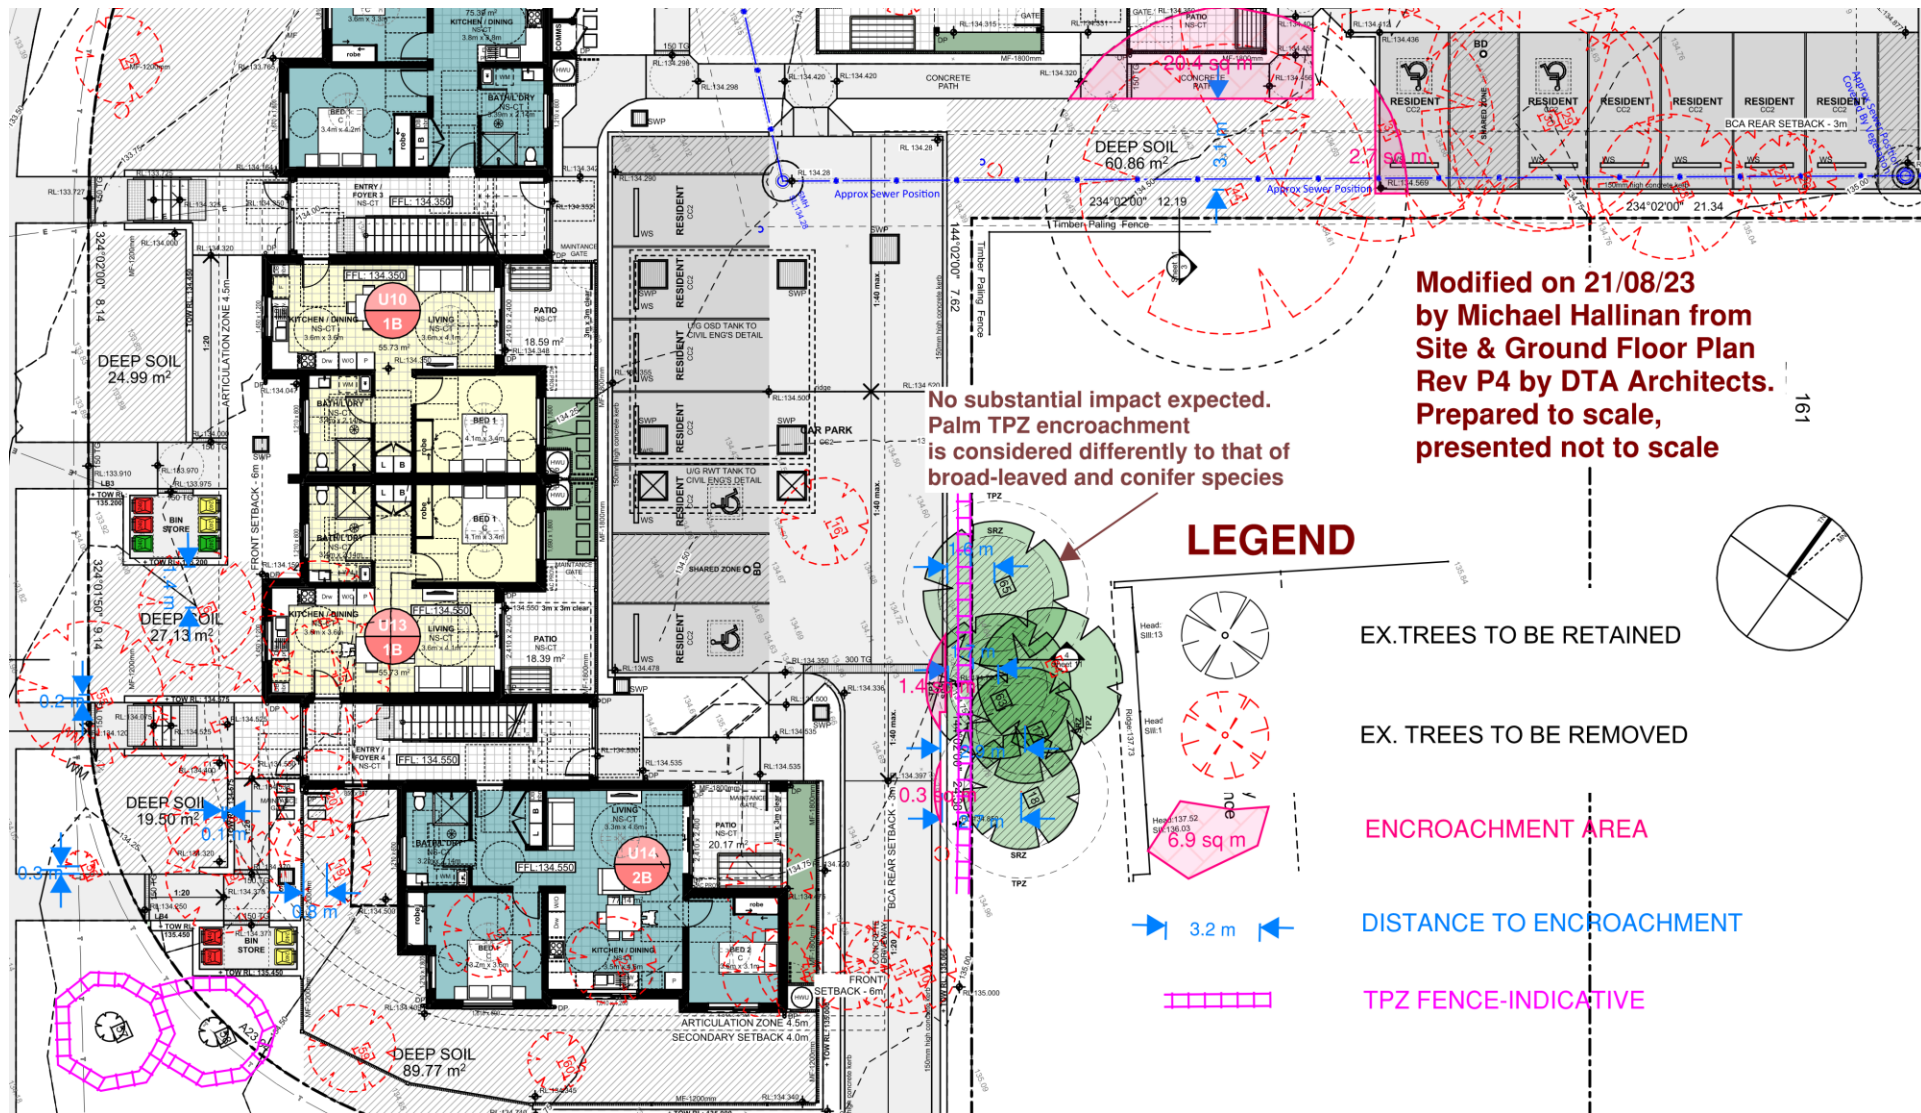
**Figure 1a. Tree retention, tree removal and tree protection plan drawing, South**

- One tree to be retained (T39) has a Major<sup>16</sup> TPZ encroachment outside the Structural Root Zone (SRZ)<sup>17</sup>, which is critical for tree stability. Proposed works within the TPZ are considered to be tolerable. Tree 39 and other trees recommended to be retained are expected to cope with construction activities, remain viable and maintain health, condition and vitality provided tree protection measures are effectively implemented as outlined below in **Section 4**.

Based on the proposed works, the following recommendations are made, refer to **Table 1** and **Figures 1a and 1b**:
