Arboricultural Development Assessment Report

Nepean Hospital Total Asset Management (TAM) Child & Adolescent Mental Health Services (CAMHS) project Kingswood NSW 2747 Updated May 2022 *Final*

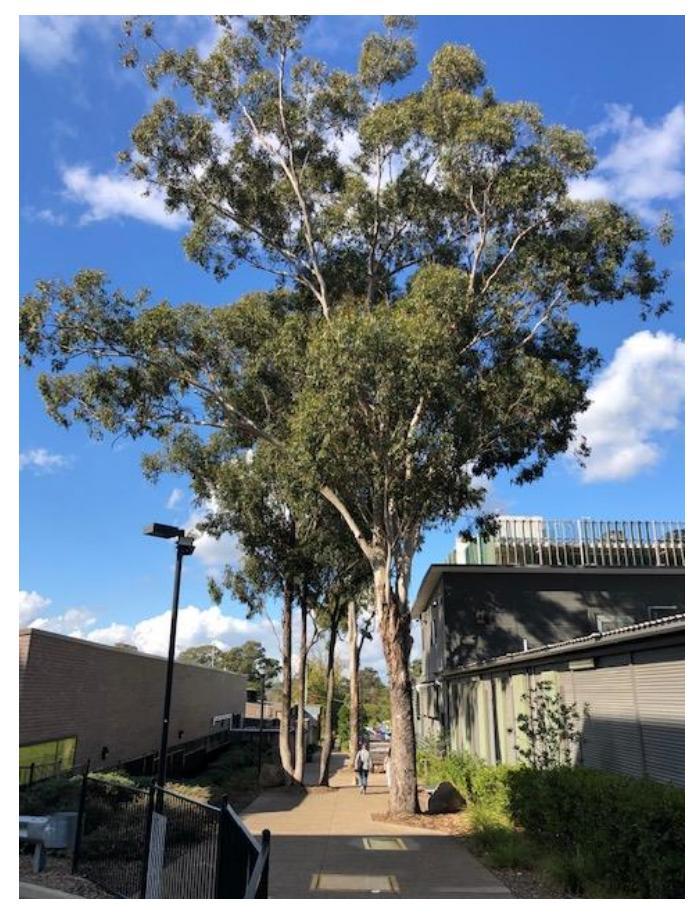
- 3.5 Trees 78-81 are all large mature Grey box (*Eucalyptus moluccana*). Apart from some very minor dead wood, these trees were found to be in good health and condition (Plate 1). These trees would be considered to be significant trees to the site.

Plate 1: Image showing Trees 78-81 along the northern portion of the study area. P.Vezgoff

- **3.13** Trees 78-81 are very close to the proposed works however it should be possible to retain these trees, provided the levels at the base can be retained. No services are to trench through the TPZ of these trees. Any complex landscape designs that require concrete footings are to be avoided below these trees.

- **5.3 Individual trunk protection:** Trees 78-81 will require trunk protection. This is achieved by attaching lengths of timber (75mm x 50mm x 2000mm) fastened around the trunk. Geotextile fabric or carpet underlay shall be wrapped around the trunk prior to the timbers being attached. These timbers are to be fastened with hoop iron strapping and not attached directly into the bark of the tree. These timbers are only to be removed when all construction is complete. See Image 1 for an example of trunk protection.

- **5.6 Root Zone Protection:** Following demolition Ply sheeting should be placed over the root zone of Trees 78-81 to reduce compaction over the root zone whilst works are occurring. The area for ply sheeting can be seen in the Tree Protection Plan.

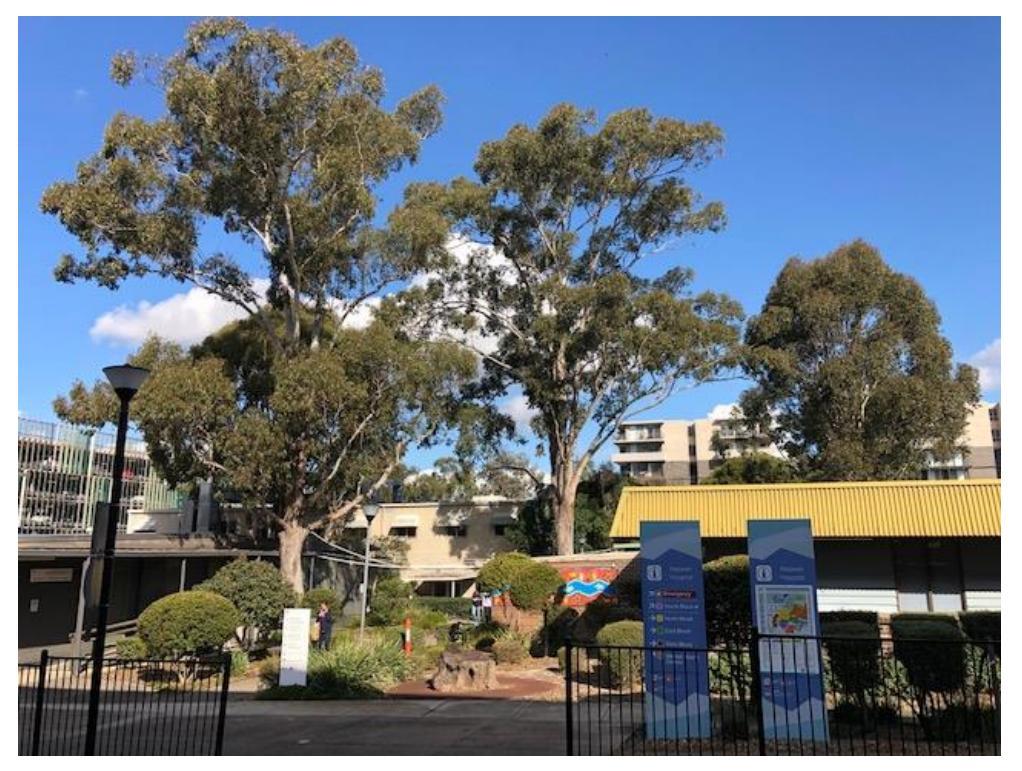
- **3.6** Trees 82 and 83 are both Grey box (*Eucalyptus moluccana*) in good health and condition (Plate 3). Again, these trees would be considered to be significant trees to the site. The first and second order branches of Trees 78-83 are free of any cracks, splits or fruiting bodies. Old pruning wounds are showing good occlusion, a sign that the trees are photosynthesizing effectively. New extension growth was noted with leaf colour showing good vitality. These trees would be considered to have 95% live canopies. The basal area and woody root zones were free of any ground heaving, or lifting.
- **3.7** Trees 88-90 are large shrubs rather than trees. These trees would be considered to be less significant trees to the site (Plate 3). Most of these specimens are in good health and condition with some minor dieback occurring (Plate 4).

Plate 2: Image showing Trees 82 (Left) and 83 (Right). P.Vezgoff

- **3.12 Impacts:** Based on the plans provided Trees 82 and 83 require removal as they are located within the proposed building footprint. Trees 128-139 will be required to be removed as they are located within the area of the proposed Total Asset Management building.

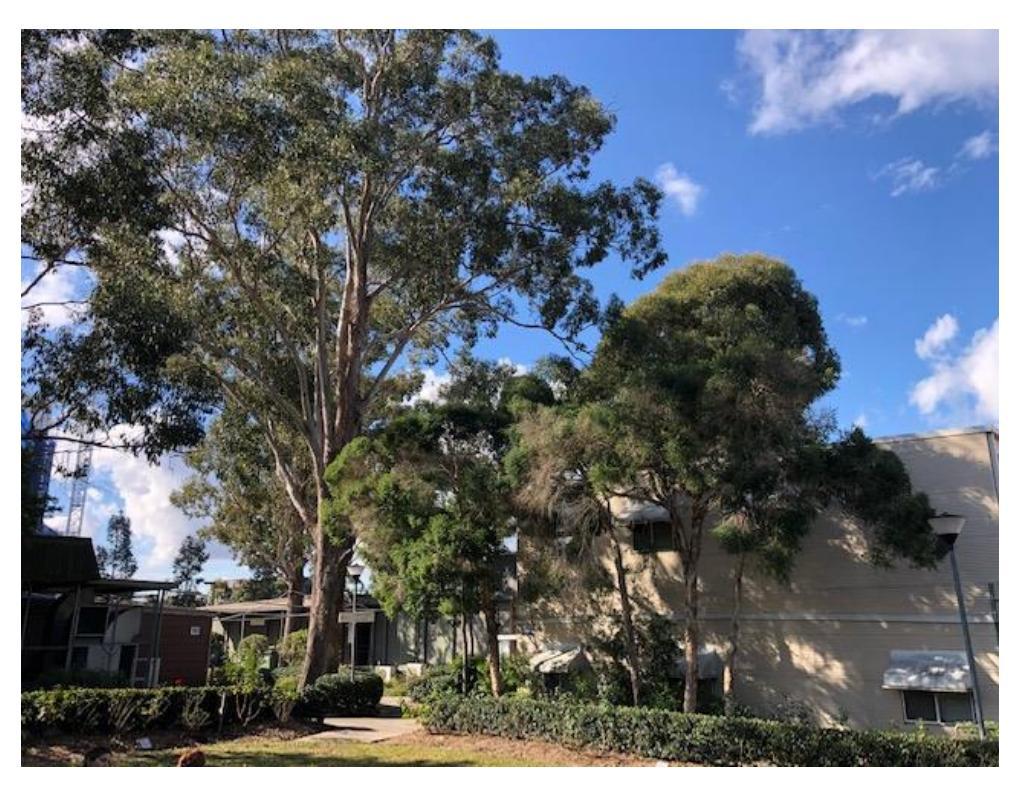
Plate 3: Image showing Trees 83 (left) and Trees 88-90. P.Vezgoff

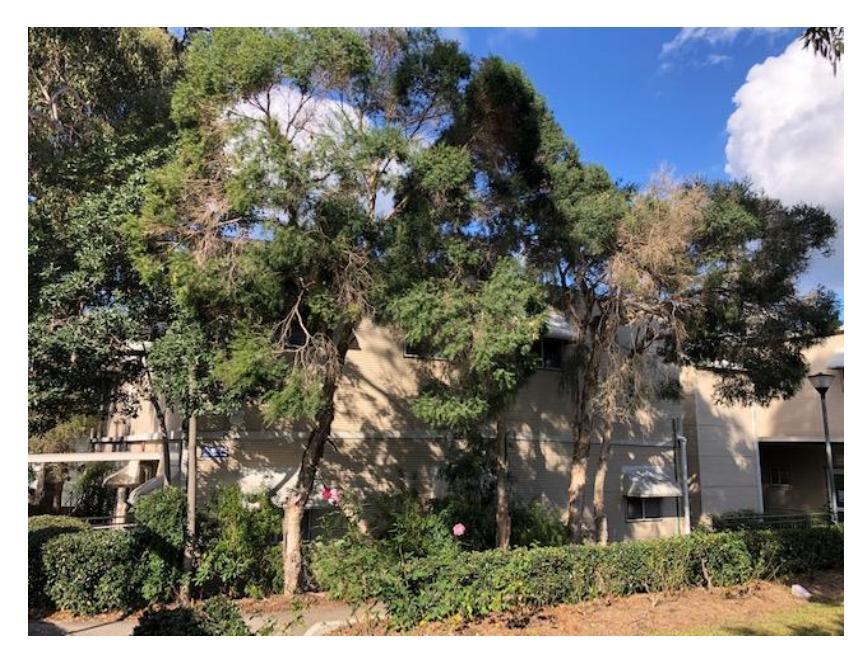
Plate 4: Image showing Trees 88-90. P.Vezgoff

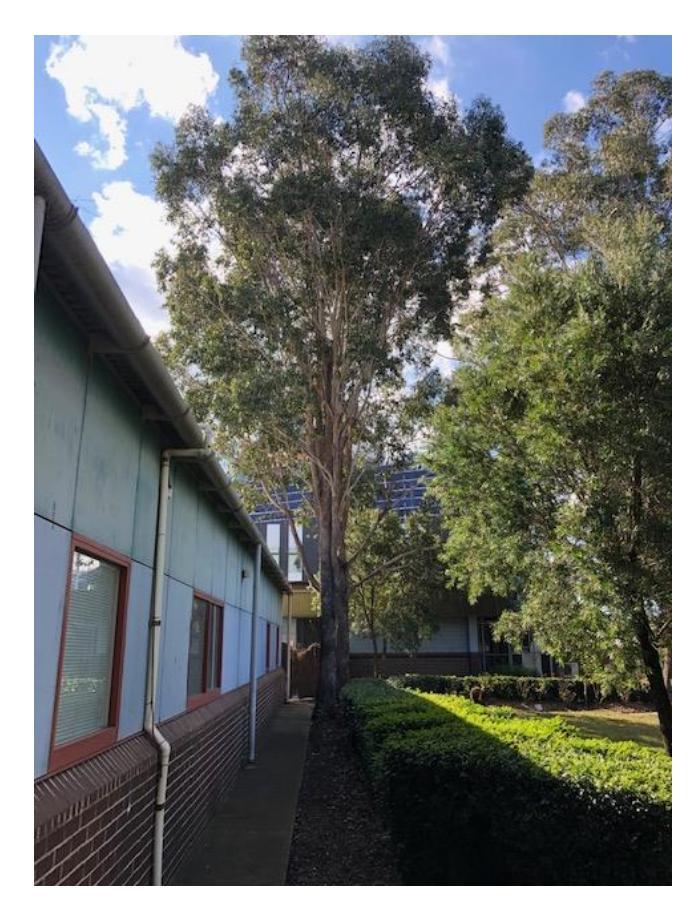
Plate 5: Image showing Trees 100 and 101. P.Vezgoff

3.8 Trees 100 and 101 are also Grey box (*Eucalyptus moluccana*) that are in good health and condition (Plate 5). These trees would be considered to be significant trees to the site.

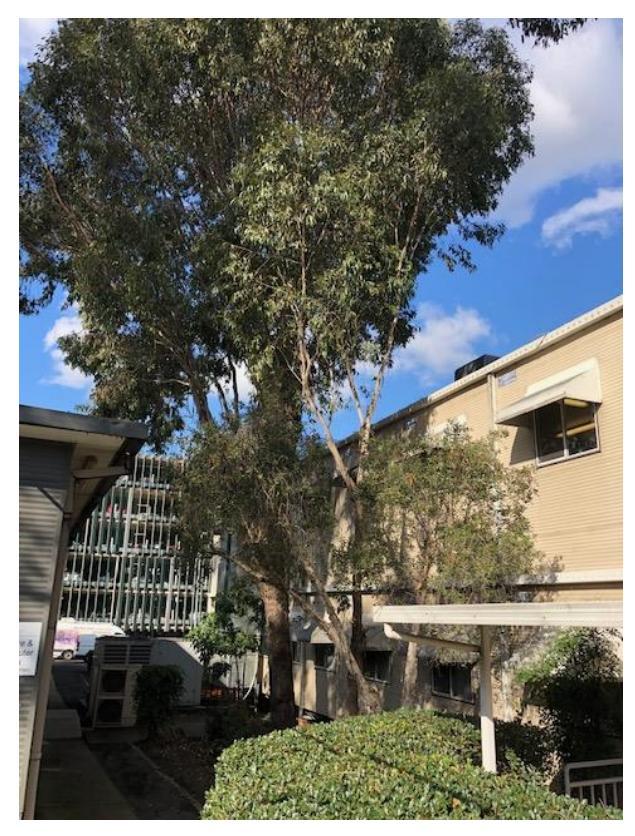
3.9 Trees 84-86 are Grey box (*Eucalyptus moluccana*) and Broad leaved paperbark these trees were found in to be in good health and condition (Plate 6). These trees would be considered to be less significant trees in relation to some of the larger trees on site.

Plate 6: Image showing Trees 84-86. P.Vezgoff

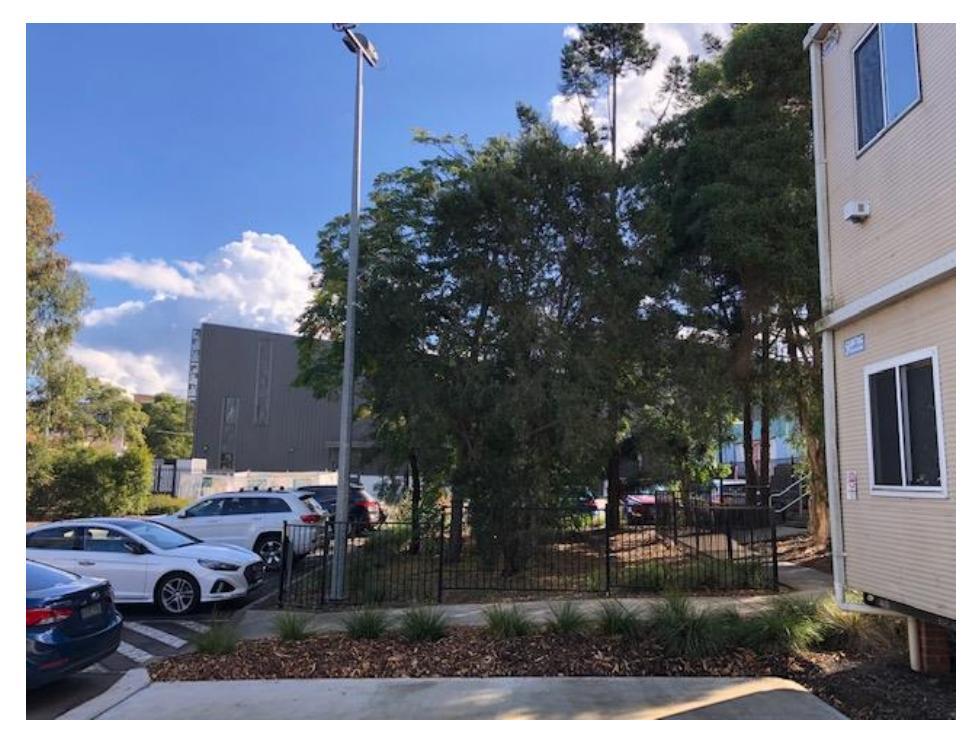
3.10 Trees 103-120 are located to the south of the proposed building area that should be well away from any works. These trees are all semi to mature specimens that consist of Tallowwood (*Eucalyptus microcorys*), Broad leaved paperbark (*Melaleuca quinquenervia*), *Hymenosporum flavum*, Chinese tallow tree (*Triadica sebifera*). These trees were found in to be in good health and condition (Plate 2). These trees would be considered to be less significant trees to the site as individual specimens, but do have value as a group (Plate 7). Around the car park area are Trees 122-140 that are all semi mature *Eucalyptus* specimens that are in good health and condition, with the exception of Trees 125 and 128 that are in poor condition.

Plate 7: Image showing Trees 106-115. P.Vezgoff

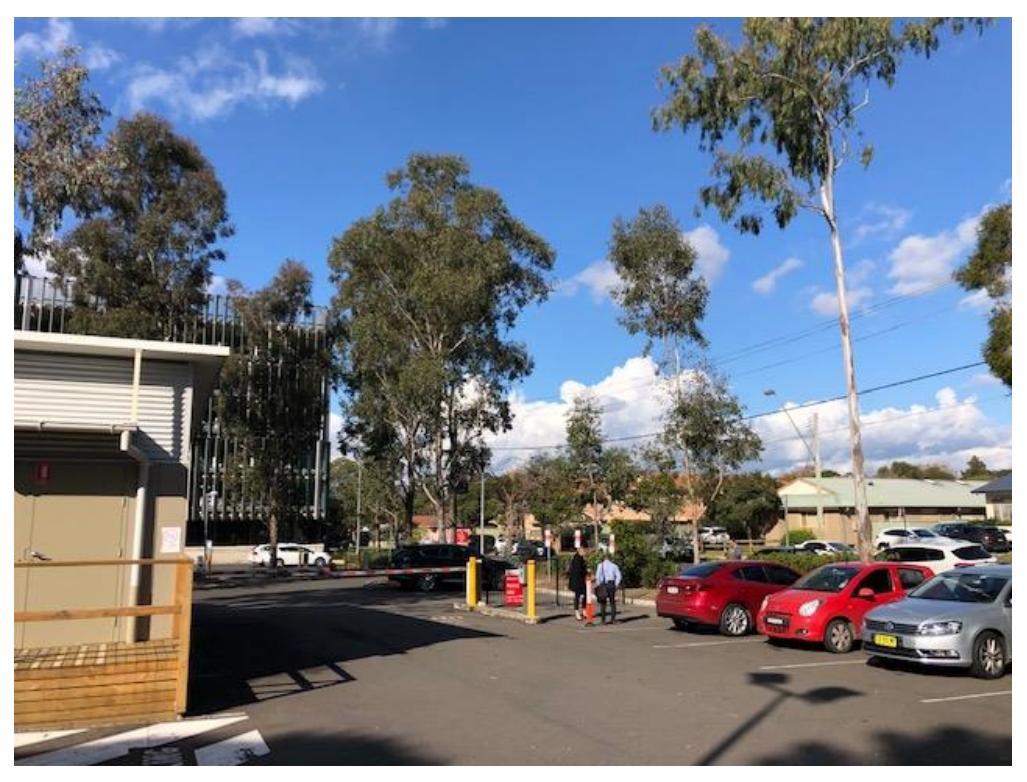
Plate 8: Image showing Trees 123-130 along the car park area. P.Vezgoff
