**ARBORICUTURAL IMPACT ASSESSMENT - FOR 2022 DEVELOPMENT AT;  
GUNNEDAH HOSPITAL NSW 2380**

**1. INTRODUCTION.**

*Gunnedah Hospital re-development, Marquis Street Gunnedah NSW 2380. Option 2 - Site Floor Plan - Stage 1. Drawing number SK-S1-9240 issue C dated 3/05/2023. DWP Architects, Sydney NSW.*

*Gunnedah Hospital re-development Anzac Parade Gunnedah. Arboricultural Assessment Review. Job no. 5668. Issue C Dated 05/05/2023. Stewart Surveys - Gunnedah NSW.*

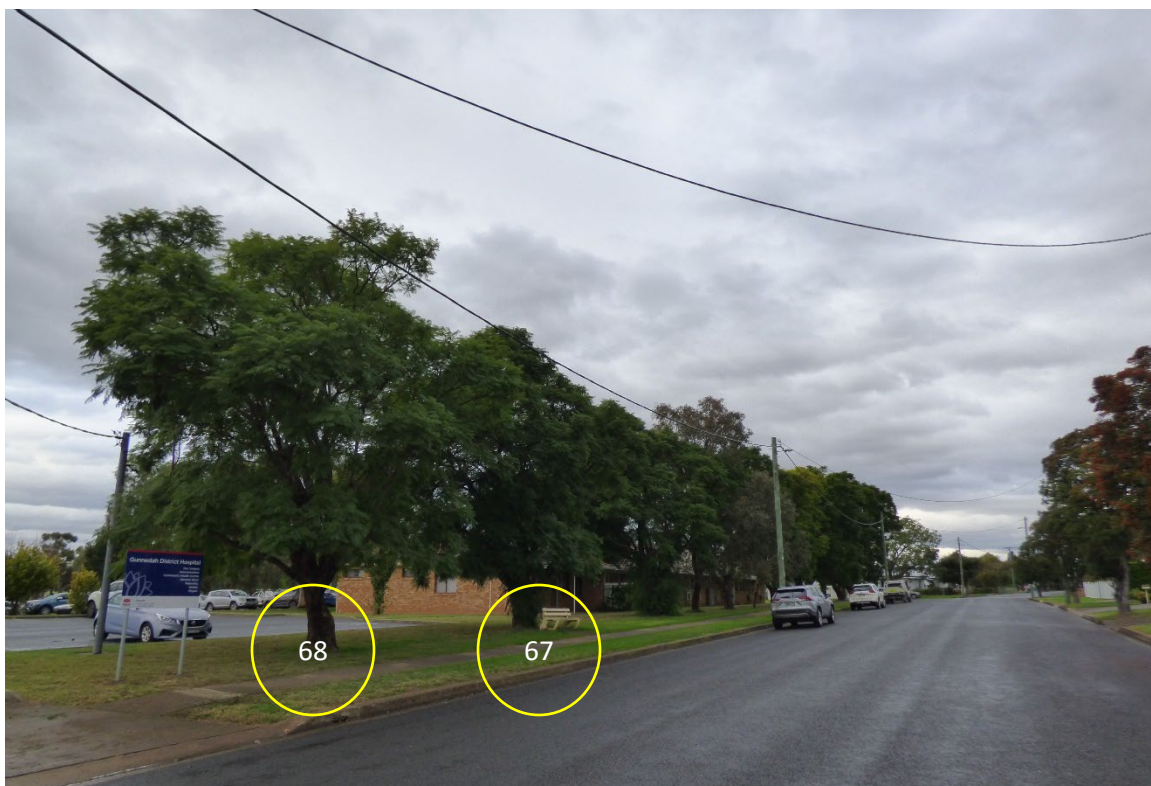
- Trees 58 to 68 inclusive form a line of trees on Reservoir Street that are of some age and are considered significant – particularly as a line of larger trees with strong amenity values and lengthy replacement time frames.

**Photo 6 – Trees 68 to 58 in sequence from foreground. Line of medium to large mature trees evaluated as high significant and ‘Retain Priority’.**

Planning should ensure that the TPZ of these tree is respected and that removal would be difficult to justify. The line of trees provides significant amenity values and would take 30-50 years to replace.
