Asbestos and Hazardous Materials Pre-Demolition Assessment

Block B

Wyong Public Hospital

21/08/2023

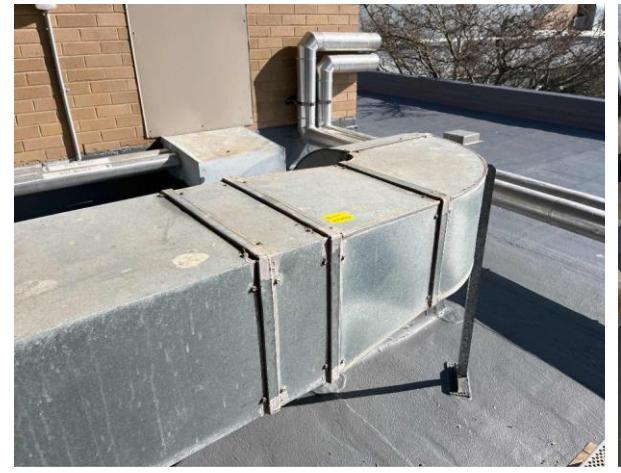
Line ID 3: External, Roof Top Plant Room, Throughout, Ductwork, Mastic Sealant - No Asbestos Detected

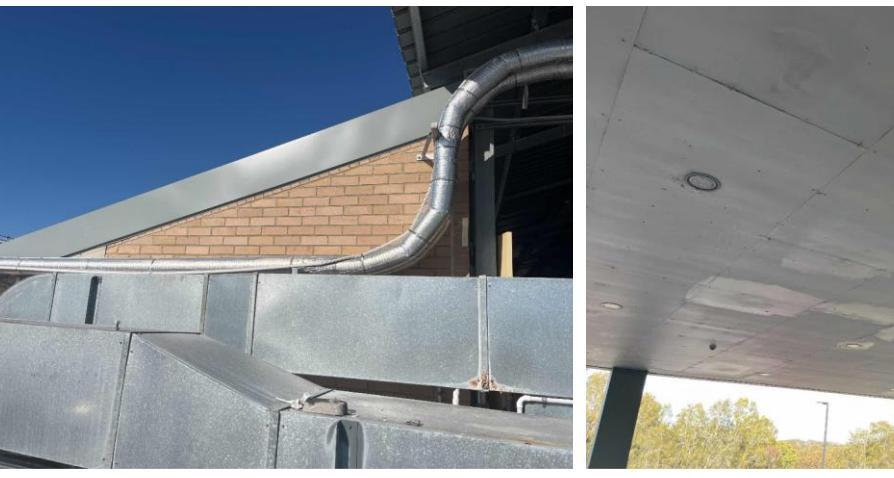
Line ID 5: External, Roof Top Plant Room, Throughout, North and South Sides Gable Verge Lining, Fibre Cement Sheet - No Asbestos Detected

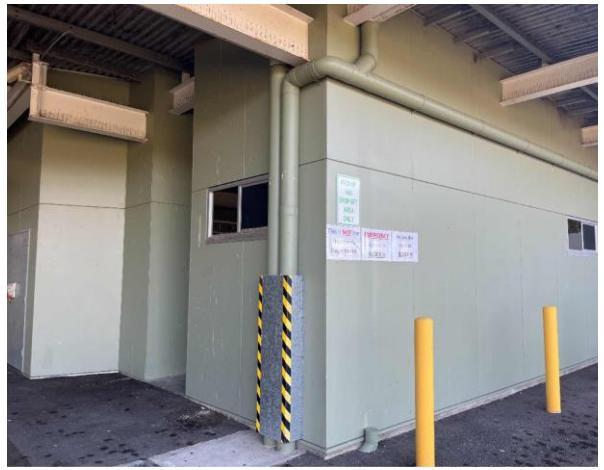
Line ID 7: External, Southern Side, Main Entrance to Building, Walls, Compressed Cement Sheet - No Asbestos Detected

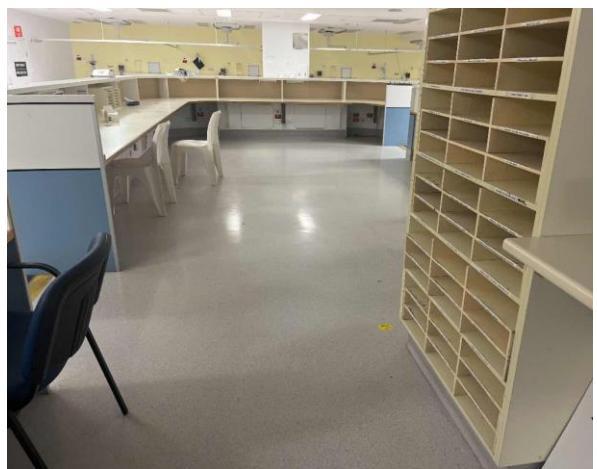
Line ID 8: Internal, Acute Emergency Unit, Central Office Area, Floor Covering, Grey Vinyl Sheet - No Asbestos Detected

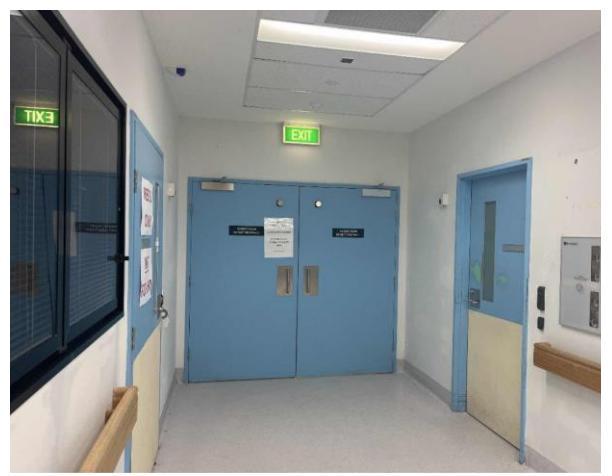
Internal	Acute Emergency Unit / EMW.C.07 / Double Fire Doors	Fire Door Core	Asbestos	754- SYDEN329755 Block B168A13	Suspected Asbestos	Friable	2 Units	Stable	Low	5 Yearly Reinspection	No door tags. Confirm status and remove under controlled friable asbestos removal conditions by a Class A (friable) licensed asbestos removal contractor. Prior to any intrusion or removal, sampling is to be conducted by a suitably trained hygienist/LAA (if state requirement) and test at a NATA accredited facility for verification of internal core system.	9
Internal	Acute Emergency Unit / Throughout / Below Vinyl Sheet	Screed	Asbestos	A12290	No Asbestos Detected	-	200 m²	-	-	-	Sampled from EMW.20.	10

Line ID 9: Internal, Acute Emergency Unit, EMW.C.07, Double Fire Doors, Fire Door Core - Suspected Asbestos

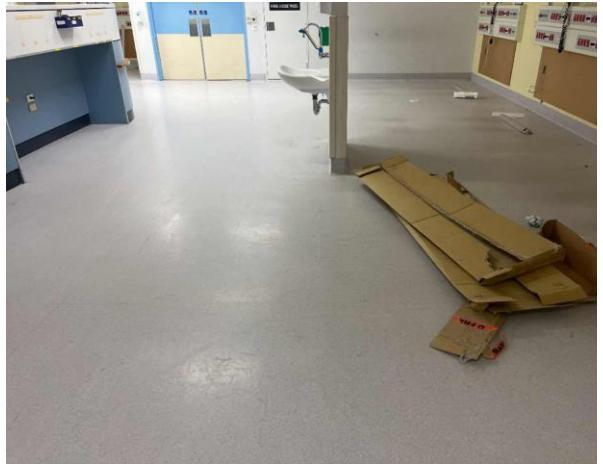
Line ID 11: Internal, Acute Emergency Unit, Throughout, Floor, Grey Vinyl Sheet - No Asbestos Detected

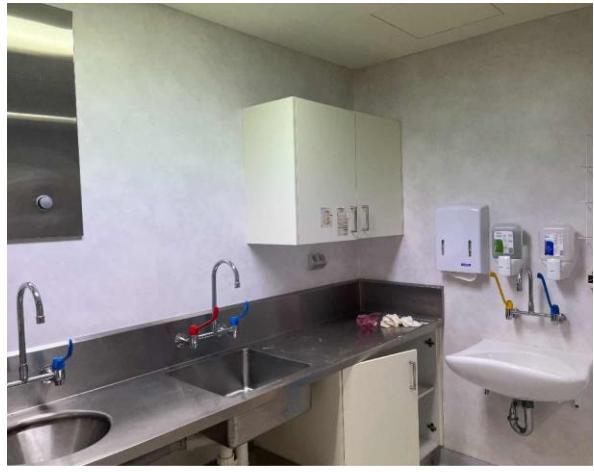
Line ID 15: Internal, House Doctor / Emergency Pediatric, EMW.31.02, Walls, Cream Vinyl Sheet - No Asbestos Detected

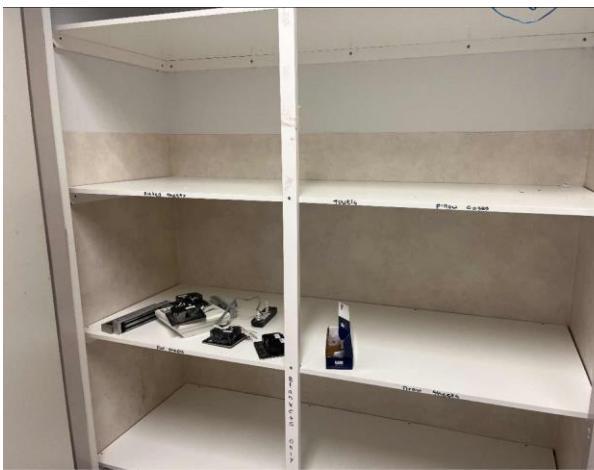
Line ID 16: Internal, House Doctor / Emergency Pediatric, EMW.37.04, Walls, Cream Vinyl Sheet - No Asbestos Detected

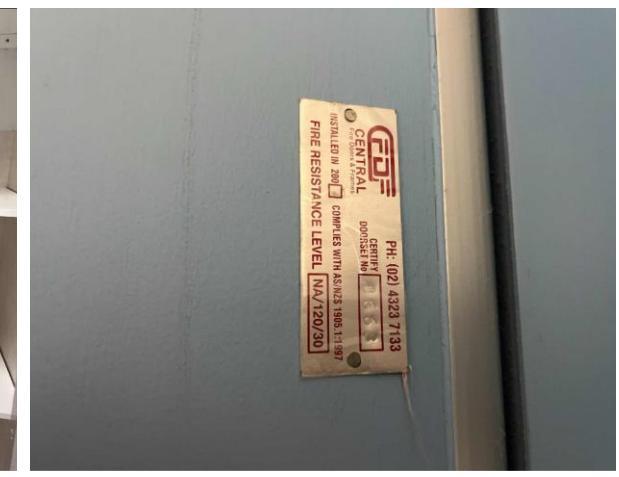
Line ID 17: Internal, House Doctor / Emergency Pediatric, EMW.C.10, Fire Door, Fire Door Core - No Asbestos Suspected

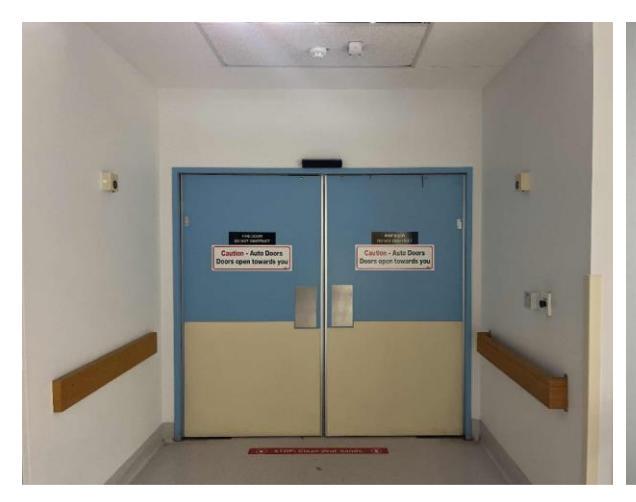
Line ID 17.1: Internal, House Doctor / Emergency Pediatric, EMW.C.10, Fire Door, Fire Door Core - No Asbestos Suspected

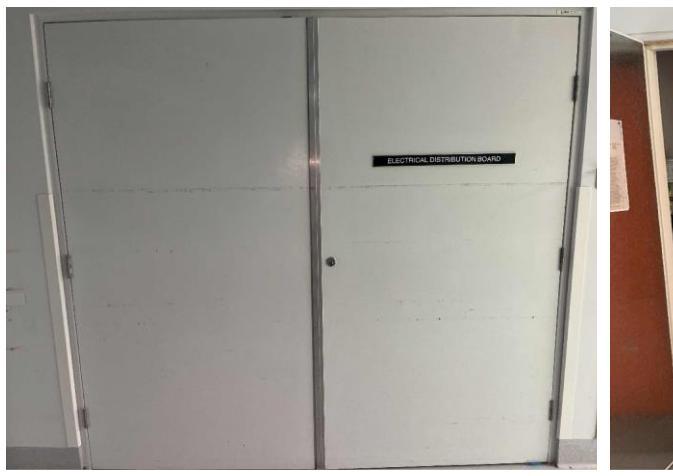
Line ID 18.1: Internal, House Doctor / Emergency Pediatric, EMW.C.10 Distribution Cupboards, Fire Doors, Fire Door Core - Suspected Asbestos

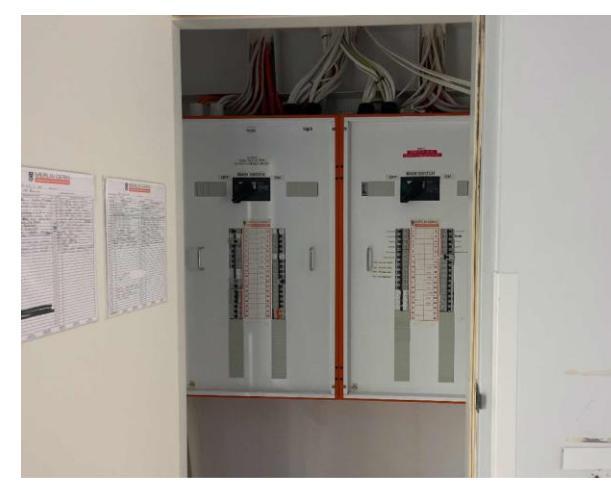
Internal	House Doctor / Emergency Pediatric / EMW.C.10 Distribution Cupboards / Within Distribution Boards	HRC fuses	Asbestos	754- SYDEN329755 Block B168A10	Suspected Asbestos	Friable	10 Units	Poor	Low	5 Yearly Reinspection	No access within the distribution board, suspected to be present based on age of building. Confirm status and maintain in current condition if to remain in-situ in accordance with relevant State Regulations, Compliance Codes, Codes of Practice and Guidance Notes. Remove under controlled friable asbestos removal conditions prior to refurbishment or demolition works by a Class A (friable) licensed asbestos removal contractor in accordance with relevant State Regulations, Compliance Codes, Codes of Practice and Guidance Notes.	19
Internal	House Doctor / Emergency Pediatric / EMW.C.11 / Fire Door	Fire Door Core	Asbestos	754- SYDEN329755 Block B168A9	No Asbestos Suspected	-	2 Units	-	-	-	Date of manufacture 2019. Suspected negative due to age and appearance.	20

Line ID 19.1: Internal, House Doctor / Emergency Pediatric, EMW.C.10 Distribution Cupboards, Within Distribution Boards, HRC fuses - Suspected Asbestos

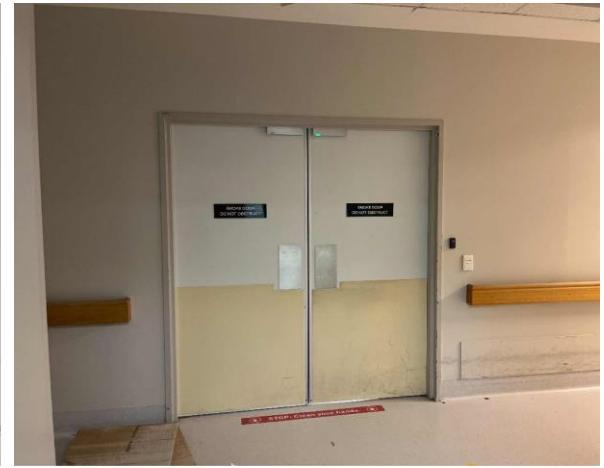
Line ID 20: Internal, House Doctor / Emergency Pediatric, EMW.C.11, Fire Door, Fire Door Core - No Asbestos Suspected

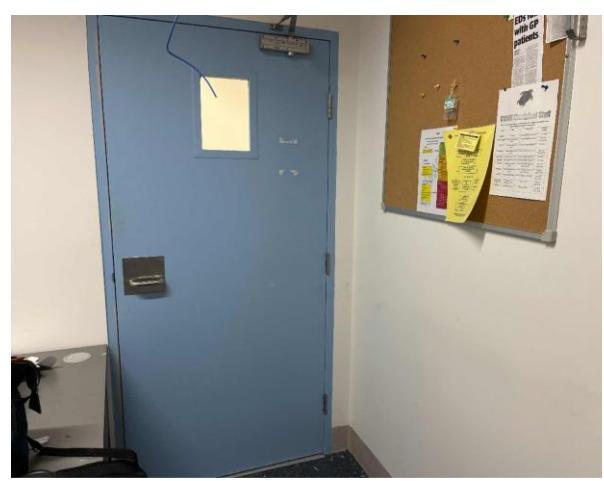
Line ID 23: Internal, Medical Imaging Unit, MIW.41, Single Fire Door, Fire Door Core - Suspected Asbestos

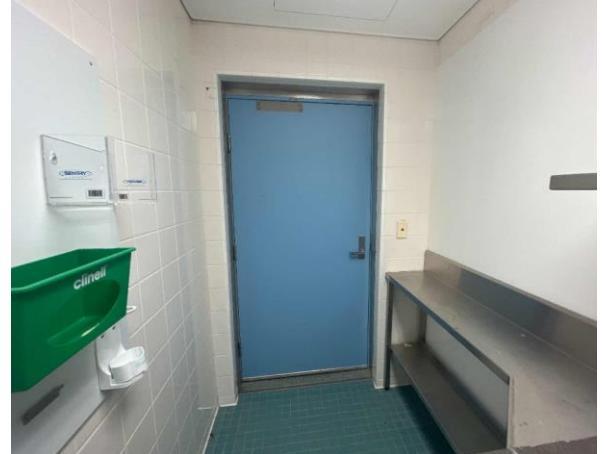
Internal	Medical Imaging Unit / MIW.42 / Southern Fire Door	Fire Door Core	Asbestos	754- SYDEN329755 Block B168A6	Suspected Asbestos	Friable	1 Unit	Stable	Low	5 Yearly Reinspection	Date of manufacture 199*. Confirm status and remove under controlled friable asbestos removal conditions by a Class A (friable) licensed asbestos removal contractor. Prior to any intrusion or removal, sampling is to be conducted by a suitably trained hygienist/LAA (if state requirement) and test at a NATA accredited facility for verification of internal core system.	24

Line ID 24: Internal, Medical Imaging Unit, MIW.42, Southern Fire Door, Fire Door Core - Suspected Asbestos

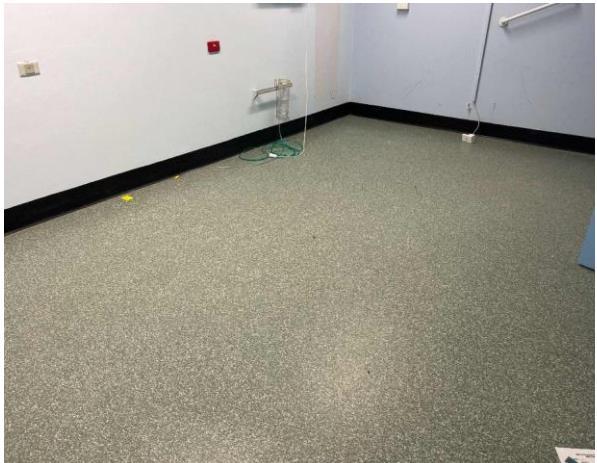
Line ID 25: Internal, Medical Imaging Unit, MIW.43, Floor Covering, Green Vinyl Sheet - No Asbestos Detected

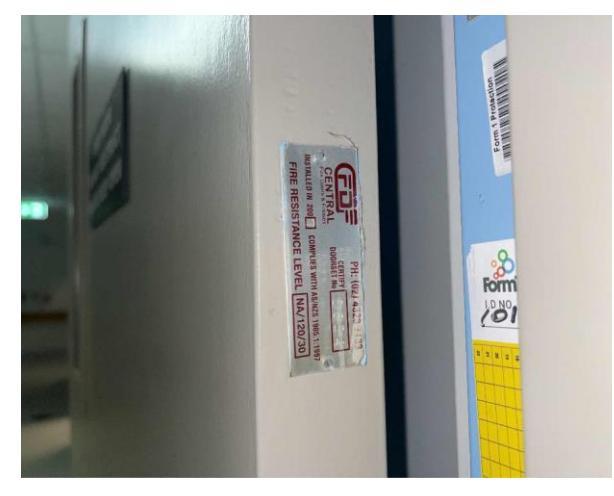
Line ID 27: Internal, Medical Imaging Unit, MIW.c.05 North End and MIW.c.06 West Side, Doors Labelled Post December 2003, Fire Door Core - No Asbestos Suspected

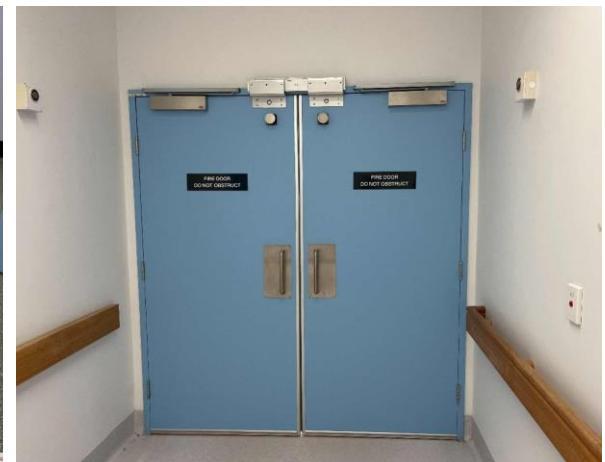
Line ID 26: Internal, Medical Imaging Unit, MIW.C.04, Double Fire Doors, Fire Door Core - Asbestos Suspected

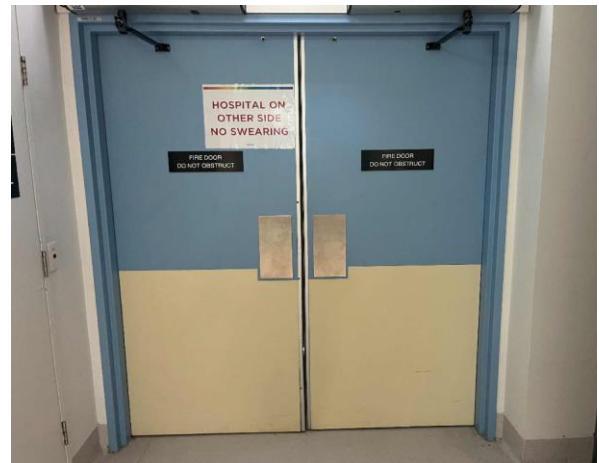
Line ID 27.1: Internal, Medical Imaging Unit, MIW.c.05 North End and MIW.c.06 West Side, Doors Labelled Post December 2003, Fire Door Core - No Asbestos Suspected

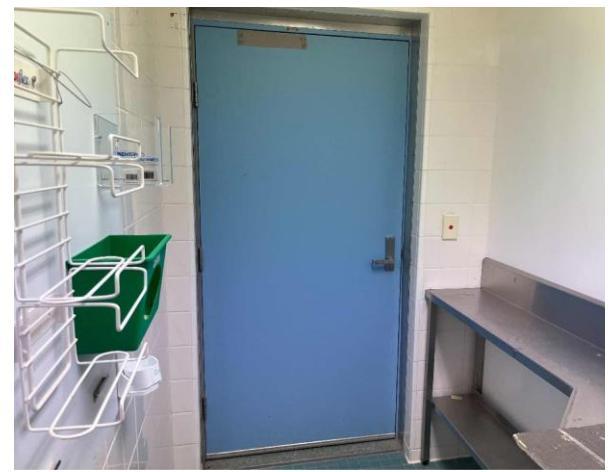
Line ID 28: Internal, Medical Imaging Unit, Throughout, Doors Dated Pre December 2003 or Unlabelled Fire Doors, Fire Door Core - Suspected Asbestos

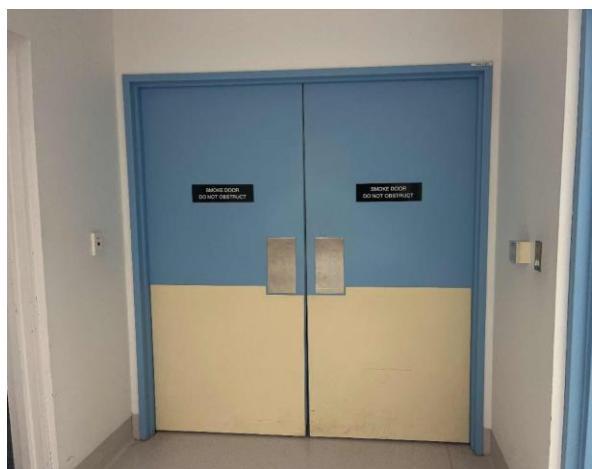
Line ID 28.1: Internal, Medical Imaging Unit, Throughout, Doors Dated Pre December 2003 or Unlabelled Fire Doors, Fire Door Core - Suspected Asbestos

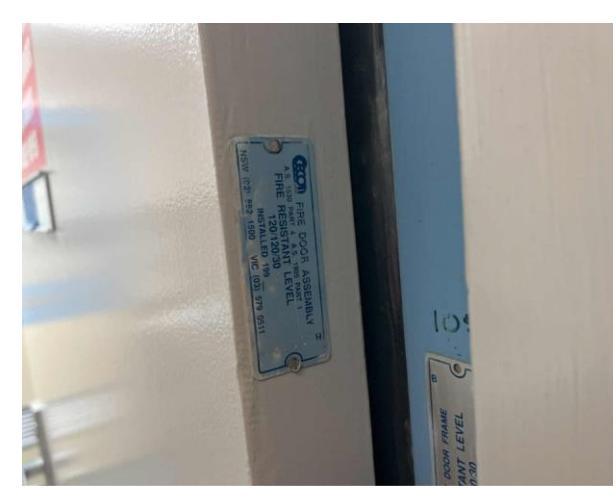
Line ID 28.2: Internal, Medical Imaging Unit, Throughout, Doors Dated Pre December 2003 or Unlabelled Fire Doors, Fire Door Core - Suspected Asbestos

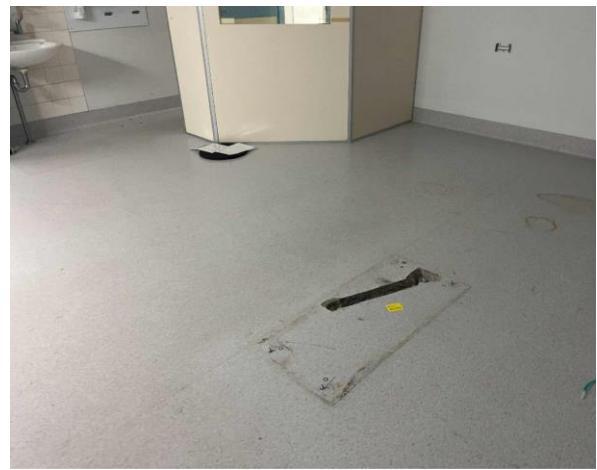
Line ID 29: Internal, Medical Imaging Unit, Throughout, Floor Coverings, Grey Vinyl Sheet - No Asbestos Detected

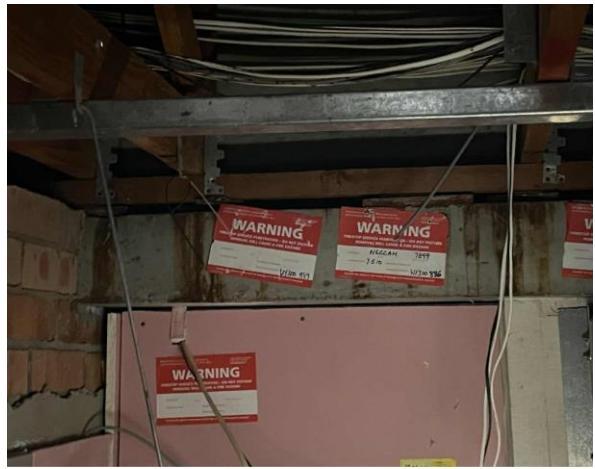
Line ID 30: Internal, Medical Imaging Unit, Western Side Ceiling Space, Lining to Rafters, Fibre Cement Sheet - Suspected Asbestos

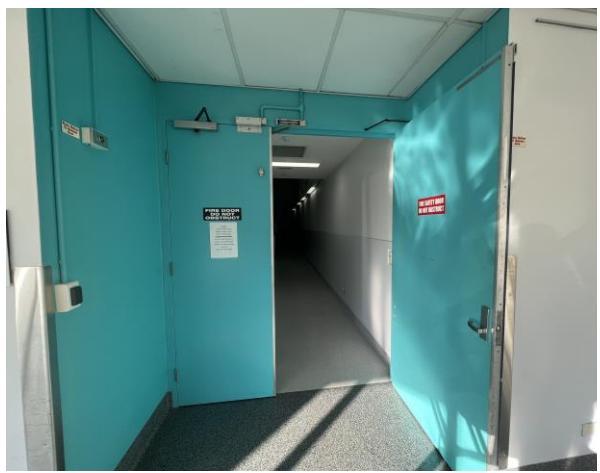
Line ID 32: Internal, Pathology Lab, Entrance, Fire Doors, Fire Door Core - Suspected Asbestos

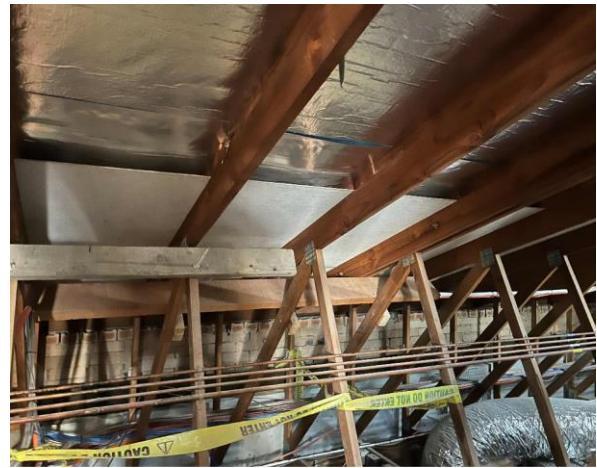
Line ID 33: Internal, Roof Top Plant Room, Ceiling 1 East Side, Ceiling, Fibre Cement Sheet - No Asbestos Detected

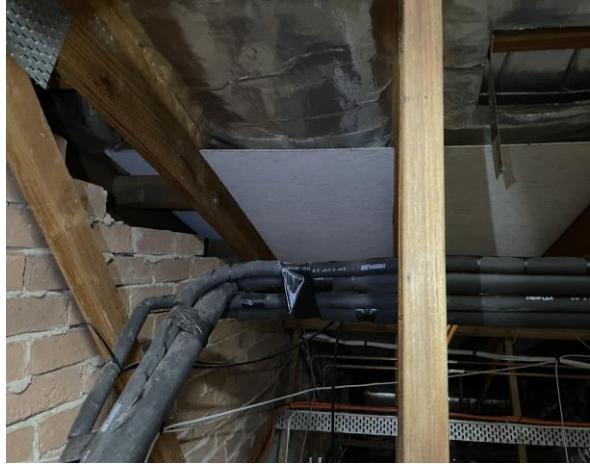
Line ID 34: Internal, Roof Top Plant Room, Roof Ceiling 3, Ceiling on Eastern Side, Fibre Cement Sheet - No Asbestos Detected

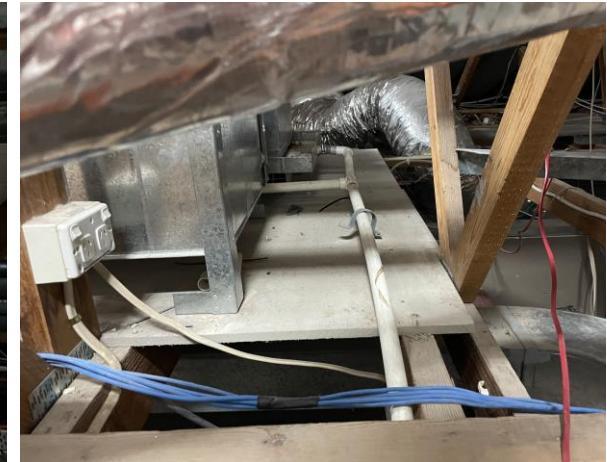
Line ID 35: Internal, Roof Top Plant Room, Roof Ceiling 3, Panel to Floor, Compressed Cement Sheet - Suspected Asbestos

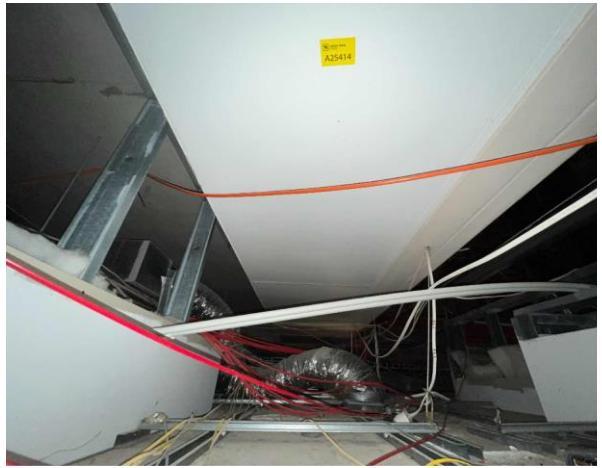
Line ID 40: Internal, Waiting Room / Security, Adjacent Bathrooms, False Ceiling Within Ceiling Space, Fibre Cement Sheet - No Asbestos Detected

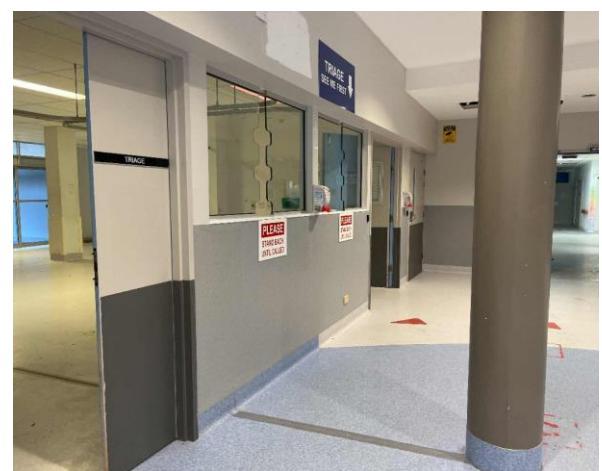
Line ID 41: Internal, Waiting Room / Security, Throughout, Walls, Grey Vinyl Sheet - No Asbestos Detected

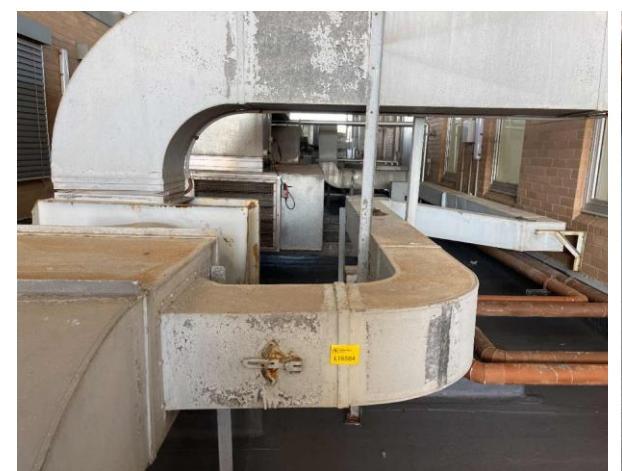
Line ID 42: External, Roof Top Plant Room, Throughout, Ductwork, Grey (Light) Paint - Lead Detected (0.02% w/w)

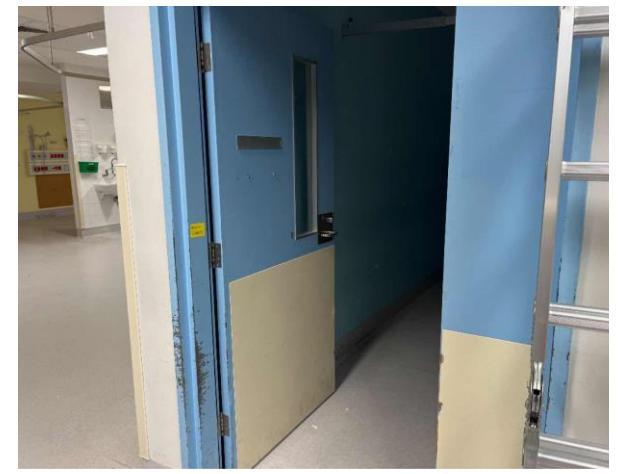
Line ID 44: Internal, Acute Emergency Unit, Throughout, Doors and Frames, Blue (Light) Paint -Lead Detected (0.04% w/w)

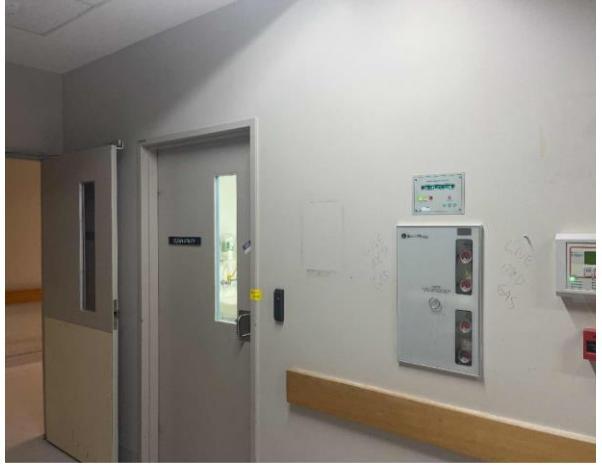
Line ID 46: Internal, House Doctor / Emergency Pediatric, Throughout, Walls, Doors and Door Frames, Beige Paint - Lead Detected (<0.005% w/w)

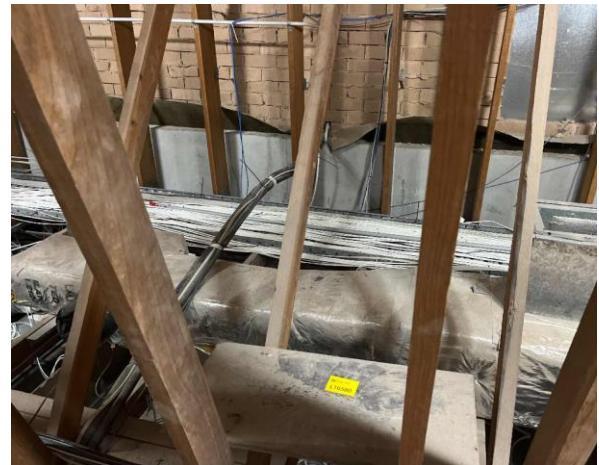
Line ID 47: Internal, Roof Top Plant Room, Ceiling 1 East Side, to Horizontal Surfaces, Dust - Lead Detected (140 mg/kg)

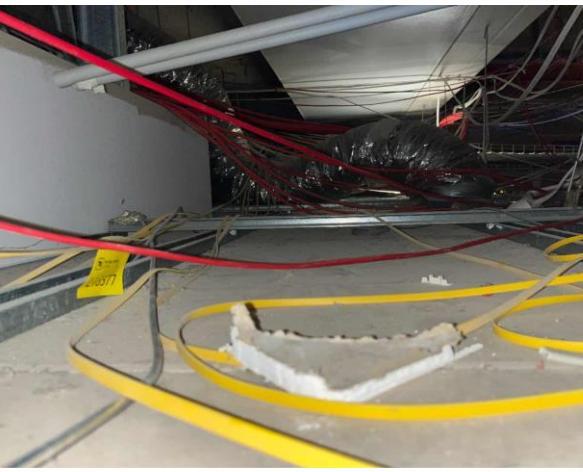
Line ID 48: Internal, Roof Top Plant Room, Ceiling 1, Western Side, Horizontal Surfaces Throughout, Dust -Lead Detected (96 mg/kg)

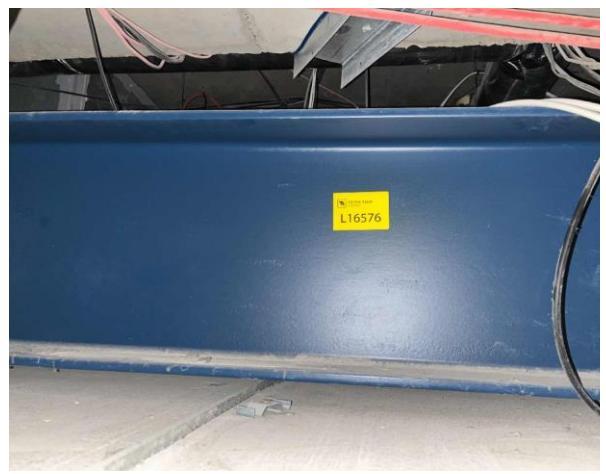
Line ID 51: Internal, Waiting Room / Security, Ceiling Space, Throughout, Dust - Lead Detected (16 mg/kg)

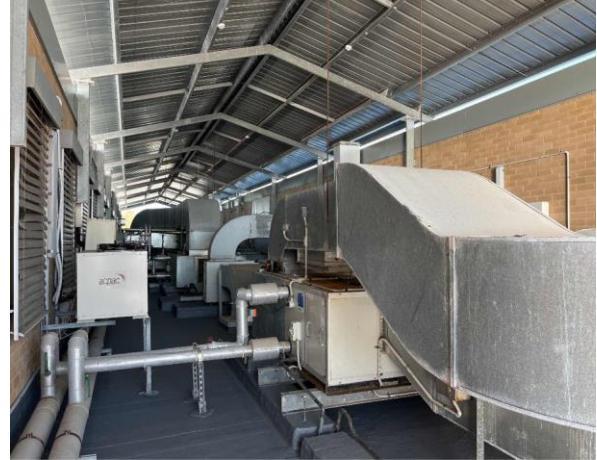
Line ID 52: External, Roof Top Plant Room, Throughout, Air Conditioning Ductwork, Internal Insulation - Suspected SMF

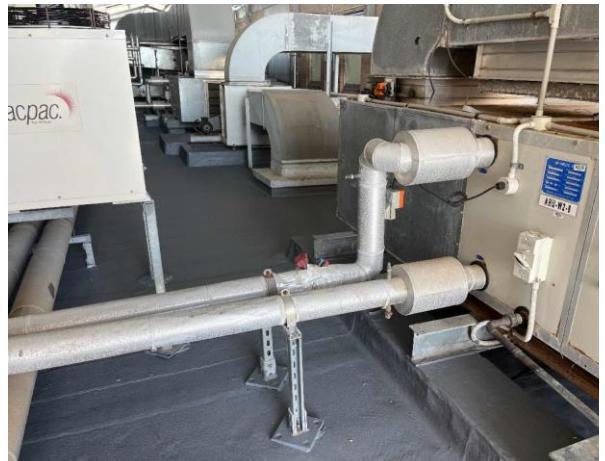
Line ID 53: External, Roof Top Plant Room, Throughout, Pipework, Internal Insulation - Suspected SMF

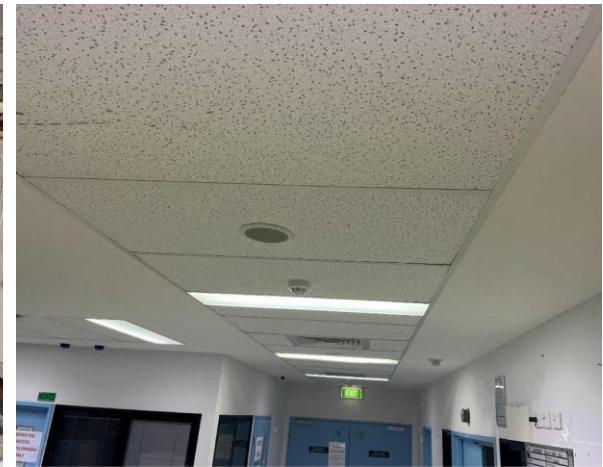
Line ID 54: Internal, Acute Emergency Unit, Throughout, Walkway Ceilings, Compressed Ceiling Tiles - Suspected SMF

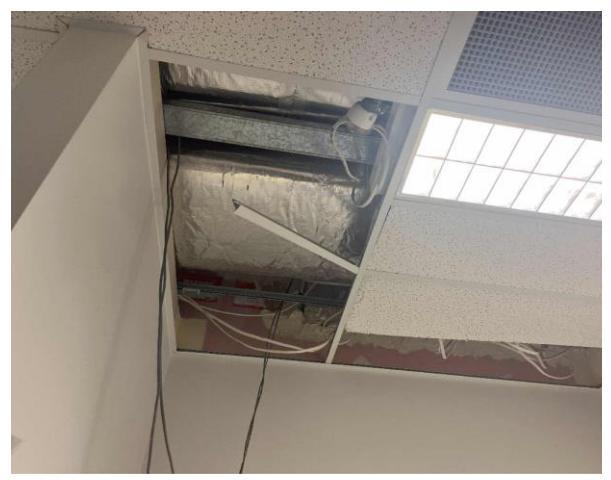
Line ID 59: Internal, Medical Imaging Unit, Throughout, Rigid Ductwork Within Ceiling Space, External Insulation - Suspected SMF

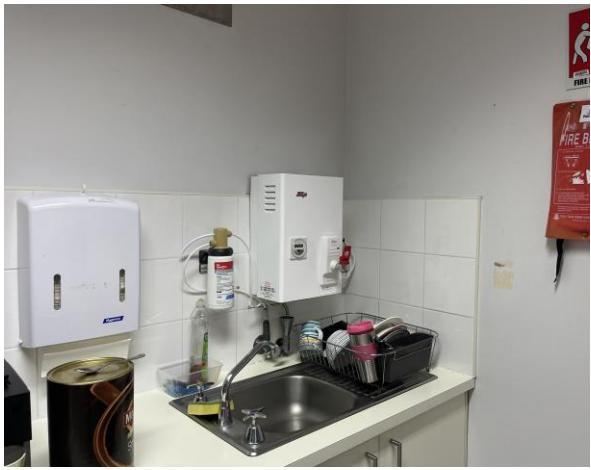
Line ID 60: Internal, Pathology Lab, Kitchen, Above Sink, Hot Water Boiler, Internal Insulation - Suspected SMF

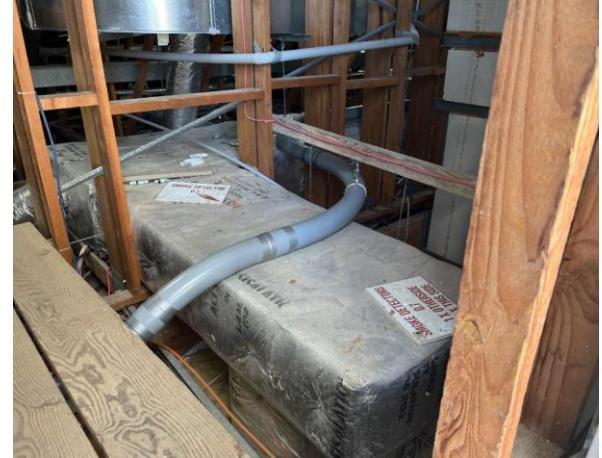
Line ID 64: Internal, Roof Top Plant Room, Throughout, Rigid Ductwork, External Insulation - Suspected SMF

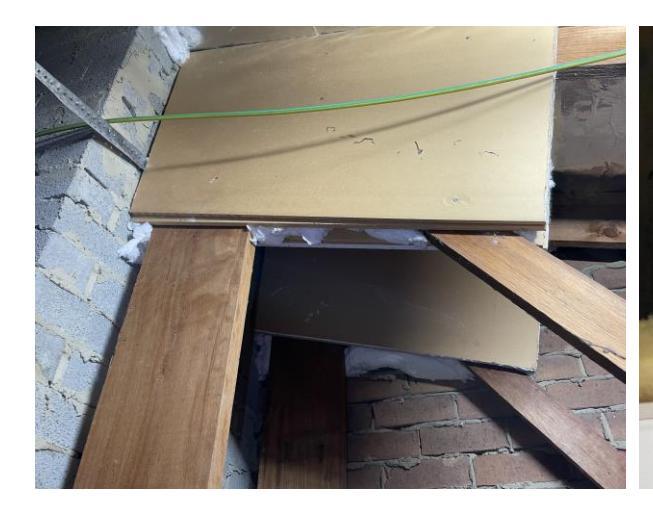
Line ID 65: Internal, Roof Top Plant Room, Throughout, Various Locations, Loose Insulation - Suspected SMF

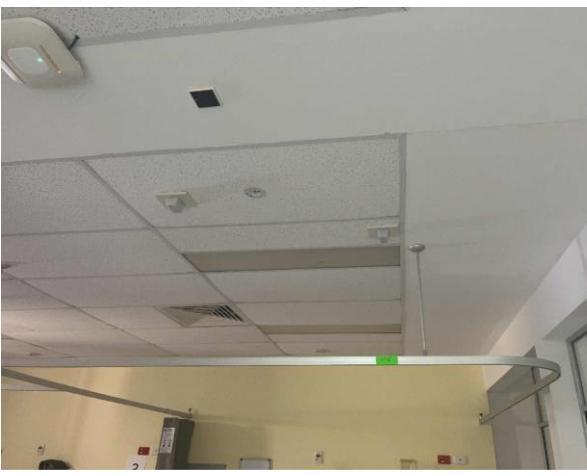
Line ID 68: Internal, House Doctor / Emergency Pediatric, Throughout, Light Fittings, Ballast(s) - Suspected PCB

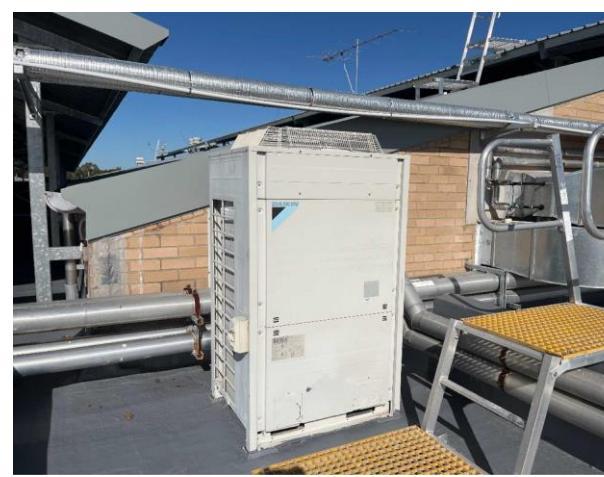
Line ID 69: External, Roof Top Plant Room, Central Area, Daikin AC Unit, Northern Side, R410A Hydrofluorocarbon (HFC) - Non ODS Refrigerant

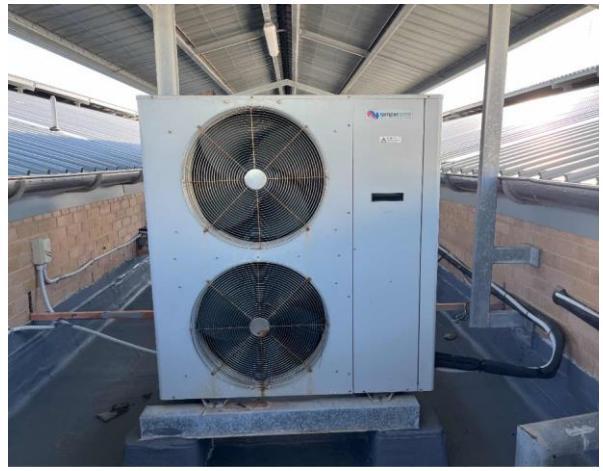
Line ID 71: External, Roof Top Plant Room, Central Area, Temperzone AC Unit, R410A Hydrofluorocarbon (HFC) - Non ODS Refrigerant

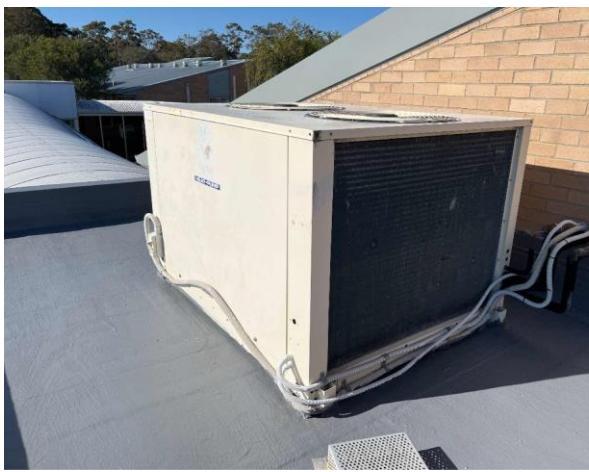
Line ID 73: External, Roof Top Plant Room, Northern Eastern Side, Acpac AC Unit, R404A Refrigerant - Non ODS Refrigerant

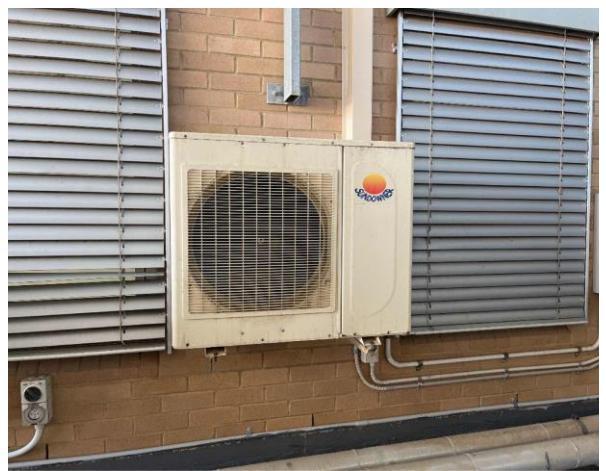
Line ID 76.1: External, Roof Top Plant Room, Throughout, North Eastern Side Sundowner and Cleanline AC Units, R22 Hydrochlorofluorocarbon (HCFC) - ODS Refrigerant

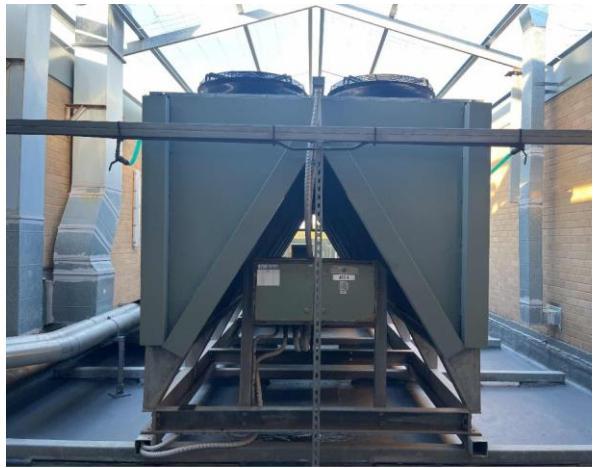
Line ID 77: External, Roof Top Plant Room, Western Side Between Ceiling 1, Central Area, Actrol Unit, R134a Refrigerant - Non ODS Refrigerant

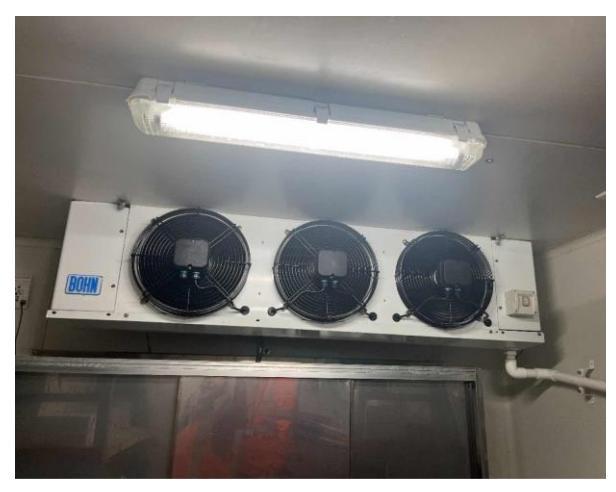
Line ID 80: Internal, Pathology Lab, Cool Room, Southern Wall, Chiller Unit, Unknown Refrigerant -Suspected ODS

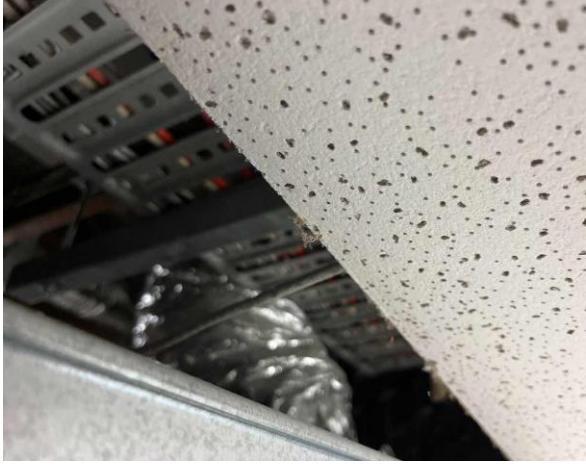
Line ID 81: Internal, Acute Emergency Unit, Ceiling space – No Access
