# **ARBORICULTURAL REPORT**

# Wentworth Health Services 24 Hospital Road, Wentworth Review of Environmental Factors

Prepared for: NSW HEALTH INFRASTRUCTURE

3<sup>rd</sup> May 2023 Revision C

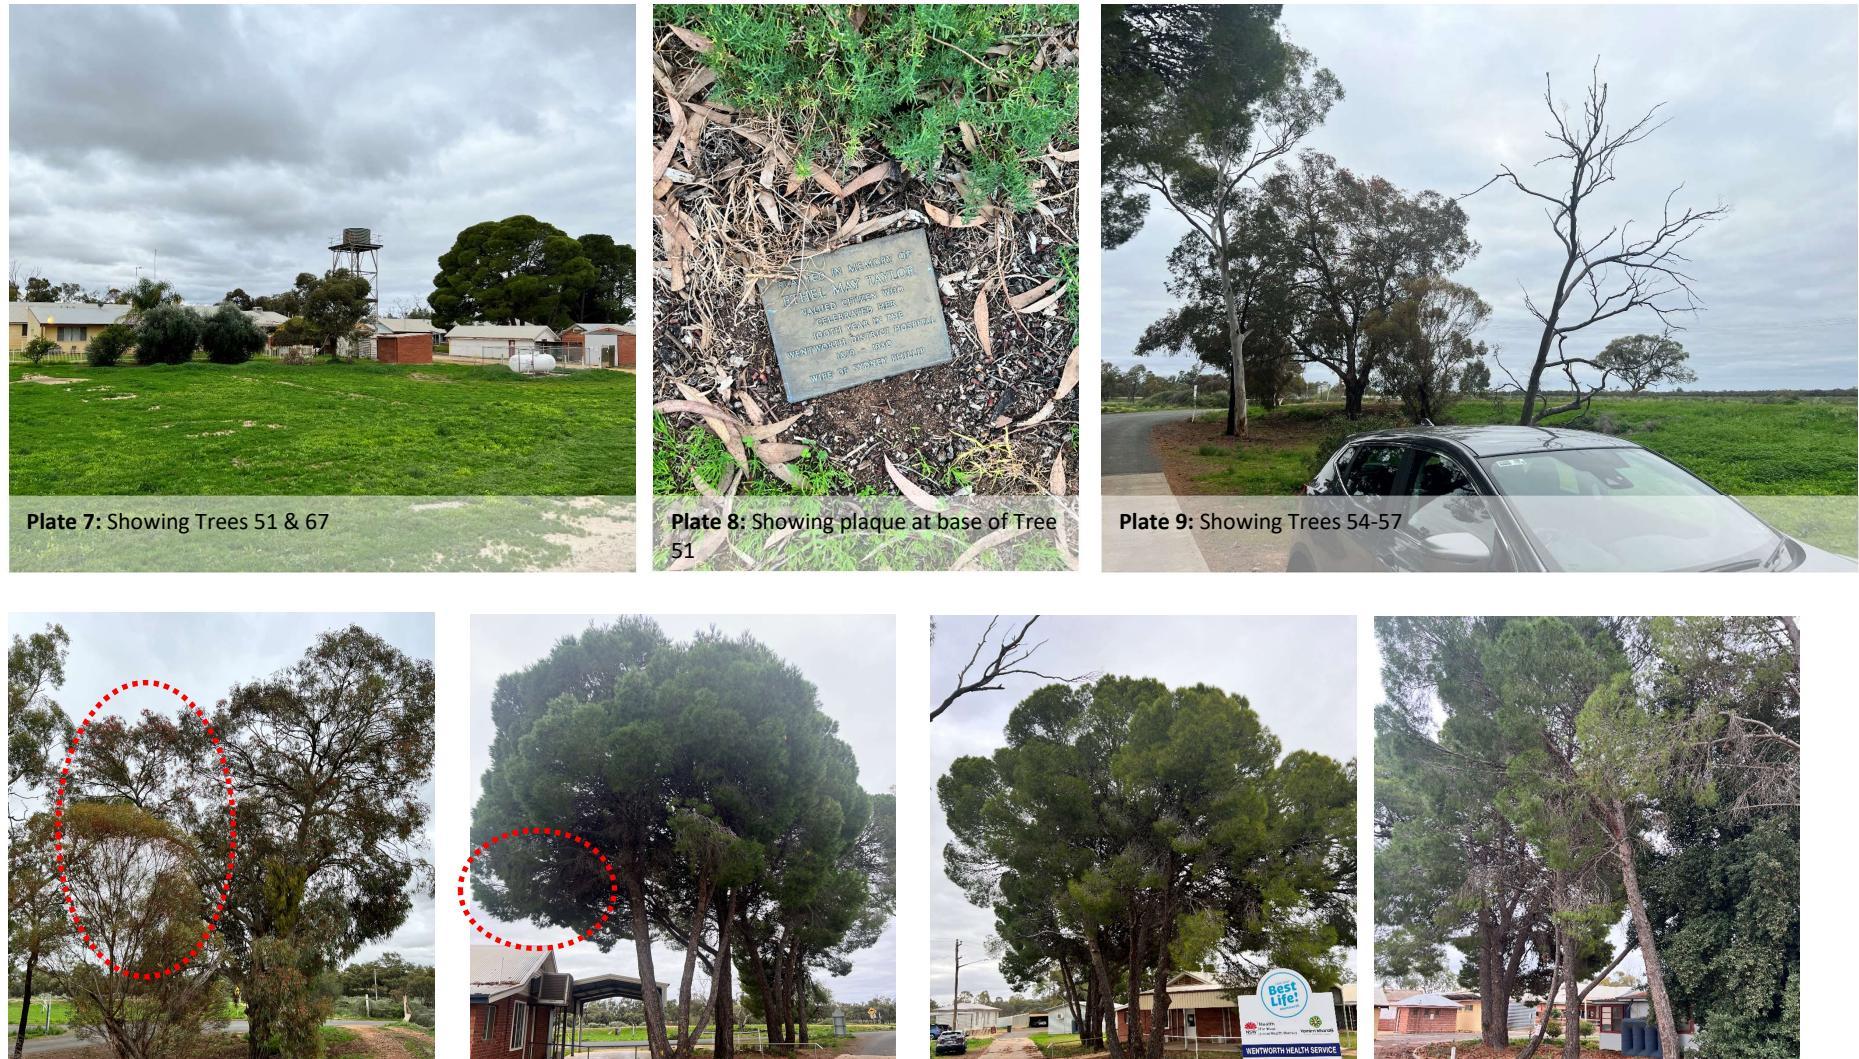
Plate 11: Showing Trees 58-61

61	<i>Pinus pinea</i> (Stone Pine)	200 800 300 300	15	12	Good	Good	Small (<25mm), medium (25-75 mm) & large (75mm+) diameter deadwood in moderate volumes. Wound(s), various stages of decay.	Mature	15-40	Moder ate	Consider for Retention	14.3	3.6	Retain. Major encroachment, pavement & remediation works. Minor encroachment, building footprint.
62	<i>Pinus pinea</i> (Stone Pine)	600	18	12	Good	Good	Small (<25mm), medium (25-75 mm) & large (75mm+) diameter deadwood in moderate volumes. Wound(s), various stages of decay.	Mature	15-40	Moder ate	Consider for Retention	7.2	2.7	Retain. Major encroachment, pavement & remediation works. Minor encroachment, fire tanks.
