# ARBORICULTURAL IMPA ASSESSMENT REPORT

New Shellharbour Hospital - HV Route

Dunmore Road, Dunmore NSW 2529 Lot 1 DP1144885 & Lot 1 DP302910 September 2022 *Final*

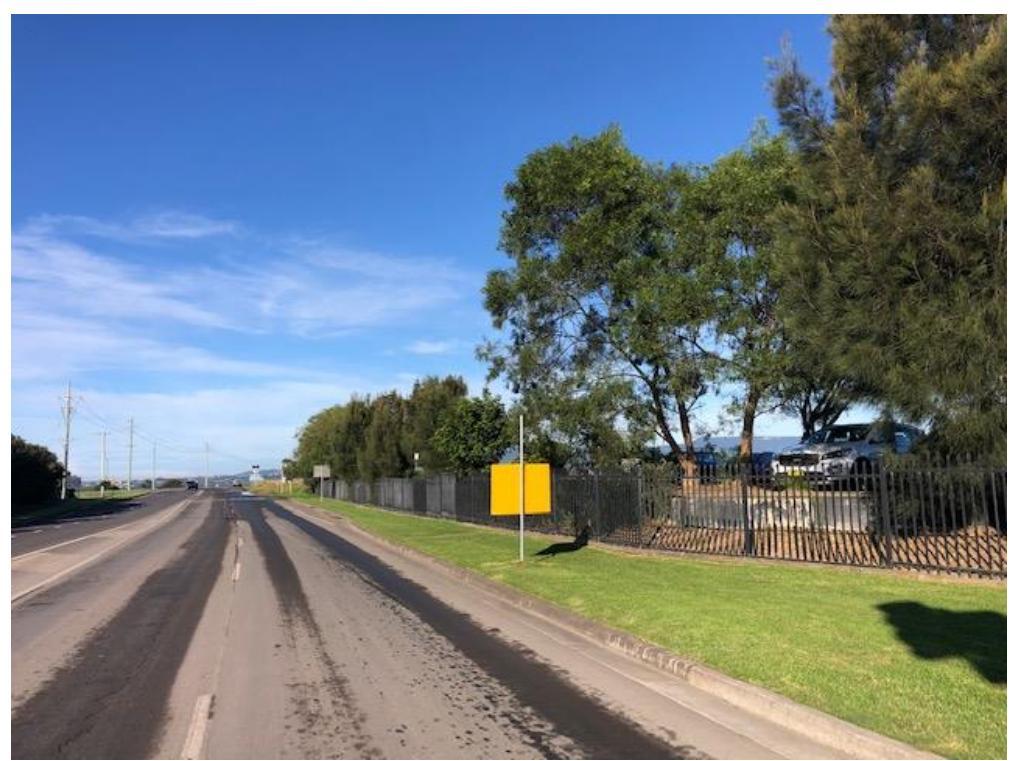
**Plate 1:** Image showing the area of trees within the Shellharbour Anglican College on Dunmore Road. P. Vezgoff.

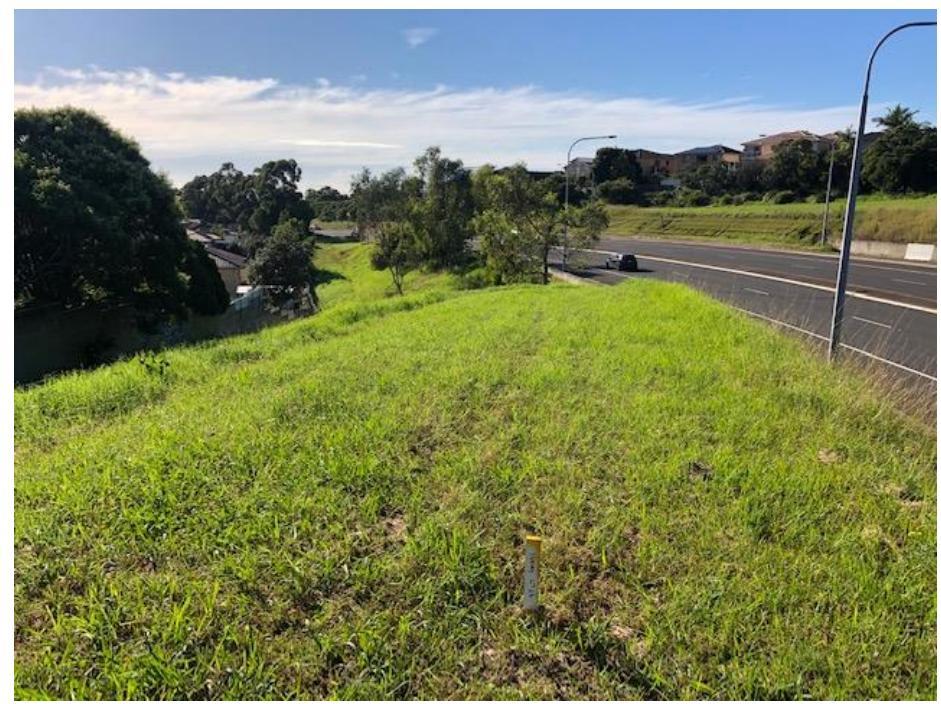
Plate 2: Shellharbour Road vegetation, showing the residential vegetation to the left.

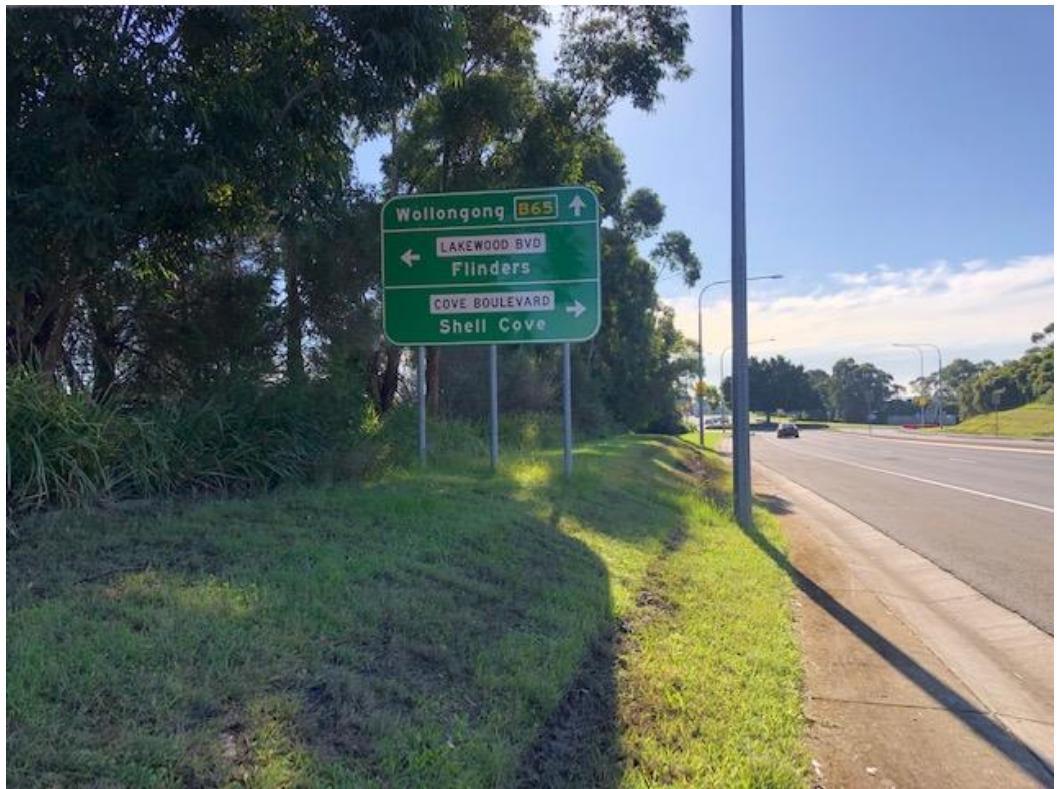
Plate 3: Image showing Trees 6-14 growing on a raised embankment. P. Vezgoff.

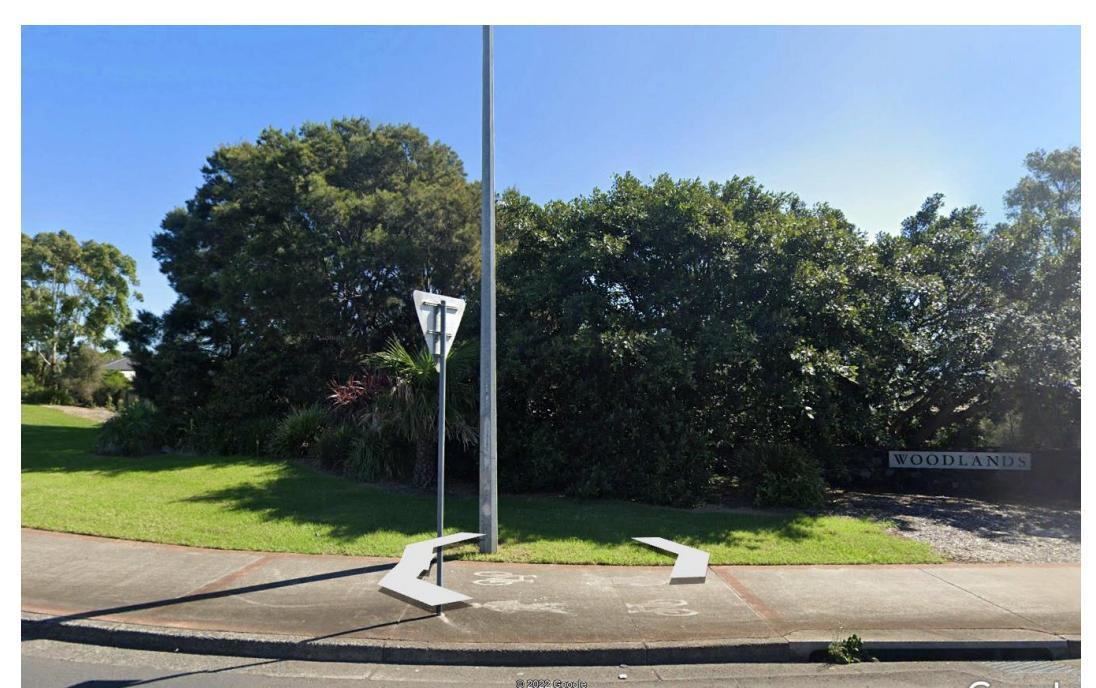
**3.8** Trees 15-18 are located on the corner of Lakewood Boulevard and Shellharbour Road (Plate 4). These trees are all natives and appear to have been planted as a screen between the road and residential buildings located in Collins Way. These trees are a mixture of Eucalyptus specimens, Acacia and Fig trees growing on the corner. These trees are all in good in health and condition, and as individual specimens they would not be considered significant, however their value is as a group planting, providing visual amenity and screening between residential houses and the freeway. It is anticipated that the trenching in this area is possible, and should be no closer than the calculated Structural Root Zone (SRZ) distances associated with these trees.

Plate 4: Image showing the larger Fig trees on the corner of Shellharbour Road and Woodlands. (Google Earth).

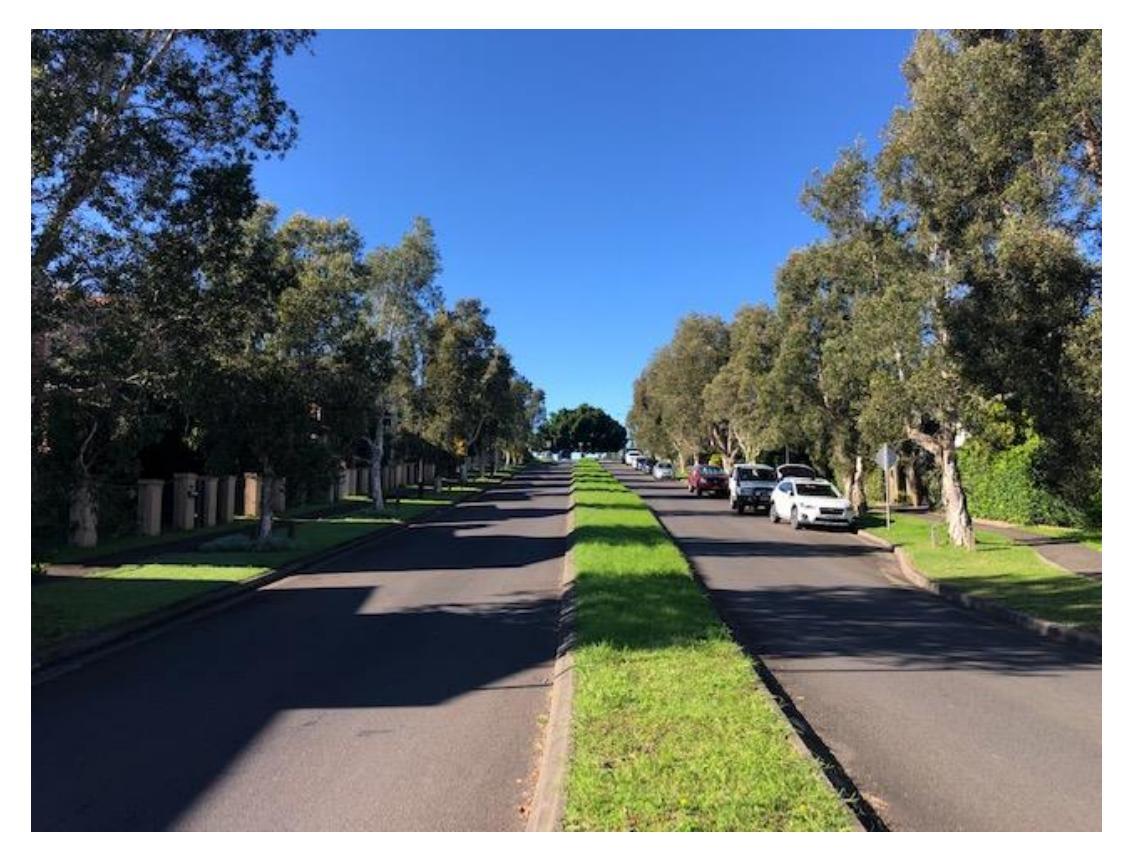
**3.9** Trees 19-41 are located on the northern side of Lakewood Boulevard, which has what would be considered an avenue planting of Broad leaved paperbark (*Melaleuca quinquenervia*). This avenue planting is named so because all of the trees in this area have been planted at a similar time and spacing, and have now reached proportions where they all create a themed visual presence along the entire length of Lakewood Boulevard (Plate 5). There is a grass median strip running down the centre of Lakewood Boulevard that separates the two (2) directional lanes. The main issues for trenching along this section will be impacting on these numerous established plantings.

Plate 5: Image showing the Lakewood Boulevard avenue planting and grass median strip. P. Vezgoff.

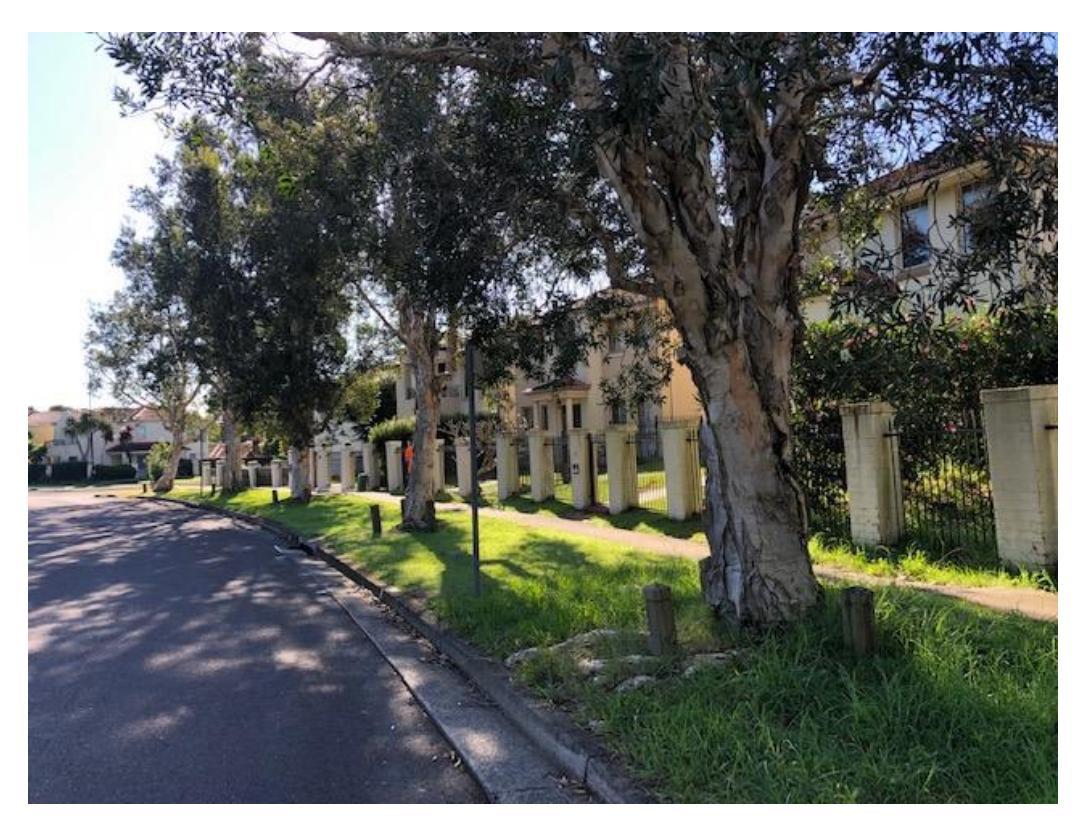
**3.10** Trees 42 to 48 are located on Munmorah Circuit. These trees are again all Broadleaf Paperbarks in good health and condition. These species are slightly older than the Lakewood Boulevard specimens and, as such, their root systems are creating a little more damage to the kerb, gutter and footpath sections in this area. There are extensive woody surface roots noted in this location. The kerb and gutter are generally in good condition with most of the damage occurring to the footpath and road verge areas. It is possible that the roots from these trees will be slightly asymmetrical, and with a bias towards the residential houses. The kerb and gutter, due to its depth and construction requirements

is likely to have caused the roots to grow in a direction downwards, or along the edge of the kerb and gutter area. Trees 42 to 48 would be considered to be quite visually significant.

Plate 6: Image showing Trees 42-48 along Munmorah Circuit. P. Vezgoff.

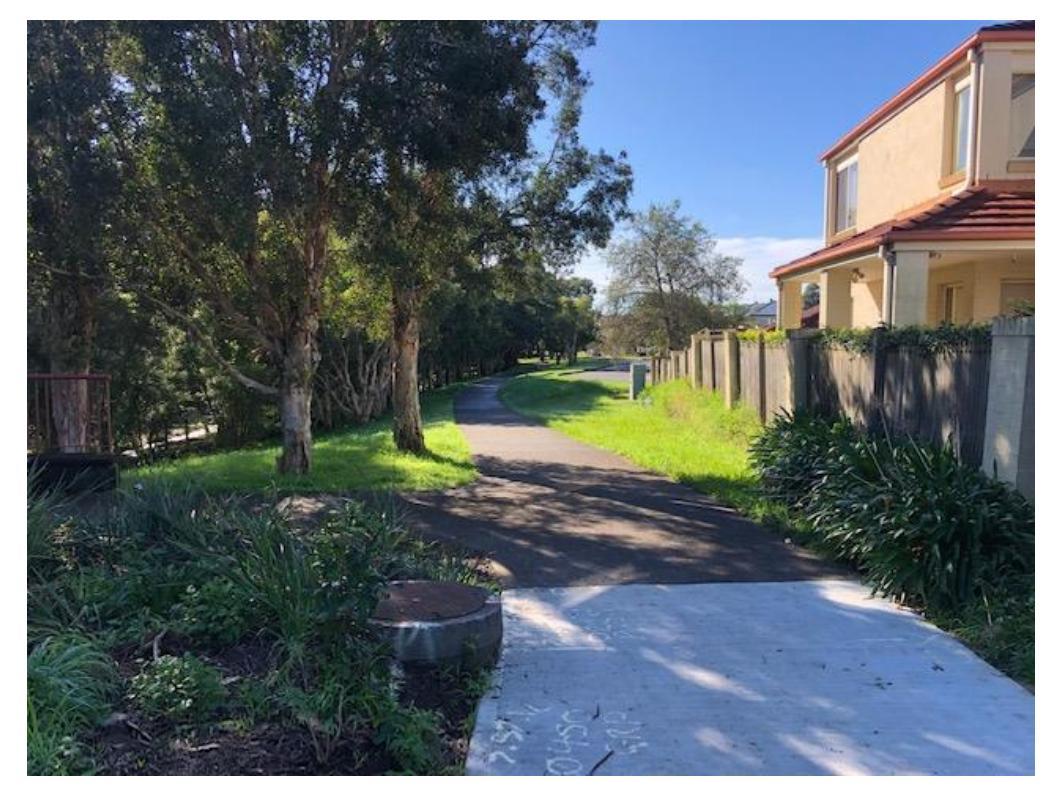
Plate 7: Image showing the route exiting from Munmorah through to Burrinjuk Avenue. P. Vezgoff.

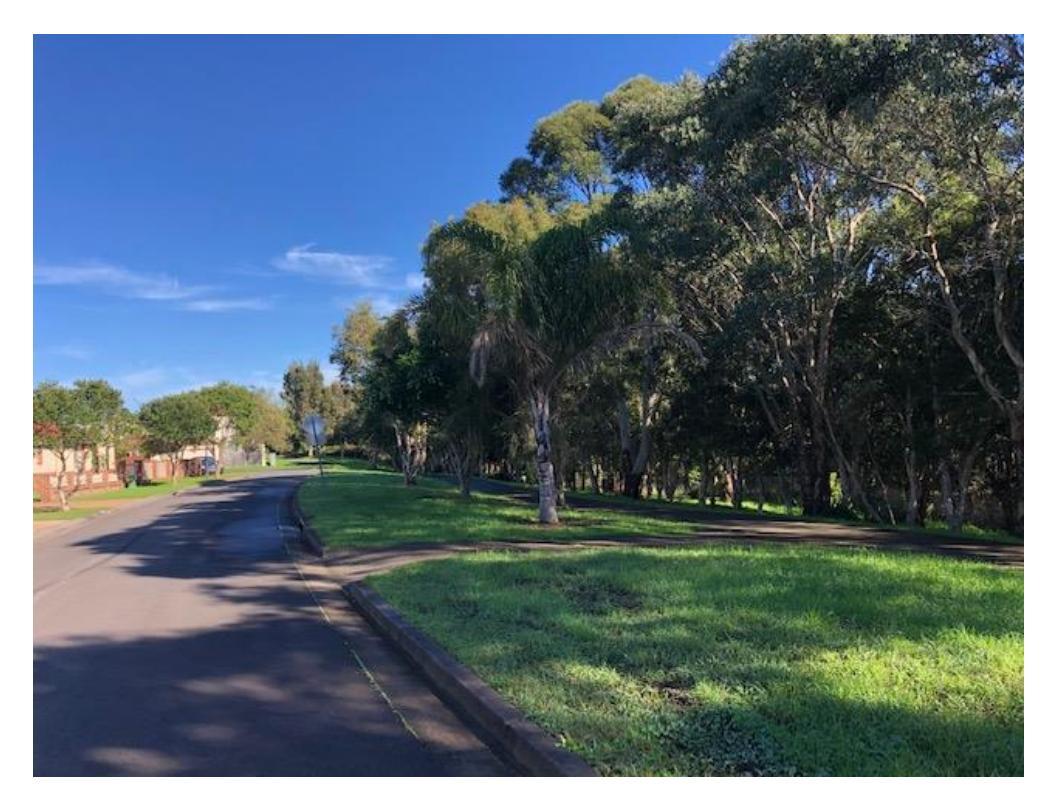
Plate 8: Image showing Burrinjuk Avenue road verge. P. Vezgoff.

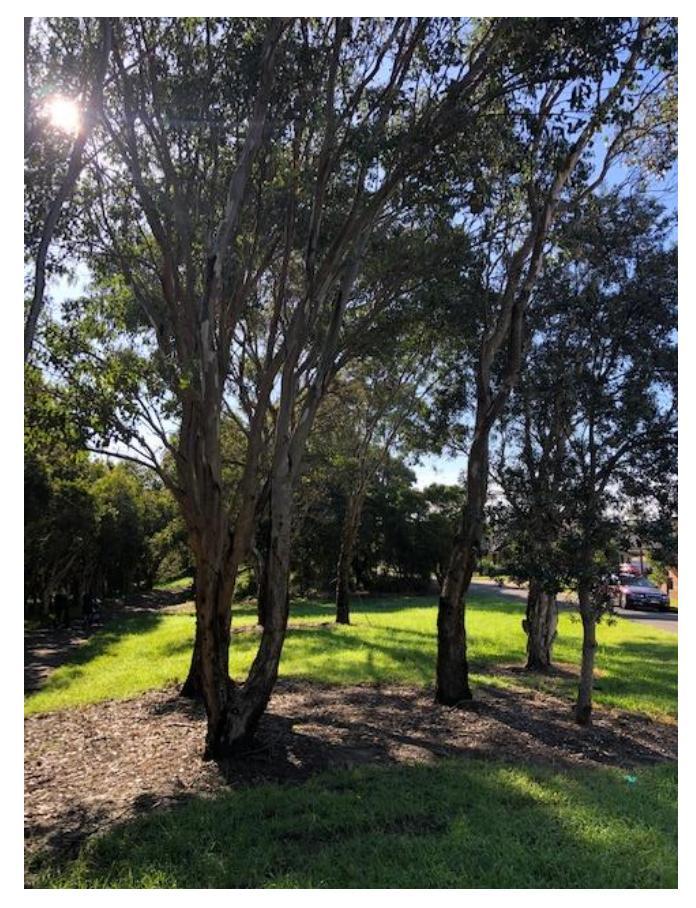
Plate 9: Image showing Burrinjuk Avenue road verge tree group. P. Vezgoff.

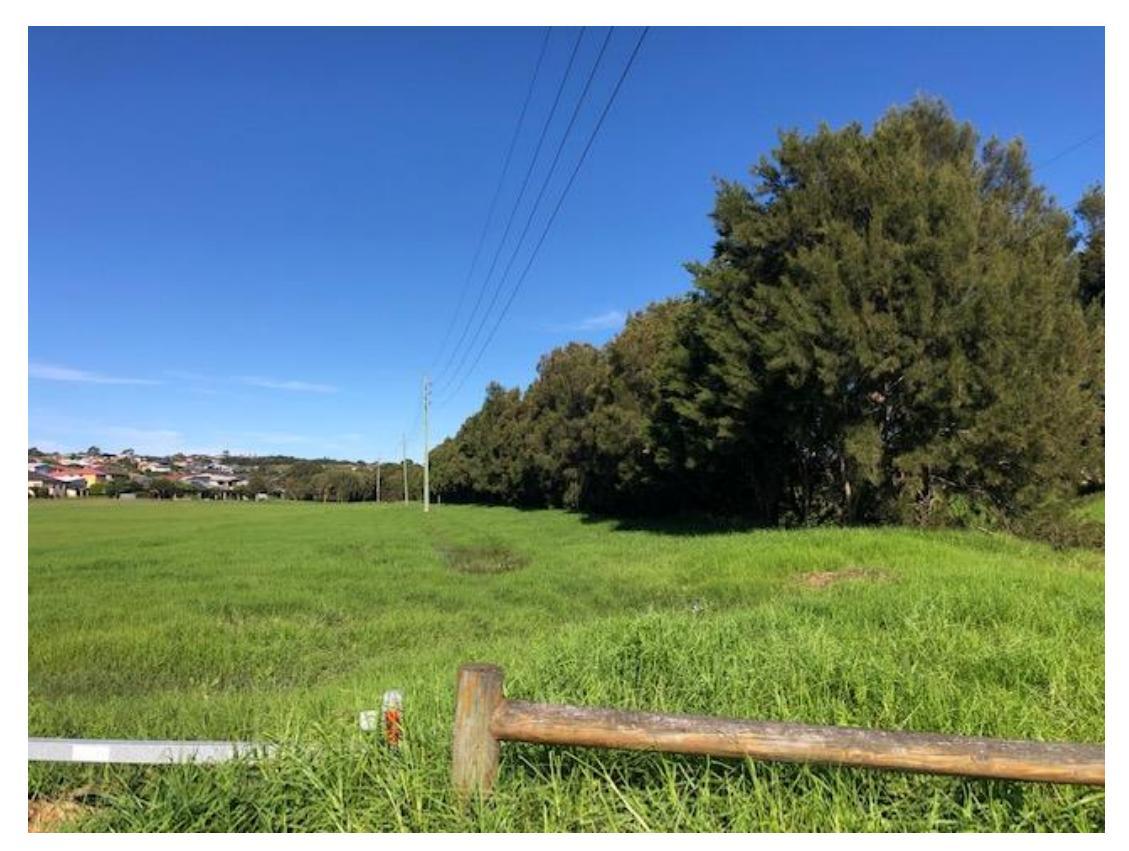
Plate 10: Image showing dense plantings of River she oak (*Casuarina cunninghamiana*) along the water course. P. Vezgoff.

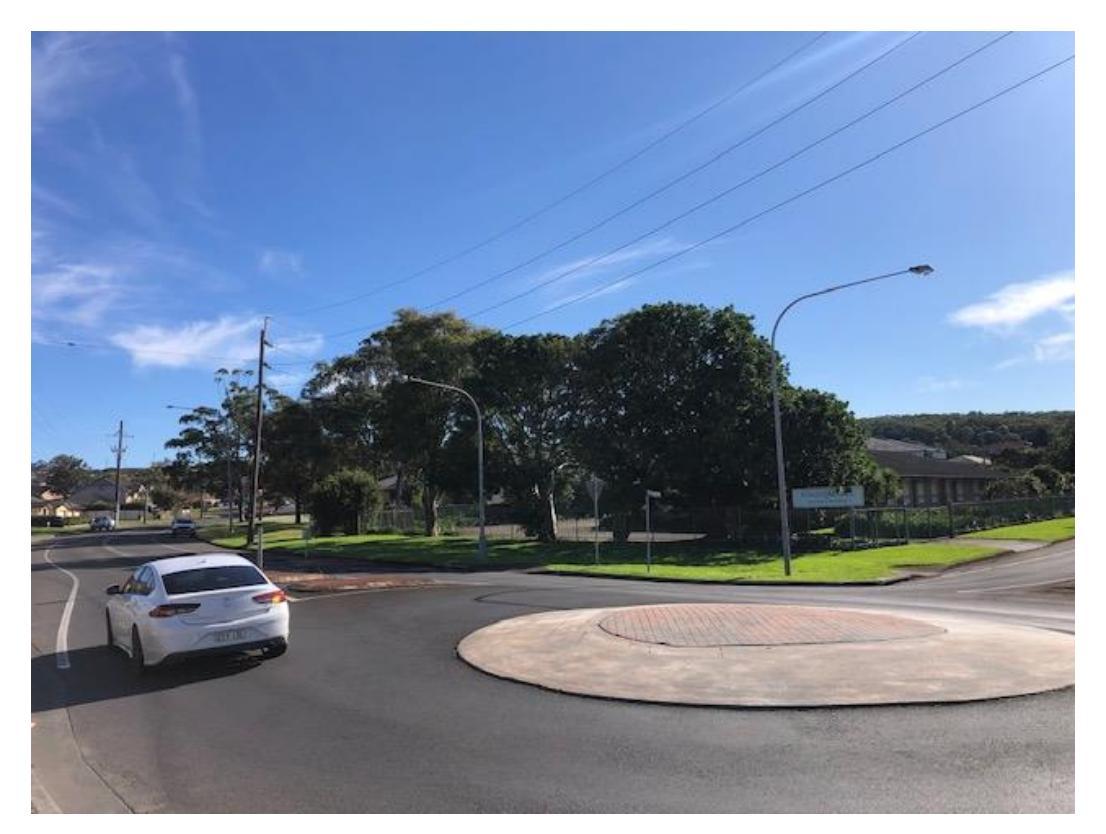
**3.12** Trees 80-85 are located on the northeastern side of Wattle Road. These trees consist of Kaffir plum (*Harpephyllum caffrum*), Woollybutt (*Eucalyptus longifolia*) and Spotted gum (*Corymbia maculata*). It is difficult to determine if these are Council or privately owned trees due to the absence of survey detail provided. Tree 80 is clearly within private property, whereas it is possible that Trees 81-85 may be within the Council road verge. Tree 85 is a large mature Spotted gum that has a substantial wound on the main stem with evidence of a cavity and it is possible that a decay pathogen has colonised this tree as evidenced by the dieback in the upper canopy. Trenching will be difficult to undertake along this section of the route due to the large mature specimens and overlapping TPZs. It is likely under boring may have to be considered for this section of the route should this direction be selected.

Plate 11: Image showing the Trees 80-85 along Wattle Road. P. Vezgoff.

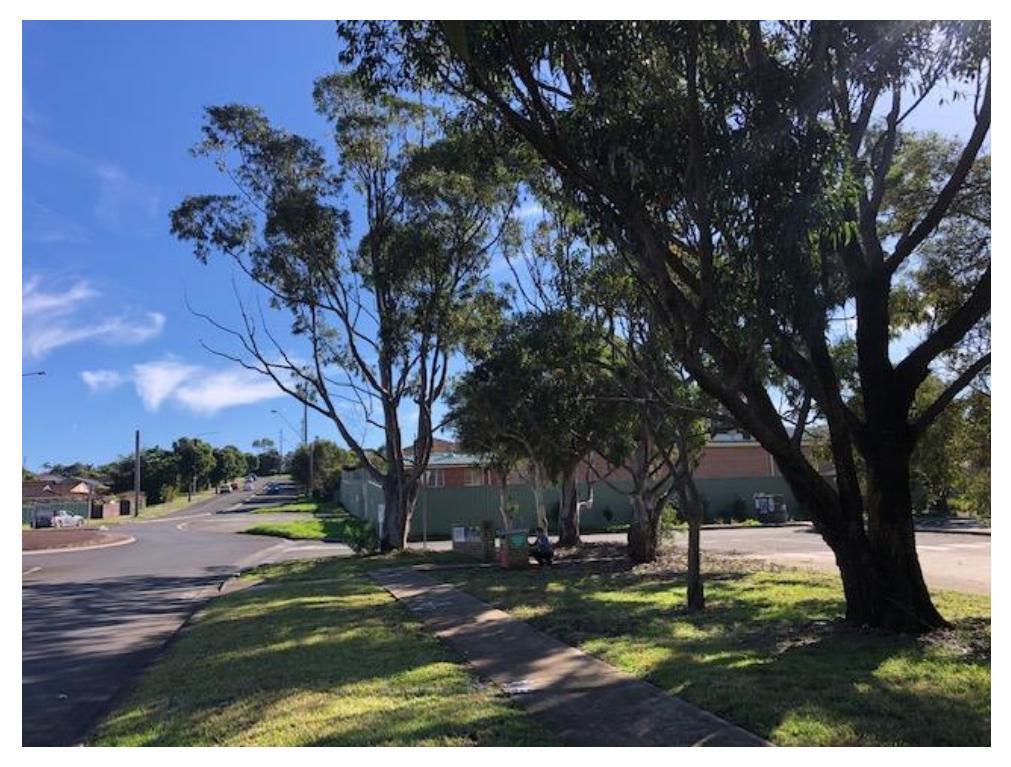
Plate 12: Image showing the Trees 84 and 85 along Wattle Road. P. Vezgoff.

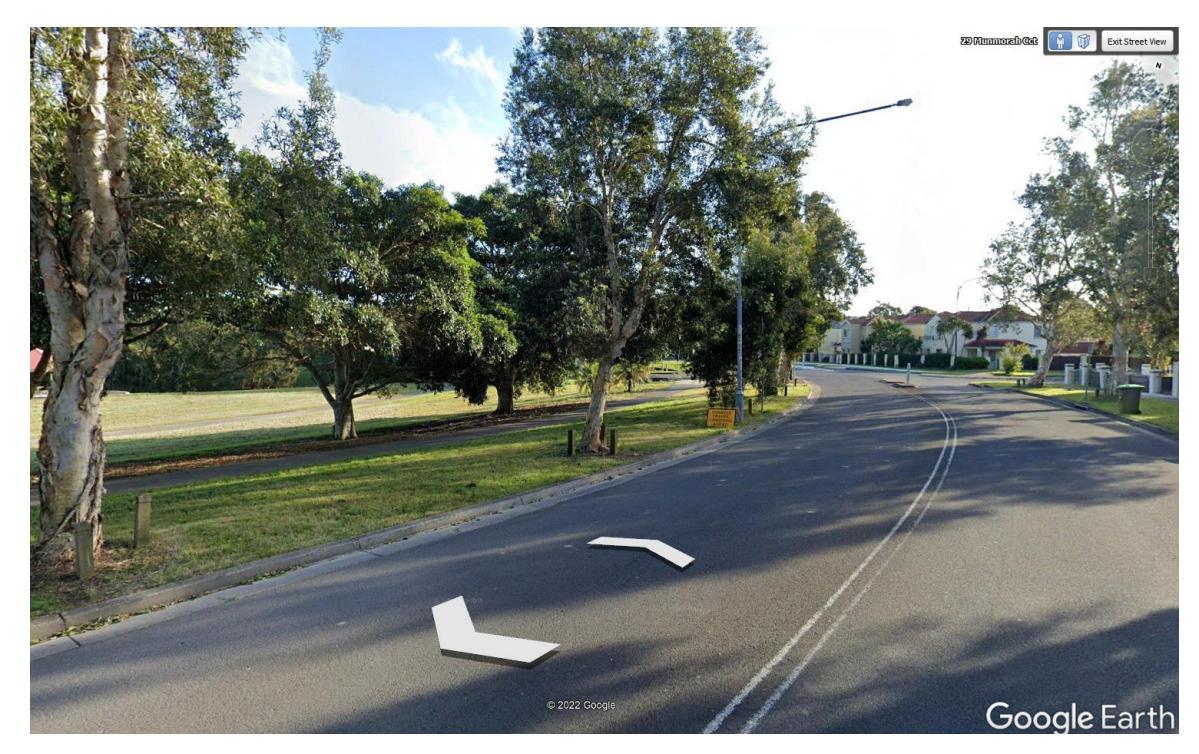
- **4.6** Updated designs following my initial report show that the route can now be installed through the centre of Lakewood Boulevard thus negating the impacts to the street trees along this section of the study area.
- **4.7** The impacts to Trees 42 to 48 have also been negated along Munmorah Circuit however the route has now been moved to the other side of this street and now impacts park trees that are growing on the road verge (Plate C).
- **4.8** Trees 80-85 will now not be impacted as the route has been altered along Parklands Drive and into an easement between building where it enters the end of the route at the substation.

Plate C: Image showing the trees to the left of the image now impacted by the new route.
