19 September 2022

Arboricultural Impact Assessment (AIA) Report – Kingscliff Rural Ambulance Infrastructure Reconfiguration (RAIR) development

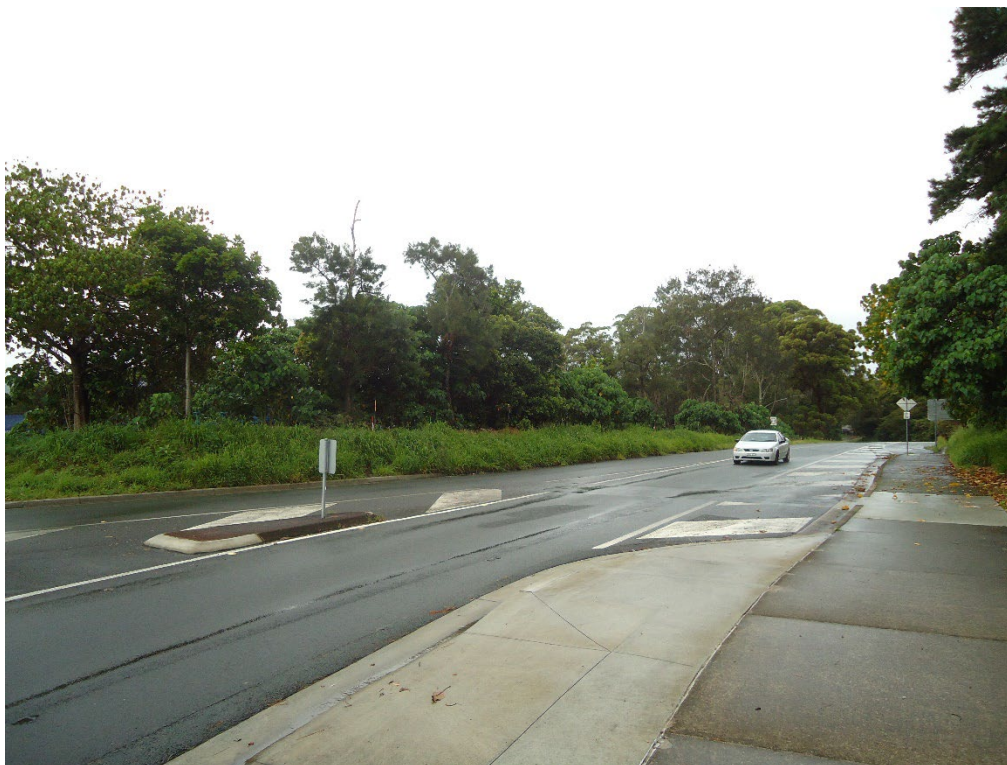
Figure 2. Image looking north along the Turnock Street verge with Tree 27 in the bottom left and Tree 1 in the top centre. (ArborSafe, November 2021).

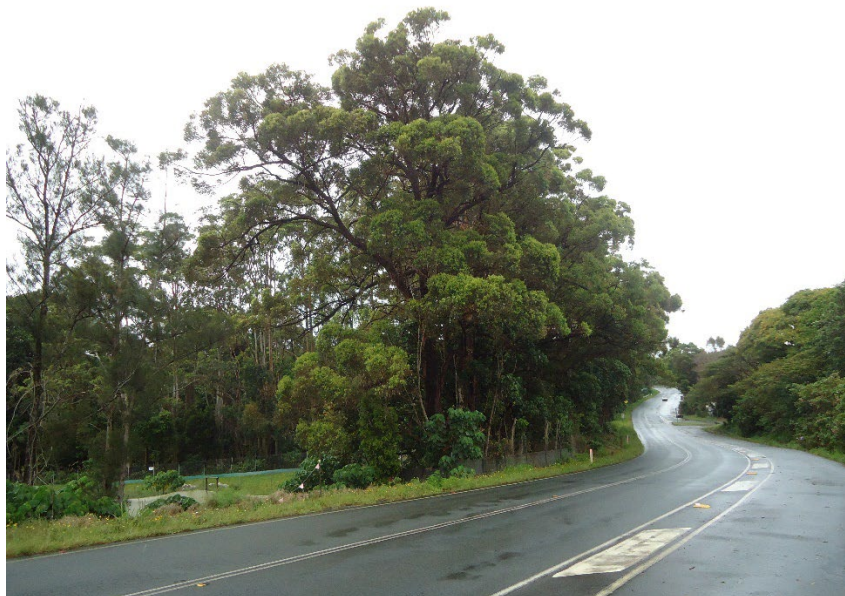
6.3.12 Tree 1 – *Eucalyptus microcorys* (Tallowwood)

- 6.3.13 A large mature tree (Category A RV) located at the end of the rock retaining wall which has no TPZ encroachment and is therefore recommended for retention.

Figure 8. View to north of Tree 1 *Eucalyptus microcorys* (Tallowwood) in its growing environment. (Andy Clark, November 2021).

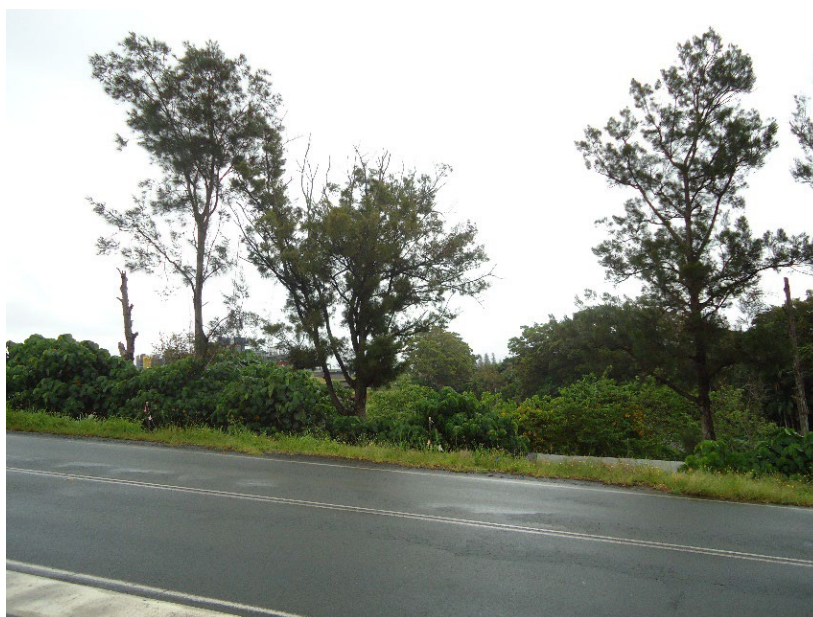
6.3.14 Trees 4, 5, 6, 7 and 8 – Dead trees and *Casuarina* sp.

- 6.3.15 An image (below) of trees situated at the northern end of the verge and numbered 8, 7, 6, 5 and 4. Trees 8 and 4 are dead trees (Category U RV) which have been recommended for removal, while the remaining trees are *Casuarina* sp. which have only minor TPZ encroachment and are therefore recommended for retention.

Figure 9. View to west of Tree 8, 7, 6, 5, 4 in their growing environment. (ArborSafe, November 2021).

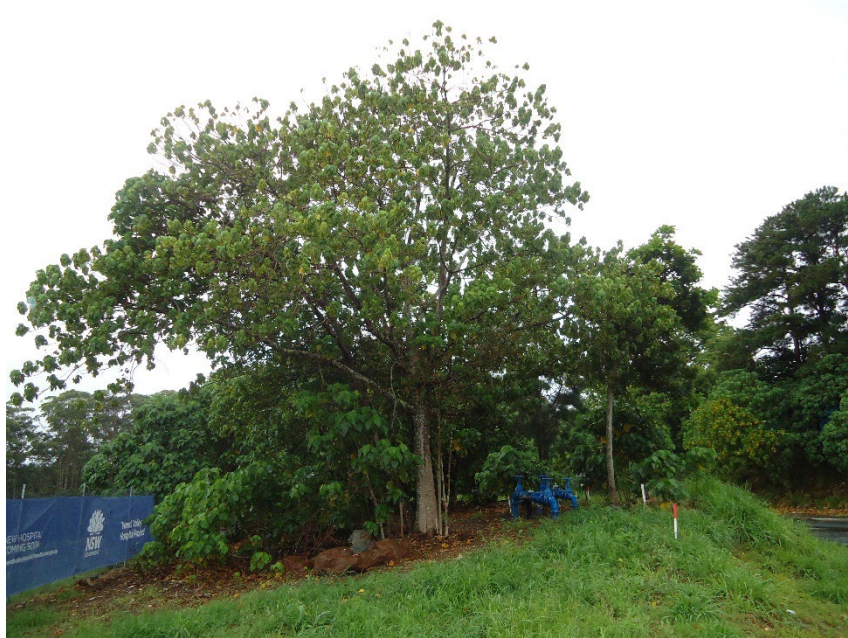
6.3.16 Tree 27 – *Macaranga tanarius* (Bullocks Heart)

6.3.17 A mature tree (Category C RV) located at the southern end of the Turnock Street verge adjacent the roundabout. This species is a pioneer plant which is easily spread and self-sown, as seen by the many juvenile saplings coming up along the verge area.

Figure 10. View to north of Tree 27 *Macaranga tanarius* (Bullocks Heart) in its growing environment. (Andy Clark, November 2021).

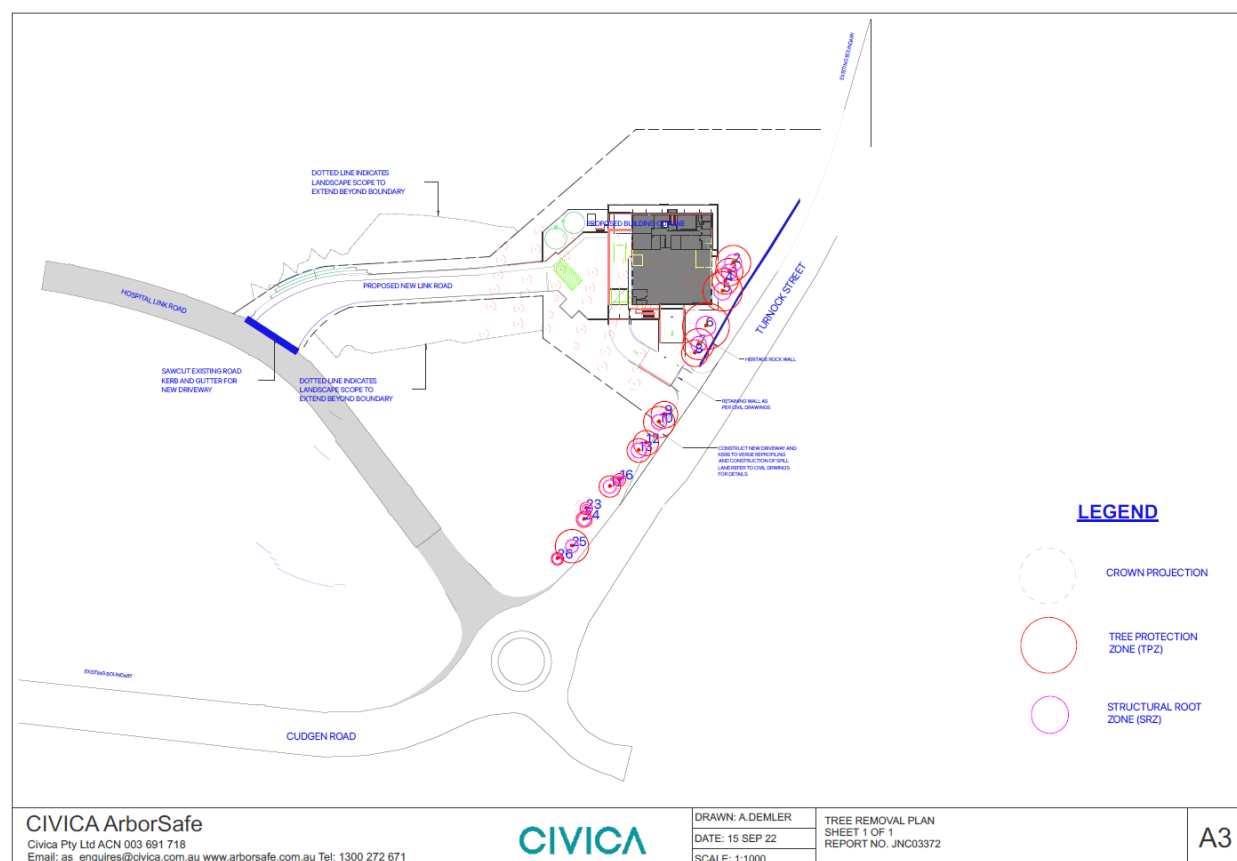
Figure 11. Site map showing trees recommended for removal. (ArborSafe, September 2022).

7.1.3 A breakdown of tree numbers and RV is displayed below:
