Health Infrastructure Hazardous Building Materials Survey

Westmead Integrated Mental Health Complex (IMHC) Early Works REF

> Corner of Redbank Road & Dragonfly Drive, Westmead NSW 2145

> > 16 September 2022 60807/142,806 (Rev 0) JBS&G Australia Pty Ltd

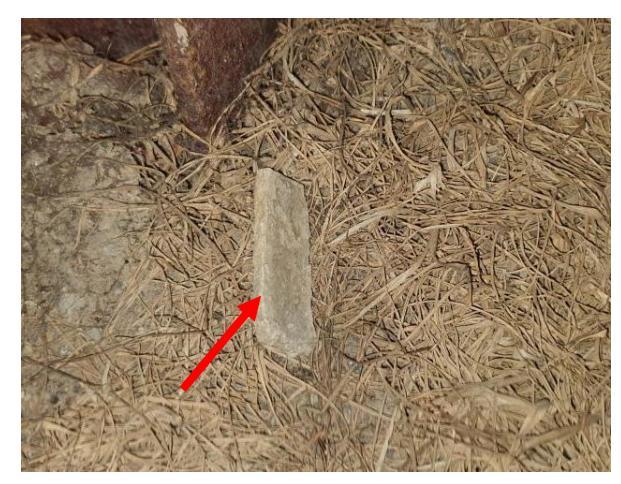
- Non-friable asbestos fibre cement debris was previously identified by Prensa 2015 (Refer to sample 53345-BIU-001-002) to the subfloor to the building which is accessed through a gate that is adjacent to the plantrooms and transitional living unit. The material was observed to still be present in the subfloor area during the inspection.

Photo 2: As bestos fragment in subfloor of BIRS building during 2021 inspection – BIRS building, sub floor

- Following completion of asbestos removal works, a clearance inspection shall be undertaken by a LAA to ensure that the friable asbestos containing detritus and non-friable ACM identified in the Hazardous Materials Register have been removed to a satisfactory industry standard.
- Following the completion of the clearance inspection, a clearance certificate shall be issued by the LAA to confirm that the friable asbestos containing detritus and non-friable ACM has been successfully removed and that the site is suitable for proposed demolition works to commence.

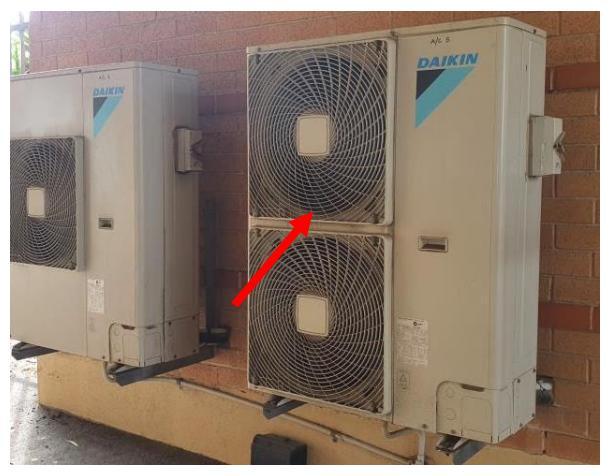
Photo 3: Air conditioning unit assumed to contain internal SMF insulation–BIRS building, Transitional living, south side, air conditioning unit

The SMF materials encountered during this inspection were generally contained and deemed to be low risk. SMF materials to be removed during demolition, can be removed with the building and demolition waste with care taken not to generate fibres. Appropriate PPE is recommended including the use of P2 respirator as minimum and appropriate removal methodology as outlined in [NOHSC: 1004(1990)] and [NOHSC: 2006(1990)].

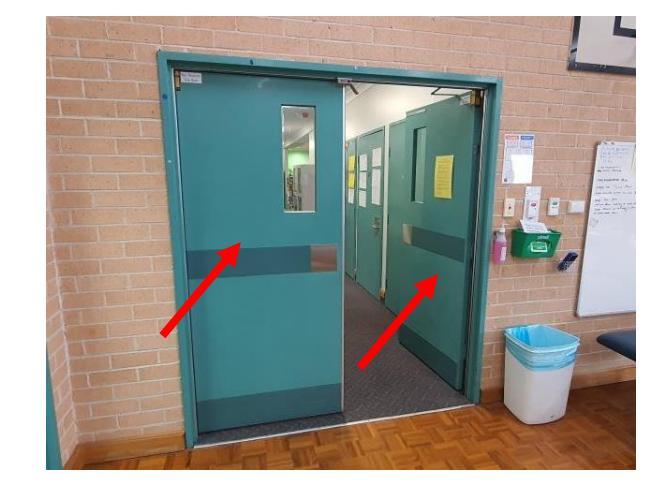
Photo 4: Suspected friable asbestos in double fire doors – BIRS building, physiotherapy gym 1 (1041), east entry doors, double fire doors

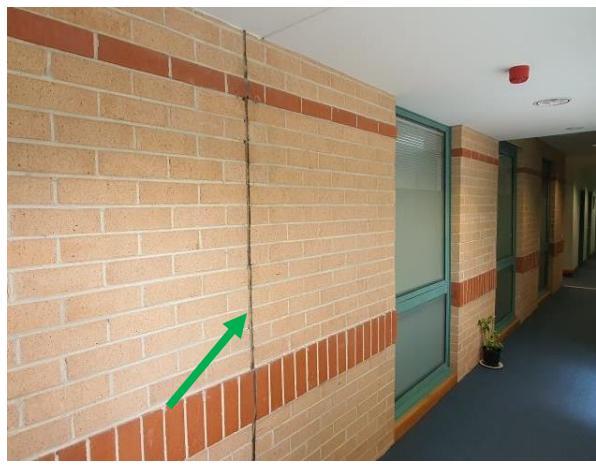
Photo 5: Non-asbestos expansion joint – BIRS building, northern hallway between brick walls.

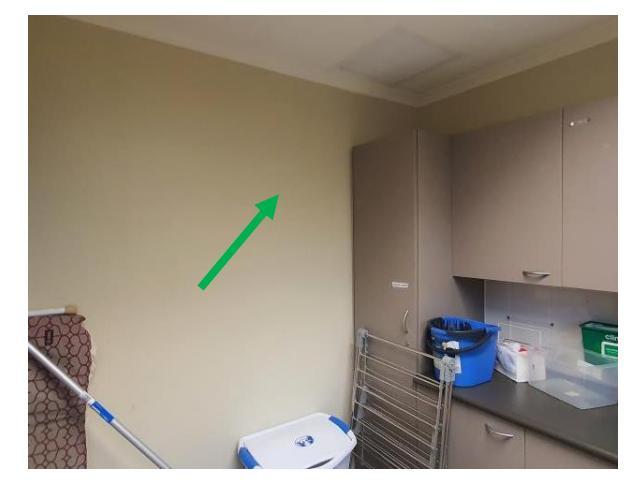
- Non-asbestos fibre cement sheeting (BIR-A3) was identified to the Transitional living unit, laundry (0029), walls.
- The electrical distribution board in plantroom 68 and 69 and the corridor between plantroom 68 and 69 was previously assumed to contain asbestos. During the survey, the electrical distribution was opened and no asbestos containing components were observed.

Photo 6: Non-asbestos fibre cement sheeting walls – BIRS building, Transitional living unit, laundry (0029), walls, fibre cement

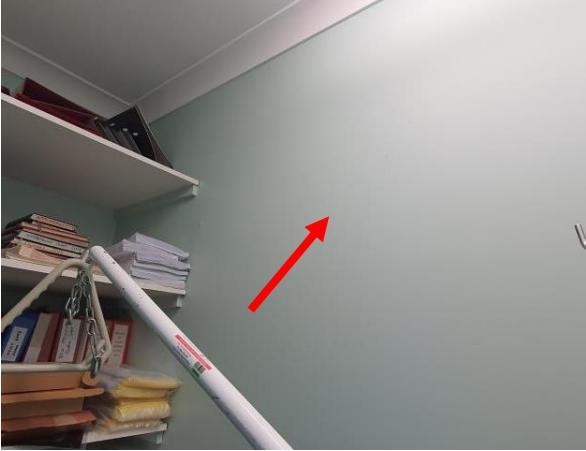
Photo 8: Lead based green paint on walls - BIRS building, Dining room (1020), storage cupboard

The paint must be managed in accordance with the AS4361.2-2017. If peeling or flaking, the deteriorated paints must be removed and stabilised under controlled conditions by an experienced contractor. In accordance with *Waste Classification Guidelines – Part 1 Classifying Waste* (NSW EPA

2014), detached lead paint waste (flakes, vacuum dusts, etc.) are pre-classified as Hazardous Waste, and must be treated and disposed of accordingly.

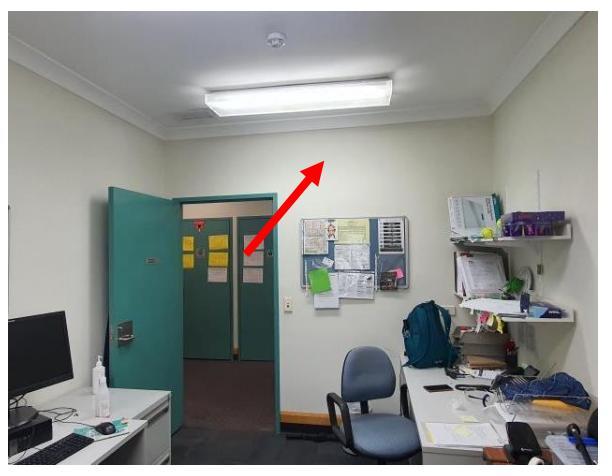
Photo 9: Lead based light green paint on walls– BIRS building, therapy assistant room (1062)

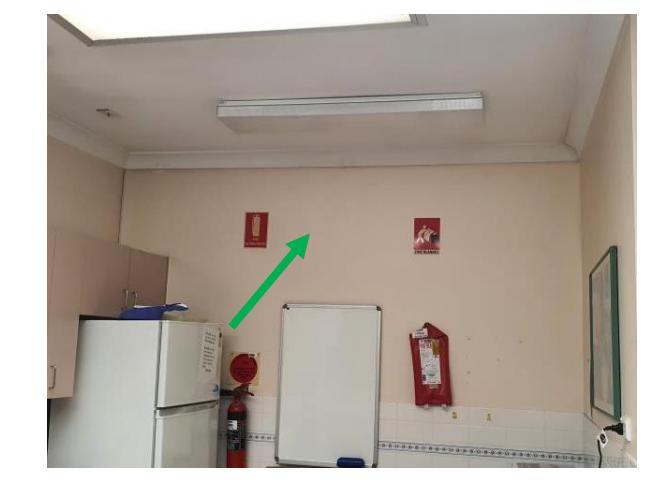
Photo10: Non-lead pink paint on walls - BIRS building, ADL Kitchen (1044)

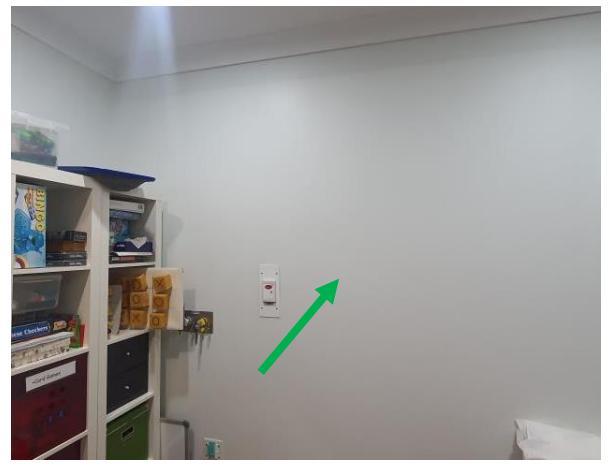
Photo 11: Non-lead white paint on walls - BIRS building, Physiotherapyroom 1 (1040)

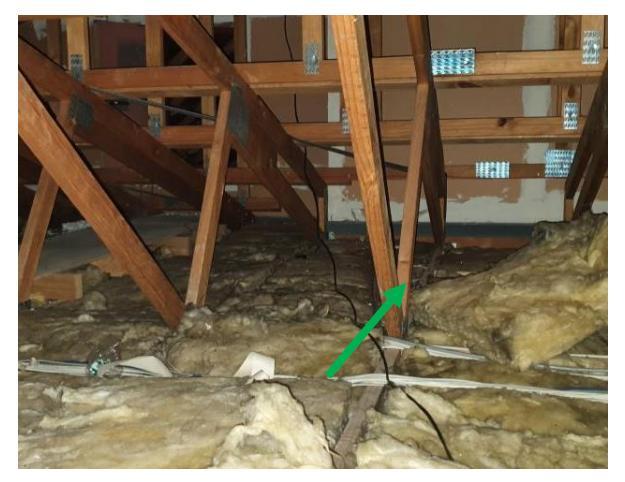
- Lead concentrations within settled dust that was identified within the ceiling space was below the adopted site criteria (BIR-LD1, 220 mg/kg).
- Various items assumed to contain SMF were identified throughout the building such as hot water units, air conditioning units, AC ducting, sarking and insulation batts.

Photo 12: Lead concentrations within settled dust was below the adopted site criteria – BIRS building, ceiling space

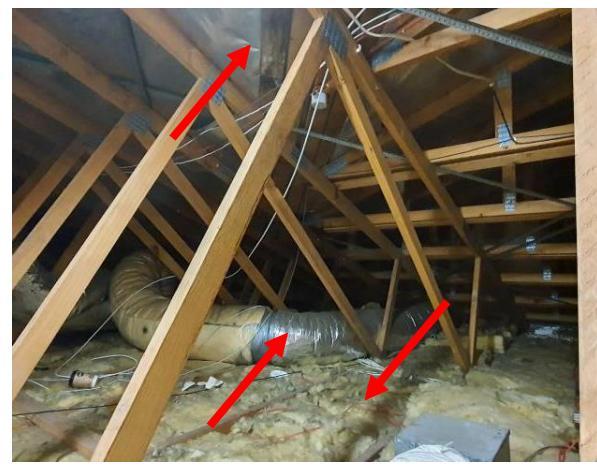
Photo 13: Sarking, ducting and insulations batts assumed to contain SMF. SMF dust was detected in dust sample - BIRS building, ceiling space

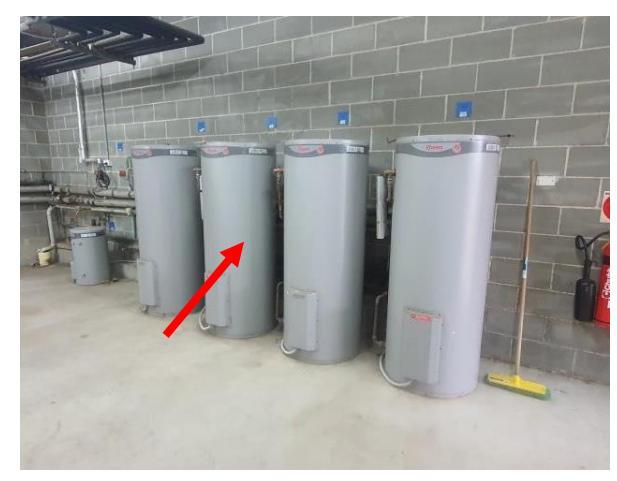
Photo 14: Hot water units assumed to contain SMF insulation – BIRS building, Plant room 67, hot water unit

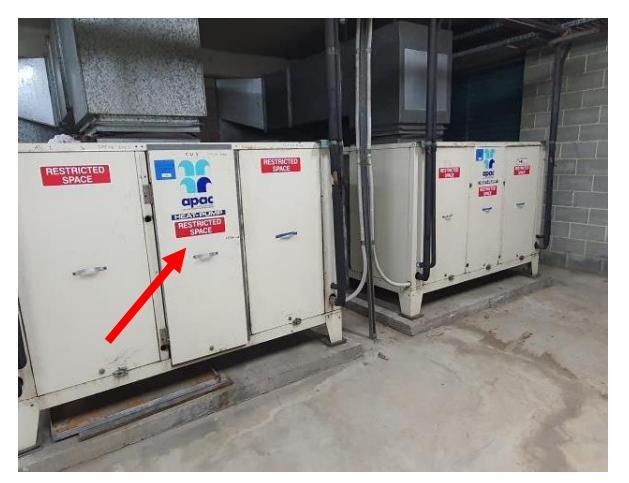
Photo 15: Air conditioning unit assumed to contain SMF insulation– BIRS building, Plant room 67, air conditioning unit

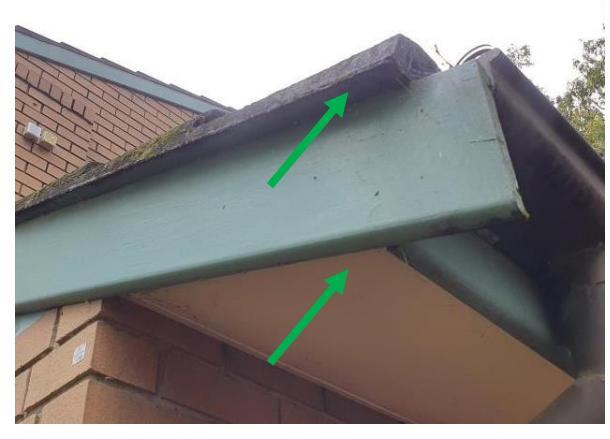
Photo 16: Non-asbestos fibre cement under cloaking and eaves – Casuarina Lodge, exterior throughout

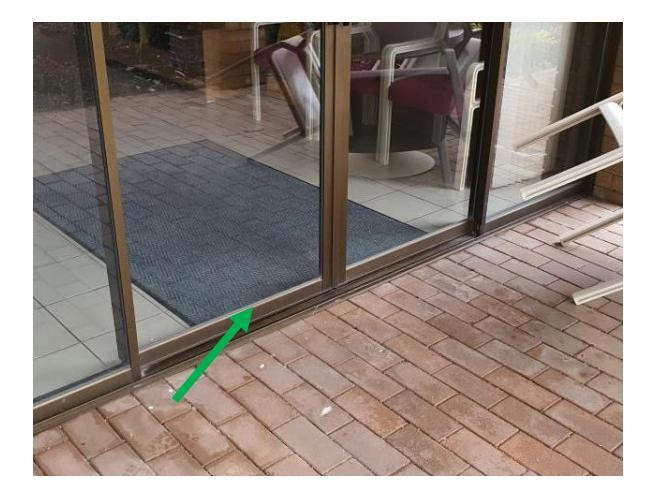
Photo 17: Non-asbestos mastic - Casuarina Lodge, north exterior, sliding door

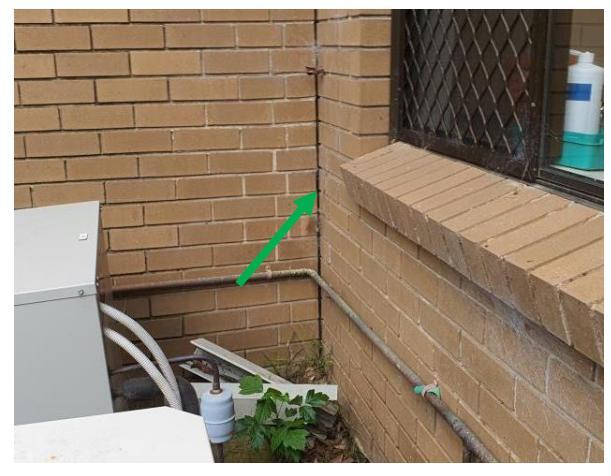
Photo 18: Non-asbestos expansion joint-Casuarina Lodge, North exterior, between brick walls

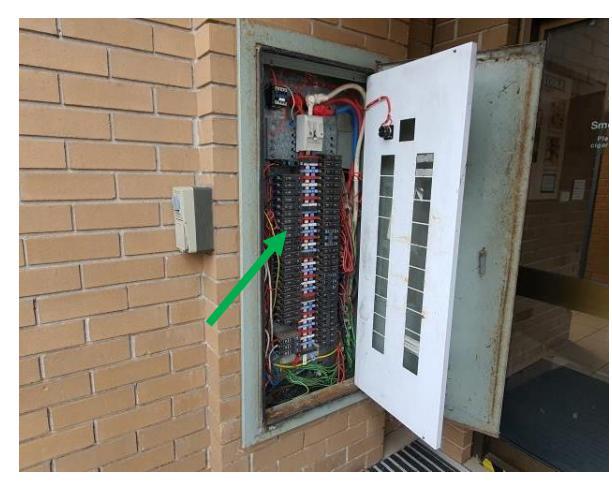
Photo 19: Non-as bestos backing board observed – Casuarina Lodge, South exterior, adjacent office entry

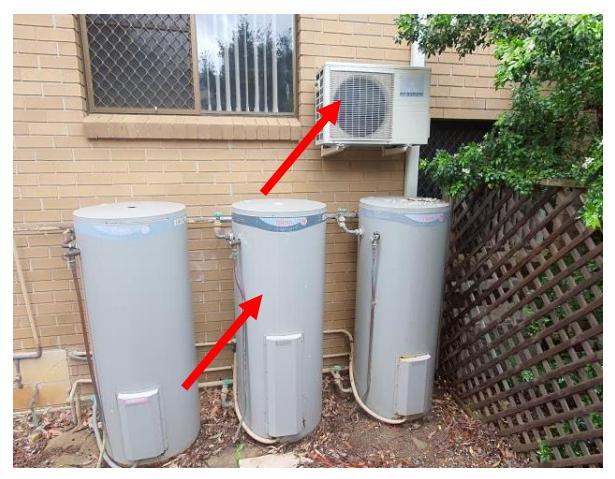
Photo 20: Hot water unit and air conditioning unit assumed to contain internal SMF insulation – Casuarina Lodge, South exterior, garden bed

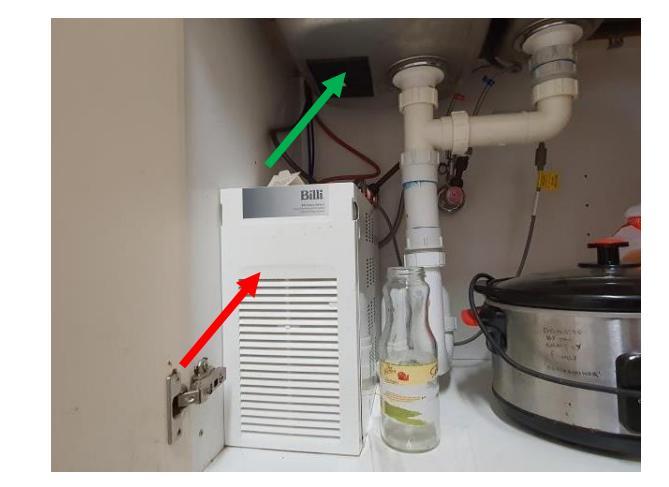
- Non-asbestos sink dampeners (CAS-A1) were identified to the ground floor and first floor eastern and western kitchen sinks.
- Non-lead based pink paint (CAS-PB1, 0.07% w/w) was identified to the Ground floor, room 7, walls. This paint was observed in all other accommodation rooms on the ground floor.

Photo 21: Non-asbestos sink dampener. Hot water unit assumed to contain internal SMF insulation – Casuarina Lodge, first floor, east kitchen, below sink.

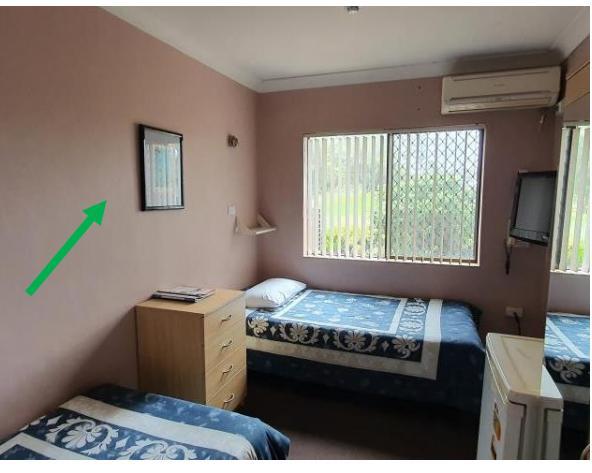
Photo 22: Non-lead based pink paint on walls - Casuarina Lodge, ground floor, room 7.

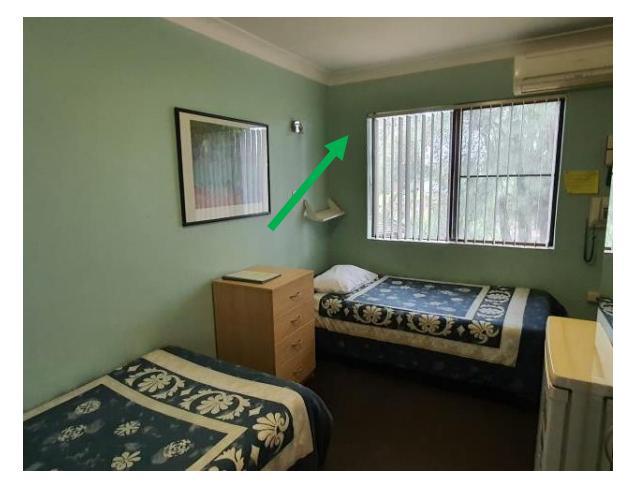
- Non-lead based green paint (CAS-PB2, 0.07% w/w) was identified to the First floor, room 15, walls. This paint was observed in all other accommodation rooms and laundry rooms on the first floor.

Photo 23: Non-lead based green paint on walls – Casuarina Lodge, first floor, room 15 $\,$

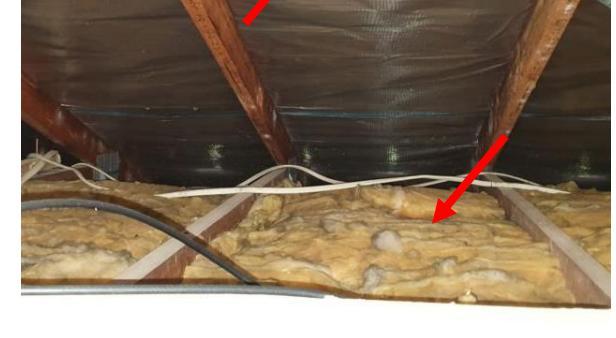
Photo 25: Insulation batts and sarking assumed to contain SMF - Casuarina Lodge, ceiling space

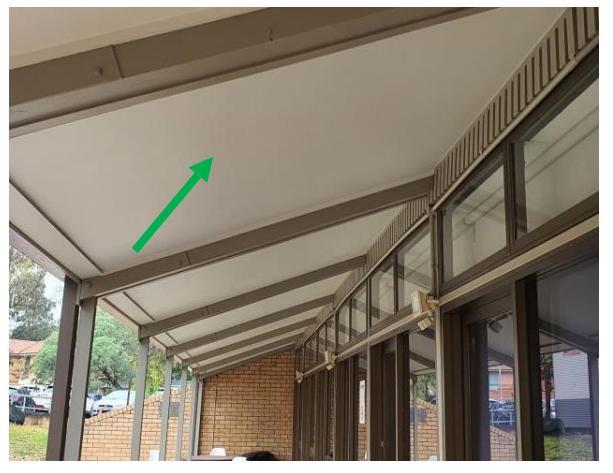
Photo 26: Non-asbestos fibre cement awnings - IPO building, north exterior

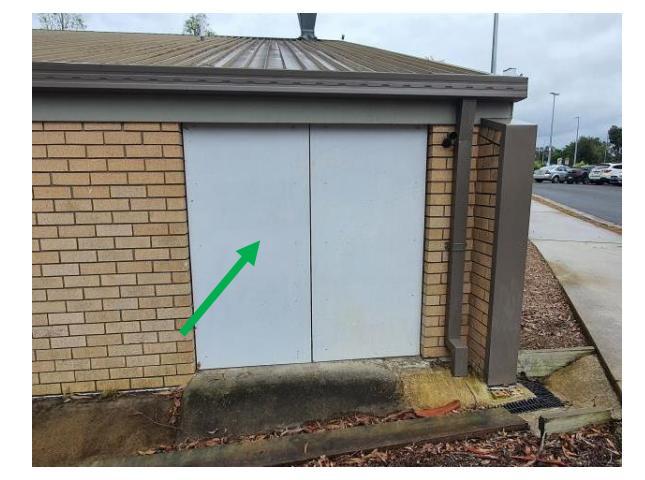
- Non-asbestos fibre cement infill panels (IPO-A1) was identified by to the southern exterior of the building.
- Asbestos fibre cement sheeting was previously identified to the risers in the previous inspection (JBS&G 2015) in the north toilet and shower room, disabled toilet and printing room. During the inspection, it was observed that the entire building had been refurbished and that the previously identified asbestos hazards had been removed. No asbestos clearance reports were provided.

Photo 27: Non-asbestos fibre cement infill panels - IPO building, south exterior

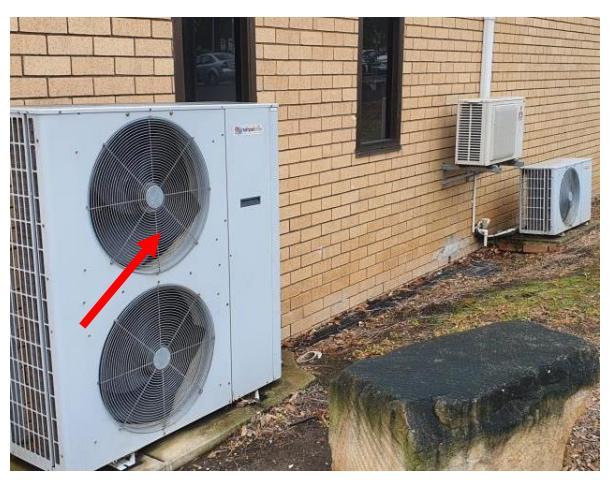
Photo 28: Air conditioning units assumed to contain internal SMF insulation – IPO building, East exterior

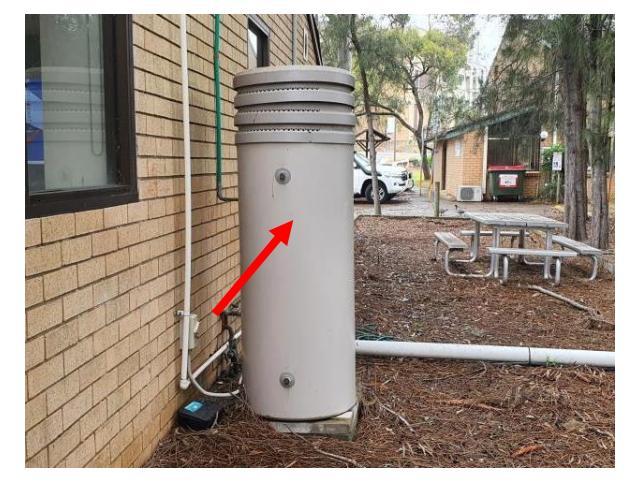
Photo 29: Hot water unit assumed to contain internal SMF insulation– IPO building, west exterior

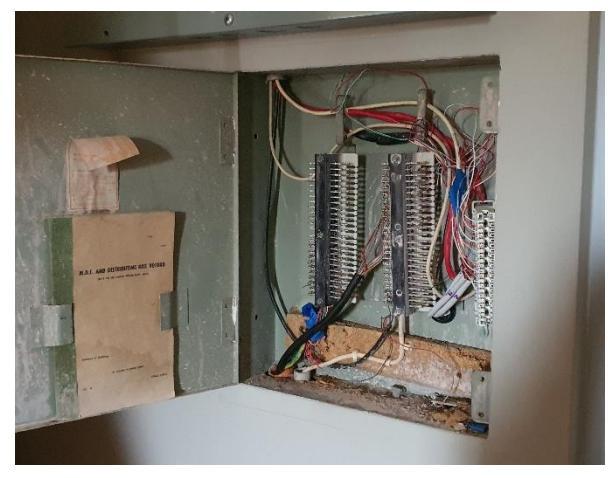
- Asbestos components were presumed to be present in the electrical distribution box on the north east section adjacent to the toilets. During the inspection, no asbestos components were observed within the electrical distribution box.

Photo 30: Non-asbestos components in electrical distribution board-IPO building, north east section, adjacent to toilets

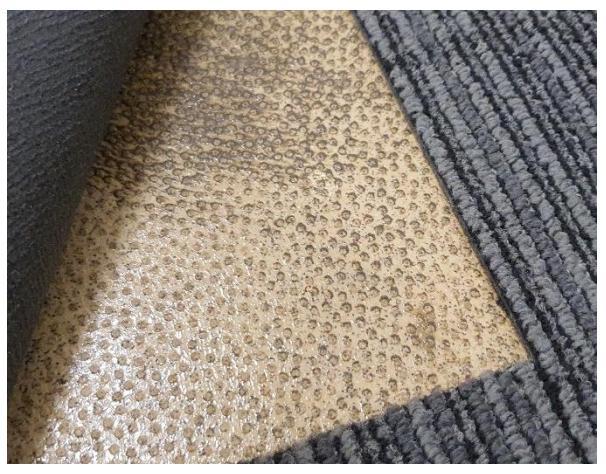
- Various items assumed to contain SMF were identified throughout the building such as hot water units and air conditioning units.
- SMF was previously identified within the vinyl floor tiling (JBS&G 2015, refer to sample WM_01) underneath the carpet throughout the building.

Photo 31: SMF containing vinyl tiles under carpet – IPO building, below carpet throughout interior
