# Arboricultural Impact Assessment Report

## For the site address Lots 3 and 4 (D.P. 35317),

No. 36-38 Birdwood Avenue, PAGEWOOD, NSW

NSW Land and Housing Corporation, Department of Planning, Industry and Environment

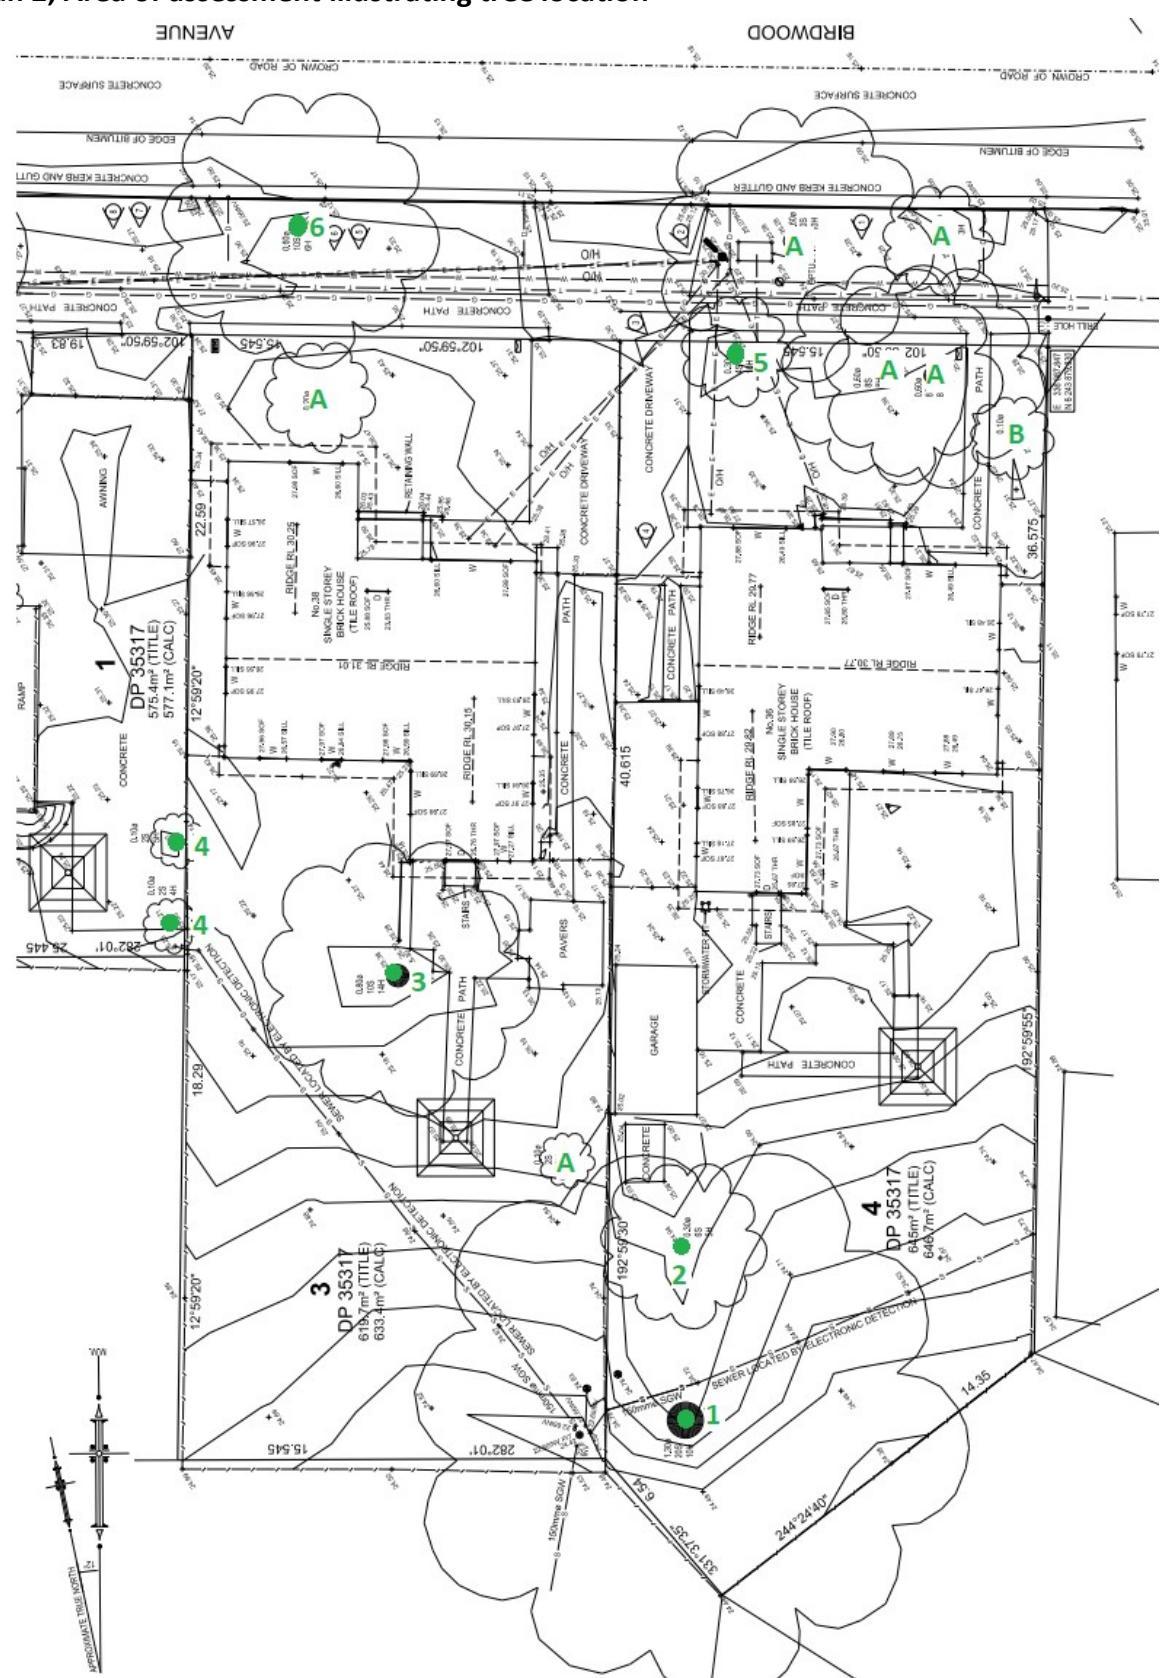
## 5.1 Plan 2; Area of assessment illustrating tree location

Not to scale Trees labelled A and B: see Section 7.0. **Note:** Tree numbering: see Section 4.3.2. <u>Source</u>: Adapted from *Cardno, Hard and Forester*, Plan 2, see Section 4.4.1
