NORTHERN
TREE
CARE

Preliminary Tree Report

195-197 Dibbs St East Lismore.

Final 01 DEC 2023

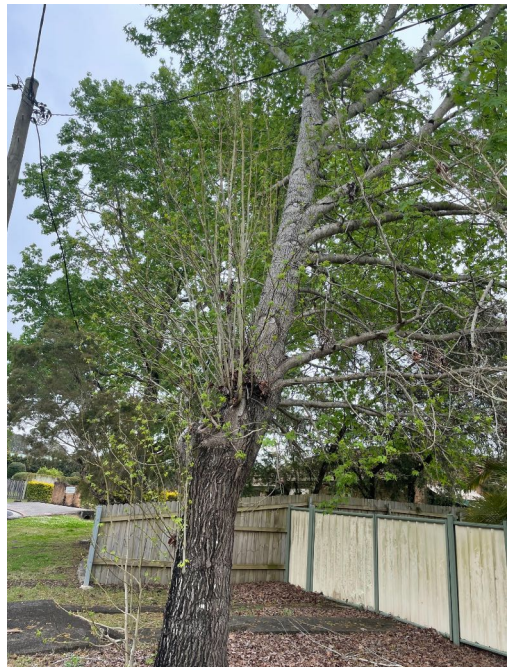
Photo 4. Tree # 4
Liquidamber

7.2 Tree # 4 is growing close to the southern boundary of 197 Dibbs St. It is a large tree with good form and is in good condition. It has a Tree Protection Zone (TPZ) of 6.0 m and a Structural Root Zone (SRZ) of 2.5 m. It can be seen from the street and makes a valuable contribution to the local streetscape. It is on the edge of the property and therefore may be a candidate for retention.

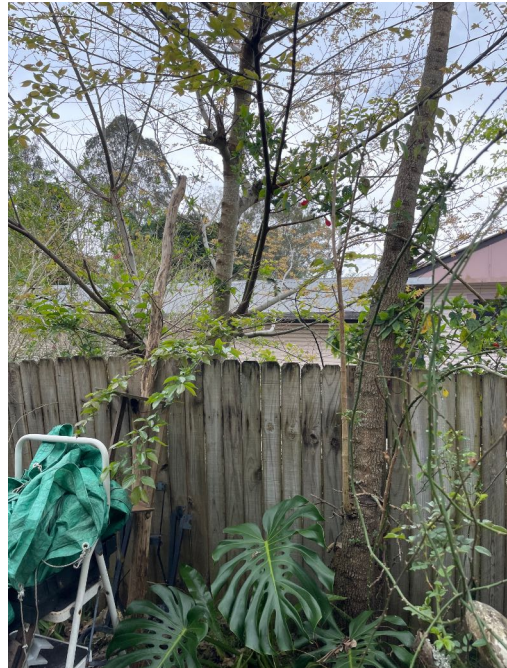
Photo 10. Tree # 14
China Doll

7.4 There are seven China Doll trees. This species is considered to be an undesirable species in many local government areas. Lismore City Council does not recognise undesirable species, only listed weed species are exempt from protection of DCP Chapter 16. Vegetation Management, so the trees are protected. However the species has weedy characteristics and has fast growing surface roots that are often problematic in urban environments.

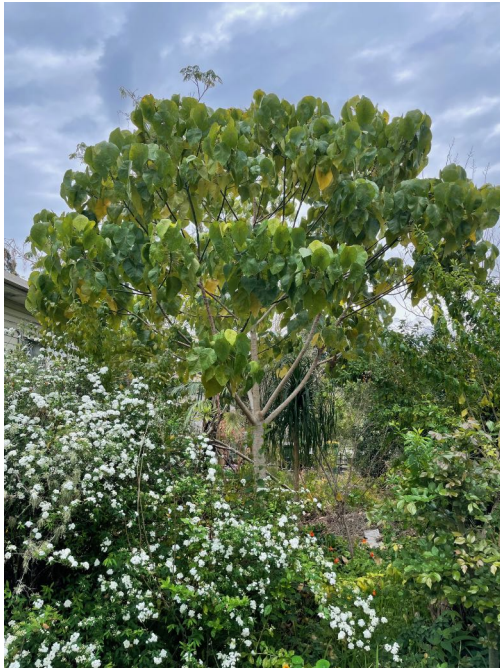
Photo 13. Tree # 23
Macaranga

7.3 The local native trees are all small or young or both. Even though they have high environmental value they do not have a high retention value. They can be easily replaced in the new development (Barrell 2006) by the use of native species in the landscaping design .

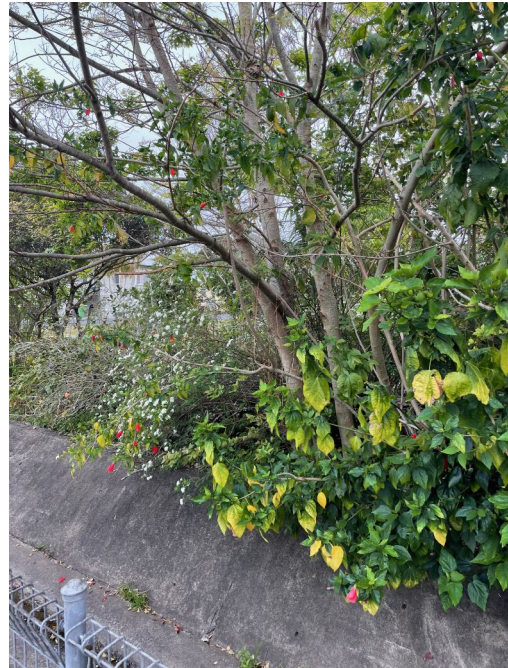
Photo 14. Tree # 24
Group of trees

7.5 There is a group of trees growing on the northern boundary of 195 Dibbs St. They are growing close to a concrete drain. There is some cracking of the concrete in the drain, possibly caused or exacerbated by the presence of the trees. The cluster of trees (# 24) within the site on the northern boundary, appear to have over time grown under the northern boundary fence and onto the neighbouring property. This tree cluster is also impacting on the adjacent stormwater channel and appear to be an ongoing maintenance issue.

8.2 The cluster of trees (24) within the site on the northern boundary, appear to have over time grown under the northern boundary fence and onto the neighbouring property. This tree cluster is also impacting on the adjacent stormwater channel and appear to be an ongoing maintenance issue. This cluster of trees (24) including the trees just inside the neighbouring property are recommended to be removed. The two trees shown as growing in the neighbouring property on the survey plan and identified as trees # 25 and 26 in this revised report are also recommended to be removed.

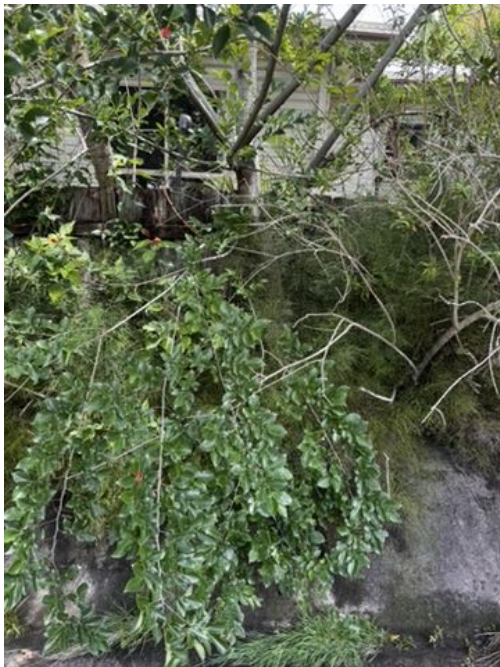
Photo 15 Tree # 25
Chinese Hackberry

7.6 Following a request for further information, two of the trees in the Group # 24 have been individually identified as trees # 25 and 26. They are shown in Attachment 3 Demolition Plan.
