Arboricultural Impact Assessment Report

**34-36 Light Street & 42 Walker Street Casino
NSW –Land & Housing Corporation NSW**

Date: 20 January 2024

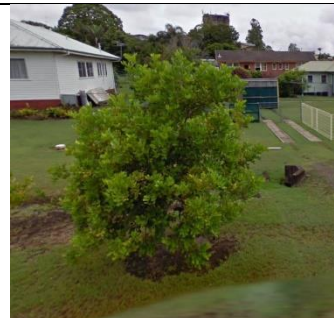
Tree Number & Identification Species Status and Values Tree Retention Values (TRVs)	DBH (cm) DARB (cm) Height & Spread (m)	Age Class Health Condition	TPZ (m) SRZ (m)	Recommendations ¹⁹ Nature of any AS4970 TPZ encroachment ²⁰ Health & Condition Observations and Comments	Plates
T1 Tuckeroo <i>Cupaniopsis anacardioides</i> Planted; Native rainforest shrub or small tree TRV Moderate	15 17 2.5 2.0	Semi- mature Good Good	2.0 1.5 0	RETAIN tree, install TPZ fence No substantial impact expected Upright, Exposed roadside planting, Low volume deadwood ²¹ , Generally a structurally stable species

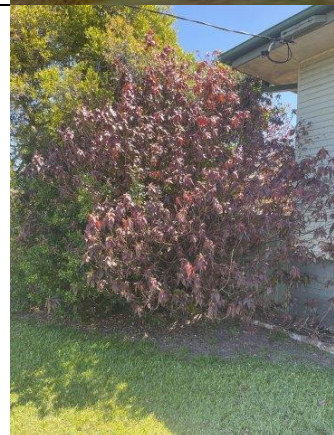
T2 Acalypha <i>Acalypha</i> sp. or var. Planted; Exotic ornamental shrub TRV Low	9 12 3 2	Mature Fair Fair	2.0 1.5	REMOVE shrub for construction Shrub base is entirely within the construction footprint Multi-stemmed, Spreading, Overly closely planting and light reaching, Low volume deadwood

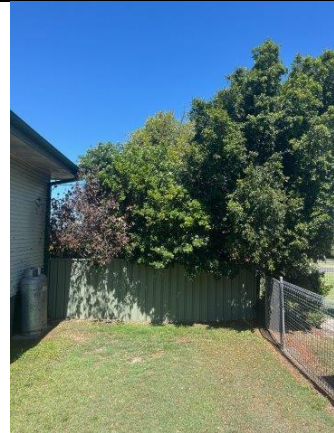
Tree Number & Identification Species Status and Values Tree Retention Values (TRVs)	DBH (cm) DARB (cm) Height & Spread (m)	Age Class Health Condition	TPZ (m) SRZ (m)	Recommendations ¹⁹ Nature of any AS4970 TPZ encroachment ²⁰ Health & Condition Observations and Comments	Plates
T3 Murraya <i>Murraya paniculata</i> Planted; Exotic ornamental shrub, Environmental weed species TRV Very Low	8 12 3.5 3	Semi- Mature Fair Fair	2.0 1.5	REMOVE shrub for construction and environmental weed status Shrub base is entirely within the construction footprint Spreading, Overly closely planting and light reaching, Poor structure and form, Low volume deadwood

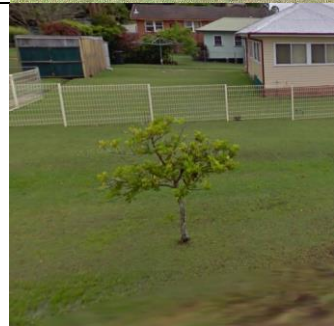
T4 Tuckeroo <i>Cupaniopsis anacardioides</i> Planted; Native rainforest shrub or small tree TRV Very Low	10 12 1.5 1.0	Juvenile Poor Poor	2.0 1.5	RETAIN tree , install TPZ fence No substantial impact expected Upright, Stunted growth, Exposed roadside planting, Low volume deadwood, Generally a structurally stable species

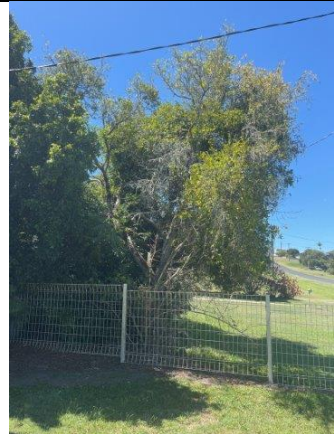
Tree Number & Identification Species Status and Values Tree Retention Values (TRVs)	DBH (cm) DARB (cm) Height & Spread (m)	Age Class Health Condition	TPZ (m) SRZ (m)	Recommendations ¹⁹ Nature of any AS4970 TPZ encroachment ²⁰ Health & Condition Observations and Comments	Plates
T5 Weeping Bottlebrush <i>Callistemon viminalis</i> Planted; Native rainforest shrub or small tree TRV Very Low	15 18 4 2.5	Semi- Mature Very Poor Very Poor	2.0 1.6	REMOVE shrub/ tree for construction Shrub/ tree base is entirely within the construction footprint Upright, Codominant stems @ ~1.2m with narrow v-shaped union, Heavy infestation of mistletoe, Low crown foliage density, Small leaf size, Moderate volume deadwood to ~5cmØ

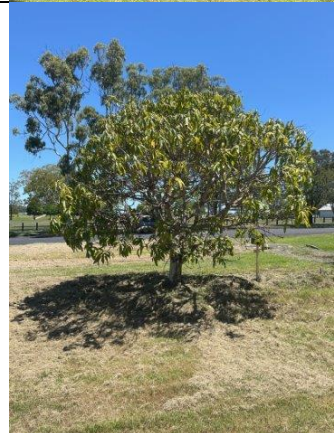
T6 Mango <i>Mangifera indica</i> Planted; Exotic fruit tree TRV Very Low	26 30 3 3	Semi- Mature Poor Poor	3.1 2.0	REMOVE tree due to Poor health and condition and Very Low TRV NA Spreading, Low crown foliage density, Stunted growth, Multi- stemmed @ ~1m, Low volume deadwood

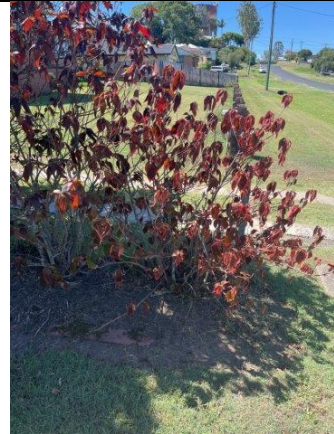
Tree Number & Identification Species Status and Values Tree Retention Values (TRVs)	DBH (cm) DARB (cm) Height & Spread (m)	Age Class Health Condition	TPZ (m) SRZ (m)	Recommendations ¹⁹ Nature of any AS4970 TPZ encroachment ²⁰ Health & Condition Observations and Comments	Plates
T7 to T9 Acalpyha <i>Acalpyha</i> sp. or var. Planted; Exotic ornamental shrub TRV Very Low	Average 6 11 2 2	Semi- Mature Poor Poor	2.0 1.5	REMOVE shrubs for construction and due to Poor health and condition and Very Low TRV Major TPZ encroachments within SRZ from building construction and stormwater drain installation Spreading; Low crown foliage density, Multi-stemmed, Moderate volume deadwood

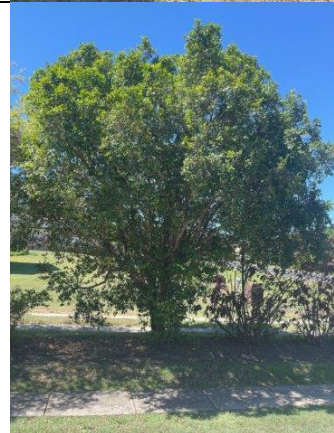
T10 Brush Cherry <i>Syzygium australe</i> Planted; Native rainforest tree TRV Moderate	25 29 5 6	Mature Fair Fair	3.0 2.0	REMOVE tree for construction Major TPZ encroachment 0.9m within SRZ from building construction Spreading, Codominant stems @ 0.5m with narrow v-shaped union, Low volume deadwood

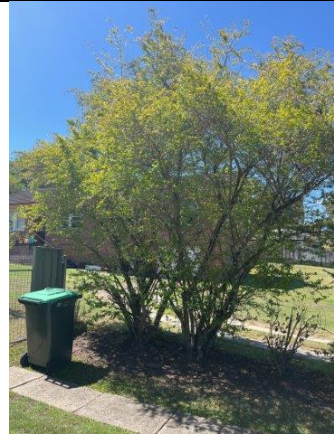
Tree Number & Identification Species Status and Values Tree Retention Values (TRVs)	DBH (cm) DARB (cm) Height & Spread (m)	Age Class Health Condition	TPZ (m) SRZ (m)	Recommendations ¹⁹ Nature of any AS4970 TPZ encroachment ²⁰ Health & Condition Observations and Comments	Plates
T11 & T12 Duranta <i>Duranta repens</i> Planted; Exotic ornamental shrub, Environmental weed species TRV Very Low	14 16 3 2	Mature Fair Fair	2.0 1.5	REMOVE shrubs for environmental weed status NA Spreading; Multi-stemmed from near base, Overly closely planting, Low volume deadwood

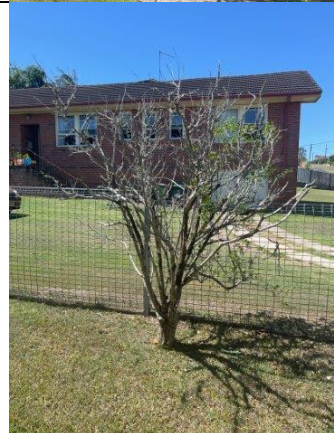
T13 Murraya <i>Murraya paniculata</i> Planted; Exotic ornamental shrub, Environmental weed species TRV Very Low	8 14 2 1	Near dead Very Poor Very Poor	2.0 1.5	REMOVE shrub for environmental weed status NA Spreading; Multi-stemmed, near leafless, High volume deadwood

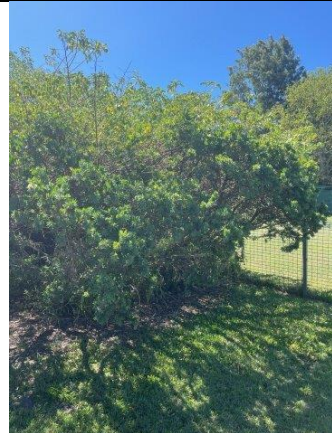
Tree Number & Identification Species Status and Values Tree Retention Values (TRVs)	DBH (cm) DARB (cm) Height & Spread (m)	Age Class Health Condition	TPZ (m) SRZ (m)	Recommendations ¹⁹ Nature of any AS4970 TPZ encroachment ²⁰ Health & Condition Observations and Comments	Plates
T14 Little John Bottlebrush <i>Callistemon var. Little John</i> Planted; Native ornamental shrub TRV Low	17 22 2 1	Mature Fair Poor	2.0 1.8	REMOVE shrub for construction Major TPZ encroachment 1.6m within SRZ from building construction Moderate lean E, Crown displaced by exotic Senna weed infestation, Moderate volume deadwood to ~5cmØ

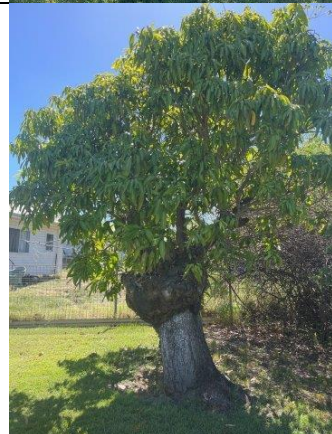
T15 Mango <i>Mangifera indica</i> Planted; Exotic fruit tree TRV Very Low	44 54 3.5 2	Mature Poor Poor	5.3 2.5	REMOVE tree for construction Tree base is entirely within the construction footprint Upright; Dead sections in crown, High Lopping/ topping, Poor past pruning. Moderate volume deadwood to ~10cmØ

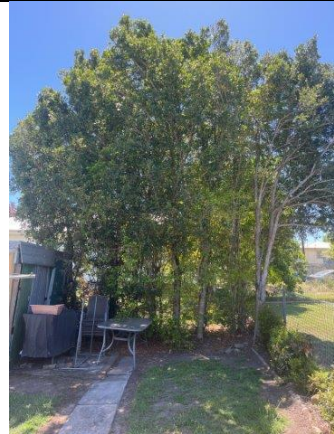
Tree Number & Identification Species Status and Values Tree Retention Values (TRVs)	DBH (cm) DARB (cm) Height & Spread (m)	Age Class Health Condition	TPZ (m) SRZ (m)	Recommendations ¹⁹ Nature of any AS4970 TPZ encroachment ²⁰ Health & Condition Observations and Comments	Plates
T16 Brush Cherry <i>Syzygium australe</i> Planted; Native rainforest tree TRV Low	17 18 6 2	Mature Good Fair	2.0 1.6	REMOVE tree for construction Tree base is entirely within the construction footprint Moderate lean to N, Multi-stemmed @ ~1.6m, Overly close Brush Cherry screen plantings, Crown lift pruning, Low volume deadwood

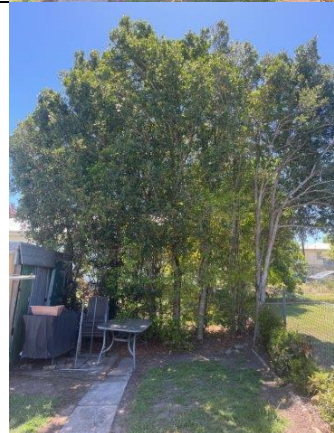
T17 Brush Cherry <i>Syzygium australe</i> Planted; Native rainforest tree TRV Low	14 16 6 4	Mature Good Fair	2.0 1.5	REMOVE tree for construction Tree base is entirely within the construction footprint Multi-stemmed, Overly close Brush Cherry screen plantings, Crown lift pruning, Low volume deadwood, Exotic Duranta weed near base

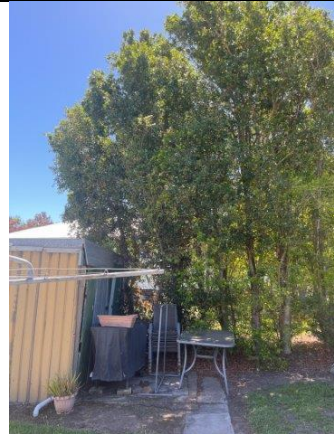
Tree Number & Identification Species Status and Values Tree Retention Values (TRVs)	DBH (cm) DARB (cm) Height & Spread (m)	Age Class Health Condition	TPZ (m) SRZ (m)	Recommendations ¹⁹ Nature of any AS4970 TPZ encroachment ²⁰ Health & Condition Observations and Comments	Plates
T18 Brush Cherry <i>Syzygium australe</i> Planted; Native rainforest tree TRV Low	26 29 6 4	Mature Good Fair	3.1 2.0	REMOVE tree for construction Tree base is entirely within the construction footprint for stormwater pipe installation Upright, Multi-stemmed, Overly close Brush Cherry screen plantings, Crown lift pruning, Low volume deadwood

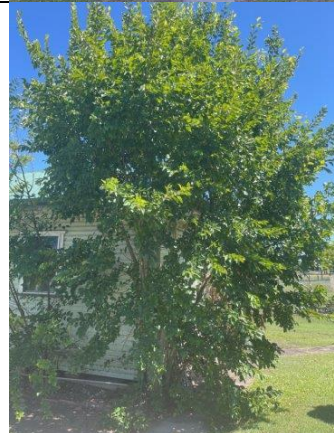
T19 Chinese Celtis <i>Celtis sinensis</i> Planted; Exotic ornamental tree, Environmental weed species TRV Very Low	19 24 3 3	Semi-Mature Good Fair	2.3 1.8	REMOVE tree for environmental weed status NA Spreading, Multi-stemmed, damaging house gutter, Poor past pruning topping/ topping, Low volume deadwood

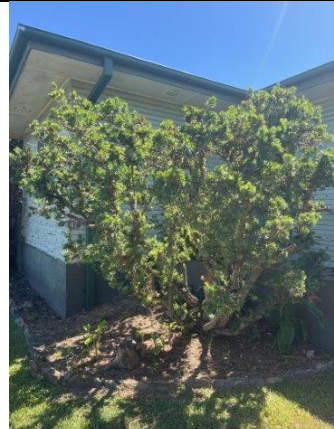
Tree Number & Identification Species Status and Values Tree Retention Values (TRVs)	DBH (cm) DARB (cm) Height & Spread (m)	Age Class Health Condition	TPZ (m) SRZ (m)	Recommendations ¹⁹ Nature of any AS4970 TPZ encroachment ²⁰ Health & Condition Observations and Comments	Plates
T20 A Bottlebrush <i>Callistemon sp. or var.</i> Planted; Native ornamental shrub TRV Moderate	26 30 2 2	Mature Fair Fair	3.1 2.0	REMOVE shrub for construction Shrub base is entirely within the construction footprint Spreading; Multi-stemmed, Low volume deadwood

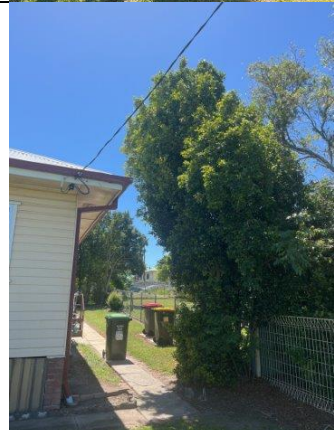
T21 Brush Cherry <i>Syzygium australe</i> Planted; Native rainforest tree TRV Moderate	20 24 5 4	Mature Good Fair	2.4 1.8	REMOVE tree for construction Tree base is entirely within the construction footprint Slight lean to S, Codominant stems with narrow v-shaped union, Formative lopping/ topping and target avoidance pruning, i.e. house and powerline, Low volume deadwood

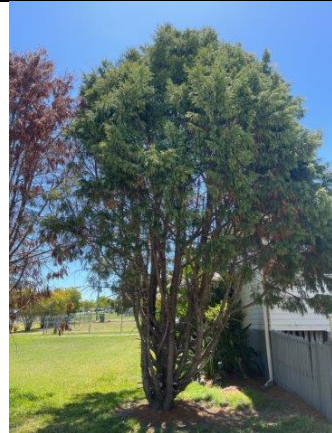
Tree Number & Identification Species Status and Values Tree Retention Values (TRVs)	DBH (cm) DARB (cm) Height & Spread (m)	Age Class Health Condition	TPZ (m) SRZ (m)	Recommendations ¹⁹ Nature of any AS4970 TPZ encroachment ²⁰ Health & Condition Observations and Comments	Plates
T22 Exotic Cypress <i>Cyressus sp.</i> Planted; Exotic ornamental tree TRV Moderate	38 46 5 2.5	Mature Fair Fair	4.6 2.4	RETAIN tree, install TPZ fence; Project Arborist to advise on tree impact avoidance and minimisation; and monitor excavation works within TPZ, avoid structural tree roots when installing new colorbond fence within TPZ Minor TPZ encroachment of 3% outside the SRZ from stormwater pipe installation Upright, Signs of inner leaf dieback, Multi-stemmed near base, Low volume deadwood

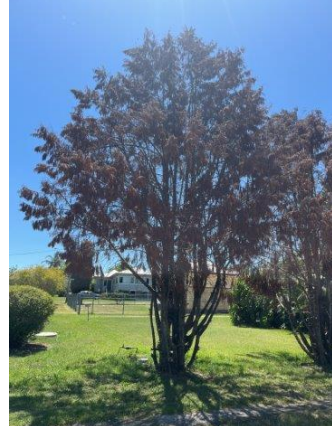
T23 Exotic Cypress <i>Cyressus sp.</i> Planted; Exotic ornamental tree TRV Very Low	34 40 5 3	Dead Dead Dead	NA NA	REMOVE dead tree NA

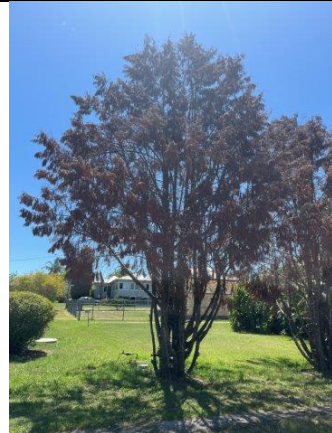
Tree Number & Identification Species Status and Values Tree Retention Values (TRVs)	DBH (cm) DARB (cm) Height & Spread (m)	Age Class Health Condition	TPZ (m) SRZ (m)	Recommendations ¹⁹ Nature of any AS4970 TPZ encroachment ²⁰ Health & Condition Observations and Comments	Plates
T24 Exotic Cypress <i>Cypressus sp.</i> Planted; Exotic ornamental tree TRV Very Low	36 43 5 3	Dead Dead Dead	NA NA	REMOVE dead tree NA

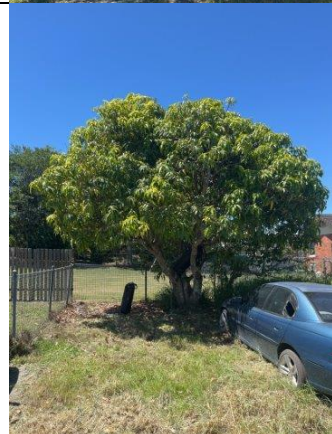
T25 Mango <i>Mangifera indica</i> Planted; Exotic fruit tree TRV Moderate	44 54 5 5	Semi- Mature Fair Fair	5.2 2.5	RETAIN tree, install TPZ fence, avoid structural tree roots when installing new colorbond fence within TPZ; Project Arborist to monitor excavation works within TPZ No substantial impact expected Spreading, Multi-stemmed from near base with narrow v-shaped unions, Concrete slab at base of tree, Low volume deadwood

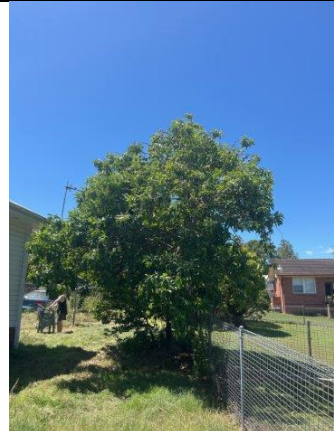
Tree Number & Identification Species Status and Values Tree Retention Values (TRVs)	DBH (cm) DARB (cm) Height & Spread (m)	Age Class Health Condition	TPZ (m) SRZ (m)	Recommendations ¹⁹ Nature of any AS4970 TPZ encroachment ²⁰ Health & Condition Observations and Comments	Plates
T26 Avocado <i>Persea americana</i> var. Planted; Exotic fruit tree TRV High	27 31 6 5	Semi- Mature Good Good	3.2 2.0	RETAIN tree, install TPZ fence, Project Arborist to advise on tree impact avoidance and minimisation; and monitor excavation works within TPZ Minor 2% TPZ encroachment outside the SRZ from retaining wall construction. Upright, Grafted and producing edible fruit (possibly Sharwil variety), Low volume deadwood

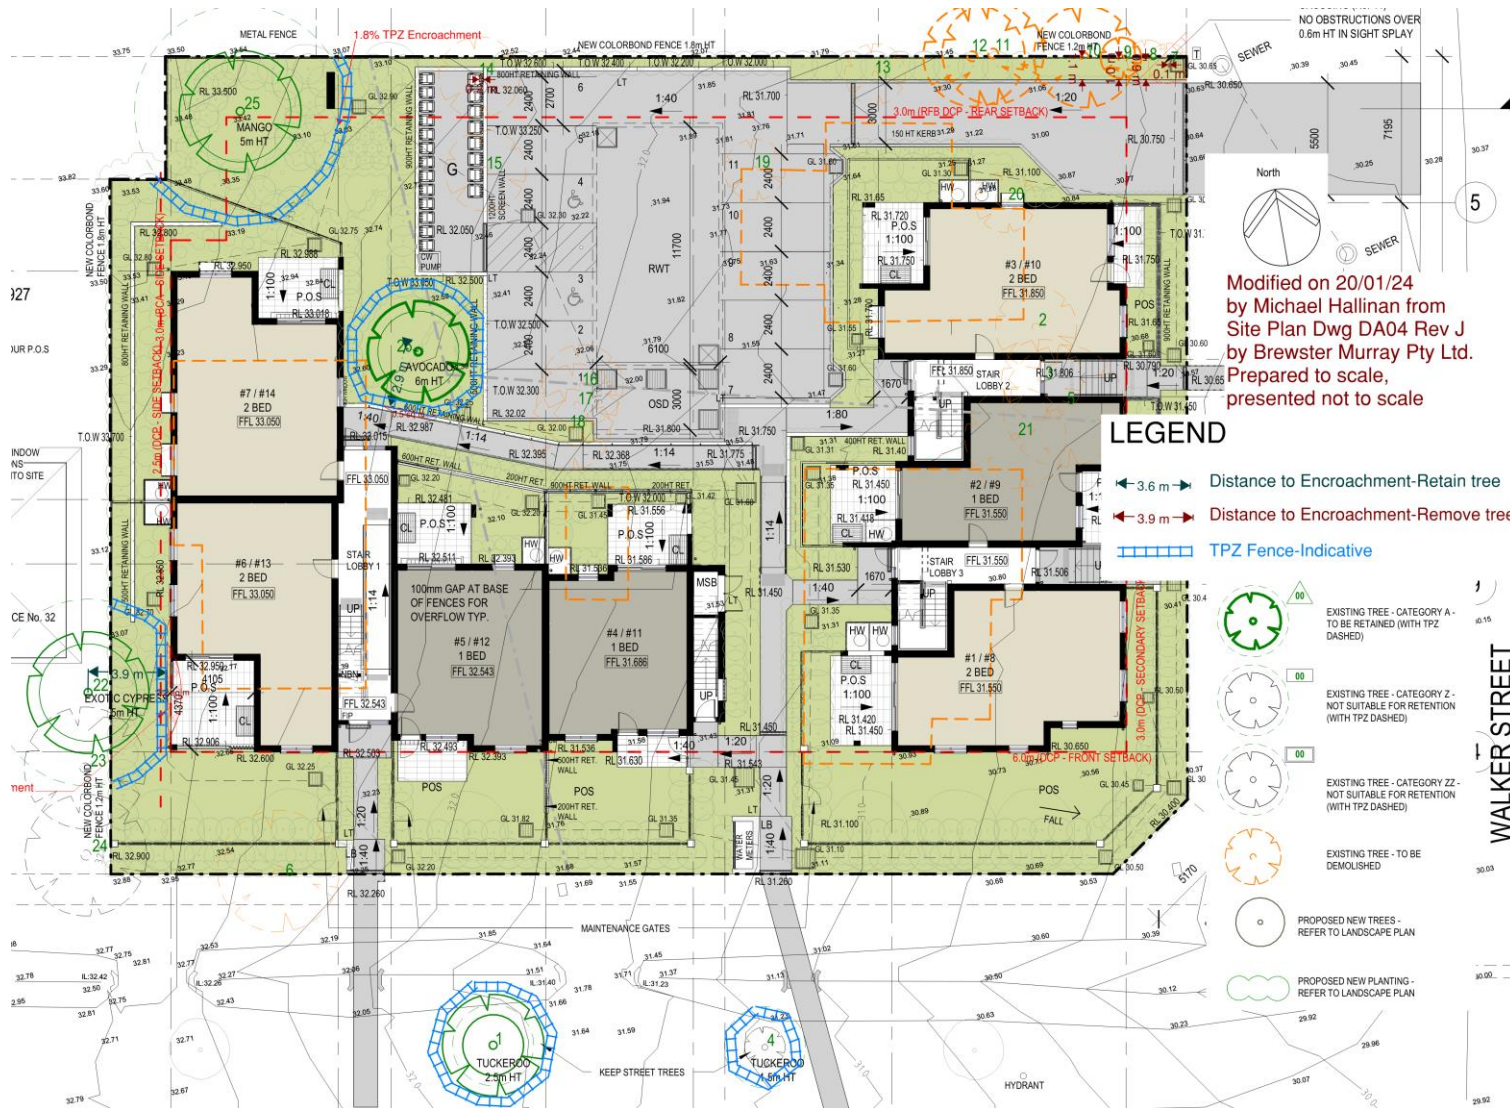
Figure 1. Tree removal, tree retention and tree protection plan drawing, refer to Table 1.

- A total of 26 trees, shrubs and clumps were assessed within the area of the site.
- Five trees are recommended to be retained, of which, no substantial impact is expected for three trees, and two trees have Minor¹⁵ TPZ encroachments of less than 10%. Standards Australia (2009) note that TPZ locations may be varied for trees with Minor TPZ encroachments where the area lost to the encroachment is compensated for elsewhere and is contiguous with the TPZ, as is the case in this instance where considered necessary.

- No trees to be retained have Major¹⁶ TPZ encroachments outside the Structural Root Zone (SRZ)¹⁷, which is critical for tree stability. Trees with Minor TPZ encroachments are recommended to be retained and are expected to cope with construction activities, remain viable and maintain health, condition and vitality provided tree protection measures are effectively implemented as outlined below in **Section 4**.

- The remaining trees and shrubs are recommended to be removed for construction and environmental weed status.
- Trees and shrubs to be removed are mostly landscape plantings with varying levels of maintenance and care and generally readily replaceable with new landscape plantings.

Based on the proposed works, the following recommendations are made, refer to **Table 1** and **Figure 1**:

The project Tree Protection Zones (TPZs) are the areas dedicated to tree protection. **Figure 1** shows the recommended project TPZ fence locations in relation to retained trees and the construction footprint.
