**ARBORICUTURAL IMPACT ASSESSMENT - FOR 2024 DEVELOPMENT AT;
GUNNEDAH HOSPITAL NSW 2380**
Version 3 dated 22 May 2024.

1. INTRODUCTION.

Gunnedah Hospital re-development, Marquis Street Gunnedah NSW 2380. Ground Floor Diagram V4 Early works for construction revised dated 20/12/23. DWP Architects, Sydney NSW.

Gunnedah Hospital re-development Anzac Parade Gunnedah. Tree Retention and Removal Plan. Drawing L02 issue D. Dated 20/10/23 Stewart Surveys - Gunnedah NSW.

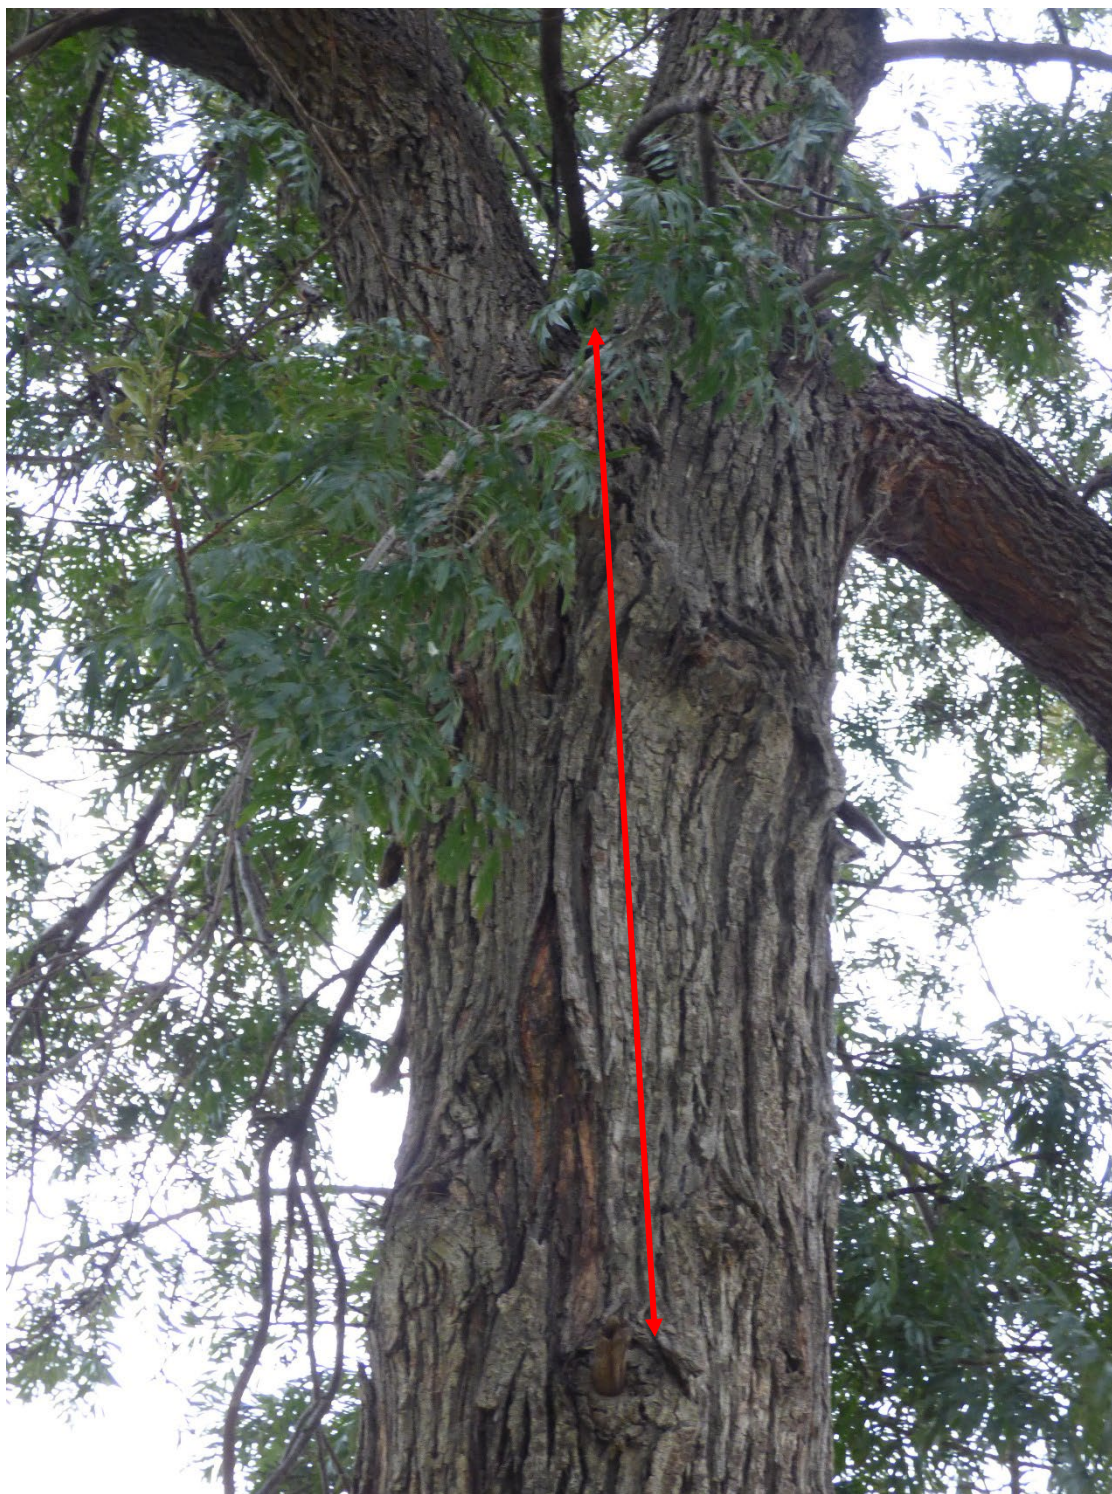
Photo 1 – Tree 24 *Grevillia robusta* (Silky Oak). Example of a tree evaluated as ‘remove priority’. It has a significant structural issue with the main stem. There is a 1 m vertical crack down the stem and the tree is a high risk of stem failure. Irrespective of the development the tree needs to be removed.

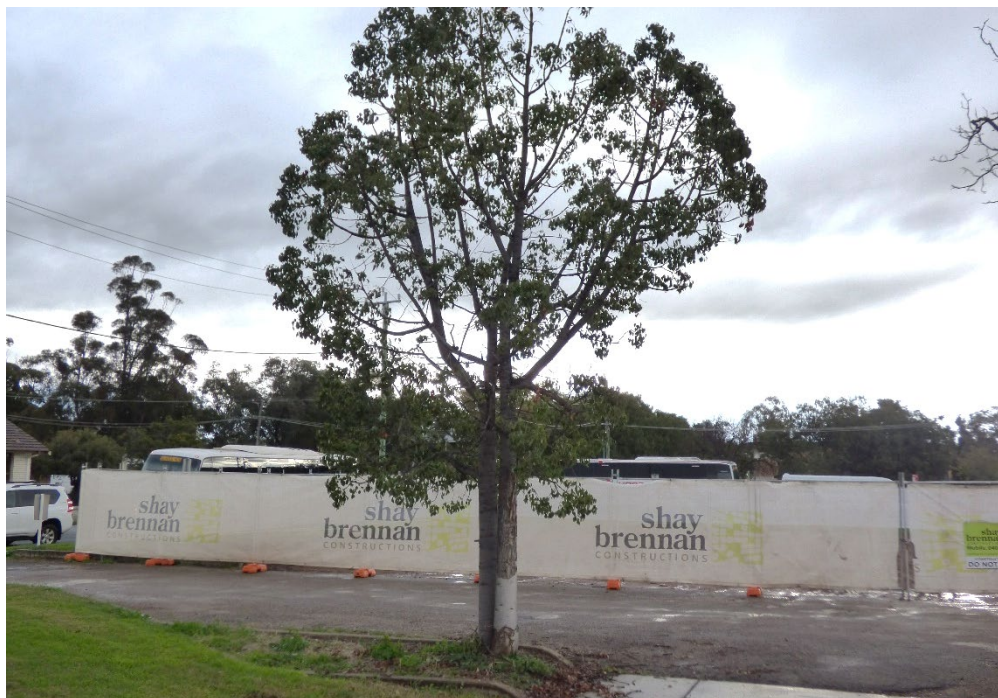
Photo 2 – Tree 1 – Example of a tree that is recommended for ‘removal’
The stem condition is poor with moderate to high potential for failure and the stem is also hard against the kerbing system.

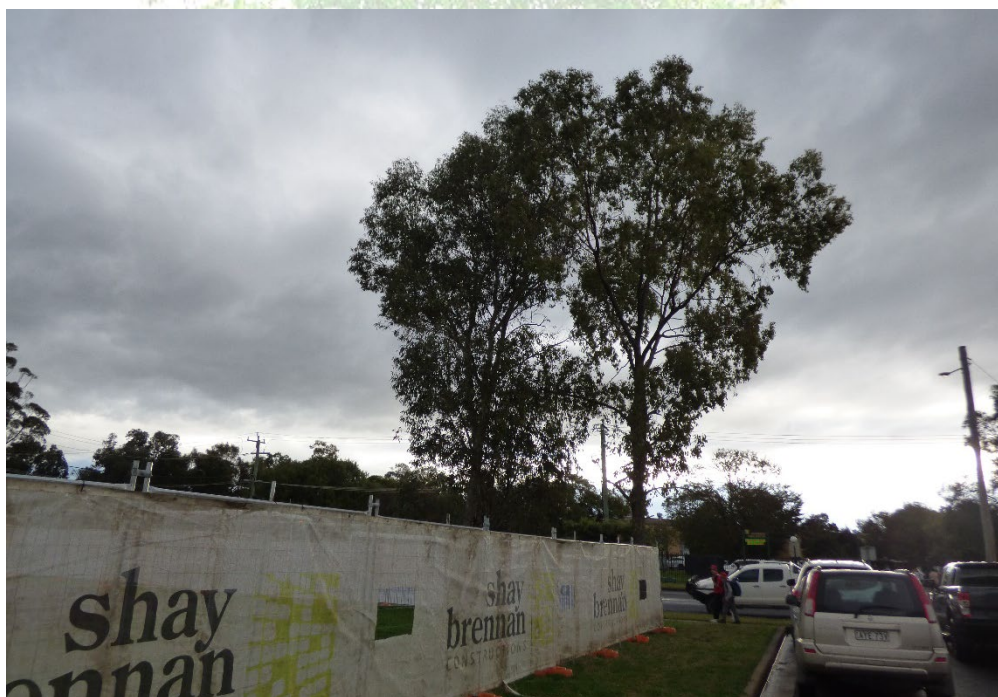
Photo 3 – Trees 5 and 6 trees evaluated as ‘Retain if possible’
Semi mature trees which on balance of considerations the tree is worth retaining.

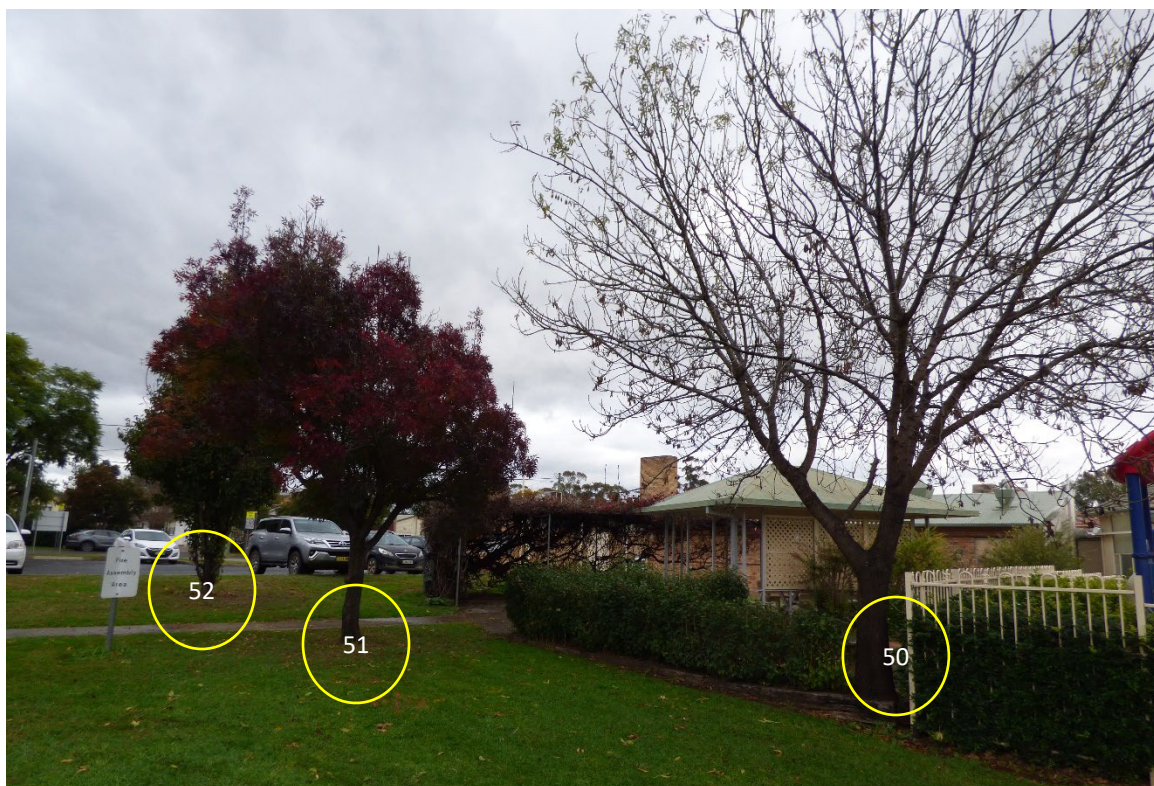
Photo 4 – 3 Trees as numbered that are in direct conflict with the development footprint. Tree 50 was evaluated as ‘retain if possible’. It will require removal, but its replacement time frame is about 7 years.

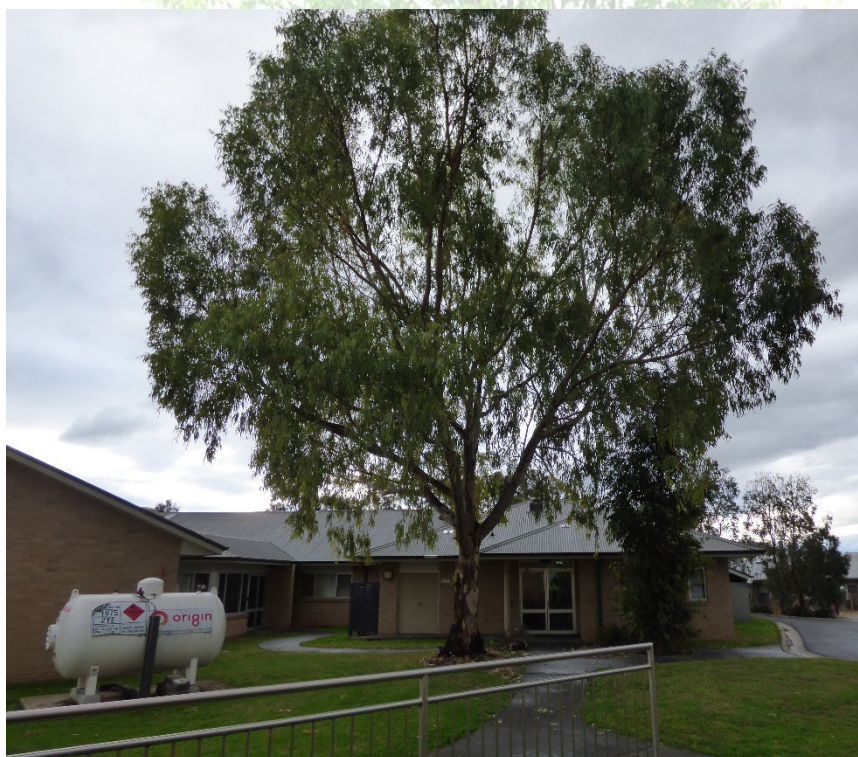
Photo 5 – Tree 19 - Eucalyptus camaldulensis (River Red Gum). Example of tree that has been evaluated as ‘Retain’.

A sound young tree in excellent condition with longer life expectancy.

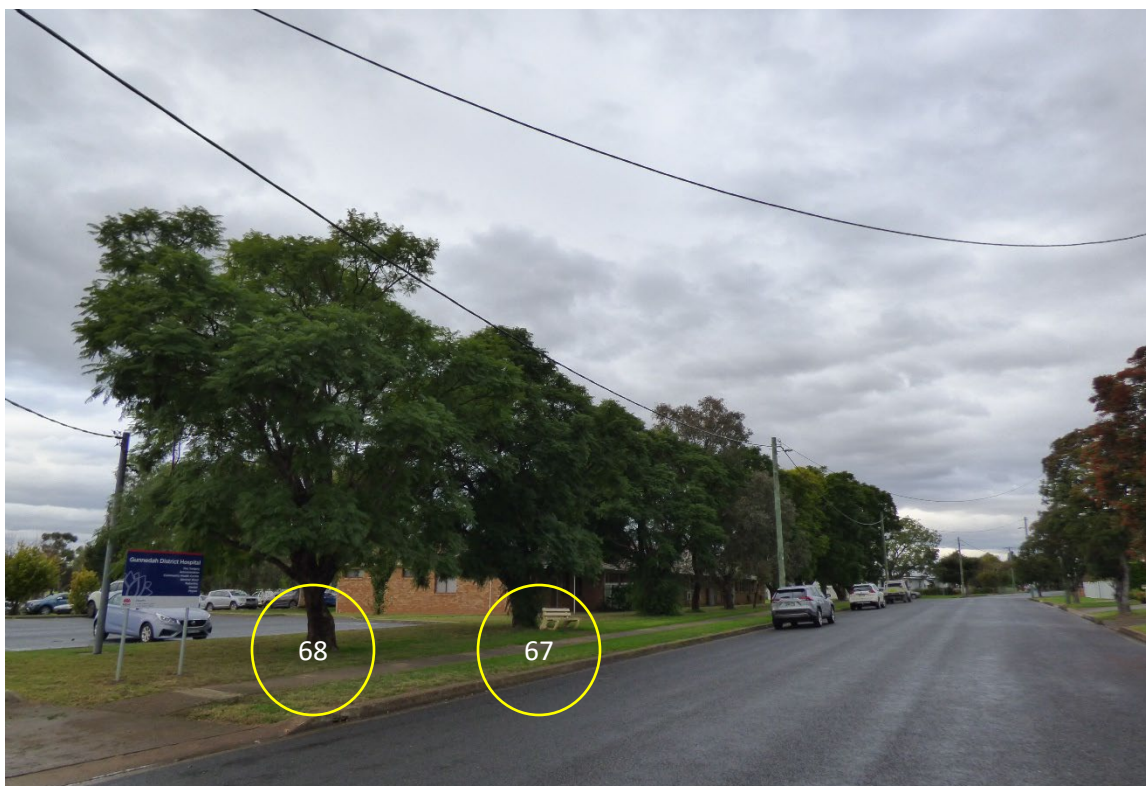
Photo 6 – Trees 68 to 58 in sequence from foreground. Line of medium to large mature trees evaluated as high significant and ‘Retain Priority’.

- Tree 58 and trees 65 to 68 inclusive are trees evaluated with moderate or high significance and have root zone impacts inside the tree protection zones. The encroachments are in the order of less than 10% and impacts can be managed with appropriate planning and amelioration measures.

Planning should ensure that the TPZ of these tree is respected and that removal would be difficult to justify. The line of trees provides significant amenity values and would take 30-50 years to replace.

- Specific measures will need to be developed in relation to all trees identified as *Retained with Impacts to Manage*. Specifically this relates to Tree 58 and trees 65 to 68 inclusive.

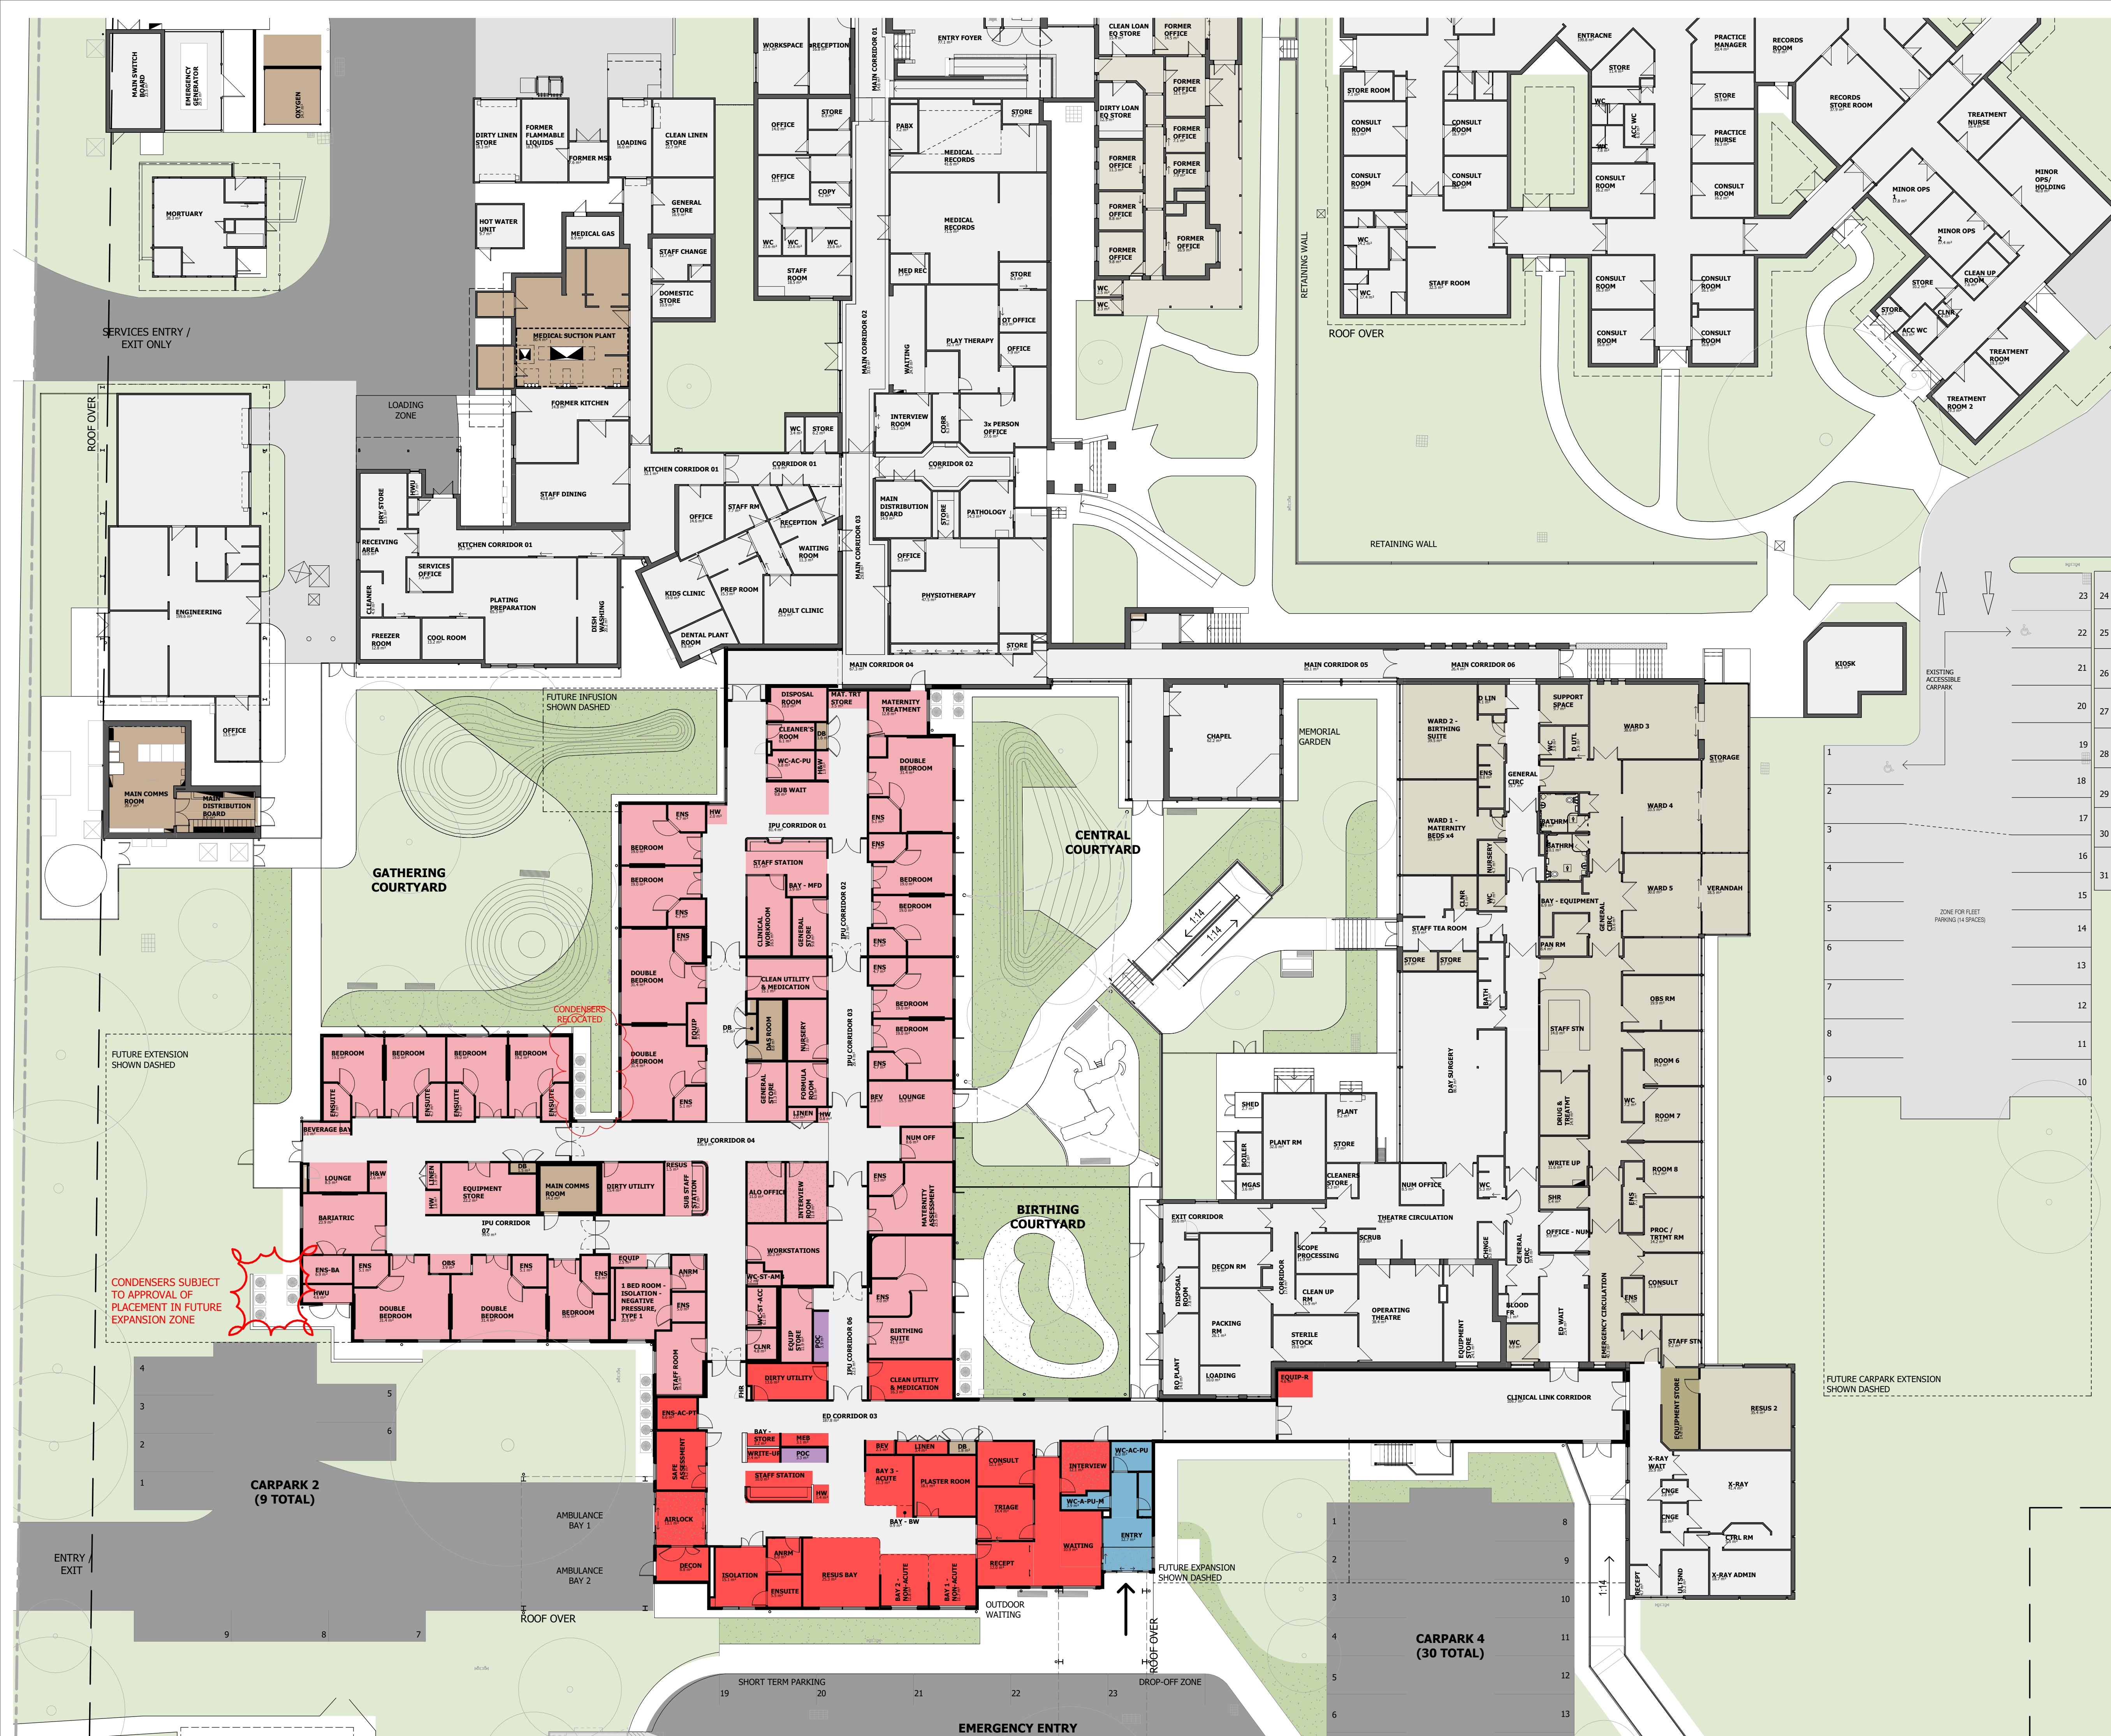
TREE 5 WAS NOT LOCATED IN THE SURVEY. IT IS LOCATED IN THE
HARDSTAND AREA OF THE CARPARK.
RECOMMEND THE THE CARPARK BE ADJUSTED TO RETAIN THE
TREE.
