# Arboricultural Impact Assessment Report

1-3 Walker St & 2-4 Caldwell Ave  
East Lismore

NSW Land and Housing  
Corporation

26 June 2023

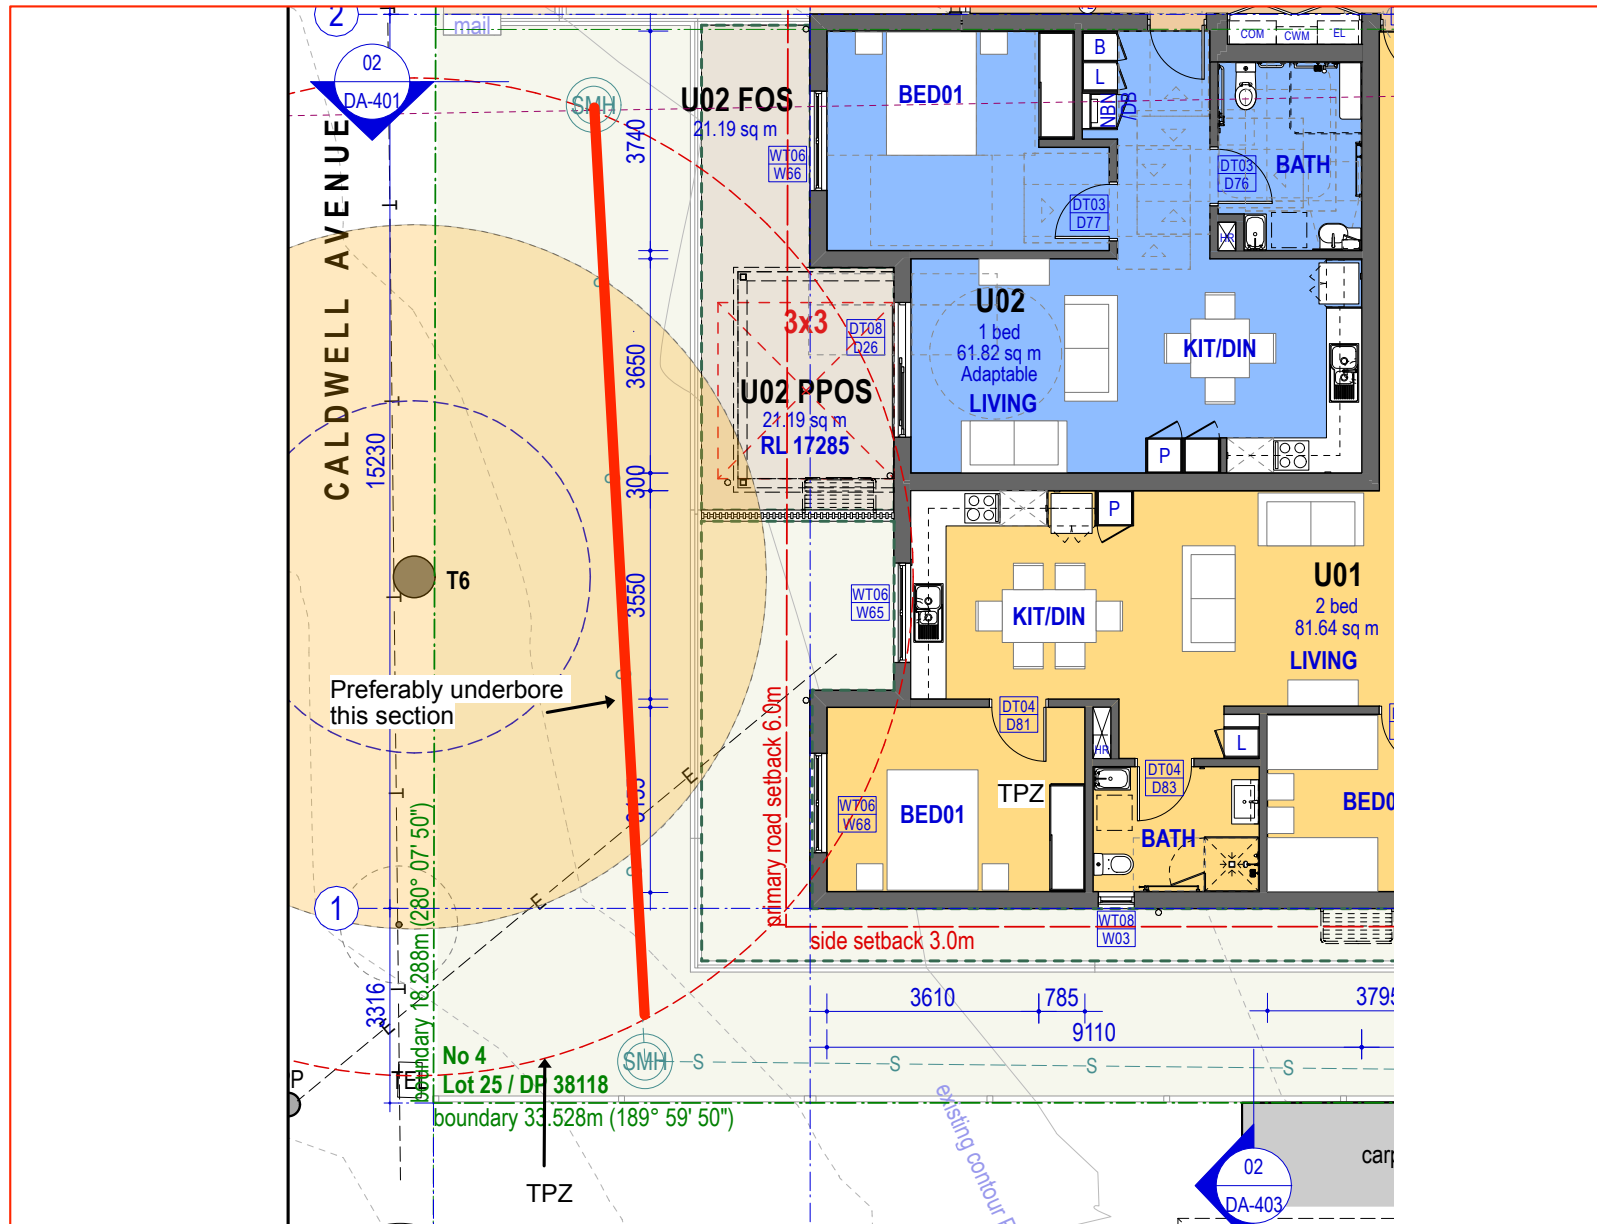
**16.  
Attachment 5  
Tree # 6  
Underbore**

7.2 The encroachment if the sewer line is installed by digging a trench into the TPZ of tree # 6 is calculated to be 25%. This is a major encroachment as defined by the Australian Standard AS 4970-2009 Protection of trees on development sites. If the sewer line were to be installed by underboring, the encroachment extent would be the retaining wall. The encroachment of the retaining wall into the TPZ is calculated to be 16%. This is also a major encroachment.

8.2 It is recommended that the sewer line be installed by underboring through the TPZ of tree # 6. The boring must be carried out so that the top of the underbore is at least 600 mm below the surface of the soil. If this is not feasible the line can be installed by digging a trench. This would result in an encroachment of 25% into the TPZ. This is not ideal but is unlikely to cause this tree to become unviable.

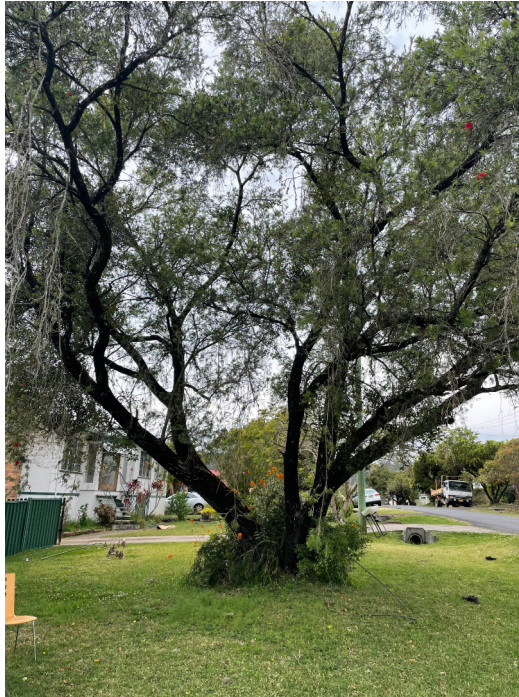
Photo 1. Tree # 6. Bottlebrush

AS 4970 Section 3.3.4 Encroachment considerations for tree # 6. Encroachment of 23%		Considerations for this tree
a	Location and distribution of roots to be determined through non destructive investigation methods.	Given that locating individual roots will not inform the assessment process, it is considered that root mapping is not appropriate or necessary to determine the viability of this tree.
b	The potential loss of root mass resulting from the encroachment.	A sewer line is proposed to be constructed just outside the Structural Root Zone of the tree. If the line is installed by digging a trench the encroachment will be 25%. If the sewer line is installed by underboring, the encroachment will be the retaining wall and the encroachment will be 16%.
c	Tree species and tolerance to root disturbance.	This species of tree is hardy and tolerant of root loss.
d	Age, vigour and size of the tree	The tree is a mature aged tree in good health and with fair vigour.

e	Lean and stability of the tree	The tree has an upright form
f	Soil characteristics	The soil is clay loam. It is well suited to the growth of trees.
g	The presence of existing or past structures	The tree is growing on the road reserve. It is expected that there will be a significant presence of tree roots where the work is proposed.
h	Design factors	The installation of the sewer line can be done by way of underboring. This will significantly reduce the impact of the development on the tree.

8.3 There construction of the retaining walls for both trees # 6 and 9 will require some footings for the retaining walls. The footings should be excavated with an earthmoving machine. Where roots are encountered that are less than 100 mm in diameter they should be broken off with the earthmoving machine. They should not be cut cleanly (Gray 2023).

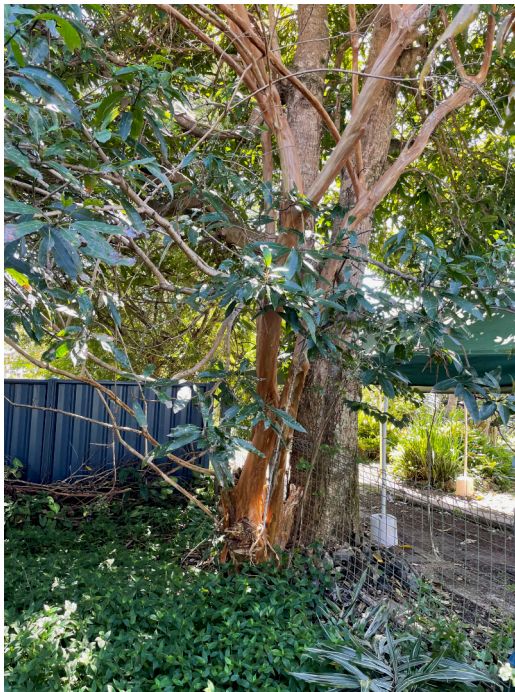
Photo 2. Tree # 9. Mango tree.

7.4 The encroachment into the TPZ of tree # 9 is calculated to be 23%. This is a major encroachment as defined by the Australian Standard *AS 4970-2009 Protection of trees on development sites. Sect 3.3.3 Major encroachment*. The Standard allows for a major encroachment where it can be demonstrated that the tree will remain viable. The considerations for the encroachment are examined in **Table 2. Encroachment Considerations**.

AS 4970 Section 3.3.4 Encroachment considerations for tree # 9. Encroachment of 23%		Considerations for this tree
a	Location and distribution of roots to be determined through non destructive investigation methods.	Given that locating individual roots will not inform the assessment process, it is considered that root mapping is not appropriate or necessary to determine the viability of this tree.
b	The potential loss of root mass resulting from the encroachment.	A retaining wall is planned to be constructed approximately 2.8 m from the boundary. This will require excavation of the soil to build the wall. The roots of the tree will be severed at this location.
c	Tree species and tolerance to root disturbance.	This species of tree is hardy and tolerant of root loss.
d	Age, vigour and size of the tree	The tree is a mature aged tree in good health and with fair vigour.
e	Lean and stability of the tree	The tree has an upright form

f	Soil characteristics	The soil is clay loam. It is well suited to the growth of trees.
g	The presence of existing or past structures	The existing building will have inhibited the growth of roots in part of the encroachment zone. It is considered that this is not a significant factor however.
h	Design factors	The retaining wall has been pushed out to maximise the distance from the tree. The site constraints make it necessary to construct a retaining wall in this position.
