# ARBORIST'S STAGE C REPORT

| PROPERTY: | 4 – 14 Peters Avenue Wallsend NSW |
| DATE OF REPORT: | 22 March 2022 (updated 19 October 2023) |
| REQUESTED BY: | Sam Crawford Architects |

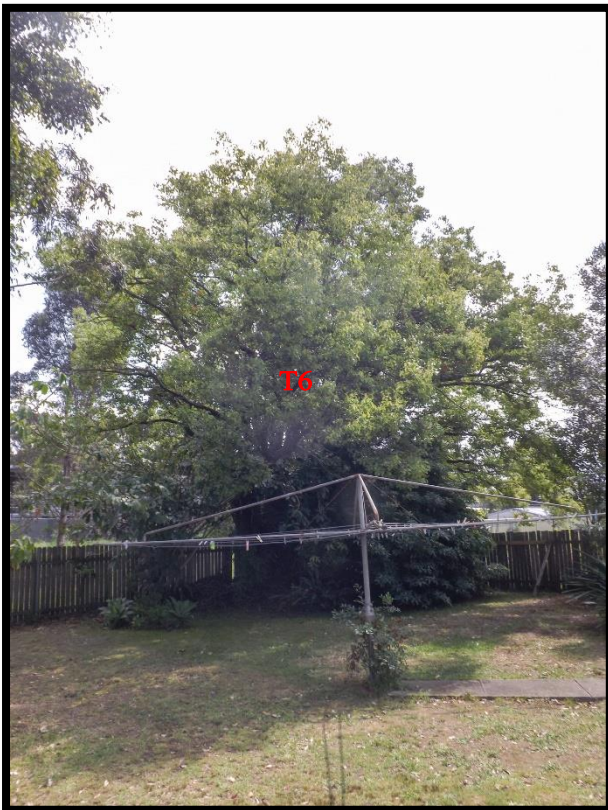
- Good health with a leaf density of 80% coverage and slight deadwood to 80 mm diameter.
- Structurally sound with poor form (multiple stems from .5 metres high).
- Undesirable species, however, is not exempt from Council's policy.
- In contact with the back fence.

Tree 6 viewed from the SE.

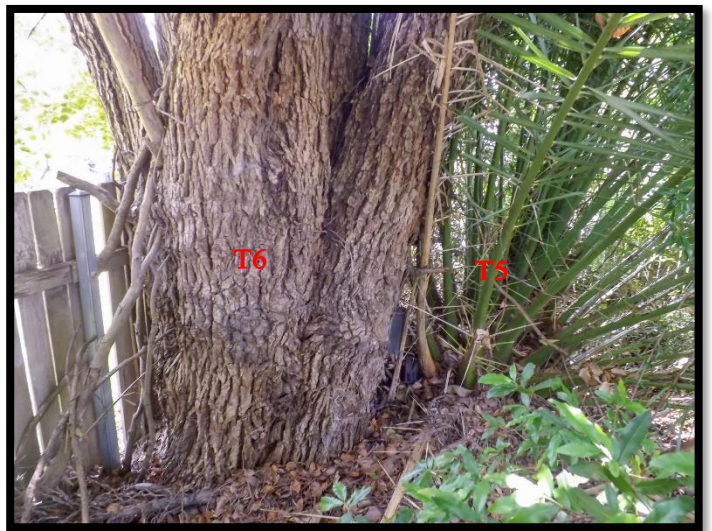
- Good health with a leaf density of 90% coverage.
- Self sown growing in contact with T6.

The bases of T5 and T6.

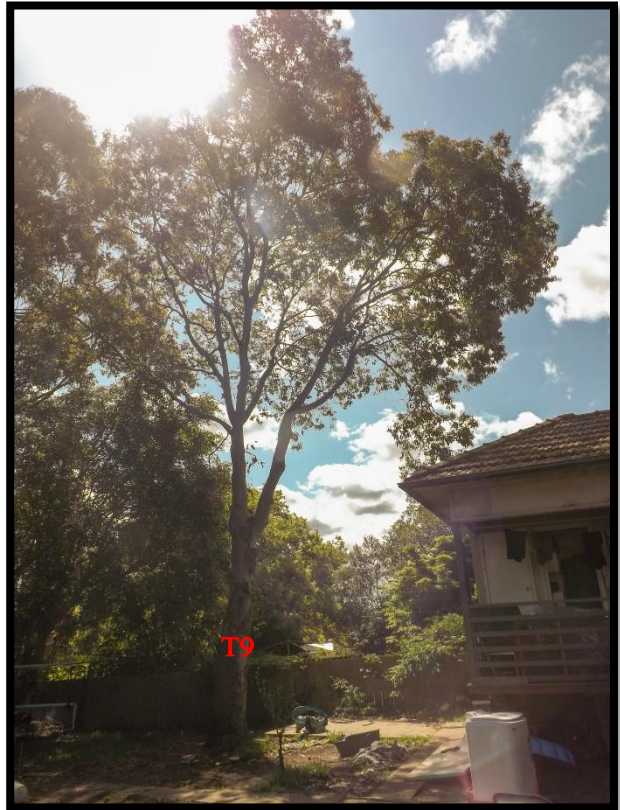
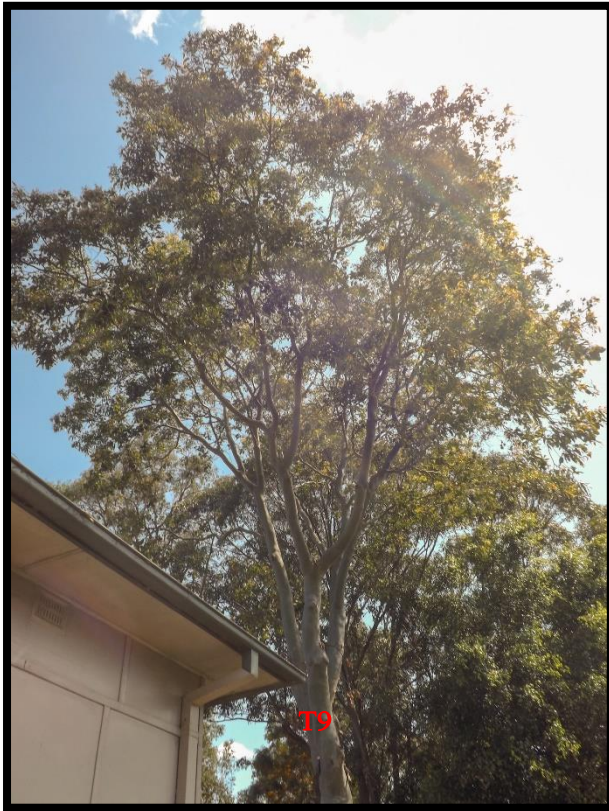
- Good health with a leaf density of 80% coverage and slight deadwood to 50 mm diameter.
- Structurally sound with fair form (co - dominant stems from 4.5 metres high).
- 4.9 metres from wall of dwelling.

Tree 9 viewed from the SE.

Tree 9 viewed from the east.

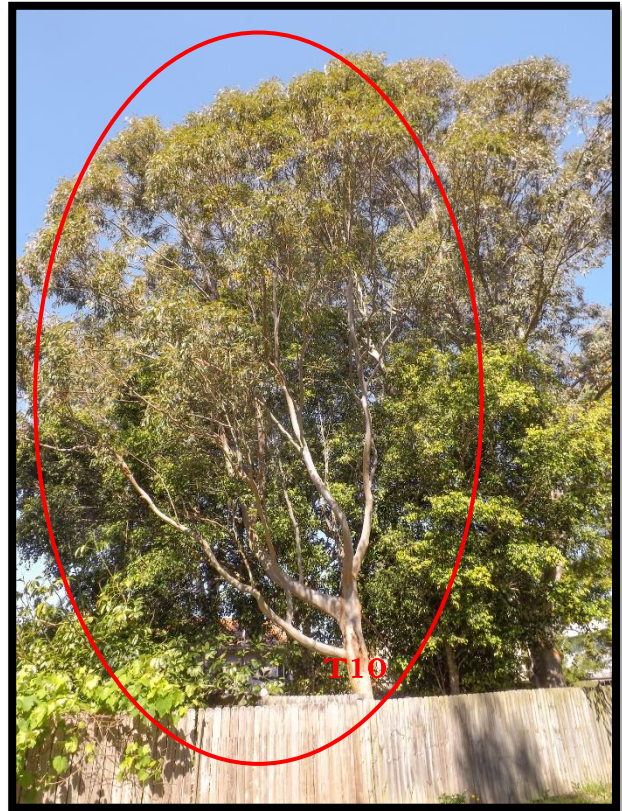
- Good health with a leaf density of 80% coverage and slight deadwood to 100 mm diameter (dead leader).
- Structurally sound with fair form (scaffolds dominant due to dead leader).
- 1.2 metres from back fence.

Tree 10 viewed from the SW.

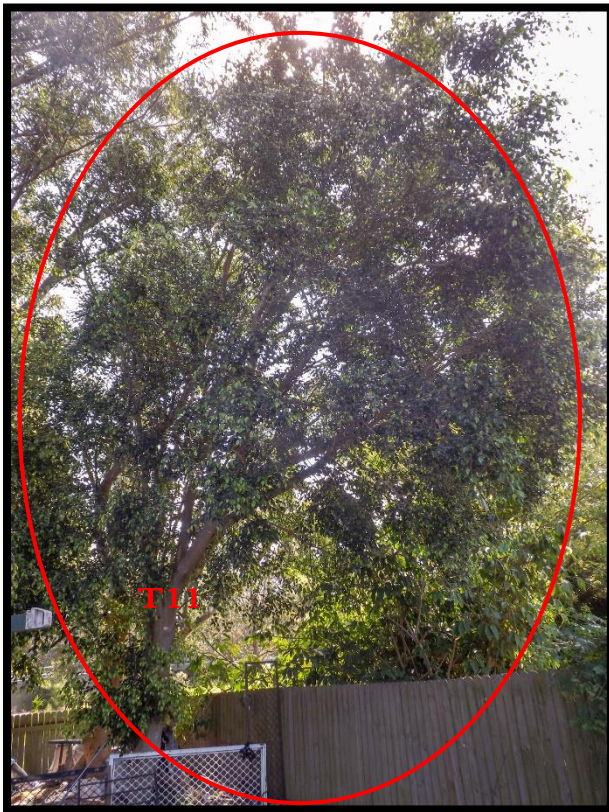
- Good health with a leaf density of 90% coverage and slight deadwood to 20 mm diameter.
- Structurally sound with fair form (co - dominant stems from .5 metres high).
- Likely to cause infrastructure damage over time if retained.

Tree 11 viewed from the SE.

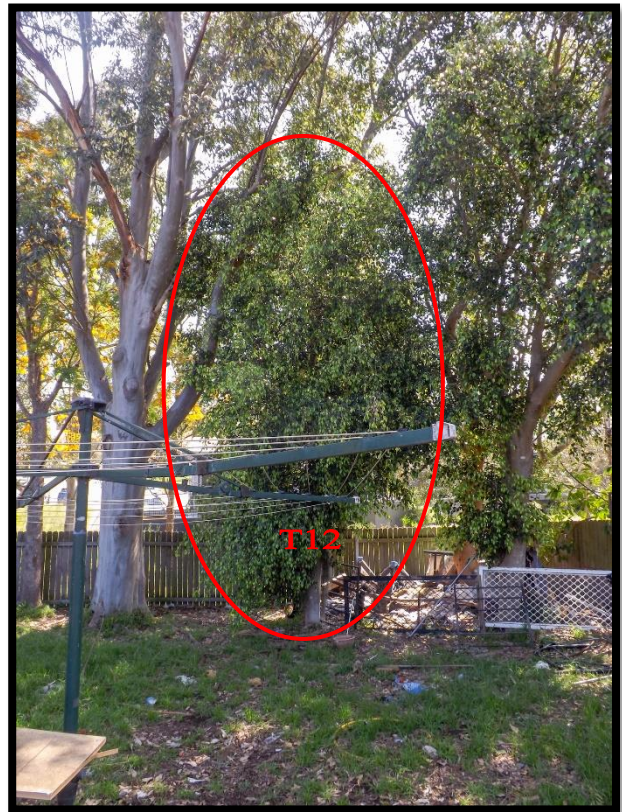
- Good health with a leaf density of 90% coverage and slight deadwood to 20 mm diameter.
- Structurally sound with fair form (co - dominant stems from .5 metres high).
- Likely to cause infrastructure damage over time if retained.

Tree 12 viewed from the east.

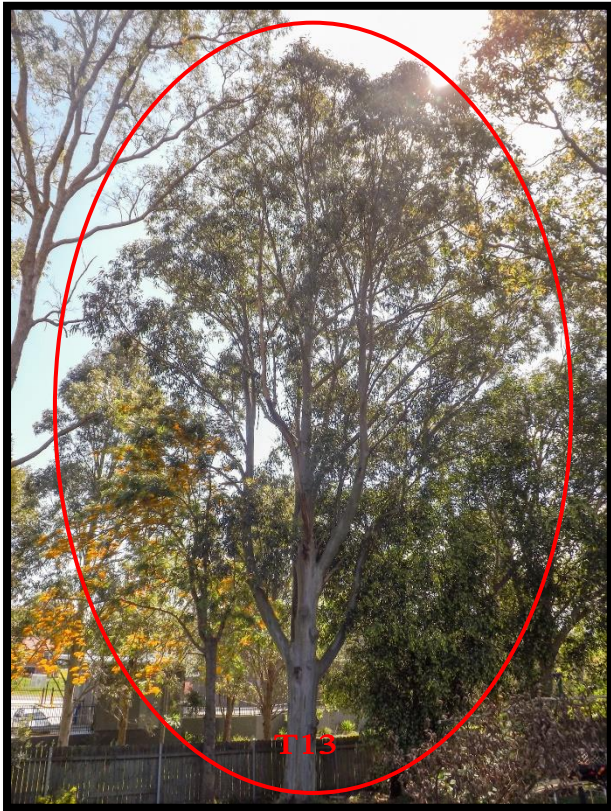
Tree 13 is structurally poor due to the parasitic fungus.

- Fair health (fungal infection) with a leaf density of 80% coverage and some deadwood to 150 mm diameter.
- Structurally poor with a fungal bracket present (fruiting body of *Phellinus* sp).
- Removal recommended (council approval required).

Tree 13 has a wood decay fungi infection *Phellinus* sp., and T14 has a low retention value and is likely to be affected by the removal of T13.

Tree 13 viewed from the east.

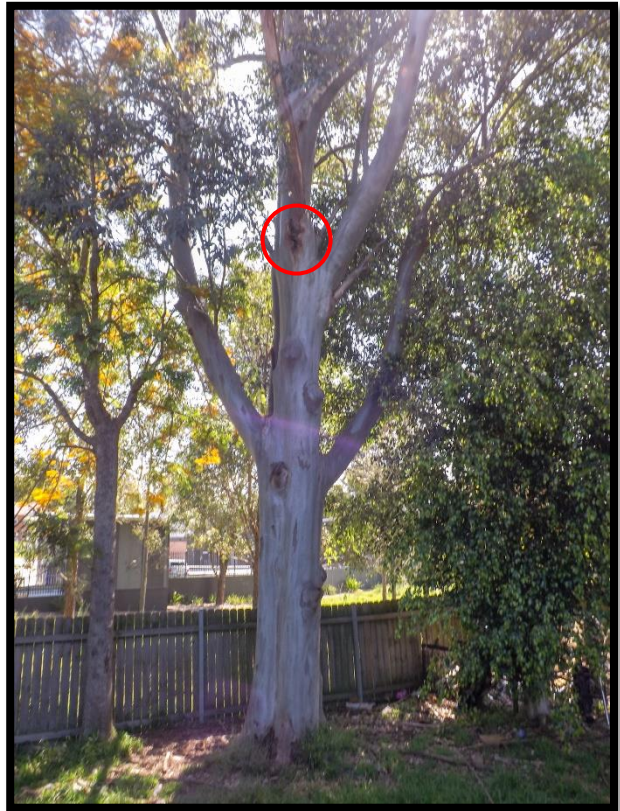
Position of fruiting body on Tree 13.

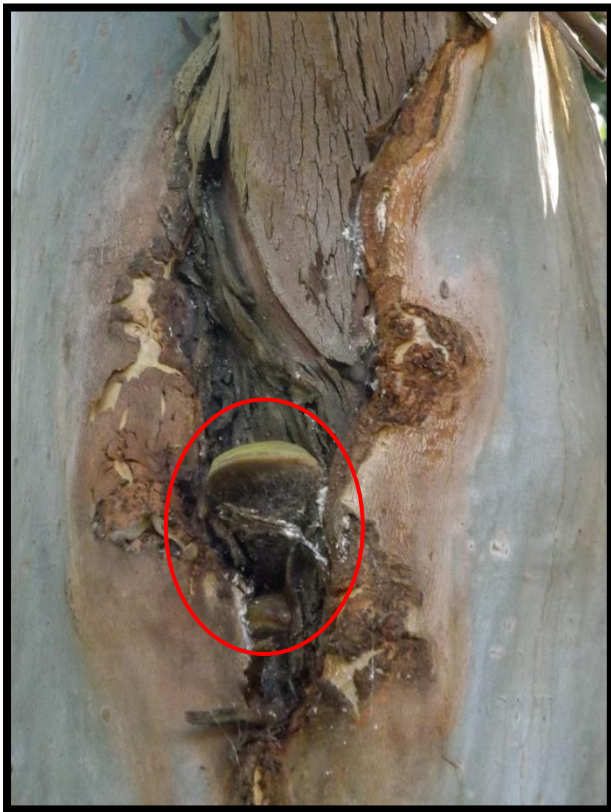
Fruiting body on Tree 13.

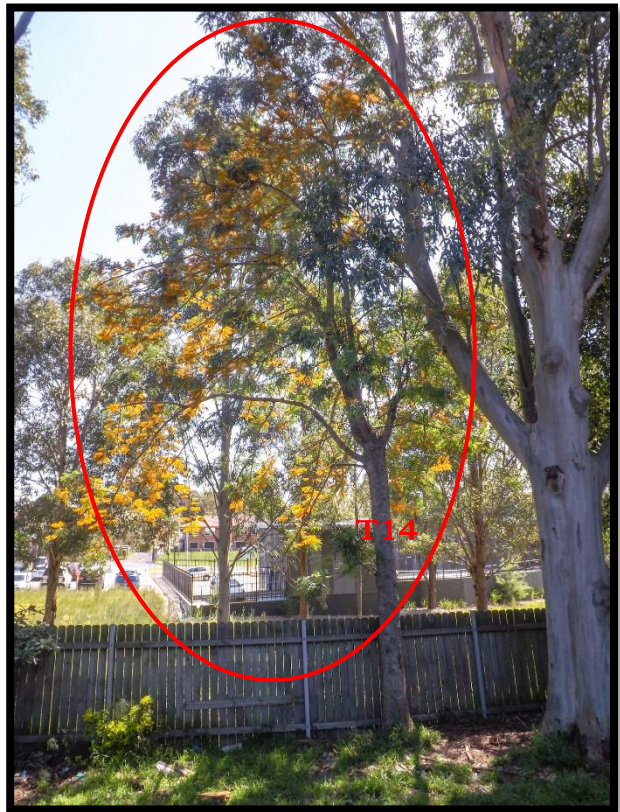
- Good health with a leaf density of 80% coverage and slight deadwood to 20 mm diameter.
- Structurally sound with good form.
- Directly adjacent to the back fence.
- Removal of T13 will likely affect this tree (removal recommended).

Tree 14 viewed from the east.

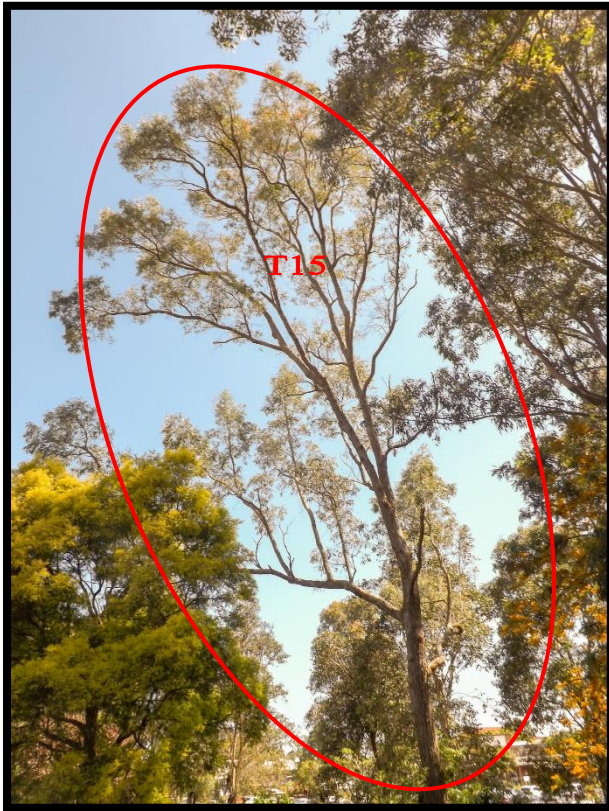
- Good health with a leaf density of 60% coverage and some deadwood to 100 mm diameter and slight tip dieback (tree under some stress).
- Structurally sound with fair form (some stem bow).
- Directly adjacent to the back fence.

Tree 15 viewed from the NE.

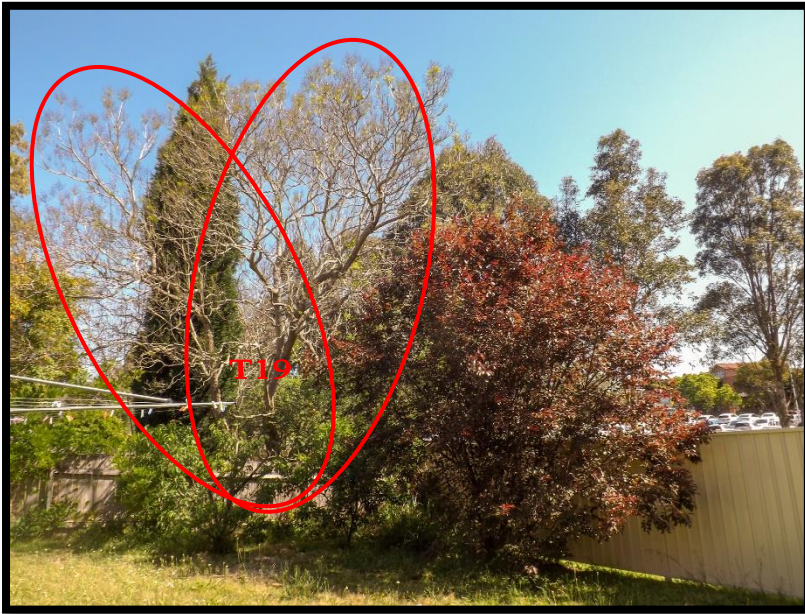
- Good health with a leaf density of 80% coverage and slight deadwood to 50 mm diameter.
- Structurally sound with fair form (three stems from .5 metres high).
- 2.5 metres from the boundary with dwelling number 12.

Tree 19 viewed from the north. The shrub in the foreground is exempt (undersize stems).
