ARBORICULTURAL IMPACT ASSESSMENT

TREE PROTECTION SPECIFICATION

REF: L&Co24004 | 10 March 2025 | v2.4SITE ADDRESS | Cammeray Public SchoolPREPARED FOR | Department of Education (DoE)PREPARED BY |Dr Matthew LaurenceMs Emma ClarkBSc. (Hons)BA (Hons)PhD (Plant Pathology)

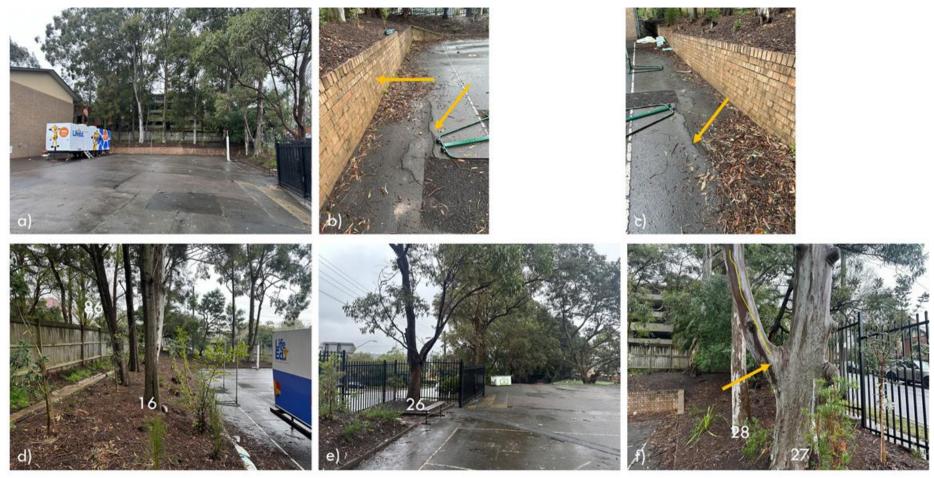
- 4.4.1 Tree 27 was identified as *Eucalyptus saligna* (Sydney Blue Gum) and was allocated a High Landscape Significance Value and a Retention Value of *Priority for Retention*. Tree 27 was assigned a Fair physiological condition due to reduced crown density.
- 4.4.2 The supplied plans show the proposed building extension is within the SRZ of Tree 27. Works within the SRZ represent a *Major Encroachment* as defined by AS-4970 as root severance within the SRZ can lead to the destabilisation of the tree. The overall TPZ encroachment was estimated to be 31.8% and also represents a *Major Encroachment* as defined by AS-4970.
- 4.4.3 There was no existing structure to prevent root growth into the encroachment area and there was evidence of roots growing under the existing asphalt (Appendix 9 Plates). The crown will also be impacted by the

proposal and a large diameter first order branch would need to be removed. Given the size, the pruning wound is unlikely to occlude and would be a source of decay in the future.

a) Showing site of the proposed development. b-c) Showing the existing retaining wall and signs of roots uplifting the asphalt. d) Showing Tree 16. e) Showing Tree 26. f) Showing trees 27 & 28 with the large first order branch that would requiring for building clearance.

- 4.4.4 Given the size and location of the encroachment, the long term structural and physiological viability of Tree
 27 is highly likely to be compromised by the proposed encroachment and the tree will need to be removed to accommodate the works.
- 4.4.5 Removal and replacement with a healthy advanced size specimen would replace the loss of amenity within a medium to long timeframe.
- 4.4.6 Refer to AS4970 and Appendices 5, 6 & 7 for further details.

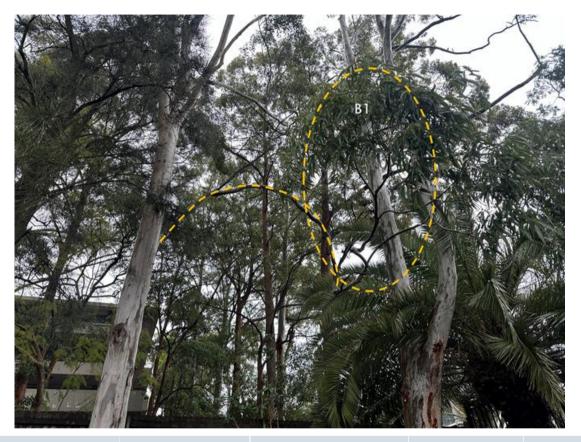
Branch 1 (B1)	50	First	Reduction Pruning (R)	West	4m	1%

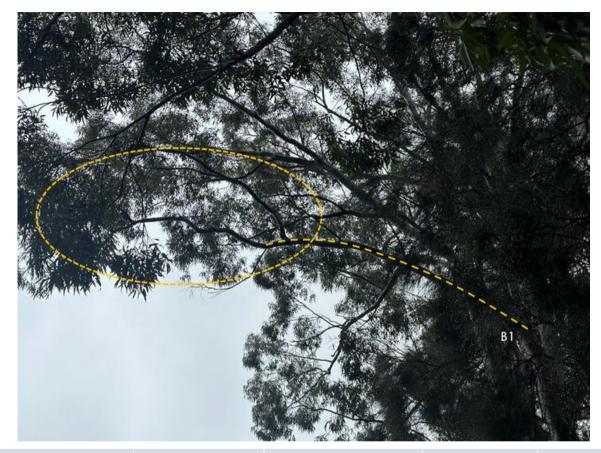
Tree No. 13	BRANCH Ø	BRANCH ORDER	AS4373 CODE	ORIENTATION	HEIGHT ABOVE GRADE (m)	Crown Encroachment (%)
Branch 1 (B1)	75	Third	Reduction Pruning (R)	North	10m	4%

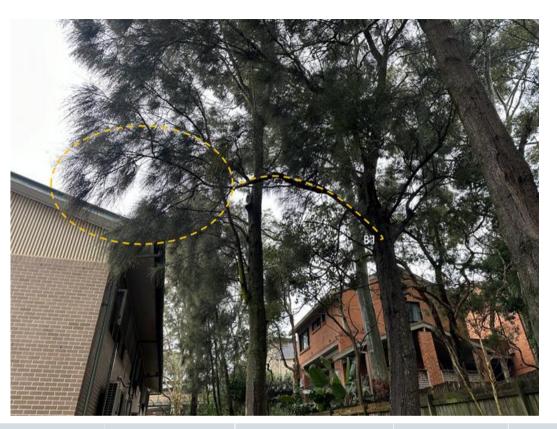
Branch 1 (B1)	50	First	Reduction Pruning (R)	North	3m	4%
