L070 Hazardous Materials Advice, REF6, RPA Hospital Rev A

Hazardous Materials Summary and Advice – REF6, Royal Prince Alfred Hospital Redevelopment, Camperdown, NSW

CPB Contractors Pty Ltd Hazardous Building Materials Survey

Main Works Package, Royal Prince Alfred Hospital Redevelopment Missenden Road, Camperdown, NSW

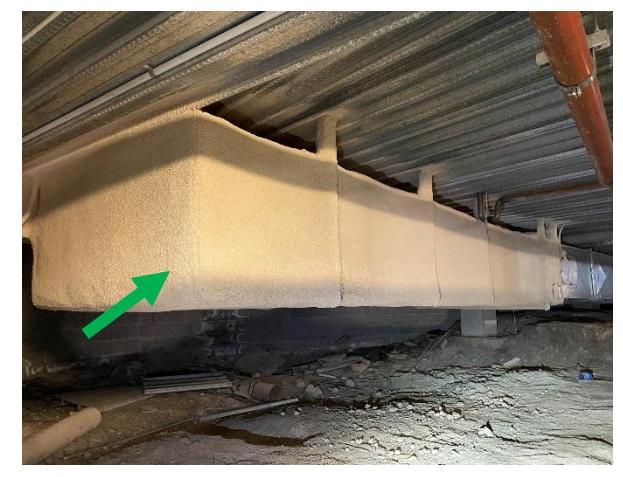
Photo 1: Level 1 – Northeast undercroft, Non-asbestos containing vermiculite fireproofing to ductwork,

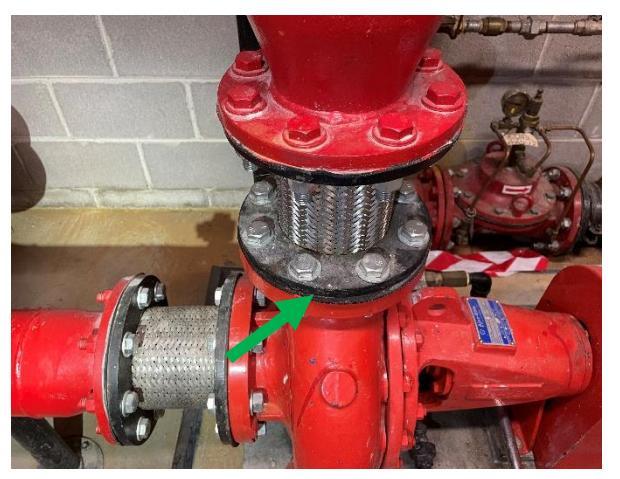
Photo 3: Level 1 – Fire pump room, Non asbestos containing gasket to pipework/pumps

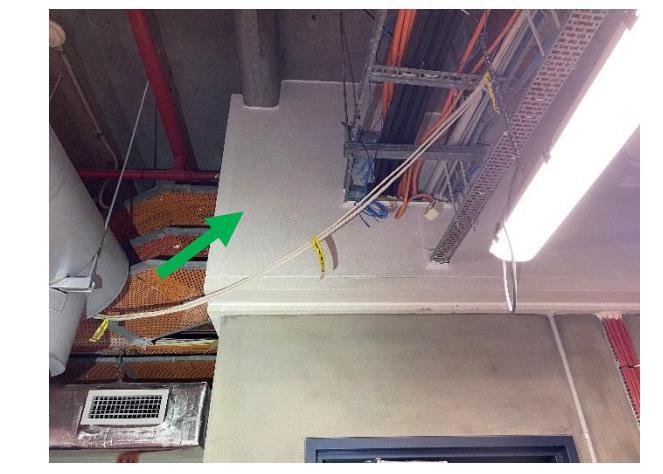
Photo 4: Level 1 – Fire pump room, Non-asbestos containing millboard to the upper north wall

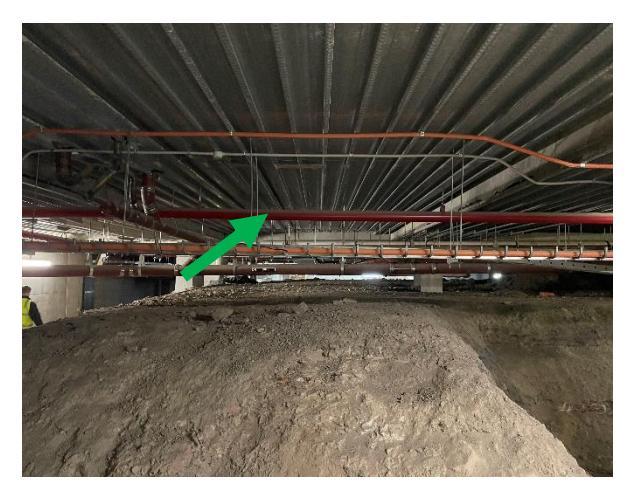
Photo 6: Level 1 – North undercroft, Non-lead based red paint to hydrant pipework

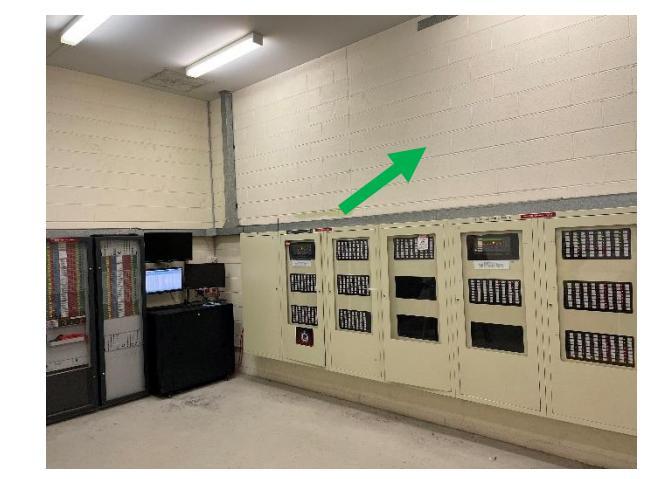
Photo 10: Level 2 - Fire control room, Non-lead based cream paint to walls

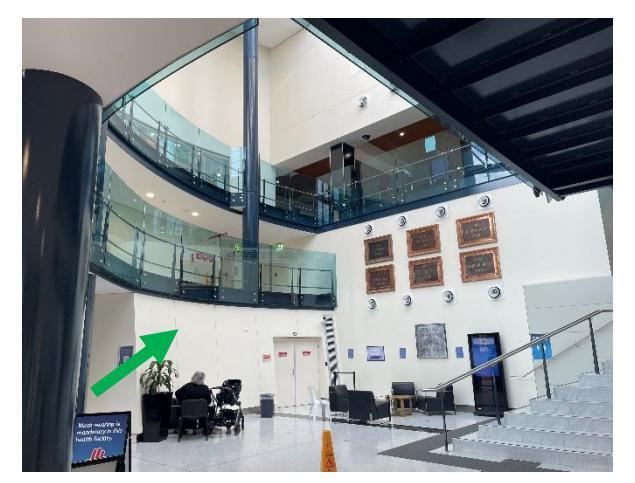
Photo 12: Level 3 – B89 Atrium, Non asbestos containing fibre cement sheeting to wall panels

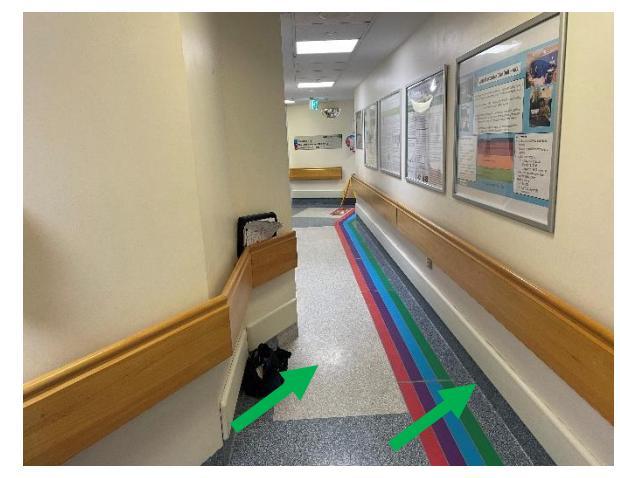
Photo 13: Level 3 – B89, ICU, Non asbestos containing light grey and mottled blue vinyl sheeting to floor

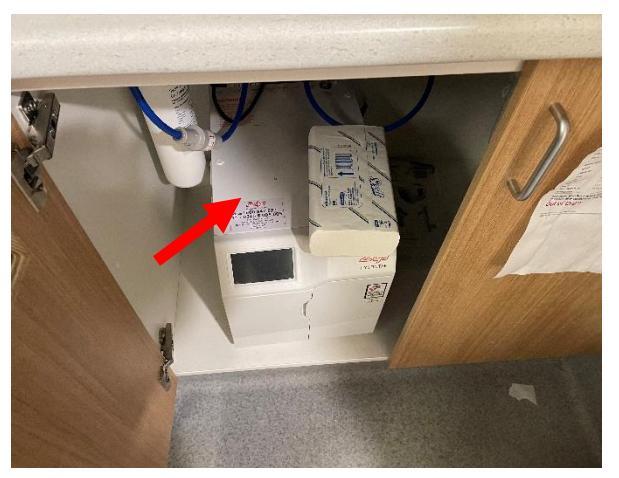
Photo 15: Level 3 – B89, ICU kitchen, Internal SMF insulation to Zip hydrotap

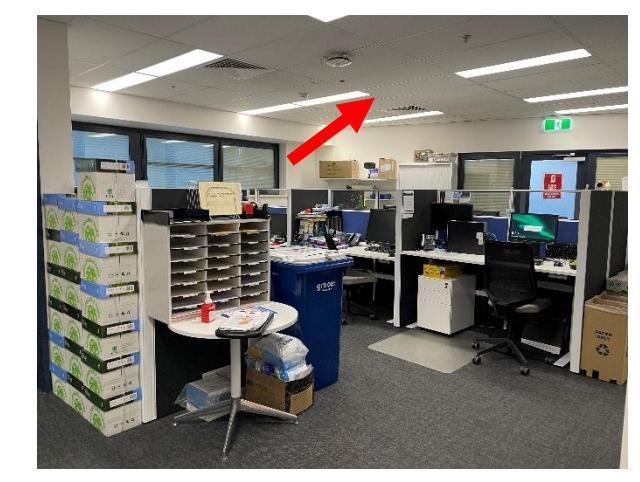
Photo 16: Level 3 – B89, ICU Admin, Assumed SMF insulation to ceiling tiles

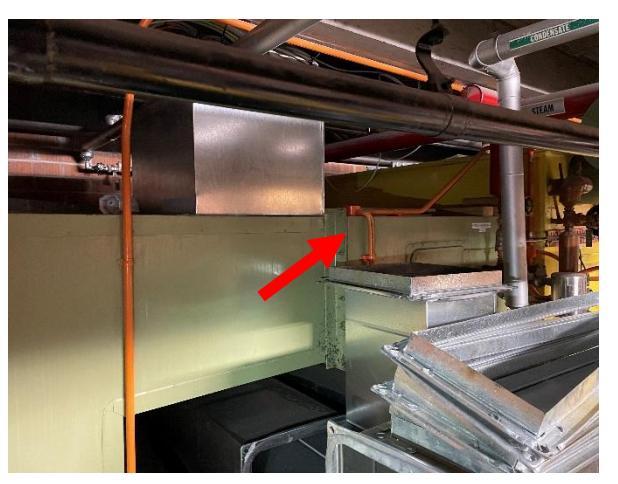
Photo 18: Level 4 - B75 plant room, Asbestos containing mastic to ductwork

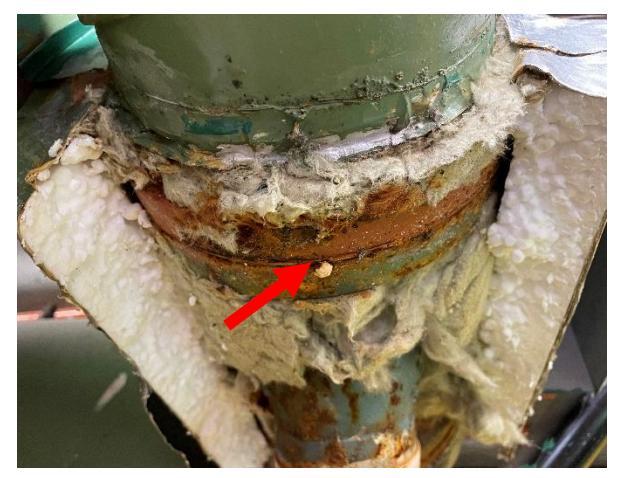
Photo 20: Level 4 - B75 plant room, Asbestos containing gasket to chilled water pipework

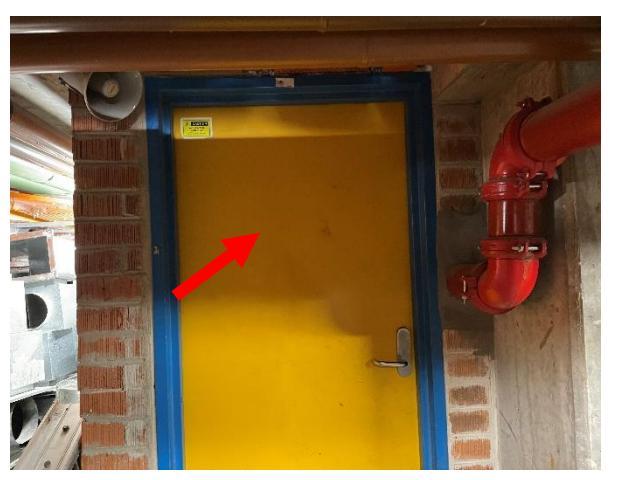
Photo 21: Level 4 – B75 plant room, Asbestos containing millboard core to fire doors

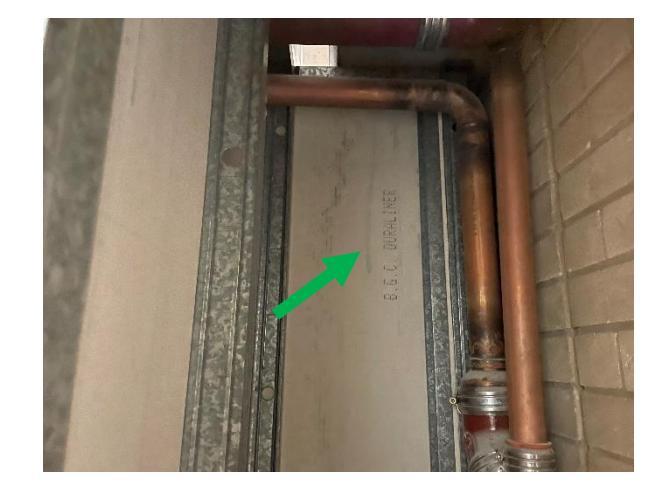
Photo 22: Level 4 - B89 service corridor, Non asbestos containing fibre cement sheeting to riser cabinet

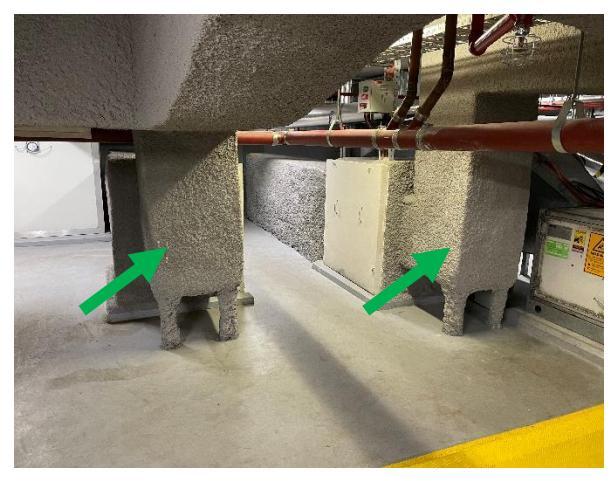
Photo 23: Level 4 - B89 main plant room, Non asbestos containing vermiculite insulation to columns, ceiling and ducting

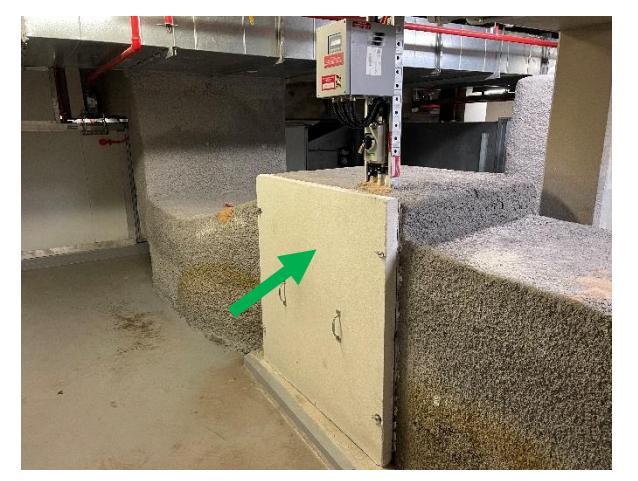
Photo 24: Level 4 - B89 main plant room, Non asbestos containing millboard insulation

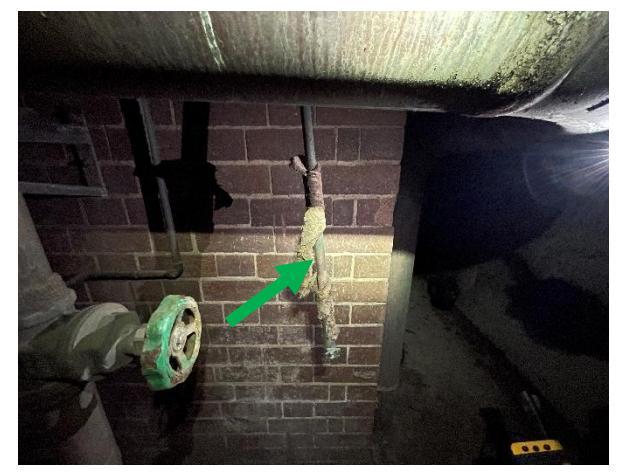
Photo 25: Level – B75 main plant room, Non asbestos containing hessian within air flow unit

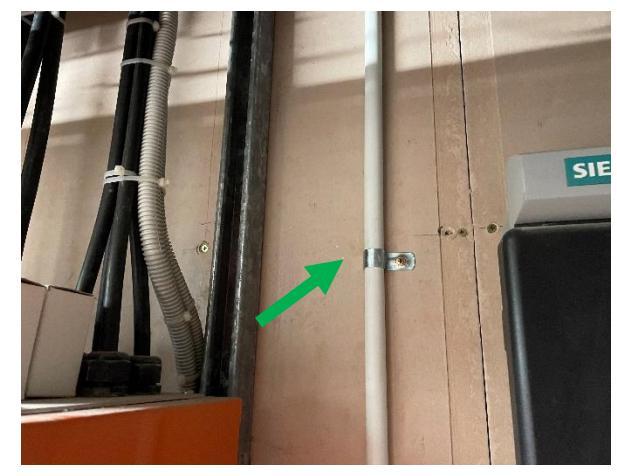
Photo 26: Level 4 – B89 south plant room, Non asbestos containing fibre cement sheeting to the north wall

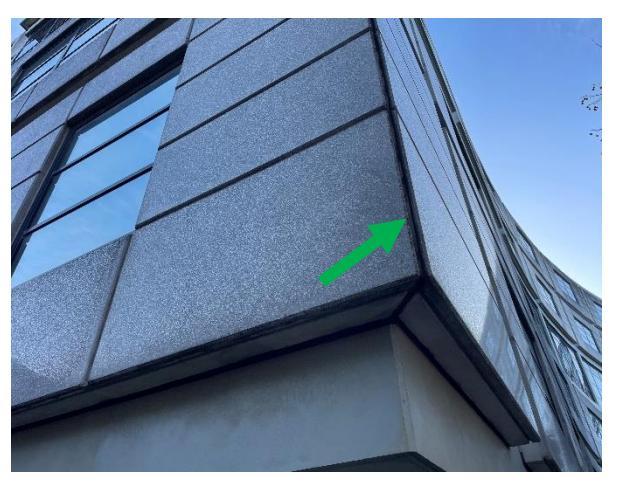
Photo 27: Level 4 - Non asbestos containing cream and black mastic to the external façade panels

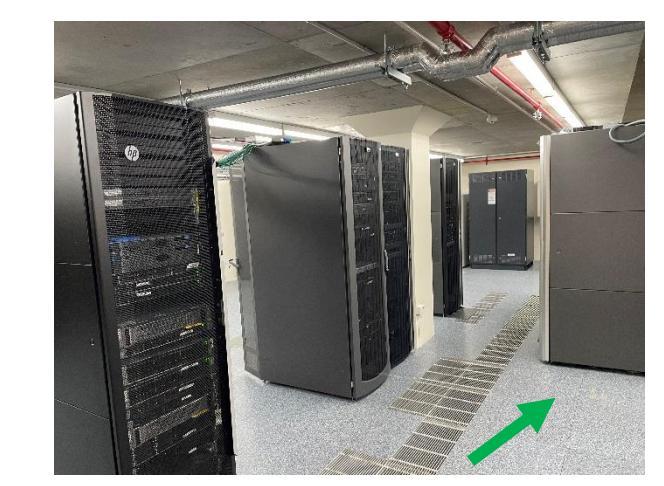
Photo 28: Level 4 – B89, Digital, Health and Innovation, Non asbestos containing blue vinyl floor to the server room

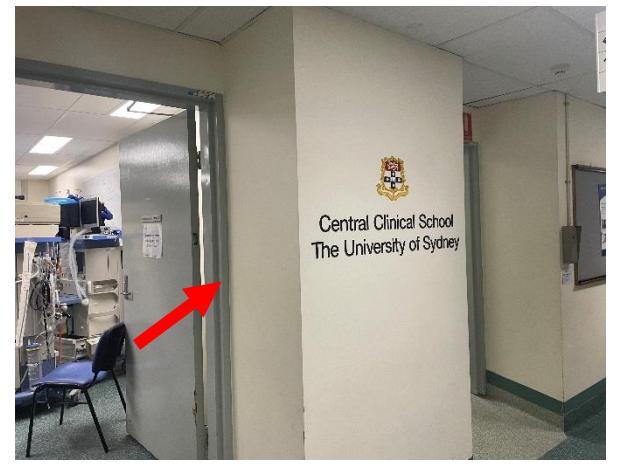
Photo 30: Level 4 – B63, Lead based green paint to door frames and pillars

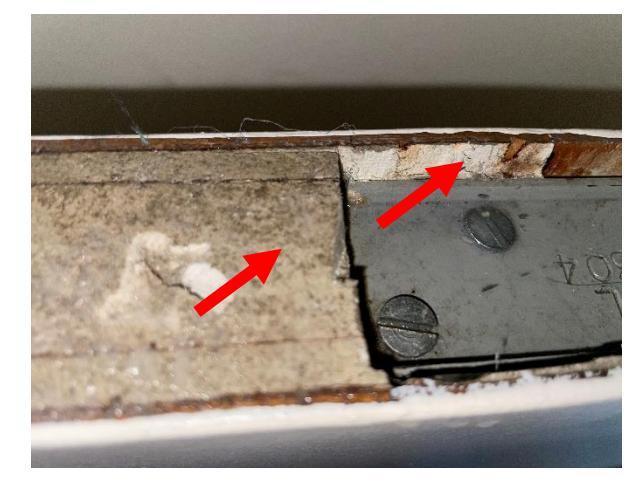
Photo 34: Level 5 – B75 Radiology, main corridor, Asbestos containing internal millboard to the double fire doors

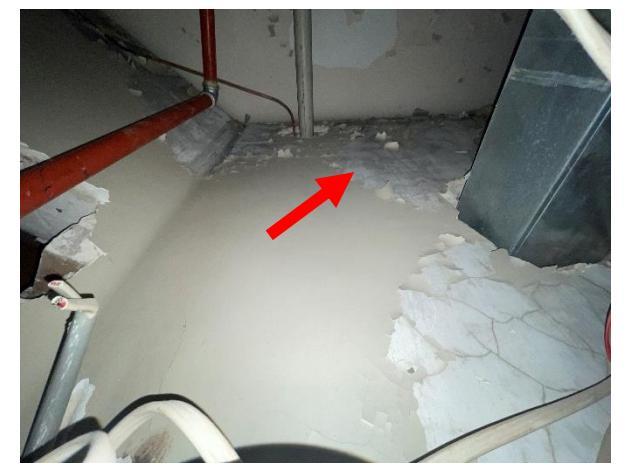
Photo 36: Level 5 – B63 Emergency Department – Lead based cream/olive paint to the riser walls in ceiling cavity

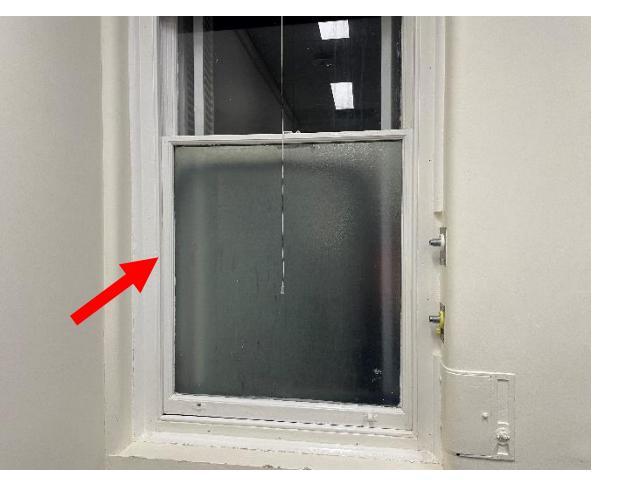
Photo 39: Level 5 - B63 Emergency Department, Lead based white paint to the timber windows

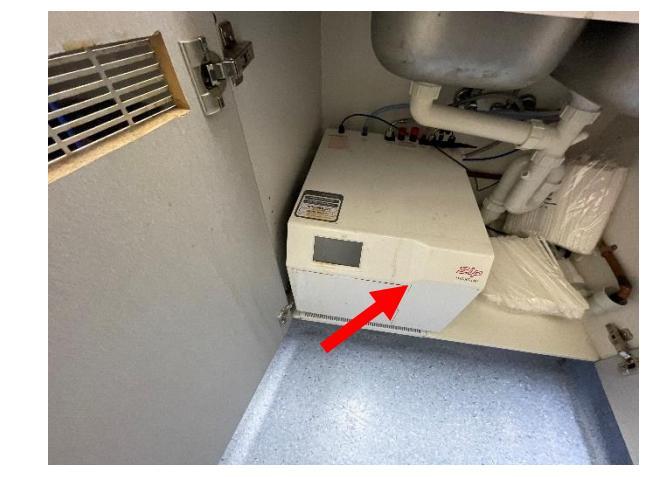
Photo 40: Level 5 – Assumed SMF internal insulation to the hot water unit's throughout

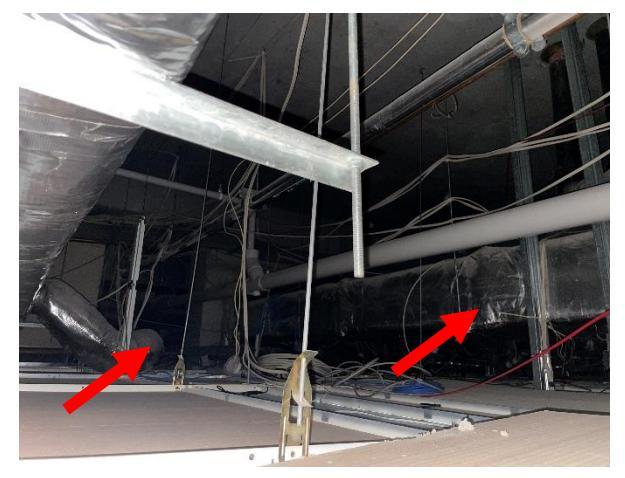
Photo 42: Level 5 - Assumed SMF insulation to the flexible air con ducting and pipework

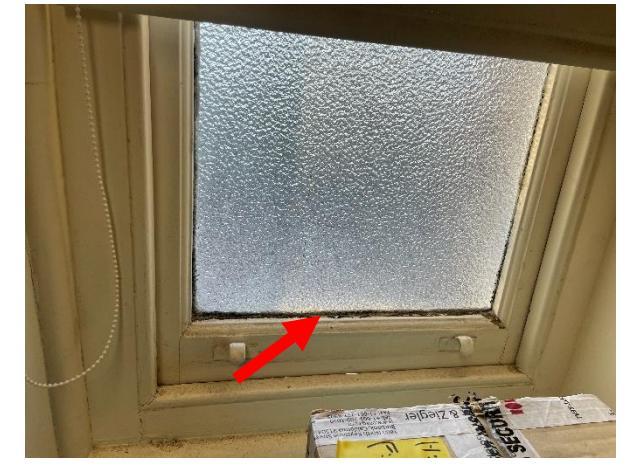
Photo 43: Level 6 – B63 Nuclear Medicine, Asbestos containing mastic to the timber windows in the small laboratory store room

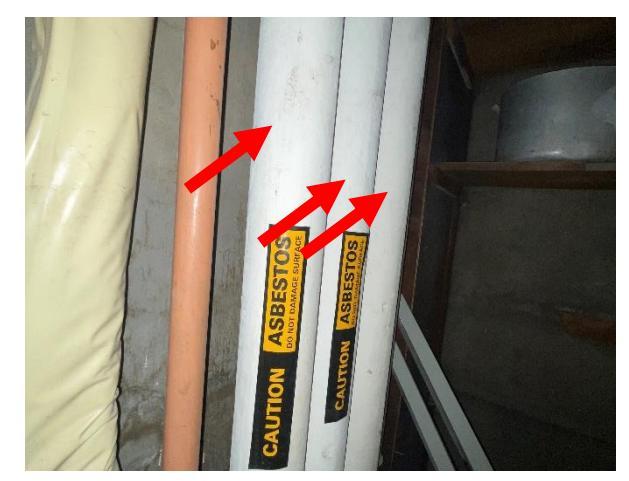
- Non-asbestos containing vermiculite insulation (L6-A16) was identified to the AHUs throughout plant room in B63;
- It is noted that assumed asbestos containing lagged pipework was identified within a storeroom adjacent to but outside of the Nuclear Medicine assessment area in B63. These assumed asbestos lagged pipes were observed to extend into Level 7 above and Level 5 below, however, were unable to be located on these levels. There is the potential for additional asbestos lagged pipework to be concealed within the assessment areas located across B63;

Photo 44: Level 6 – B63 store room adjacent Nuclear Medicine, Assumed asbestos containing lagged pipework

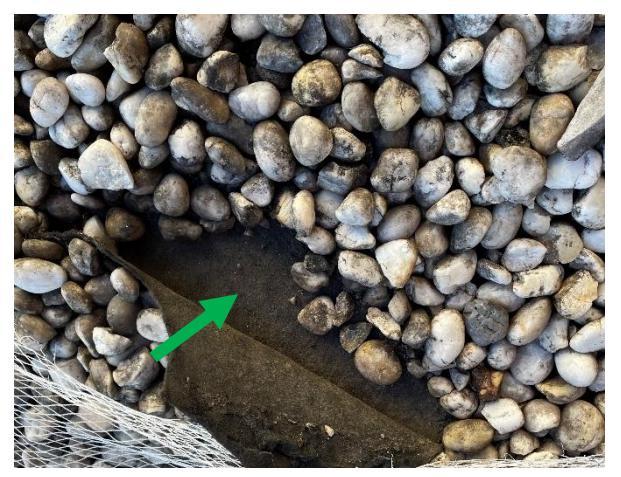
Photo 45: Level 6 – B89 Roof – Non-asbestos containing felt membrane beneath pebbles

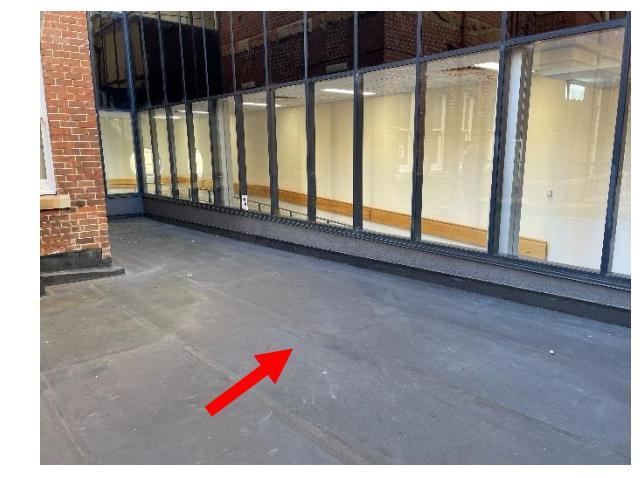
Photo 46: Level 6 – B63/B64 West Roof – Asbestos containing bituminous waterproofing membrane underlying the surface non asbestos containing bituminous membrane

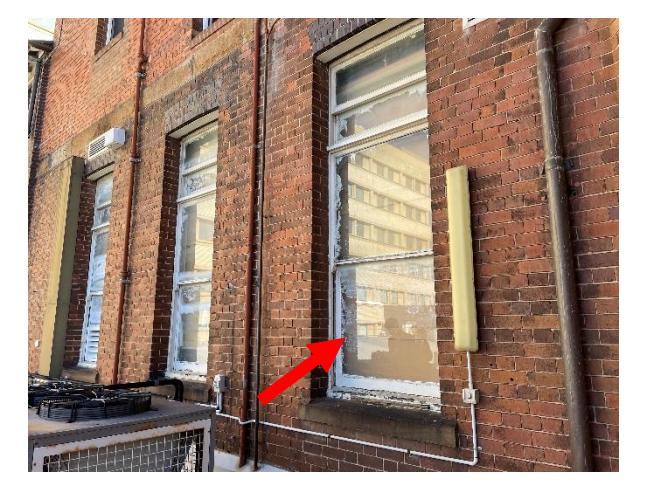
Photo 48: Level 6 – B63, Lead based white paint to the external timber windows

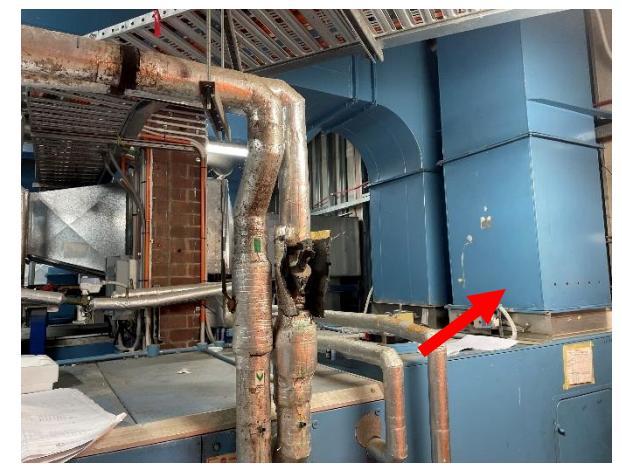
Photo 49: Level 6 - B63 Mechanical Plant Room, Lead based blue paint to the AHUs and ductwork

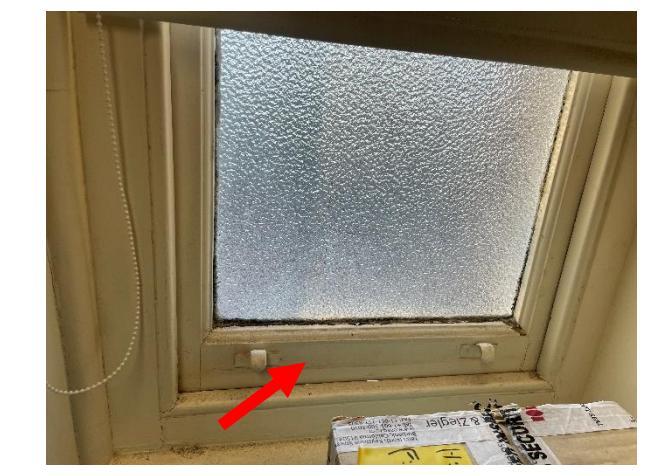
Photo 52: Level 6 - B63 Nuclear Medicine, Lead based white paint to the internal timber windows

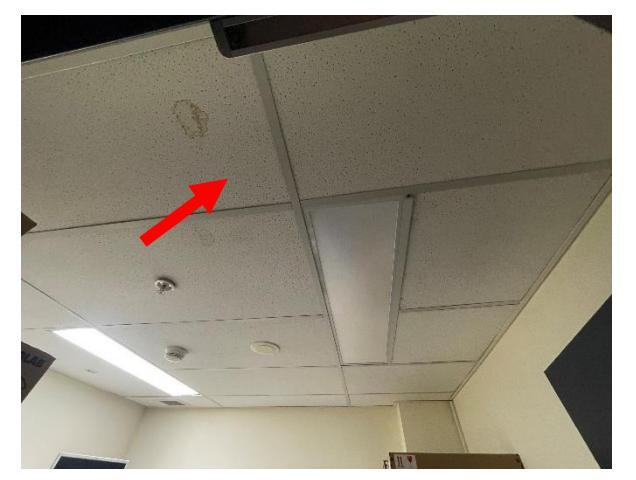
Photo 54: Level 6 - Assumed SMF internal insulation to the ceiling tiles throughout

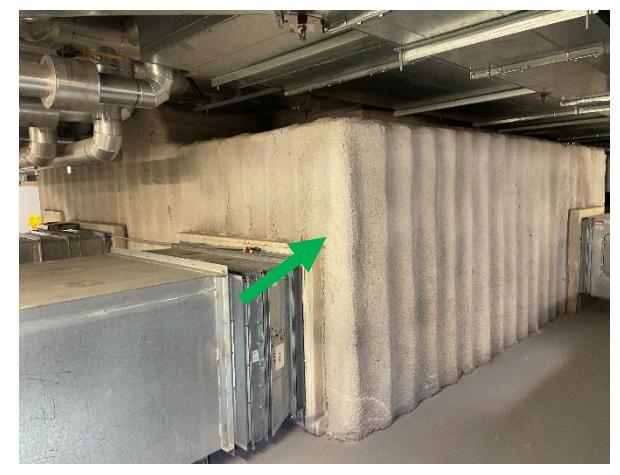
Photo 55: Level 7 – Plant Room, Non asbestos containing vermiculite insulation

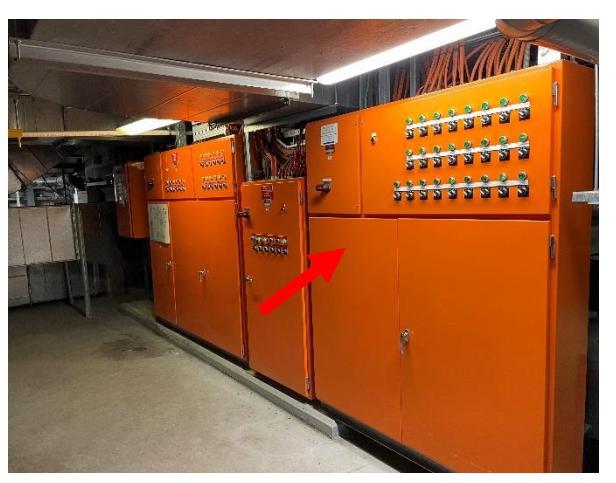
Photo 57: Level 7 – Plant Room, Lead based orange paint to the electrical cabinets

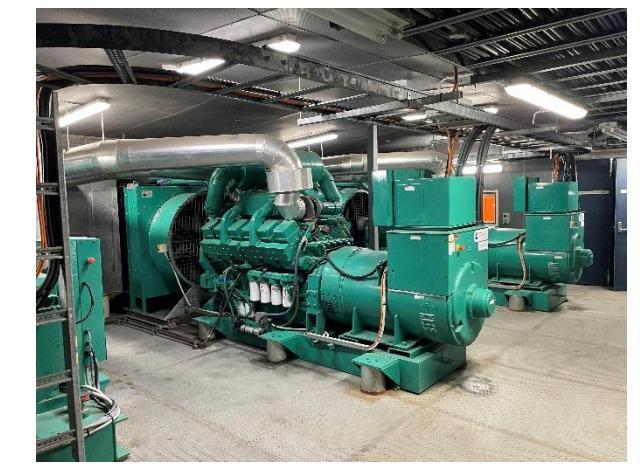
Photo 58: Level 7 - Plant Room, - Lead based green paint to the generators

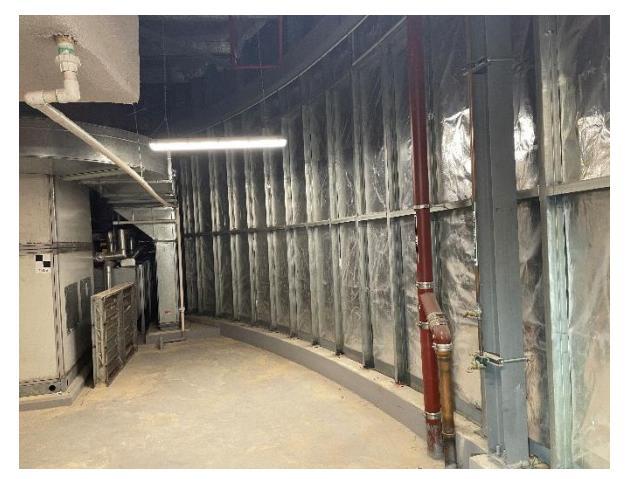
Photo 60: Level 7 - Assumed SMF insulation sarking to the roof and walls

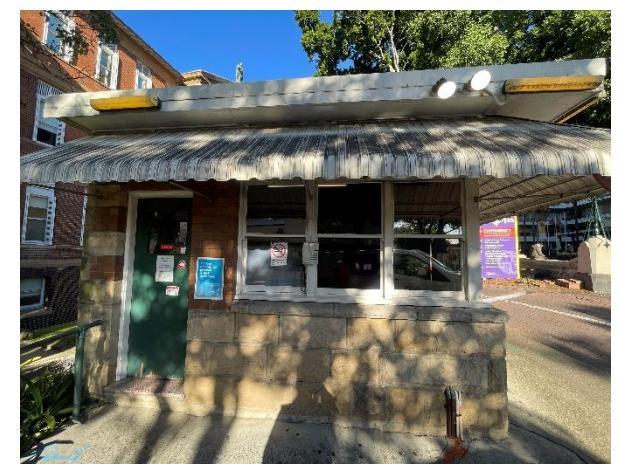
Photo 61: Gate House Overview

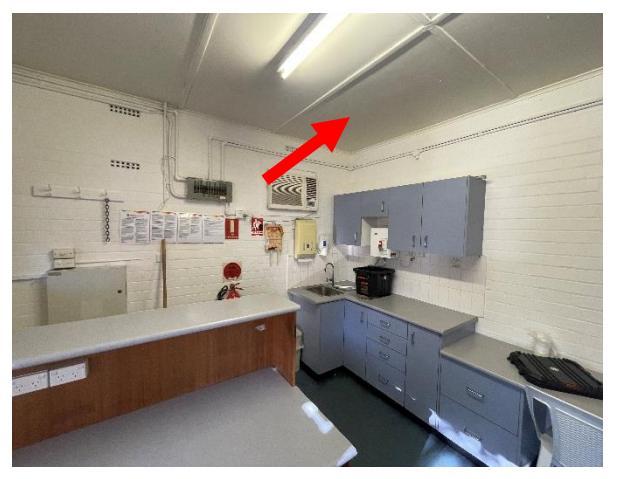
Photo 63: Gate House – Asbestos containing fibre cement sheeting to the ceiling
