New High School for Leppington and Denham Court – Hazardous Building Materials Survey

NSW Department of Education

JBS&G 67606 | 163,954 Rev 1 13 January 2025

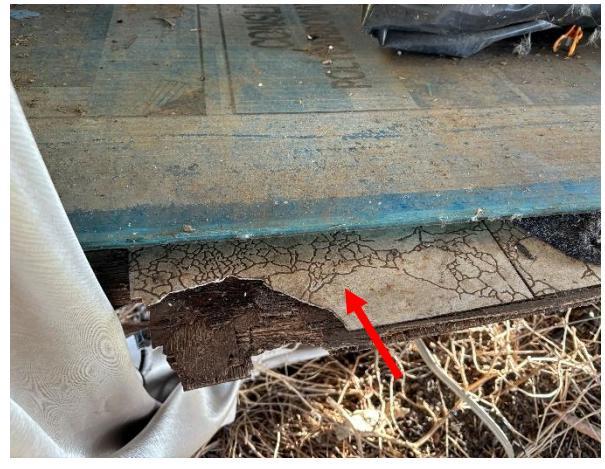
Photo 2: Caravan - asbestos containing vinyl floor tiles to the floor

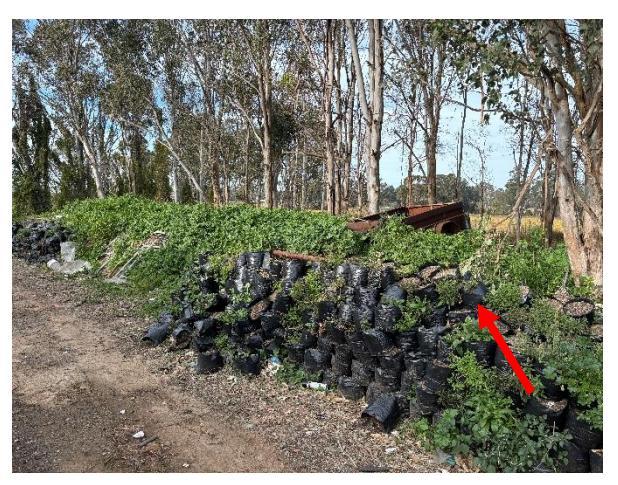
Photo 3: Large stockpile adjacent driveway (south) – asbestos containing fibre cement debris ident
6ified within stockpiled material

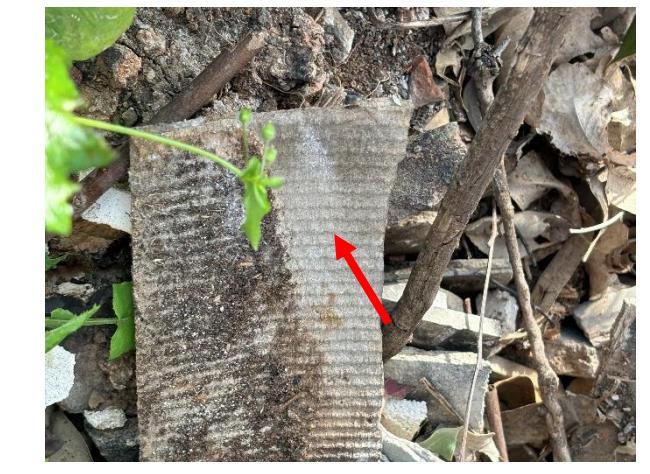
Photo 4: Large stockpile (south) – asbestos containing fibre cement sheeting debris within stockpiled material

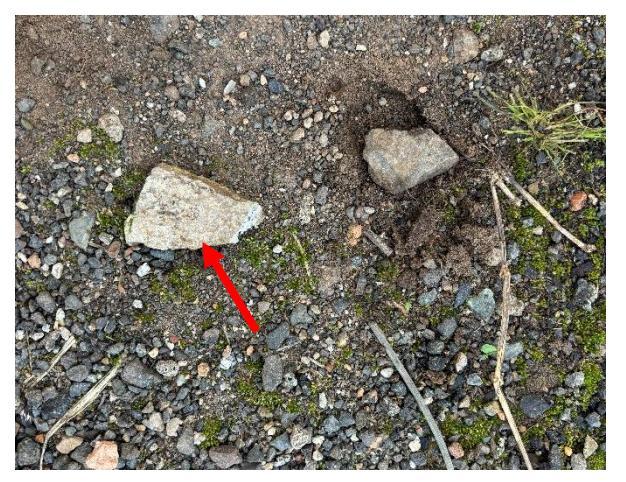
Photo 6: Chicken coops (central) – asbestos containing fragment identified to the ground surface

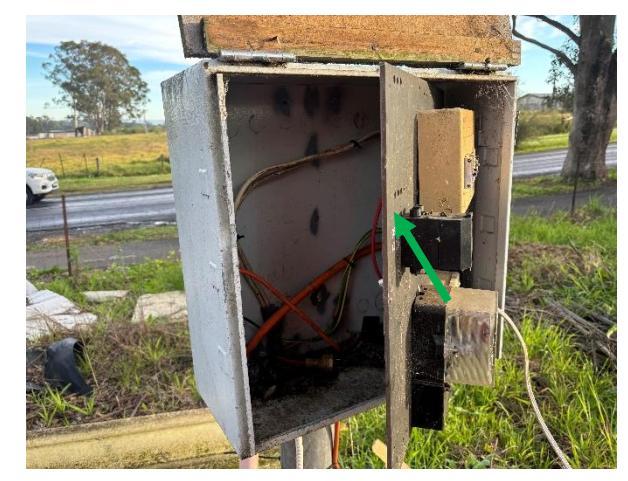
Photo 7: Non-asbestos containing compressed fibre cement backing board

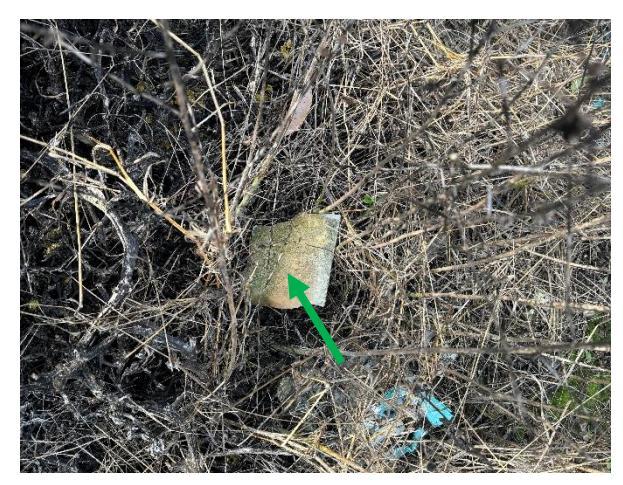
Photo 8: Non-asbestos containing fibre cement sheeting debris to ground surface adjacent south fence line

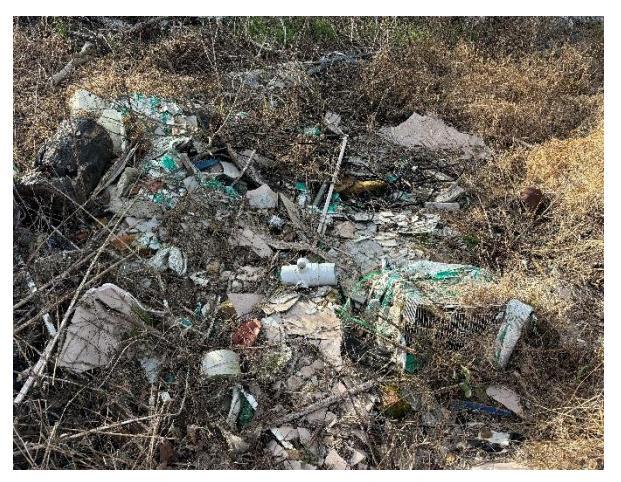
Photo 9: Ground surface adjacent the large shed (south) – non-asbestos containing fibre cement sheeting

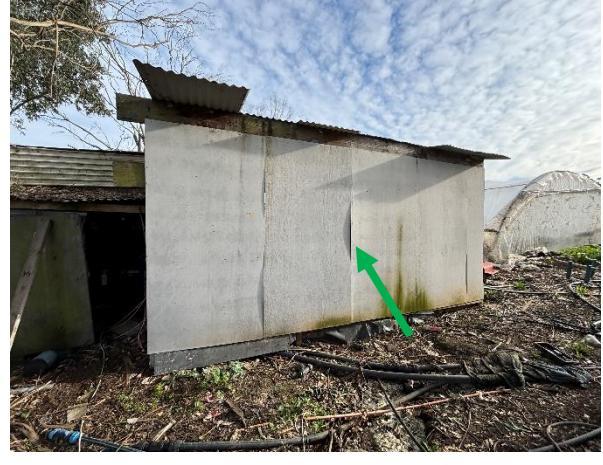
Photo 11: Large Shed Area - Non-asbestos containing fibre cement sheeting to the wall panels

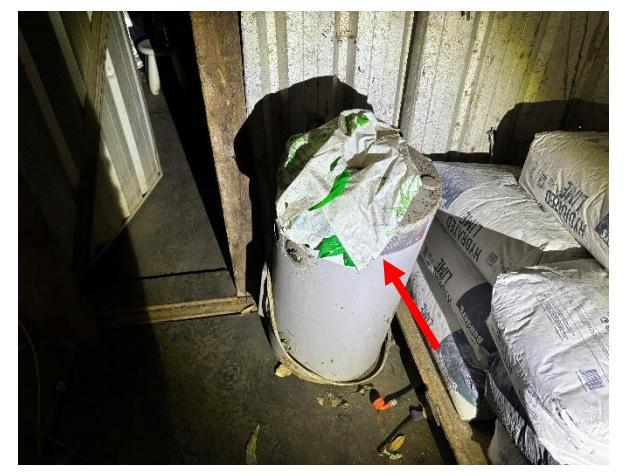
Photo 12: Assumed SMF internal insulation to HWU

All synthetic mineral fibres encountered during this inspection were generally contained and deemed to be low risk. These SMF materials can be removed with the building and demolition waste with care taken not to generate fibres. Appropriate PPE is to be worn including the use of P2 respirator as minimum and appropriate removal methodology as outlined in [NOHSC: 1004(1990)] and [NOHSC: 2006(1990)].

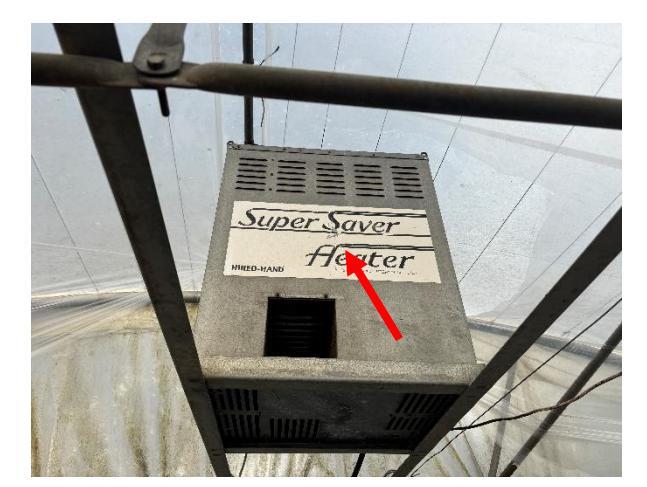
Photo 13: Enclosed Green Houses – Assumed SMF internal insulation to the heaters
