# Astrea

Part 1 – Desktop Analysis Review for Vincentia High SchoolPrepared for:(Commercial in Confidence)

Project Name	SINSW Due Diligence – Vincentia HS
Report Title	Survey Report
File Name	Land Survey DD – Vincentia – 8593 - Astrea – DDW005391/23

School Name	Vincentia High School	Consultancy Name	Astrea Pty Ltd
School ID Number	8593	Report Status	Final
School Address	142 The Wool Road, Vincentia.	Report Date:	15.12.2023
School Region	Southern NSW	Contract Number:	DDW005391/23

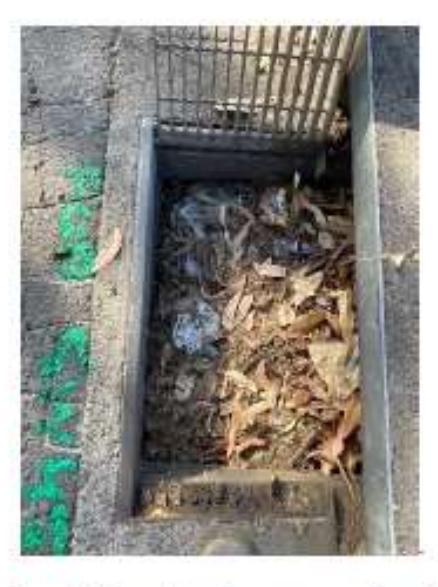
There are some instances onsite where a pipe network could not be determined due to features blocked pipes, pits full of debris, buried pits or junction chambers or non-present junction chambers. See (image 2) below.

Image 2 – SW Pit 45, unable to visually inspect and measure pipes. Pit has substantial debris. Pit has been joined into the network to quality level C specification.

Astrea can make recommendations on alternative methods such as CCTV or jetting of blockages that may assist in confirming these networks. (UTO) unable to open – Where possible technicians open pits using best industry practice however in some instances there were pits that cannot be opened without specialised mechanical lifting or casing unnecessary damage to existing areas. (Image 3) below is an example pit that could not be opened during routine investigations.

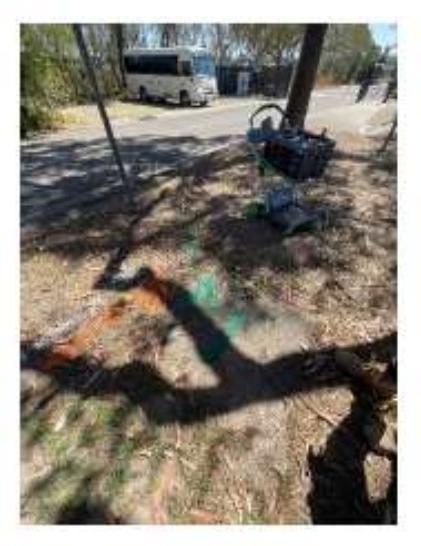
Image 3 – SW32, Stormwater pit cover has no lifting points and cannot be manually lifted by a twoperson team.

Pit Asset	Limitation	Comment	Recommendation
UP04	Safety – Confined Space Full of Debris	Large retention pit – unknow functionality – The pit is full of debris and needs a confined space setup to investigate further	Confined space setup and pit clean out, Potential robotic CCTV inspection
SEW02	Incomplete trace downstream outlet	A trace rod has been inserted into the downstream outlet; this has become stuck along the alignment – due depth of the pit	Robotic CCTV camera/trace
SW04	Incomplete trace to next downstream Pit/outfall	A trace rod has been inserted into the downstream outlet. This has become stuck along the alignment	Robotic CCTV camera/Trace
SW32	UTO - Unable to open pit	The pit Lid does not have any lifting points and is too heavy to manure otherwise	Install lifting points or mechanical lift

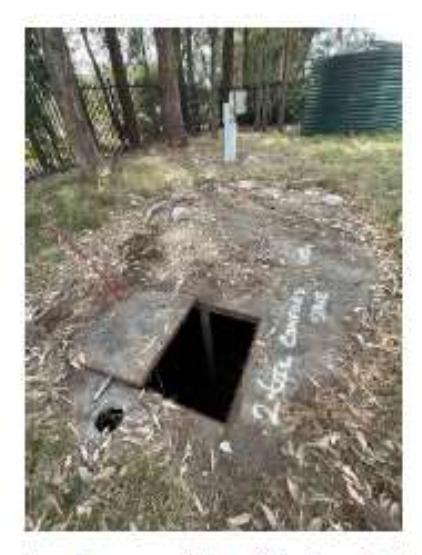
Image 4 – UP04 Large retention chamber cannot be safely investigated without confined space setup. Locked Pits – Some pits have been locked by service authorities – These may require service representatives to provide access/or attend site.

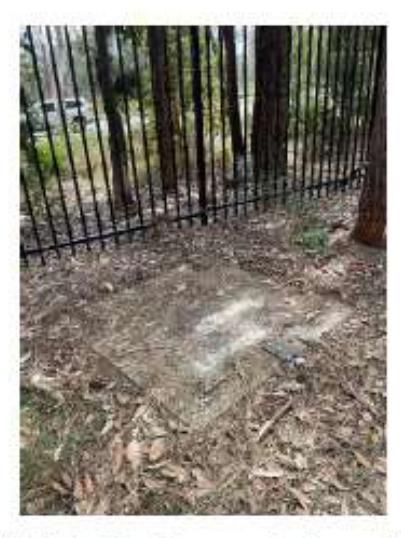
Image 5 – Sewer Rising Main pit locked – Shoalhaven water to provide access if internal information is required.
