Arboricultural Impact Assessment

<u>Site Address</u>: Sutherland Primary School, 38-54 Eton St. Sutherland NSW

Client: NSW Department of Education

Date Prepared: 23rd January 2025

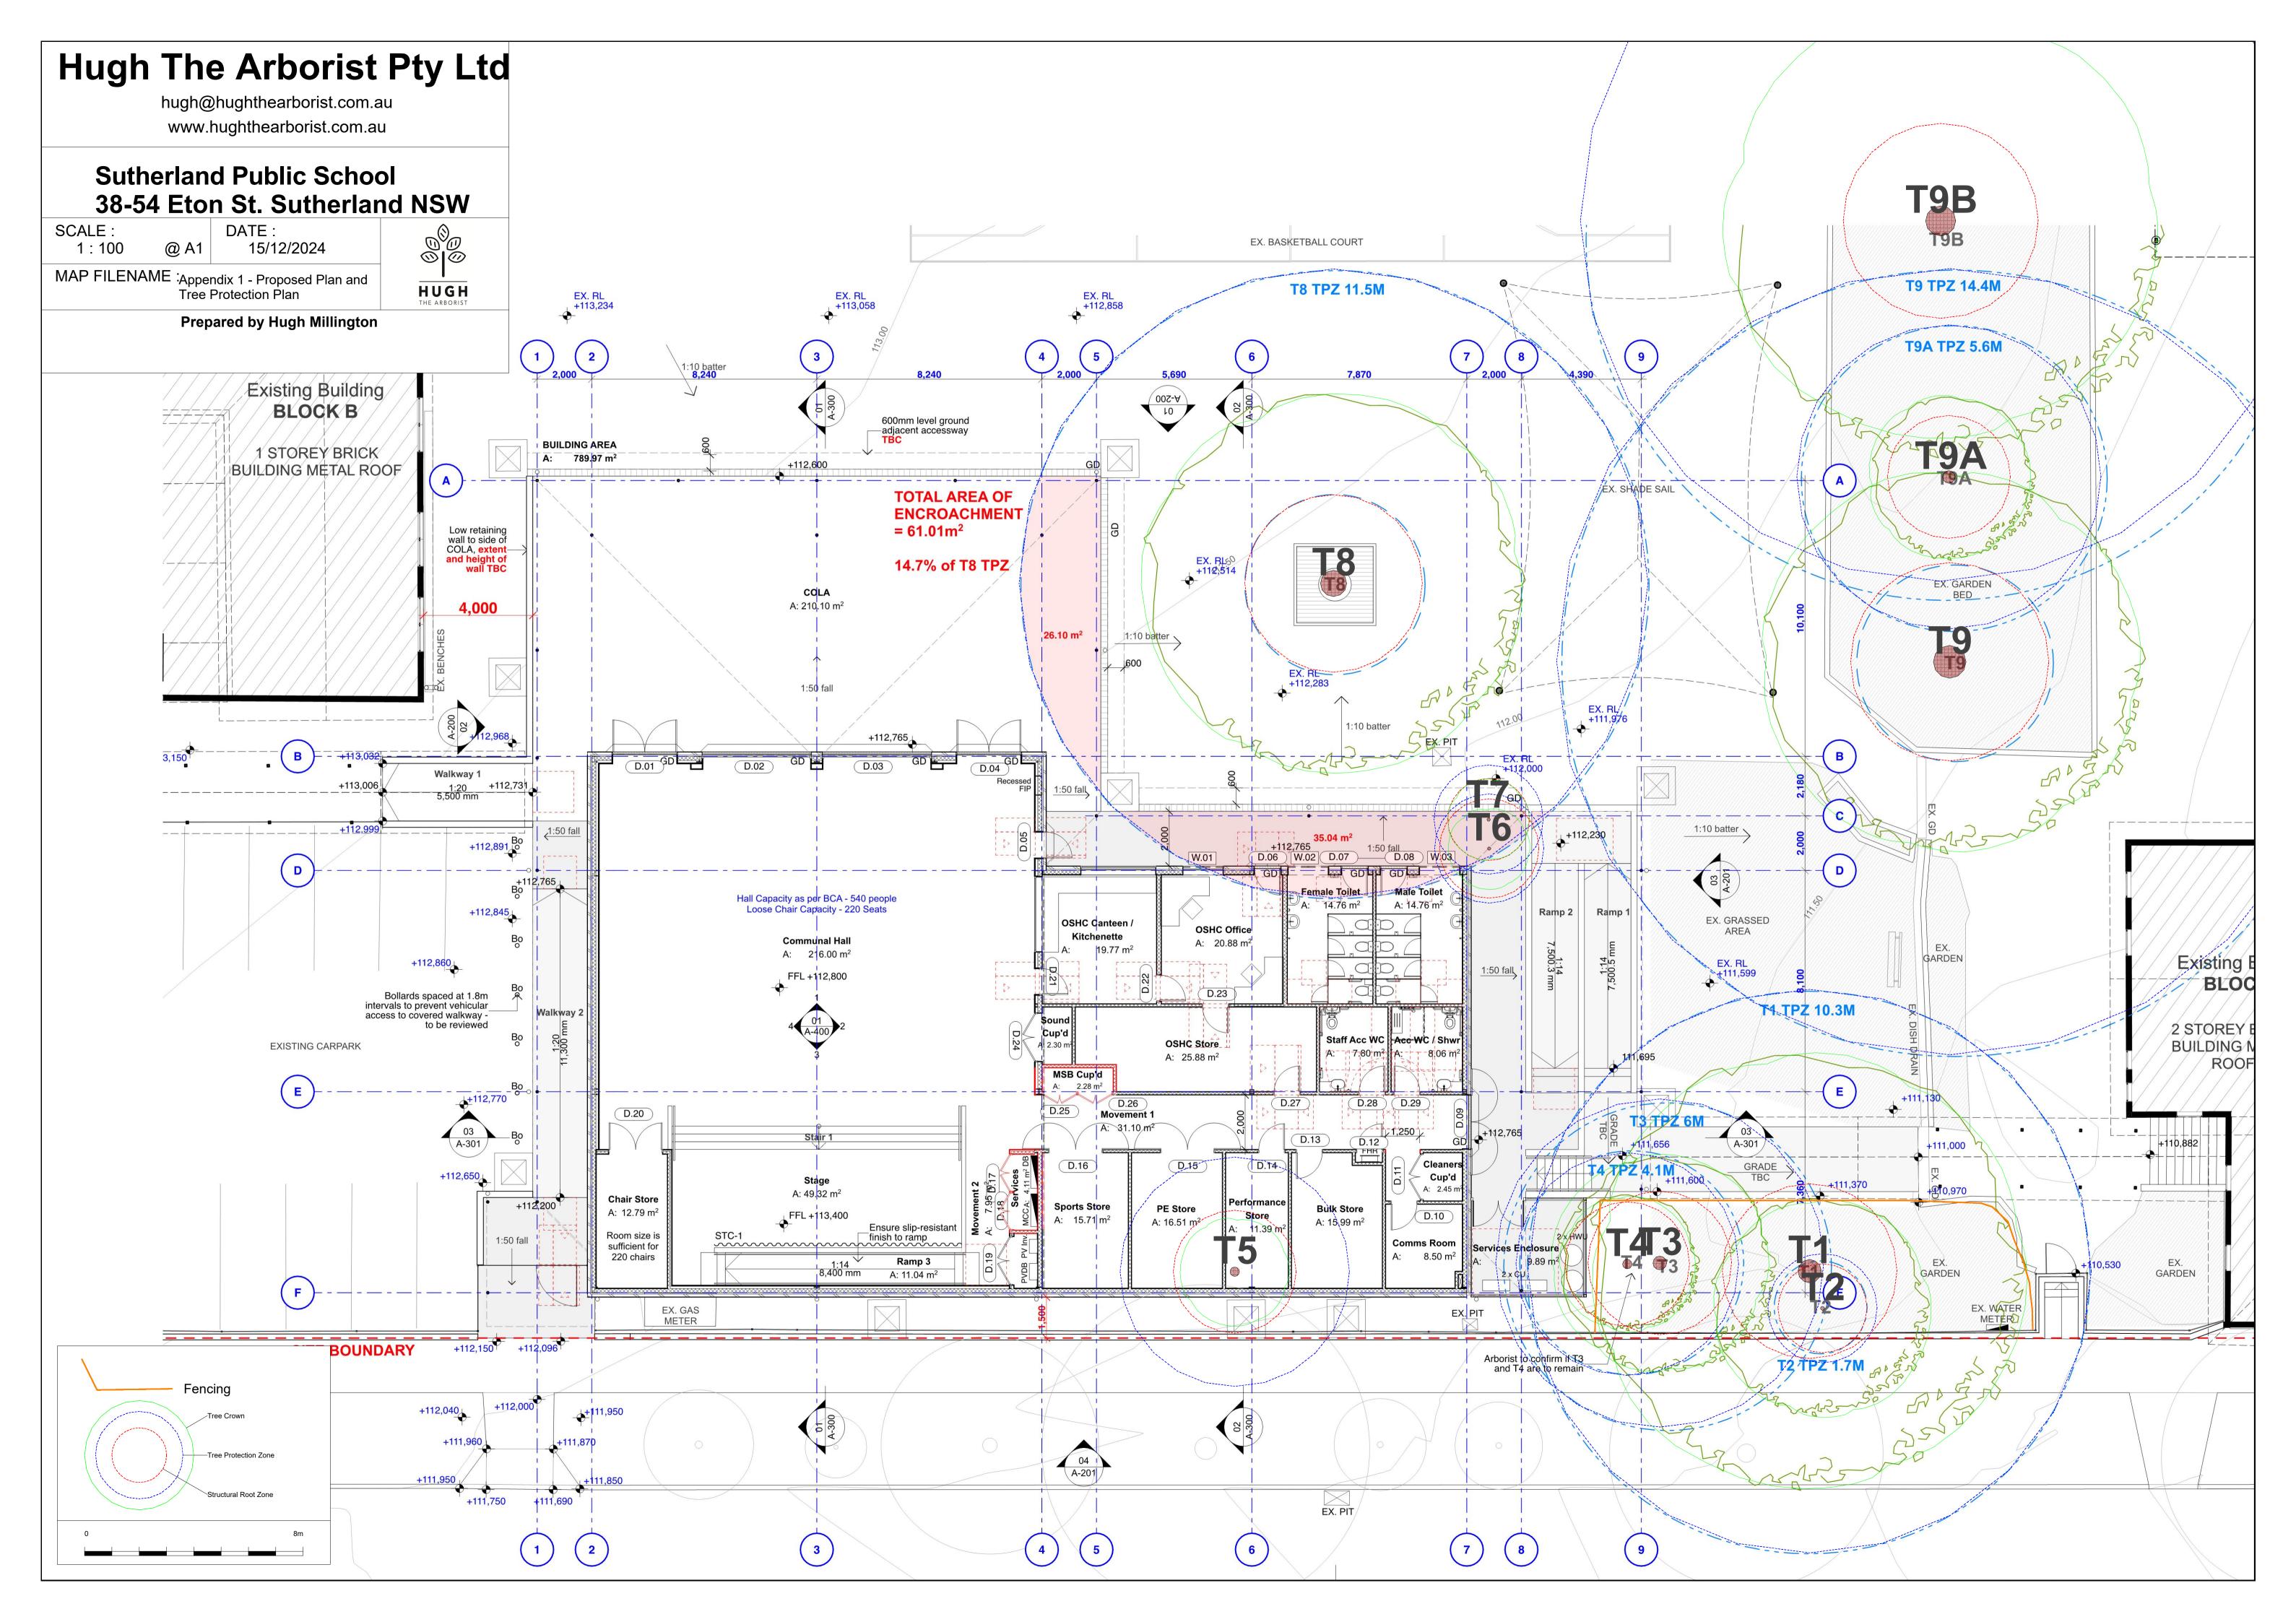
Appendix 2 - Tree Inspection Schedule

Tree ID	Species	Trees AZ Value	TPZ radius (m)	SRZ radius (m)	TPZ encroachment	Discussion/ Conclusion	Recommendation
1	Eucalyptus microcorys	A1	10.3	3.2	Major	According to the demolition plan the existing garden bed containing the tree is proposed to be demolished and the existing footpath reconstructed at a lesser setback to the trunk of the tree. The proposed Ground Floor Plan Identifies proposed levels that are between approximately 40mm and 100mm lower than the existing and notes the work as grading. Beyond the proposed footpath the plans show existing levels to be maintained. While the proposed grading will remove some of the fine root system in the upper layers of the soil the deeper tree roots are more likely to be retained and providing the tree is provided with remediation the fine root system is more likely to redevelop. The services enclosure and structures requiring more significant footings to the north may require root severance however as a standalone component this is unlikely to significantly affect the tree. The total encroachment from the proposed works is up to 28% within the TPZ and the SRZ which is a major encroachment, However, the encroachment is dominated by the footpath which is a lightweight structure and includes the area of TPZ beyond the footpath to the east proposed to be retained as existing. On the provision significant tree roots can be retained below the new footpath via tree sensitive construction methods and the tree is provided remediation the associated impacts are unlikely to have significant long-term impacts to the trees viability. Refer to the recommendations section for specifications.	Retain with tree sensitive construction

2	Eucalyptus microcorys	A1	1.7	1.6	None	No encroachment proposed.	Retain and protect
3	Eucalyptus robusta	A1	6.0	2.6	Major	The proposed access ramp, stairs, services enclosure and associated stormwater pipes will encroach into the TPZ and the SRZ by up to 38%. This is a major encroachment that is likely to affect the viability of the tree.	Remove

Tree ID	Species	Trees AZ Value	TPZ radius (m)	SRZ radius (m)	TPZ encroachment	Discussion/ Conclusion	Recommendation
4	Melaleuca quinquenervia	A1	4.1	2.3	Major	The proposed access ramp, stairs, services enclosure and associated stormwater pipes will encroach into the TPZ and the SRZ by up to 33%. This is a major encroachment that is likely to affect the viability of the tree.	Remove
5	Brachychiton acerifolius	A1	4.2	2.3	Major	The tree is located within the footprint of the building proposing 100% encroachment. The tree is not retainable under the proposed development.	Remove
6	Leptospermum petersonii	A1	1.5	1.8	Major	The tree is located within the footprint of the covered walkway proposing 100% encroachment. The tree is not retainable under the proposed development.	Remove
7	Leptospermum petersonii	A1	1.5	1.5	Major	The tree is located within the footprint of the covered walkway proposing 100% encroachment. The tree is not retainable under the proposed development.	Remove

8	Lophostemon confertus	A2	11.5	3.3	Major	The proposed extended Cola and covered walkway will encroach into the TPZ but not the SRZ by up to 14%. The proposed electrical services and new pits transect through the SRZ of the tree on two sides and are within close proximity to the trunk of the tree. The combined encroachment from the works is considered to be a major encroachment that is likely to affect the viability of the tree.	Remove
9	Ficus macrocarpa var. hillii	A1	14.4	3.6	None	No encroachment proposed	Retain and protect
9A	Ficus macrocarpa var. hillii	A1	5.6	2.3	None	No encroachment proposed	Retain and protect
9B	Ficus macrocarpa var. hillii	A1	13.2	3.6	None	No encroachment proposed	Retain and protect

- 9.4 One tree (T1) will require tree sensitive construction methods to reduce the associated impacts to enable its retention and be provided with remediation to encourage new root development. Refer to the paragraphs below for specifications.

- 9.4.1 **Mulch (T1)** applied to the Tree protection Zone prior to the commencement of any works will enrich the soil by improving aeration, promote healthy Mycorrhizal (Fungal) associations and provide consistent organic matter as the mulch breaks down. The layer also acts as a barrier from the wind and the sun reducing the evaporation of ground water, all of which promote the development of tree roots and healthy soils.

- 9.4.2 Irrigation (T1) can be installed within or on top of the mulch. A moisture probe and an automatic timer with a drip/soaker hose can provide consistent and accurate irrigation for mature trees during the development phase and minimise risks of waterlogged or hydrophobic soils. This, in combination with mulch, tree protection and a nutrient rich soil conditioner will provide favourable growing conditions for trees to offset the impacts of major incursions to the TPZ area that are associated with root loss.

- 9.4.3 Tree Sensitive Hard Surfacing Construction (T1): Hard surfacing within the TPZ of retained trees should be constructed in a tree sensitive method. The hard surfacing should be constructed above existing grades in the TPZ of the trees. The diagram below (Image C) gives an example of a no-excavation method for constructing hard surfacing close to trees. The location of retaining pegs should be flexible, avoiding damage to structural roots. If excavations are essential, they must not exceed 100mm below the existing grades. The excavations should be supervised by a project Arborist with a minimum AQF level 5 qualification. All excavations for the hard surfacing should be carried out manually to avoid impacting retained tree roots. All tree roots greater than 40mm in diameter should be retained unless the project arborist has assessed and advised that the pruning/severing of the root will not impact the condition or stability of the tree. Manual excavation may include the use of pneumatic and hydraulic tools, high-pressure air or a combination of high-pressure water and a vacuum device. Where tree roots greater than 40mm are encountered that must be retained, the hard surfacing should be elevated over the individual tree
