## REPORT

### Arboricultural Impact Assessment

Eagle Vale High School  
27 Drysdale Street  
Eagle Vale NSW 2558

14<sup>th</sup> July 2025  
Version 7

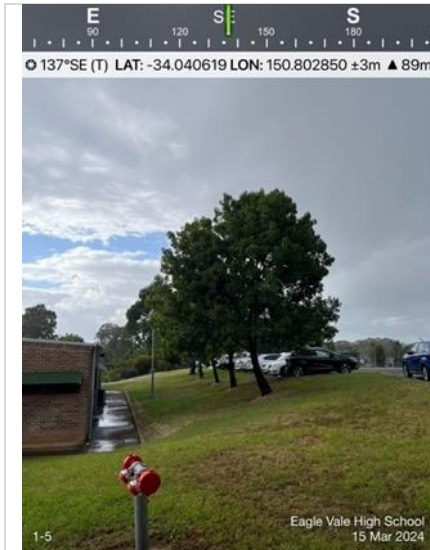
**Plate 1: Trees 1 to 5**  
(from left to right).

| Tree No. | Location | Scientific Name<br>Common Name | canopy (m) | Height (m) | DBH*<br>DRC*<br>(cm) | TPZ*<br>SRZ*<br>(m) | Visual Tree Assessment (VTA) – Tree Health & Condition | TULE*<br>A-Z | Retention Value | Proposed Measures |
|---|---|---|---|---|---|---|---|---|---|---|
| 1 | Carpark, adjacent office. | <u>Fraxinus angustifolia spp.oxycarpa</u><br>Claret Ash | 8 | 8 | 28<br>34 | 3.4<br>2.1 | Semi-mature, good condition but poor development, with root damage, a lean to the west, and epicormics at the base of the tree. | 2d<br>A2 | Moderate | Outside of scope |
| 2 | Carpark, adjacent office. | <u>Fraxinus angustifolia spp.oxycarpa</u><br>Claret Ash | 7 | 8 | 20<br>22 | 2.4<br>1.8 | Immature, poor condition, with over 20% dieback, and 10% dehydration. | 4a<br>Z10 | Very Low | Outside of scope (Poor Condition). |
| 4 | Carpark, adjacent office. | <u>Fraxinus angustifolia spp.oxycarpa</u><br>Claret Ash | 8 | 8 | 22<br>25 | 2.6<br>1.9 | Immature, good condition but poor development, with 10% dehydration, and soil compaction. | 2d<br>A2 | Low-Moderate | Outside of scope |
| 5 | Adjacent building. | <u>Fraxinus angustifolia spp.oxycarpa</u><br>Claret Ash | 8 | 9 | 30<br>36 | 3.6<br>2.1 | Semi-mature, moderate condition, with a lean, and minor root damage. | 2d<br>A2 | Moderate | Outside of scope |

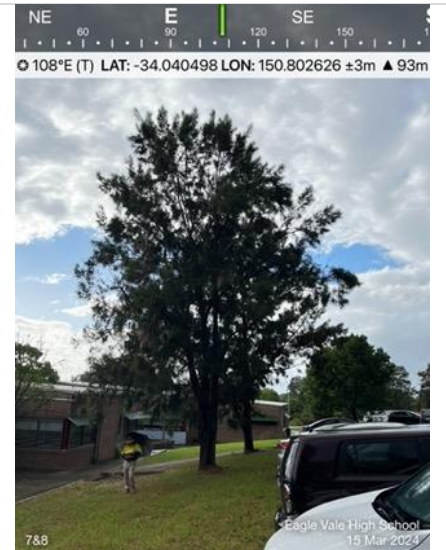
**Plate 3: Trees 7 and 8**  
(from right to left).

| Tree No. | Location | Scientific Name<br>Common Name | canopy (m) | Height (m) | DBH*<br>DRC*<br>(cm) | TPZ*<br>SRZ*<br>(m) | Visual Tree Assessment (VTA) – Tree Health & Condition | TULE*<br>A-Z | Retention Value | Proposed Measures |
|---|---|---|---|---|---|---|---|---|---|---|
| 7 | Carpark. | <u>Casuarina glauca</u><br>Swamp She-Oak | 8 | 15 | 37<br>40 | 4.4<br>2.3 | Semi-mature, good condition but poor development, with an unbalanced canopy to the east. | 2d<br>A1 | Moderate | Outside of scope |
| 8 | Carpark. | <u>Casuarina glauca</u><br>Swamp She-Oak | 10 | 15 | 78<br>83 | 9.4<br>3.1 | Semi-mature, good condition but poor development, with twin stems, 10% dehydration, and a beam crack in a branch to the east at 5m height. | 2a<br>A2 | Moderate | Outside of scope |

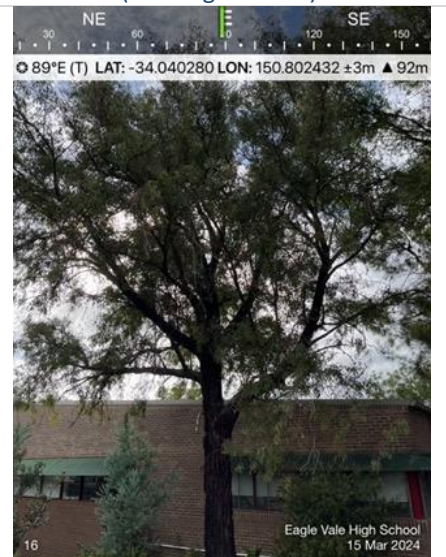
**Plate 6: Tree 16.**

| Tree No. | Location | Scientific Name<br>Common Name | canopy (m) | Height (m) | DBH*<br>DRC*<br>(cm) | TPZ*<br>SRZ*<br>(m) | Visual Tree Assessment (VTA) – Tree Health & Condition | TULE*<br>A-Z | Retention Value | Proposed Measures |
|---|---|---|---|---|---|---|---|---|---|---|
| 16 | 4m from building. | <u>Eucalyptus sideroxylon</u><br>Mugga Ironbark | NS 15<br>EW 14 | 20 | 59<br>64 | 7.1<br>2.7 | Mature, good condition but poor development, with insect attack. | 2d<br>A2 | High | Outside of scope |

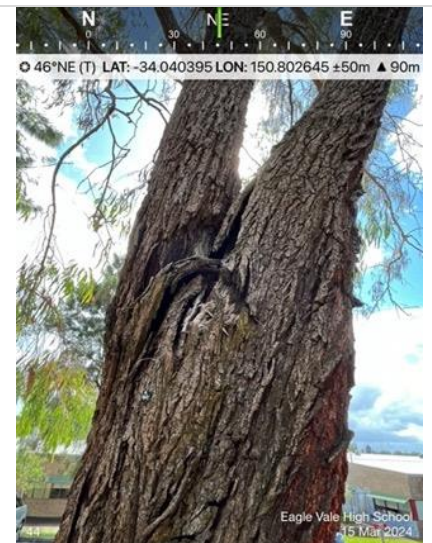
**Plate 15: Tree 44 has a split inclusion**

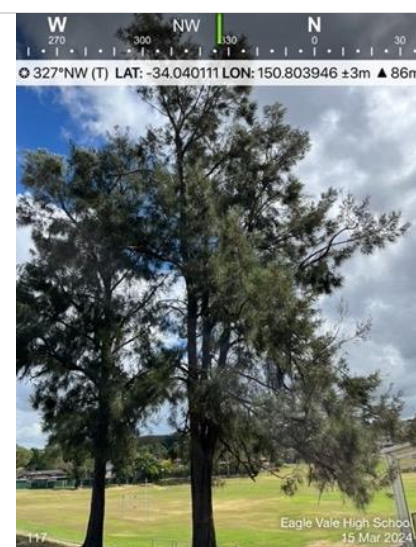
**Plate 26: Trees 116 and 117  
(from left to right).**

| Tree No. | Location | Scientific Name<br>Common Name | canopy<br>(m) | Height<br>(m) | DBH*<br>DRC*<br>(cm) | TPZ*<br>SRZ*<br>(m) | Visual Tree Assessment (VTA) – Tree Health & Condition | TULE*<br>A-Z | Retention<br>Value | Proposed Measures |
|---|---|---|---|---|---|---|---|---|---|---|
| 116 | South of sports court. | <i>Casuarina glauca</i><br>Swamp She-Oak | 8 | 12 | 25<br>30 | 3.0<br>2.0 | Immature, good condition but poor development. | 2a<br>A1 | Moderate | Remove and replenish |
| 117 | South of sports court. | <i>Casuarina glauca</i><br>Swamp She-Oak | 9 | 14 | 50<br>60 | 6.0<br>2.7 | Semi-mature, good condition but poor development, with minor root damage. | 2d<br>A2 | High | Remove and replenish |

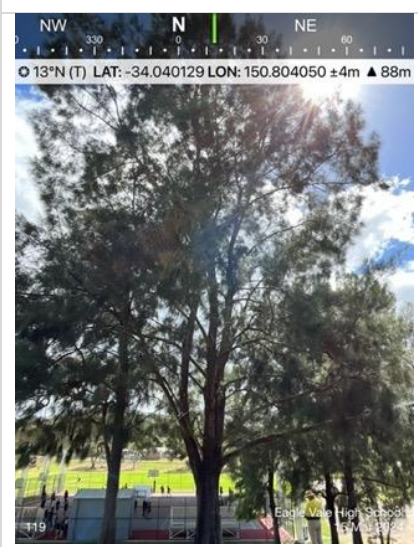
**Plate 27: Trees 118 to 119  
(from left to right).**

| Tree No. | Location | Scientific Name<br>Common Name | canopy<br>(m) | Height<br>(m) | DBH*<br>DRC*<br>(cm) | TPZ*<br>SRZ*<br>(m) | Visual Tree Assessment (VTA) – Tree Health & Condition | TULE*<br>A-Z | Retention<br>Value | Proposed Measures |
|---|---|---|---|---|---|---|---|---|---|---|
| 118 | South of sports court. | <i>Casuarina glauca</i><br>Swamp She-Oak | 8 | 20 | 38<br>43 | 4.6<br>2.3 | Mature, good condition but poor development, with a suppressed canopy to the east. | 2a<br>A1 | Moderate | Remove and replenish |
| 119 | South of sports court. | <i>Casuarina glauca</i><br>Swamp She-Oak | 14 | 21 | 55<br>60 | 6.6<br>2.7 | Mature, good condition but poor development, with extended laterals to the north. | 2a<br>A2 | High | Remove and replenish |

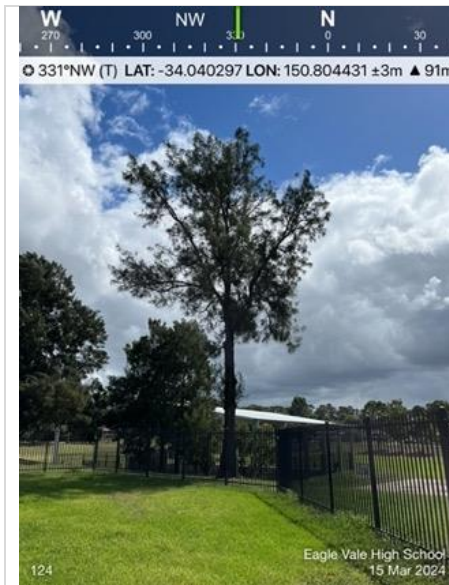
**Plate 28: Tree 124.**

| Tree No. | Location | Scientific Name<br>Common Name | canopy<br>(m) | Height<br>(m) | DBH*<br>DRC*<br>(cm) | TPZ*<br>SRZ*<br>(m) | Visual Tree Assessment (VTA) – Tree Health & Condition | TULE*<br>A-Z | Retention<br>Value | Proposed Measures |
|---|---|---|---|---|---|---|---|---|---|---|
| 124 | South of sports court. | <u>Casuarina glauca</u><br>Swamp She-Oak | 14 | 23 | 70<br>92 | 8.4<br>3.2 | Mature, moderate condition, previously pruned, top heavy. | 3a<br>A2 | Moderate | Remove and replenish |

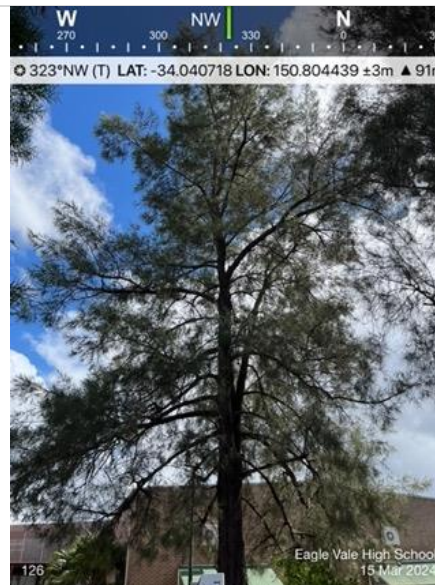
**Plate 29: Tree 126.**

| Tree No. | Location | Scientific Name<br>Common Name | canopy<br>(m) | Height<br>(m) | DBH*<br>DRC*<br>(cm) | TPZ*<br>SRZ*<br>(m) | Visual Tree Assessment (VTA) – Tree Health & Condition | TULE*<br>A-Z | Retention<br>Value | Proposed Measures |
|---|---|---|---|---|---|---|---|---|---|---|
| 126 | Hydrant. | <u>Casuarina glauca</u><br>Swamp She-Oak | 14 | 25 | 70<br>94 | 8.4<br>3.2 | Mature, good condition but poor development, with twin stems. | 2d<br>A1 | High | Retain and protect. |

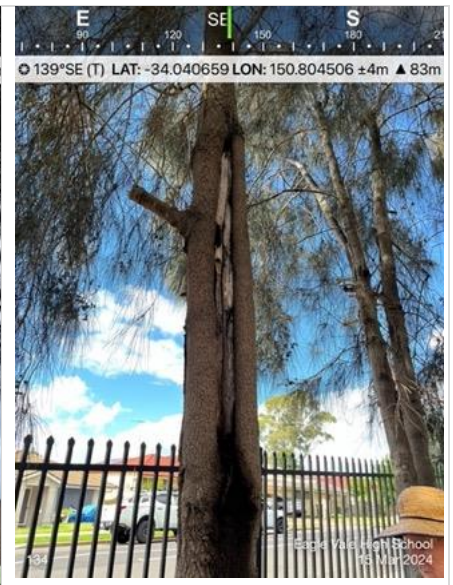
**Plate 30: Tree 134.**

| Tree No. | Location | Scientific Name<br>Common Name | canopy<br>(m) | Height<br>(m) | DBH*<br>DRC*<br>(cm) | TPZ*<br>SRZ*<br>(m) | Visual Tree Assessment (VTA) – Tree Health & Condition | TULE*<br>A-Z | Retention<br>Value | Proposed Measures |
|---|---|---|---|---|---|---|---|---|---|---|
| 134 | 1m from fence. | <u>Casuarina glauca</u><br>Swamp She-Oak | 6 | 14 | 23<br>24 | 2.8<br>1.8 | Immature, with a cavity at 3m height, and over 20% dieback. | 4c<br>Z10 | Very Low | Remove and replenish<br>(Poor Condition). |

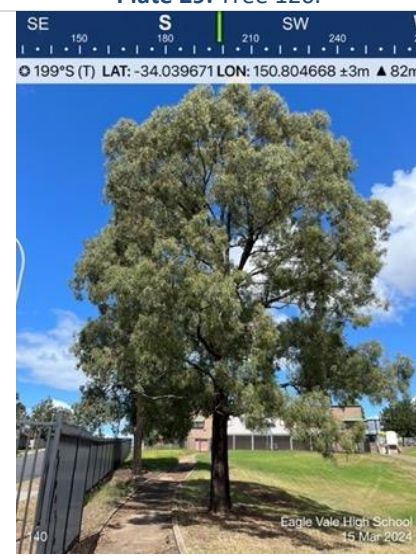
**Plate 32: Tree 140.**

| Tree No. | Location | Scientific Name<br>Common Name | canopy<br>(m) | Height<br>(m) | DBH*<br>DRC*<br>(cm) | TPZ*<br>SRZ*<br>(m) | Visual Tree Assessment (VTA) – Tree Health & Condition | TULE*<br>A-Z | Retention<br>Value | Proposed Measures |
|---|---|---|---|---|---|---|---|---|---|---|
| 140 | Eastern fence. | <u>Eucalyptus sideroxylon</u><br>Mugga Ironbark | 14 | 22 | 58<br>60 | 7.0<br>2.7 | Immature, good condition but poor development, with minor dehydration. | 2d<br>A2 | High | Retain and protect. |

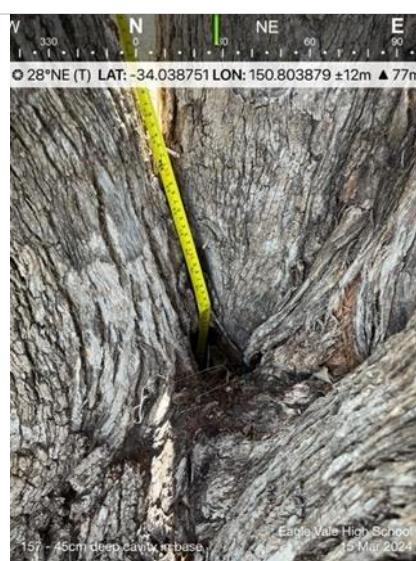
**Plate 35: Tree 157 has a cavity at the base of the tree.**
