Report on
Geotechnical Investigation

Proposed Perisher View Ski Lodge
Lot 1, DP1192372, Perisher Valley, NSW

Prepared for
Geoanalysis Pty Ltd

Project 94499.00
June 2020

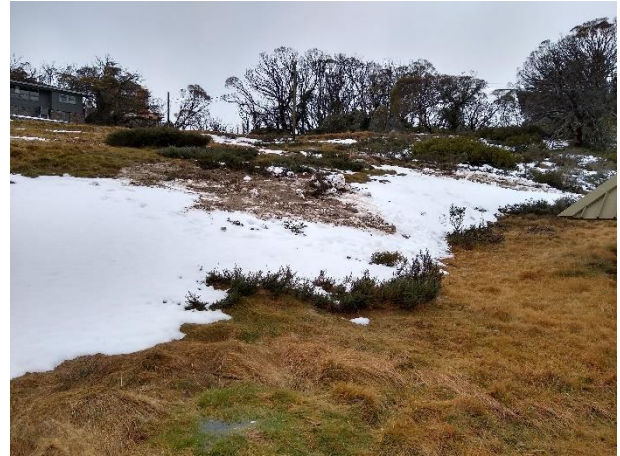
Figure 3: View north-west diagonally from south-east corner of Lot 1.

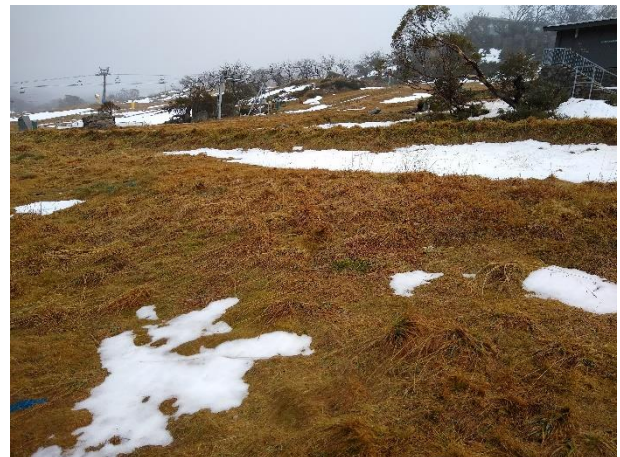
Figure 5: View west across upslope portion of Lot 1 adjacent to Burramys Road.

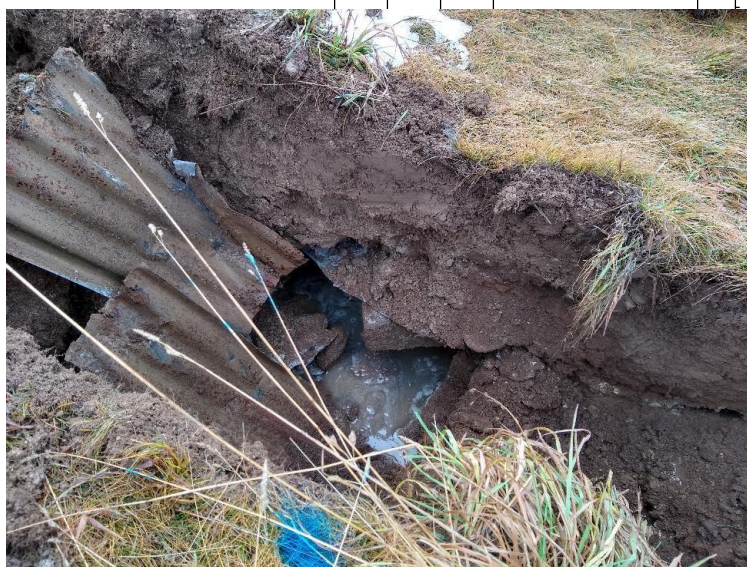
PIT No: 7
PROJECT No: 94499.00
DATE: 26/5/2020
SHEET 1 OF 1

Groundwater seepage was encountered in the sandy residual strata and/or EW granodiorite at depths of 2.3 m, 2.4 m and 1.6 m in Pits 1, 4 and 6 respectively, and was present in the tunnel-like structure at Pit 7. It was not encountered in the other three pits. It should be noted that groundwater presence is affected by weather conditions, soil permeability and other factors, and may vary with time.

RL	Depth (m)	Description of Strata	Graphic Log	Sampling & In Situ Testing				Water	Dynamic Penetrometer Test (blows per mm)			
				Type	Depth	Sample	Results & Comments		5	10	15	20
1739	0.2	TOPSOIL FILL/Silty CLAY (CL): low plasticity, brown, with rootlets, moist, w~PL, soft, TOPSOIL FILL										
		FILL/Clayey SAND (SC): fine to coarse grained, grey-brown, low plasticity clay, with sub-angular granodiorite gravel up to 60mm in size, moist, loose to medium dense, FILL -from 0.5m, an underground structure comprised of bricks, corrugated iron and concrete was uncovered										
1	0.9	Pit discontinued at 0.9m - abandoned due to underground structure										
1738												
2												
1737												
3												
1736												
4												
1735
