HAZARDOUS MATERIALS SURVEY & MANAGEMENT PLAN

Brisbane Waters (NSW) Legacy 51 Masons Parade POINT FREDERICK, NSW 2250

S109616 - Alliance Geotechnical - Brisbane Water Legacy Village

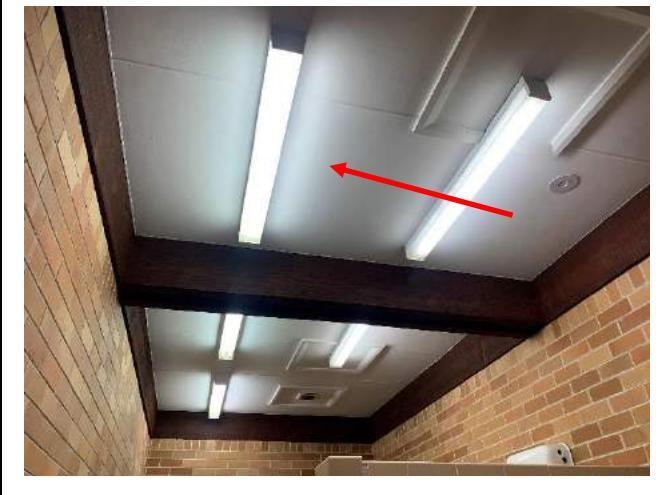
Photograph 7: Hall, bathroom ceiling lining presumed to contain asbestos.

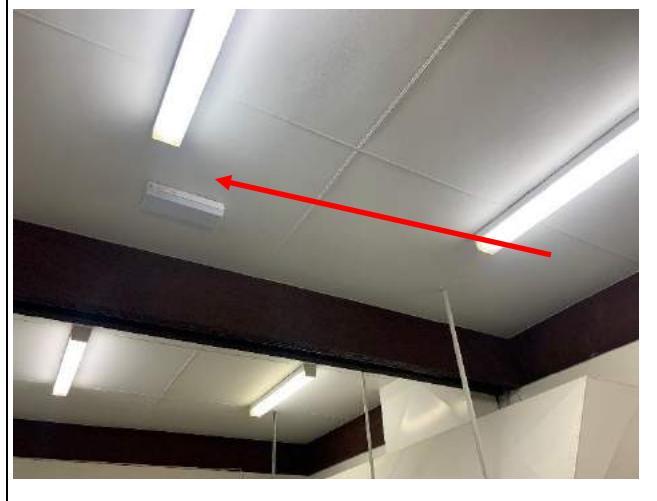
Photograph 9: Hall, kitchen ceiling lining presumed to contain asbestos.

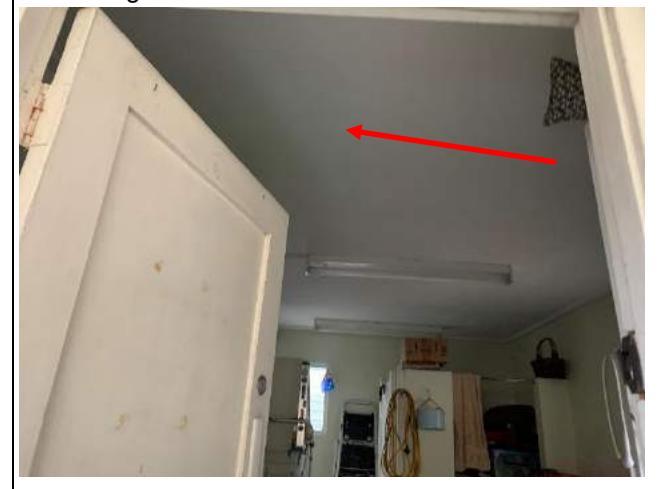
Photograph 11: Cottage internal laundry ceiling lining containing asbestos.

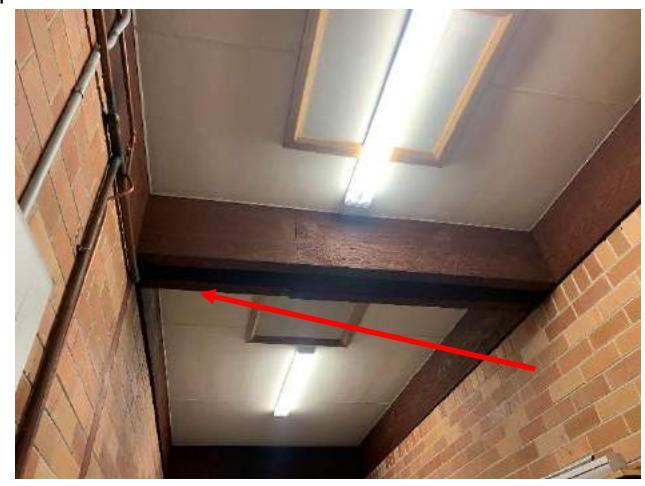
Photograph 8: Hall, storage room ceiling lining presumed to contain asbestos.

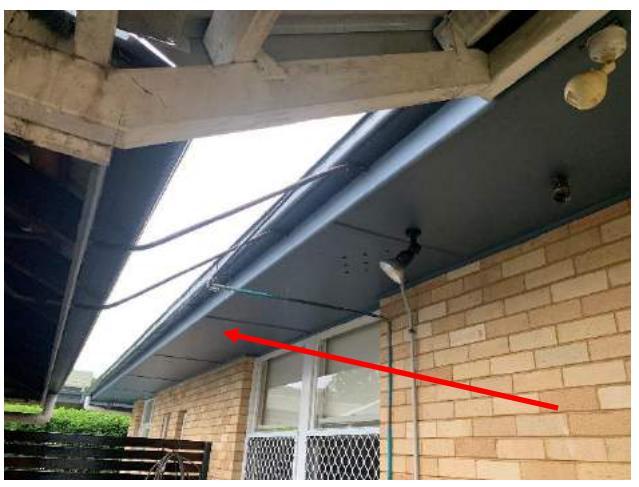
Photograph 10: Cottage, eave lining containing asbestos.

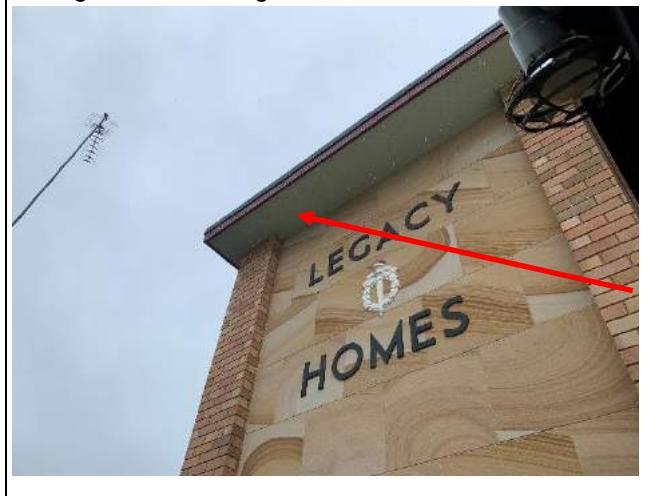
Photograph 12: Housing blocks, eave lining throughout containing asbestos.

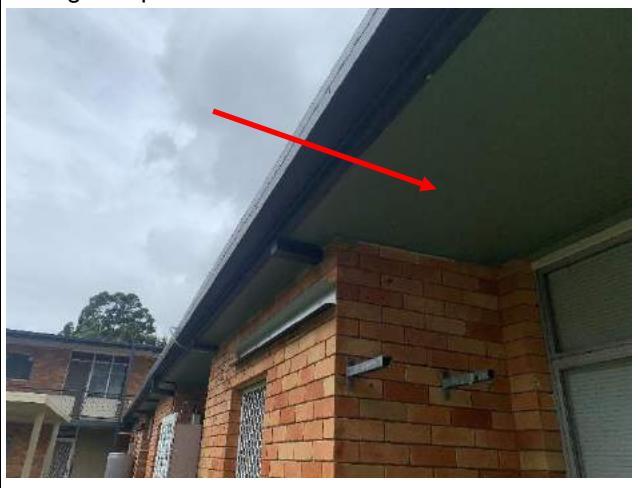
Photograph 13: Housing blocks, rear balcony awnings throughout presumed to contain asbestos.

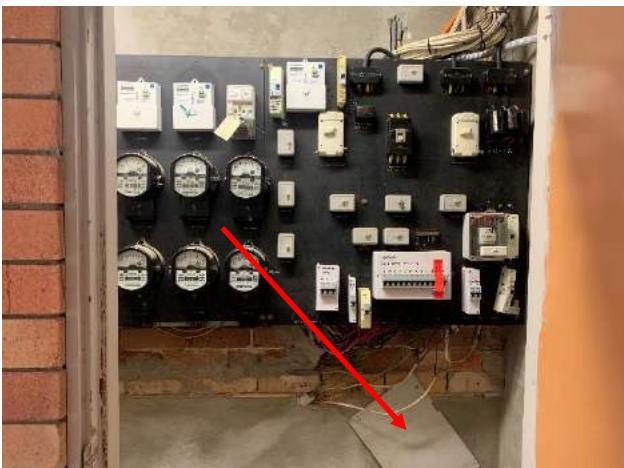
Photograph 15: Housing blocks, meter room adj. unit 18, sheet below backing board presumed to contain asbestos.

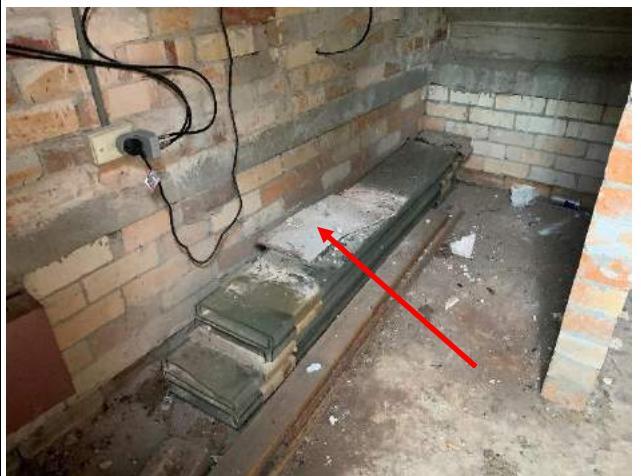
Photograph 17: Housing blocks, storage room behind units 39 & 45, loose sheets presumed to contain asbestos.

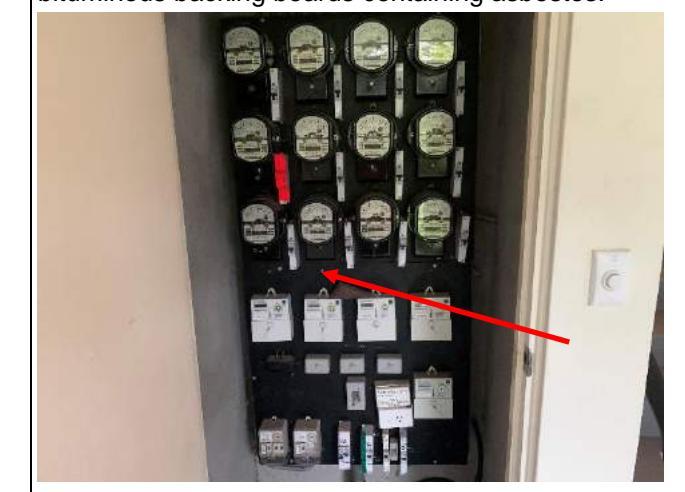
Photograph 14: Housing blocks, example of bituminous backing boards containing asbestos.

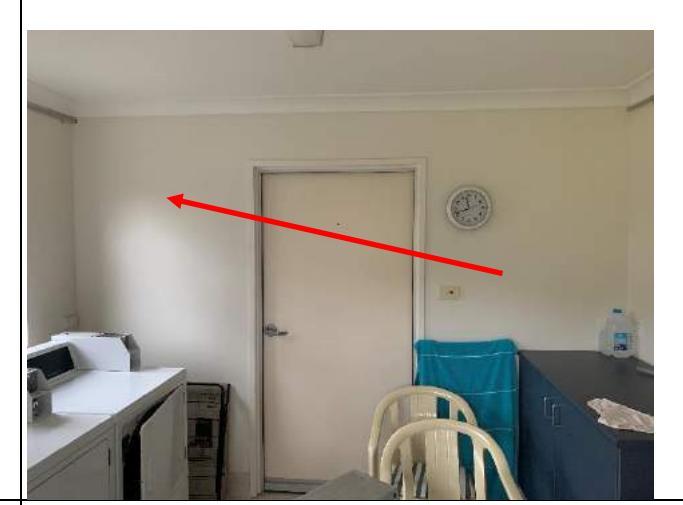
Photograph 16: Housing blocks, laundry adj. unit 48 wall lining presumed to contain asbestos.

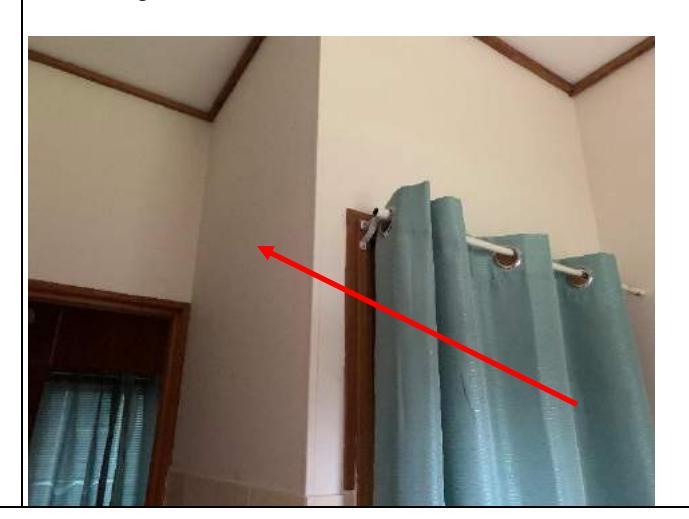
Photograph 18: Housing units, units 53-56 wall lining containing asbestos.

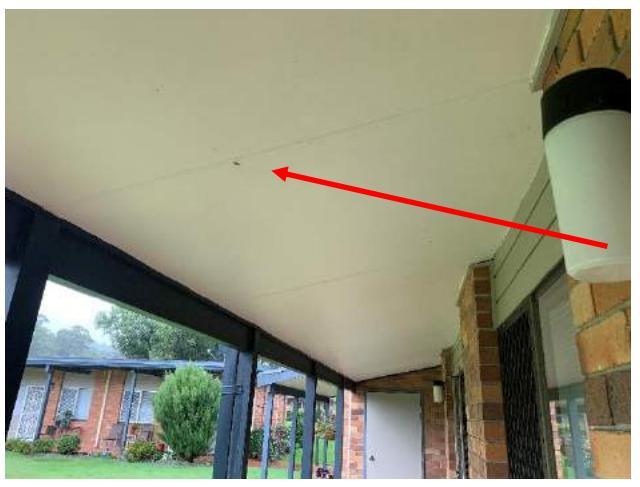
Photograph 19: Villas, front & rear awnings containing asbestos.

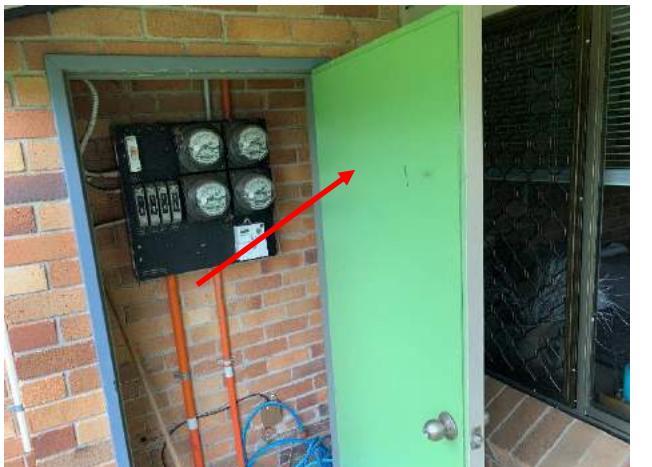
Photograph 21: Villas, meter rooms adj. unit 58 and 62, sheeting attached to underside of doors, presumed to contain asbestos.

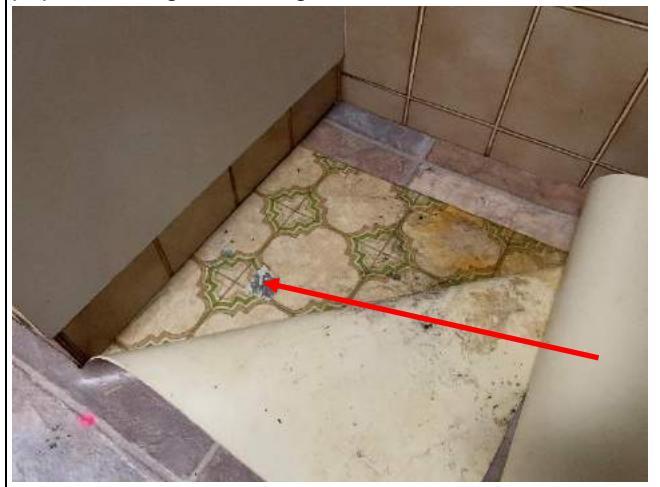
The majority ACM encountered on Site was in good condition and therefore are considered **Low Risk**. Friable linoleum paper backing was found in villas 57-64, however this material was generally in good condition, this was conserved **Medium Risk**. If disturbed, please follow the control measures presented in **Section 7.2**.

Photograph 23: Villas, units 57-64, original lino flooring paper backing containing asbestos.

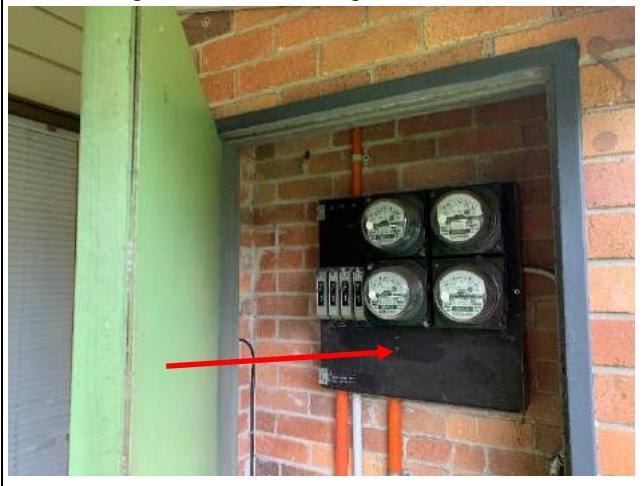
Similar to S109616.1-A05	Presume Positive	20	Bituminous Backing Board	Villas, external, meter room adj. unit 62, electrical backing board.	1	1	1	2	1	2	L	1m²	Maintain in good condition & remove prior to refurbishment or demolition.
VO	Presume Positive	21	Fibrous Cement Sheeting	Villas, external, meter room adj. unit 62, internal sheeting to underside of door.	1	1	1	2	1	2	L	3m ²	Maintain in good condition & remove prior to refurbishment or demolition.
S109616.1-A12	СН	22	Fibrous Cement Sheeting	Villas, internal, bathroom wall lining, units 57-64.	1	1	2	3	3	18	L	10m ²	Maintain in good condition & remove prior to refurbishment or demolition.
S109616.1-A11	СН	23	Linoleum paper backing	Villas, internal, kitchen/laundry, original linoleum flooring below modern linoleum, units 57-64.	2	1	2	3	3	36	М	80m ²	Maintain in good condition & remove prior to refurbishment or demolition.
	NITS

Photograph 20: Villas, meter rooms adj. unit 58 and 62, backing boards containing asbestos.

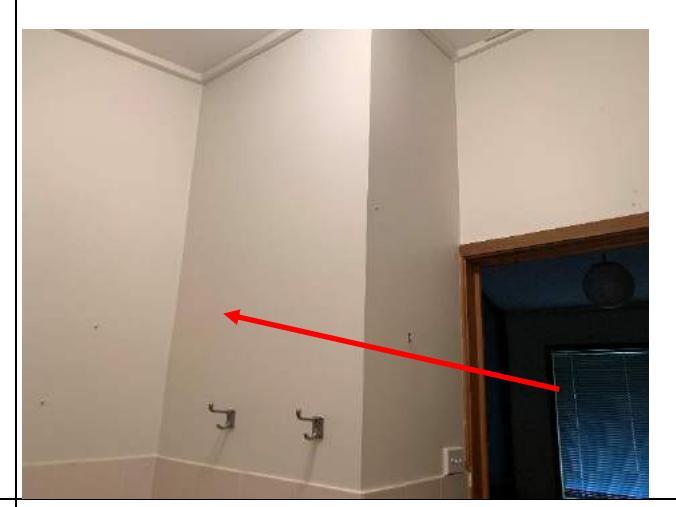
Photograph 22: Villas, units 57-64 bathroom wall lining containing asbestos.

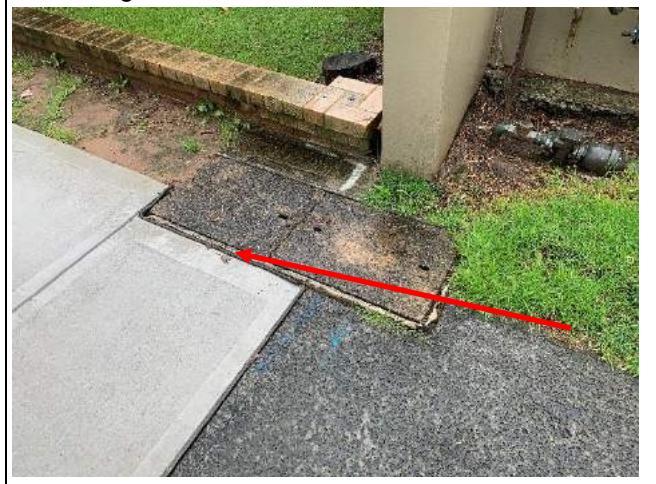
Photograph 24: Telecommunication pit adj. cottage containing asbestos.

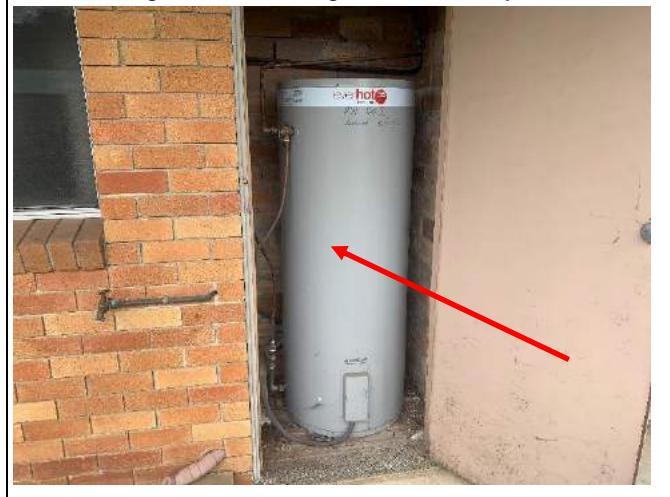
Sample No.	Results	Photo ID	Description	Location	SMF Type	Condition	Accessibility	Airborne Potential	Exposure Potential	Risk Score	Action Priority	Quantity (Lm, m², m³)	Comments/ Recommendations
VO	Positive	31	Hot Water Tank	Housing blocks, external, Doug Fagan Lounge, south end, small hot water tank	1	-	-	-	-	-	L	1 unit	Maintain in good condition. Remove prior to refurbishment of demolition works.
VO	Positive	31	Hot Water Tank	Housing blocks, cupboard between units 3&4, hot water tank	1	-	-	-	-	-	L	1 unit	Maintain in good condition. Remove prior to refurbishment of demolition works.
VO	Positive	31	Hot Water Tank	Housing blocks, cupboard between units 15&16, hot water tank	1	-	-	-	-	-	L	1 unit	Maintain in good condition. Remove prior to refurbishment of demolition works.
VO	Positive	31	Hot Water Tank	Housing blocks, cupboard between units 21&22, hot water tank	1	-	-	-	-	-	L	1 unit	Maintain in good condition. Remove prior to refurbishment of demolition works.

Photograph 31: Housing blocks, example of hot water tanks throughout containing SMF internally.

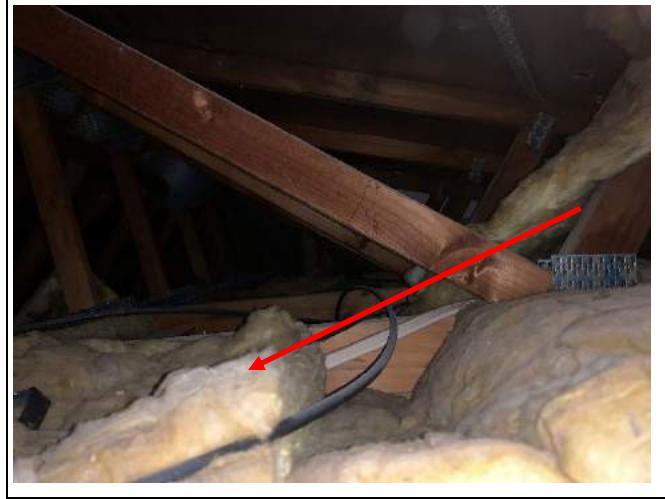
Photograph 33: Villas, units 57-64, example insulation batts on underside of ceiling containing SMF.

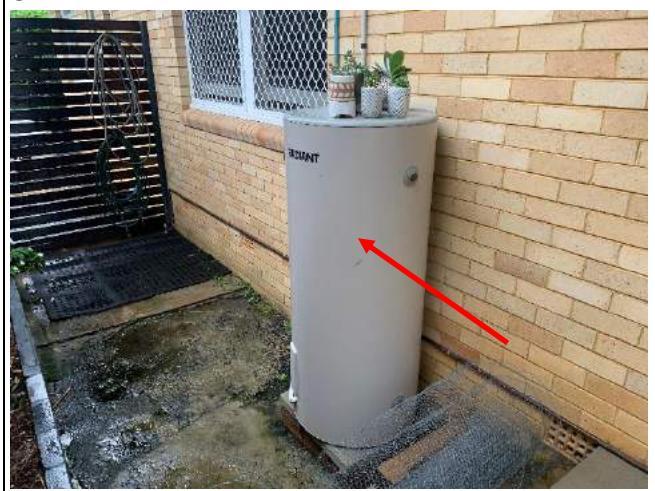
Photograph 35: Cottage, hot water tank containing SMF.

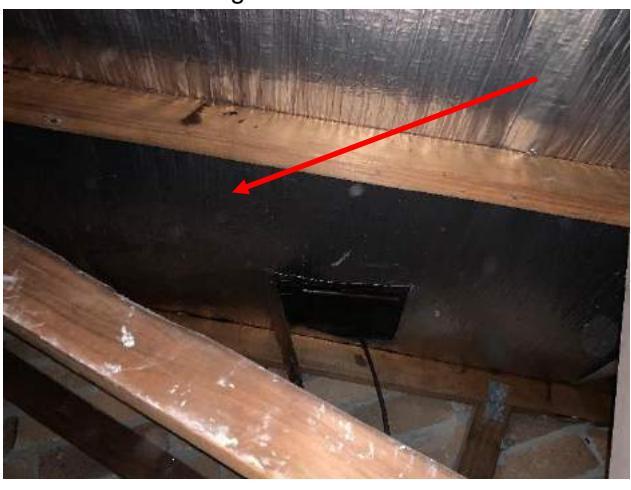
Photograph 32: Villas, units 57-64, roof backed insulation containing SMF.

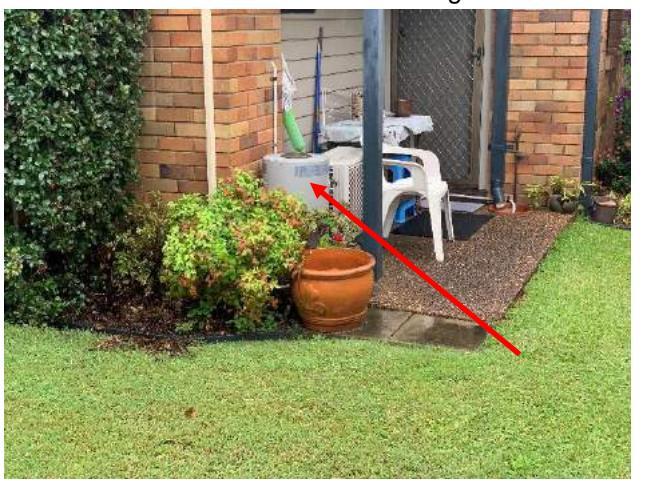
Photograph 34: Villas, units 57-64, example of small hot water tanks at each villa containing SMF.

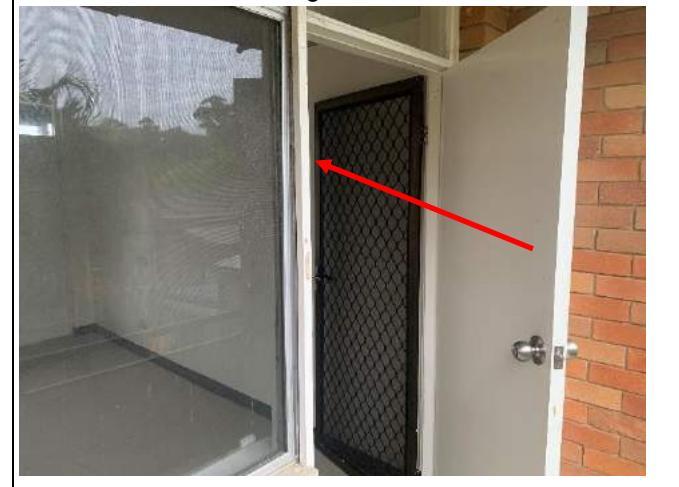
Photograph 36: Housing blocks, cream paint systems to door frames containing lead.

The Lead based paint systems identified on site varied in condition. It recommended that flaking and caulking sections of paint in high access area be removed and replaced with a lead-free substitute.

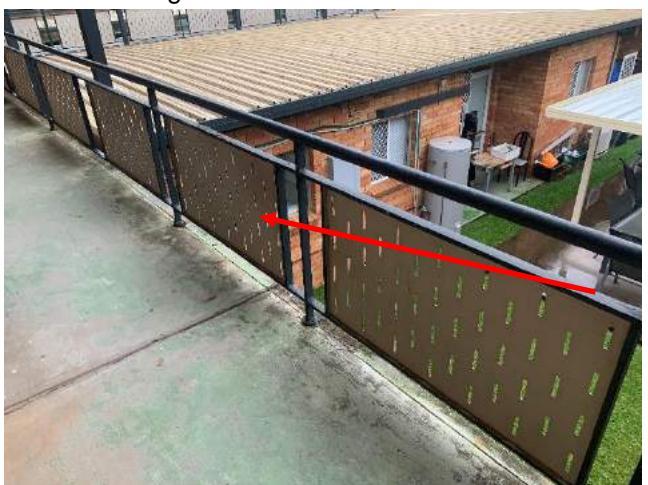
Photograph 37: Housing blocks, white paint system to rails containing lead.

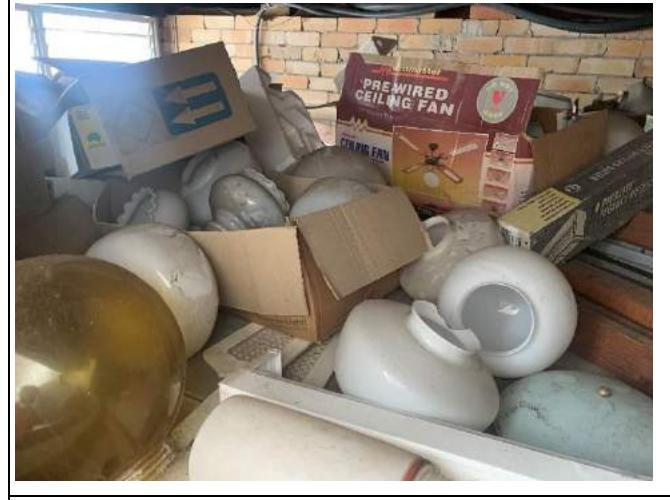
Photograph 39: Housing blocks, storage void adj lounge light fixtures presumed to contain PCB's.

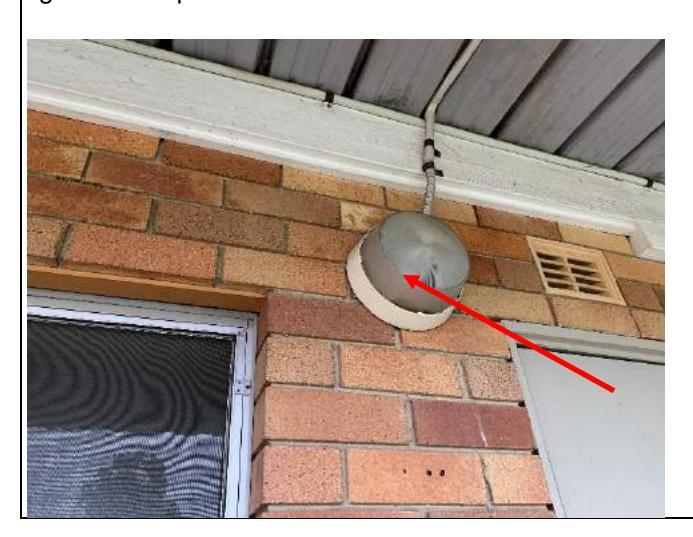
Photograph 41: Housing blocks, circular wall mounted light fixtures presumed to contain PCB's.

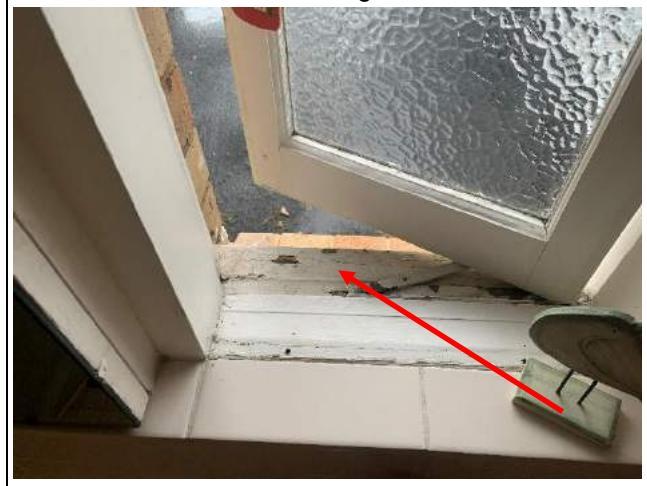
Photograph 38: Cottage, cream paint system to door and window frames containing lead.

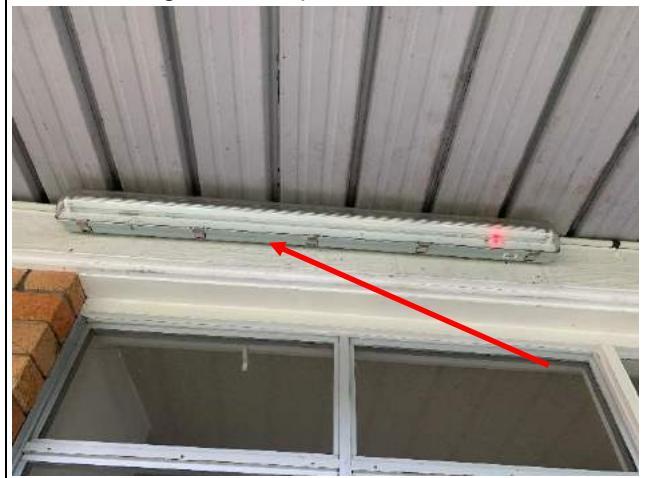
Photograph 40: Housing blocks, long single fluorescent light fixtures presumed to contain PCB's.

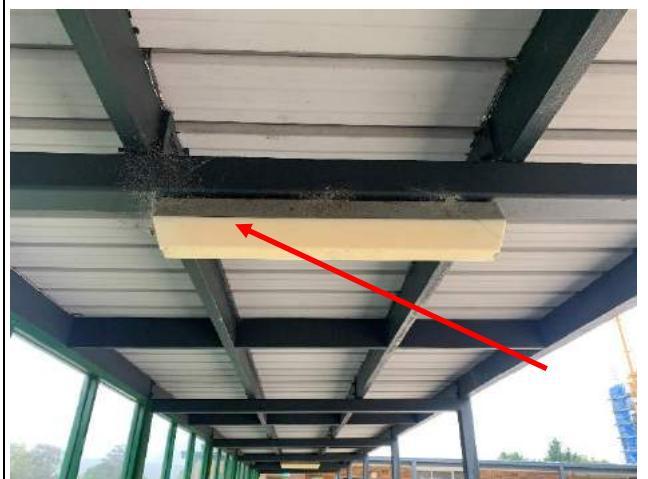
Photograph 42: Housing blocks, breezeway, older medium single fluorescent light fixtures presumed to contain PCB's.

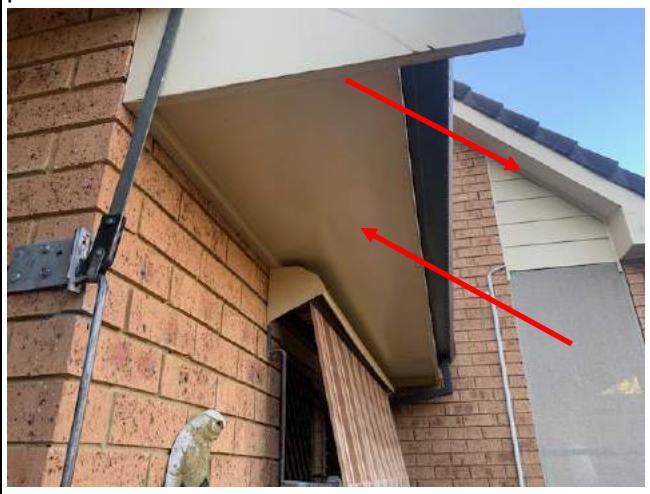
Photograph 43: York street units eaves and awnings presumed to contain asbestos.

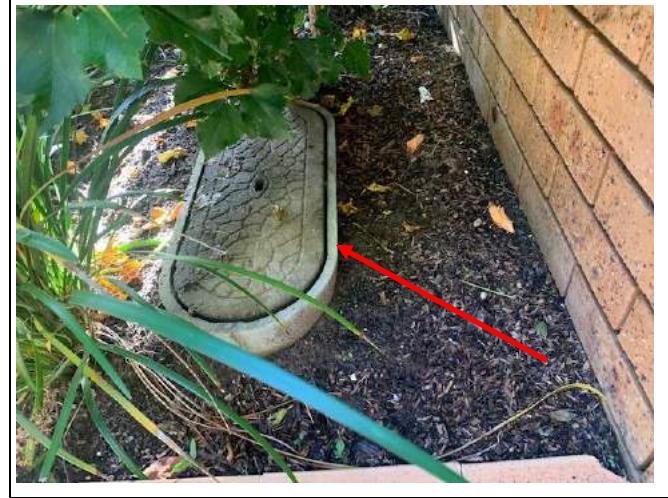
Photograph 45: York street units, telcom pit adj. unit 68 presumed to contain asbestos.

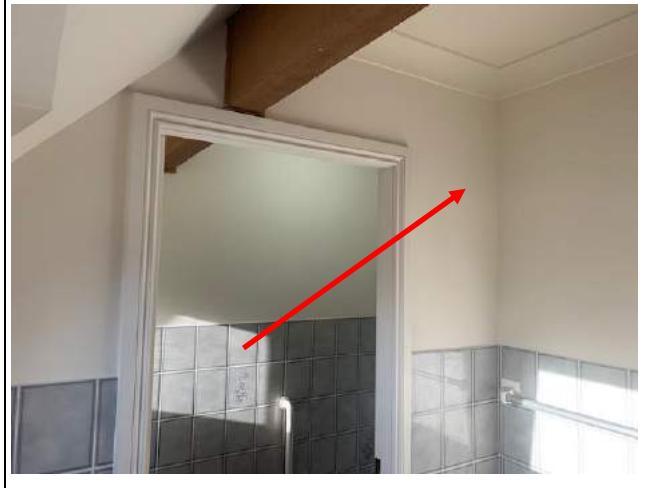
Photograph 44: York street units upstairs bathrooms wall lining presumed to contain asbestos.

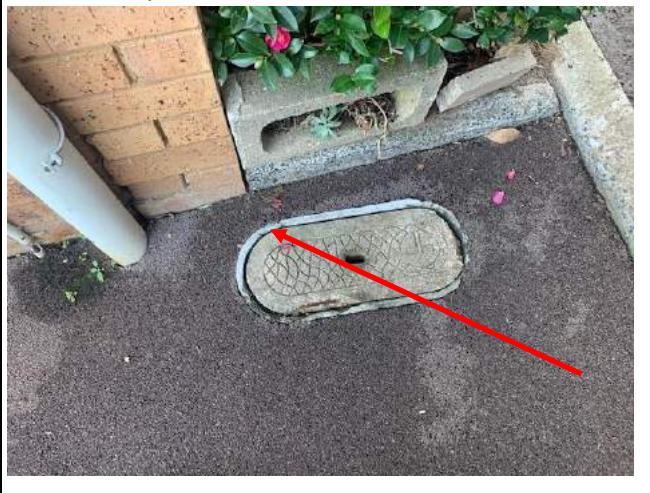
Photograph 46: York street units, telcom pit adj. unit 66, SE end presumed to contain asbestos.
