LIMITED GEOTECHNICAL **INVESTIGATION REPORT**

Job No:	211013
Address:	711 Henry Lawson Drive East Hill
Lot/DP:	Lot 21, DP 17857
Client:	New South Homes
Date:	20/09/2021
Issued:	A.E

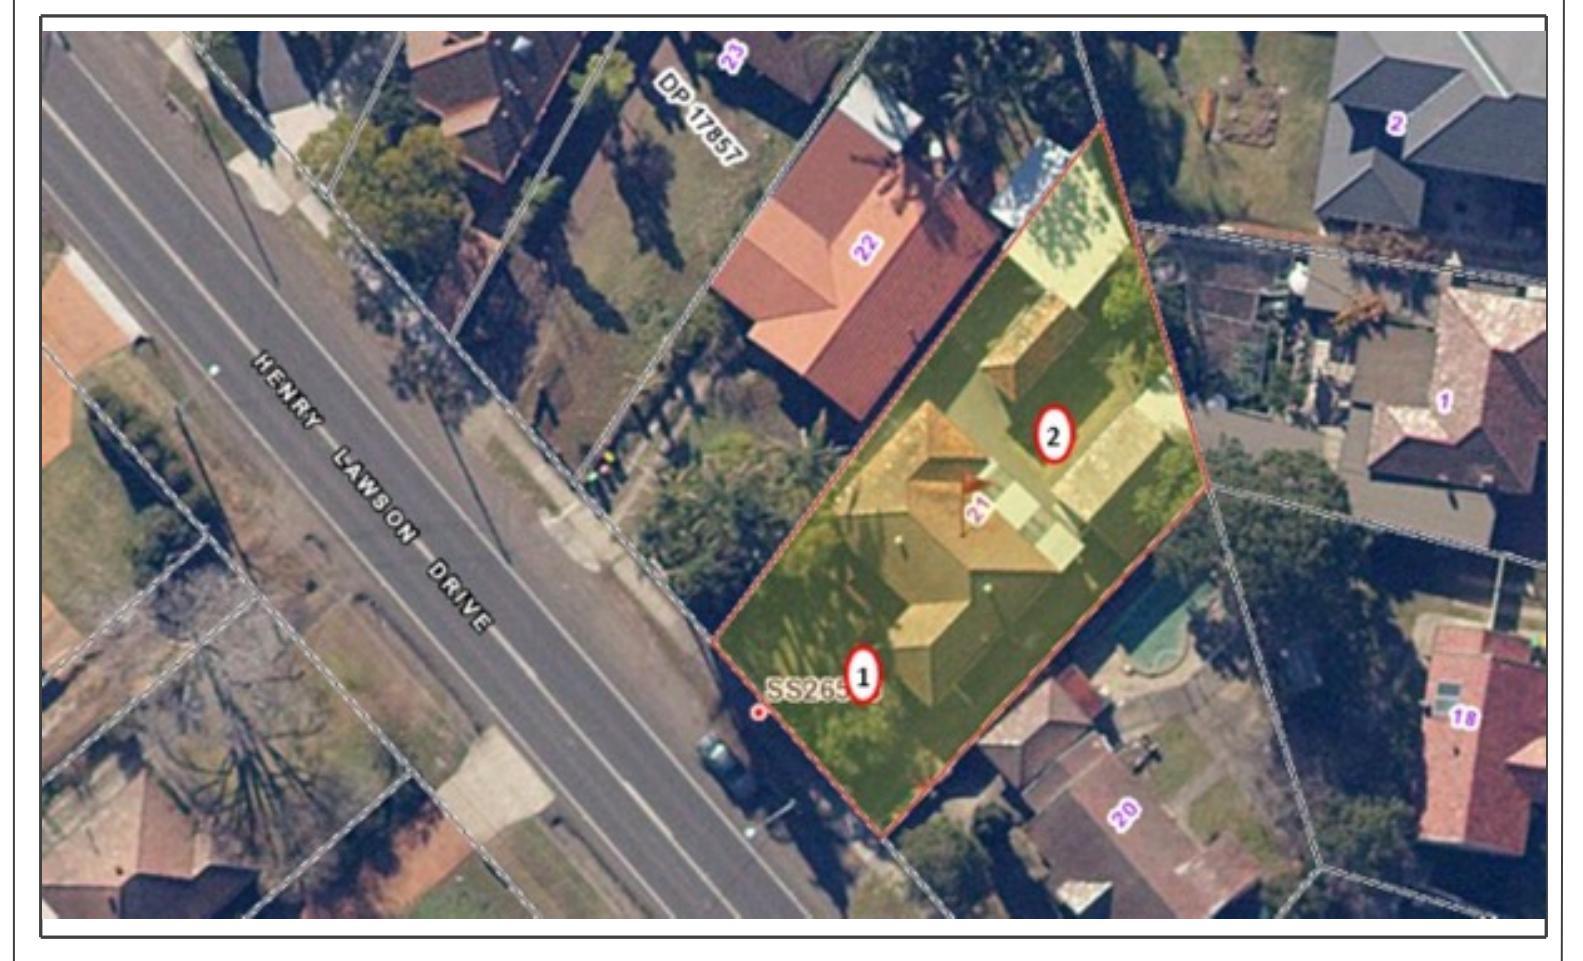
BOREHOLE LOCATIONS (NTS)

Medium to large trees located within the property and neighbouring properties. Inferred bedrock at DCP refusal. All footings are to founded within extremely weathered bedrock or better proportioned to a maximum allowable bearing capacity of 400 kPa.
