Merritts Mountain House Restaurant – Sewer and Water Services Thredbo NSW

EVT / Kosciuszko Thredbo Pty Ltd

Geotechnical Assessment

Our ref: 6713-1-G1 Rev 2 7 April 2022

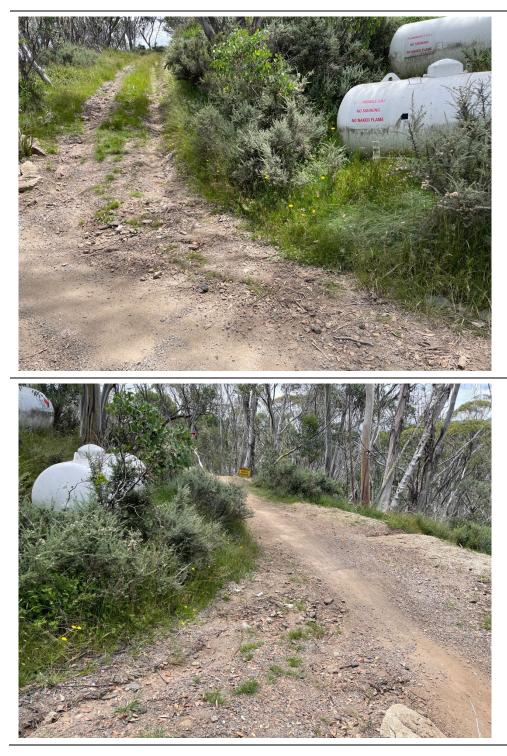
Photo 1

View of track down from Merritts Mountain House Restaurant past storage tanks

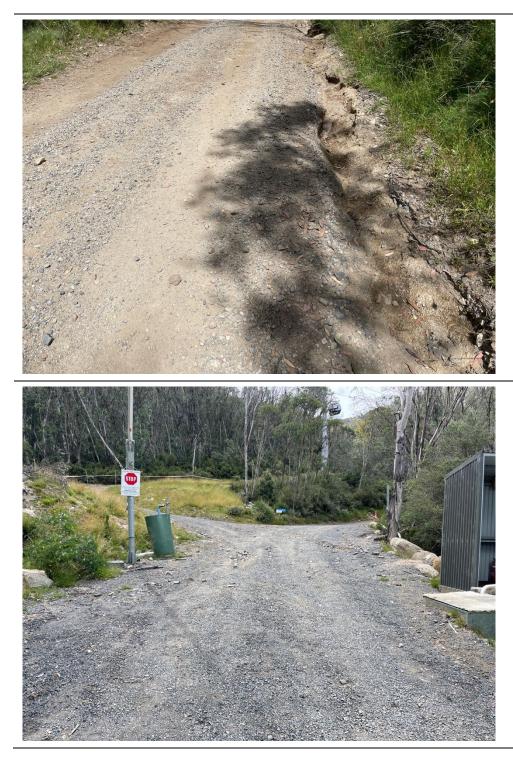
Photo 3

- Erosion protection measures must be maintained to prevent concentrated flows. For the access track, this has been achieved with regularly spaced berms to direct flows across the track and downslope of the road embankment via corrugated open channel. Consideration could be given to use of polymer binders to reduce erosion. Sections of pipeline through disturbed terrain should be vegetated over after construction to aid with erosion control.

Typical view of track erosion south of Merritts Mountain House Restaurant

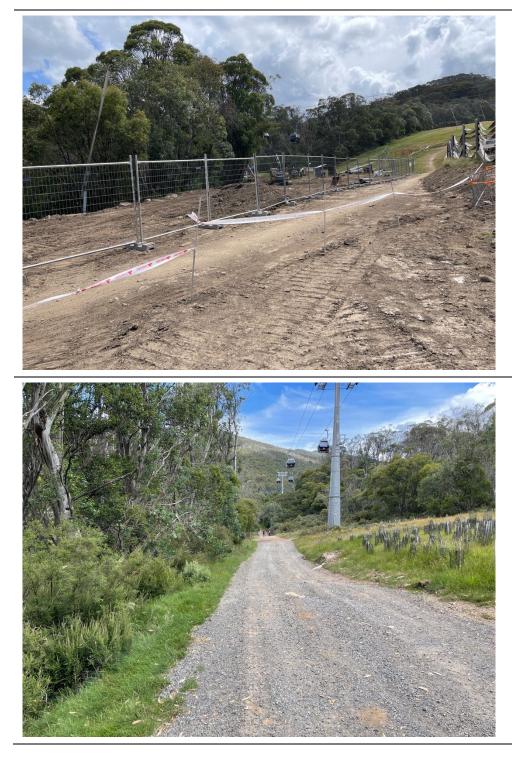
Photo 5

View of earthworks for nearby Sundowner Snowmaking Upgrade

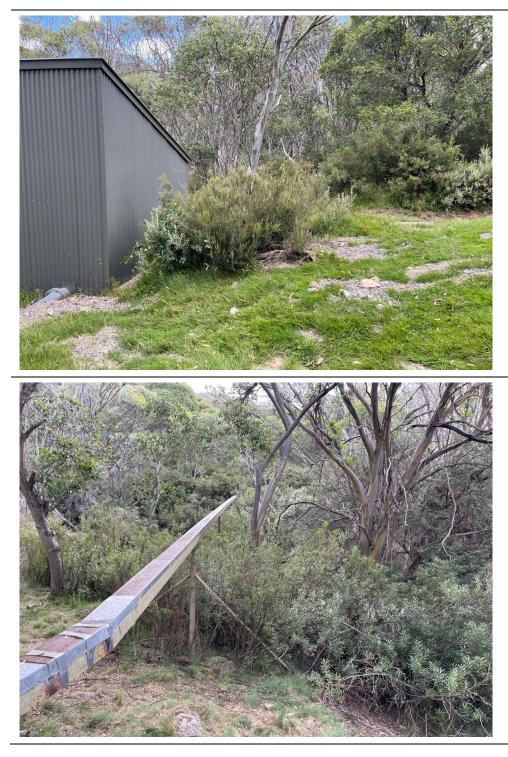
- Footings for the UV building should be formed on completely weathered or better granite, or dense or very dense sands, or very stiff or hard clays, and may be designed for a maximum allowable bearing pressure of 150 kPa. Further geotechnical advice should be sought if poorer foundation soils are exposed at footing excavation level.

View of UV Treatment building, showing location of new pump extension
