ARBORICULTURAL IMPACT ASSESSMENT REPORT

6 Miriam Street, Bass Hill

Rev & Mrs M Sleiman

28th February 2022

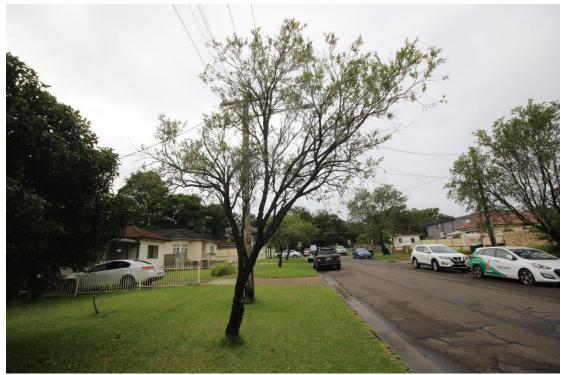
Plate 1: Street tree.

1. Tree 1 Callistemon viminalis is a street tree in front of the Site – refer plate 1.

The existing driveway will be moved towards this tree and a new driveway constructed on the east of this tree for Unit 2 - refer Annexure C.

These works are outside the TPZ of this tree, thus ensuring its retention.

Note this tree for retention and protection in the Tree Management Plan (TMP).

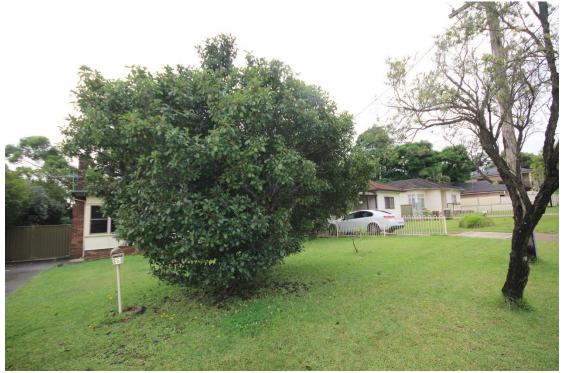
Plate 2: Tree 2.

2. Tree 2 *Photinia glabra* is showing good condition and form – refer plate 2.

The widening of the driveway has an encroachment of less than 10% of its TPZ, thus ensuring retention.

Note this tree for protection and retention in the TMP.

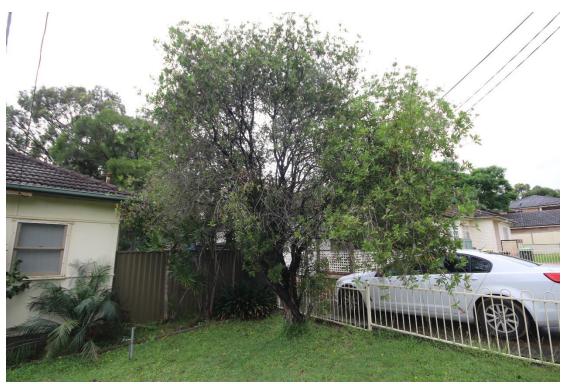
Plate 3: Tree 3.

3. Tree 3 *Callistemon citrinus* is showing good vitality with the typical internal dieback and deadwood – refer plate 3.

This tree is within the eastern corner of Unit 2, impacted by the driveway and access path to the rear of Unit 2 - refer Annexure C.

This tree is assessed to be of low retention value and can be easily replaced in the landscaping works.

Note this tree fOR removal in the TMP.

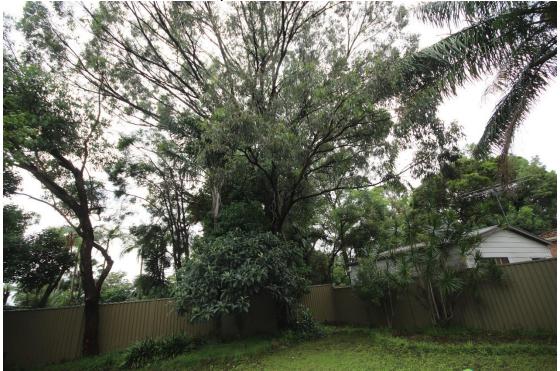
Plate 4: Trees 8 & 10.

5. Tree 8 *Eucalyptus botryoides* and tree 10 *Eucalyptus paniculata* are located along the rear boundary – refer plate 4.

The development works are well away from these trees and outside their TPZ, thus ensuring retention.

Note these trees for retention and protection in the TMP.

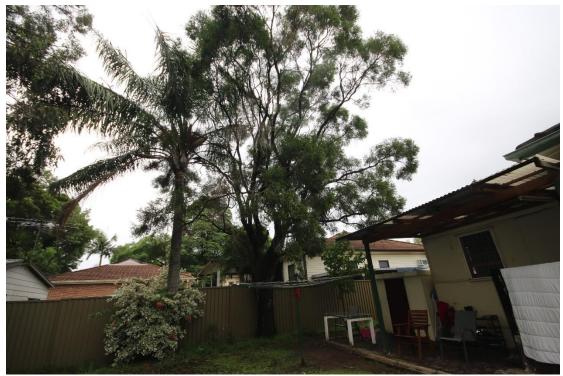
Plate 5: Tree 12.

6. Tree 12 *Melaleuca linariifolia* is showing fair condition and is located at the rear of the existing dwelling – refer plate 5.

The construction of Unit 2 has encroachment of 25% of this tree's TPZ which is assessed to be a major encroachment as described in Section 3 of AS 4970 - 2009.

This tree is located along the NSW coast on heavy soils and into Queensland³.

In this location it appears to be a planted specimen, rather than and remnant tree, therefore it is considered to be neither rare nor an endangered tree and can be supported for removal to allow the development to proceed.

There is ample space on Site to replant an endemic species found in the Bankstown area, e.g., *Eucalyptus moluccana, Eucalyptus tereticornis, Backhousia myrtifolia or Casuarina glauca*⁴

Note this tree for removal in the TMP with the replanting of one endemic tree.

- e) That one tree be replanted on site to compensate for the removal of Tree 12 and selected from the following species: *Eucalyptus moluccana, Eucalyptus tereticornis, Backhousia myrtifolia or Casuarina glauca.*
