Bushfire Assessment Report

Snowy River Ski Club

Doorack 8 Farm Ck Place, Guthega 2624

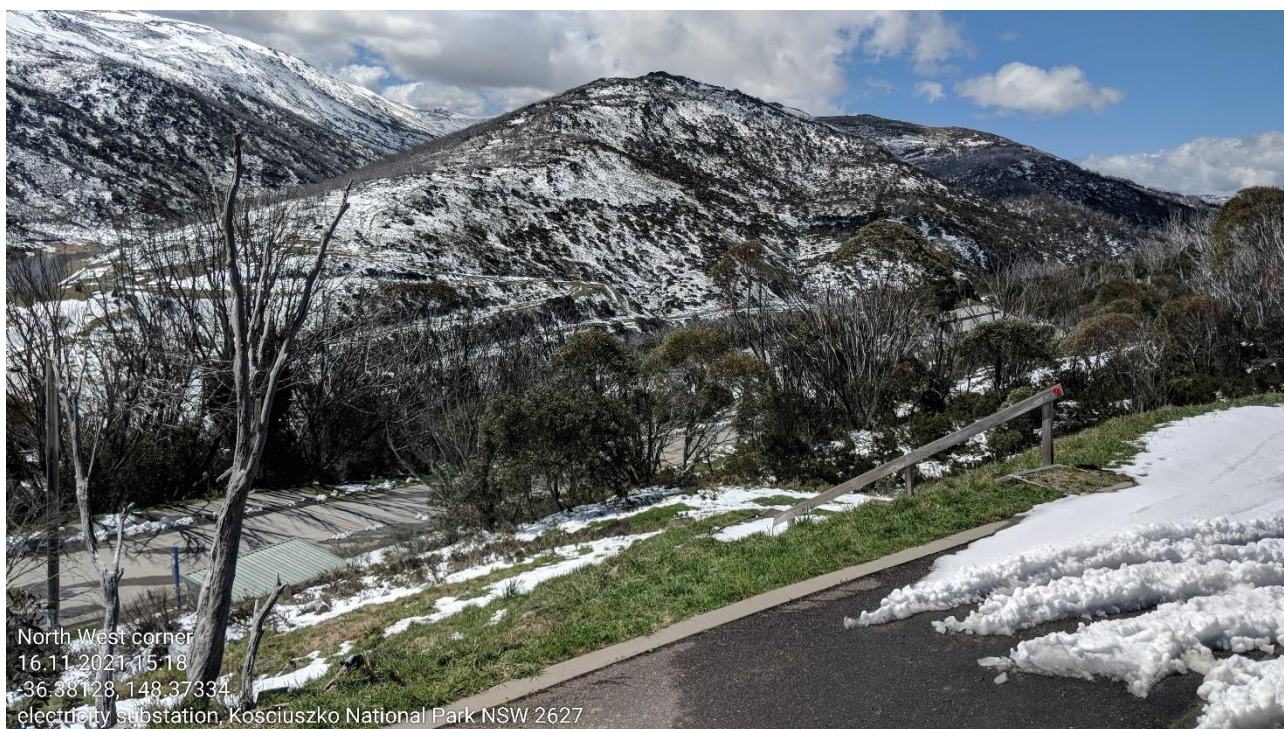
The immediate area in front of the lodge down to Farm Ck place is maintained as cultivated shrubs below 500 mm in height by club members. There is a small dead snow gum slightly west of the Northwest downslope below Farm Creek place about 20 m from the building. The remainder is grassland broken by two separate widths of sealed road. This area being grassland and devoid of flora over 500 mm in height and broken by two sealed roads is considered BAL-40. The closest Alpine woodland area is about 40 m below the lease across Mount Tate Road and Farm Creek Place; some mixed low woodland (pictured, below) is further away in a more northerly direction beyond Jagungal. The presence of Alpine woodland means this part of the downslope would be considered BAL-FZ. The average downslope to the water at Guthega dam 400m away is about 15° – information taken from topographic map of the area.

View NW from ground level at entrance

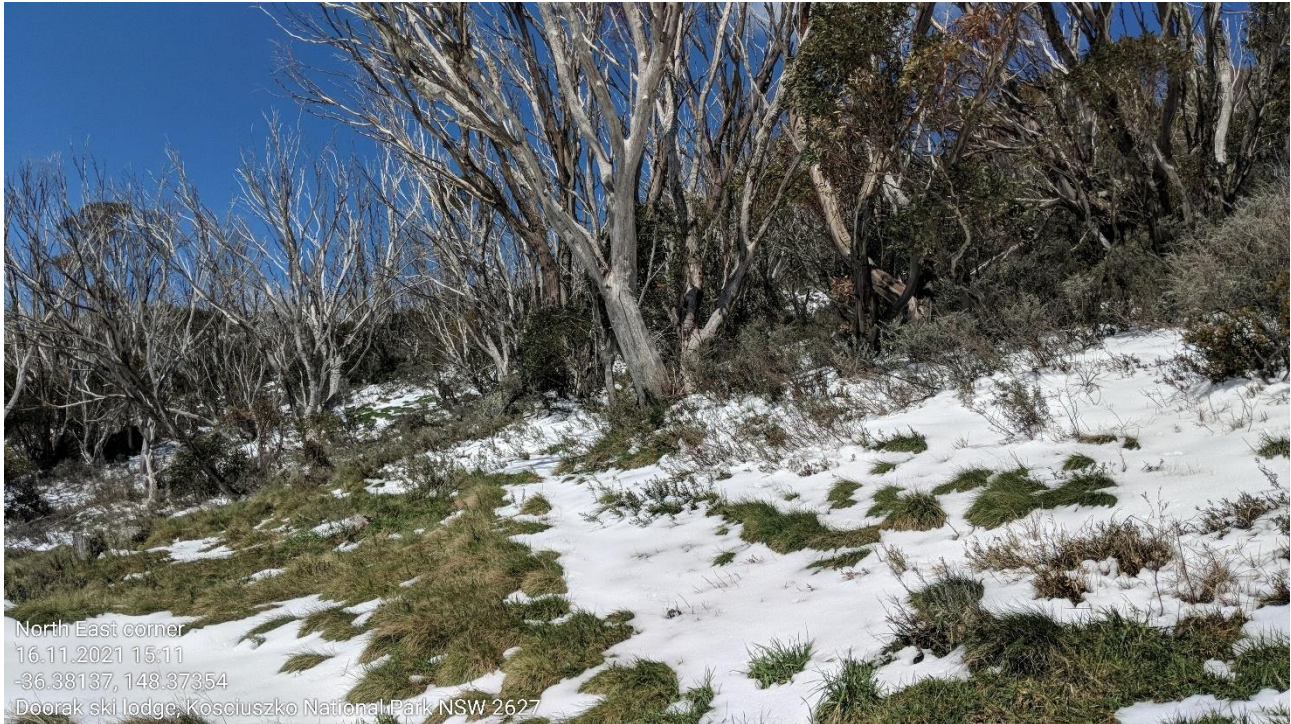
The more northerly aspect faces Jagungal Lodge and is entirely maintained grassland by both clubs at 100-200 mm in the absence of snow cover. There is a level vehicle turnaround on the Jagungal lease and the Doorack side is essentially level between the two lodges with a downslope contiguous with the northwest aspect. The more easterly upslope area between Doorack and Jagungal is jointly maintained as grassland <100mm height by the two lodges and is considered BAL-29

View NE from fire escape

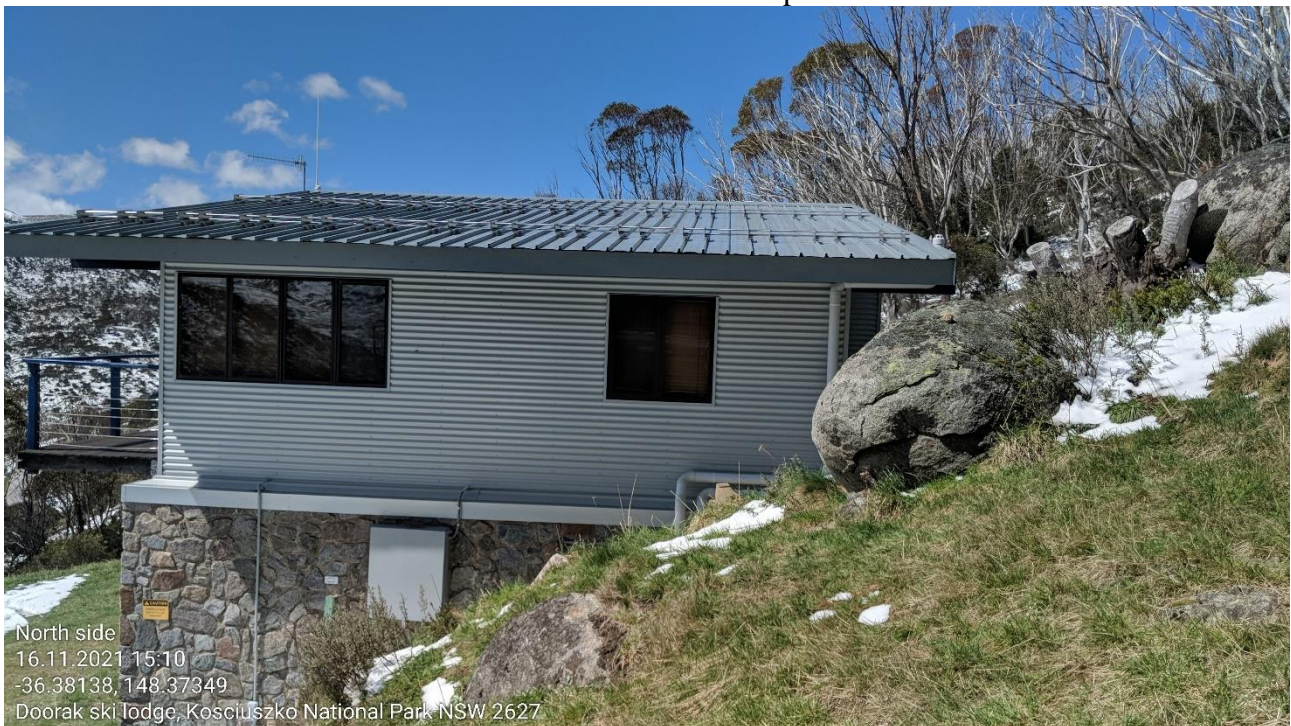
North, facing Jagungal

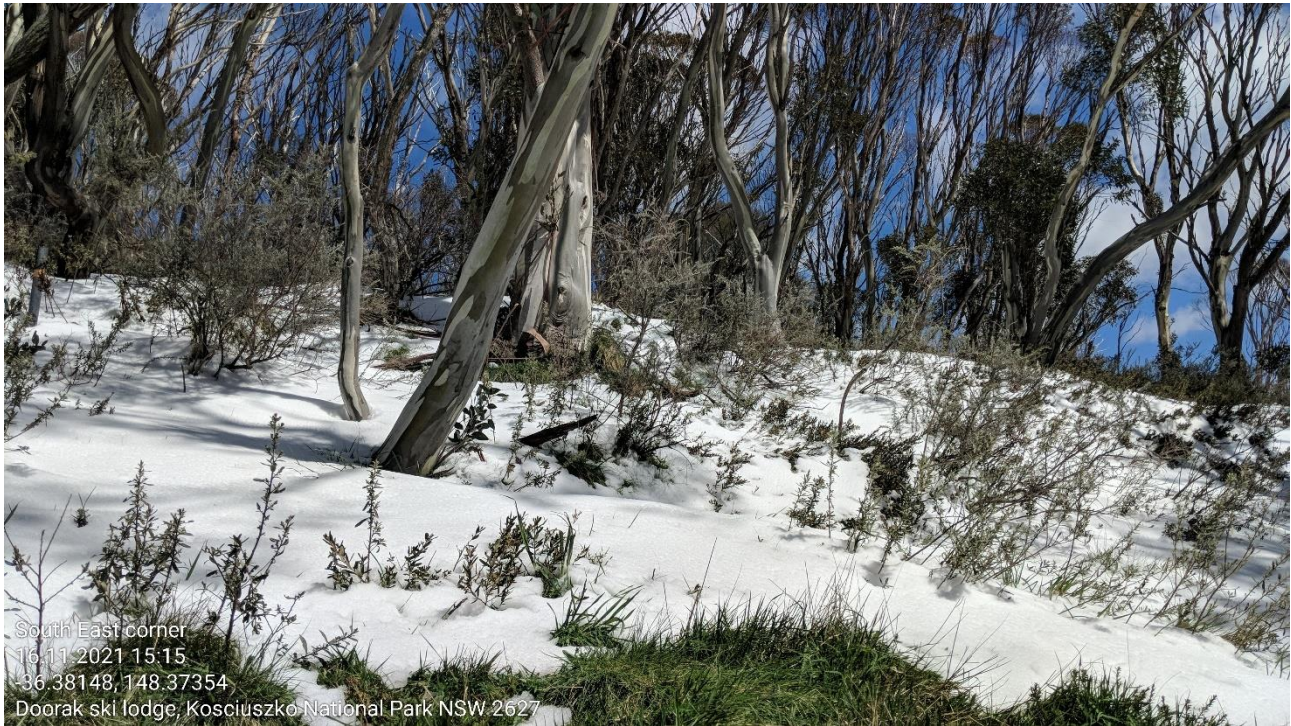
An upslope of about 15°, contiguous with previously noted topography, is maintained by the club as grassland with some low shrubs to 10 m from the building. Above that is Alpine Complex with trees up to 1.5m circumference at 500mm above ground level. The grassland upslope, extending to 10 m from the lodge, is considered BAL-29 and the Alpine Complex bushland beyond is considered BAL-FZ. This classification and proposed cladding and ember attack protection will be considerable improvements over the existing structure. The Club is prepared to share required management of area beyond the lease with NPWS.

View SE showing closest upslope tree

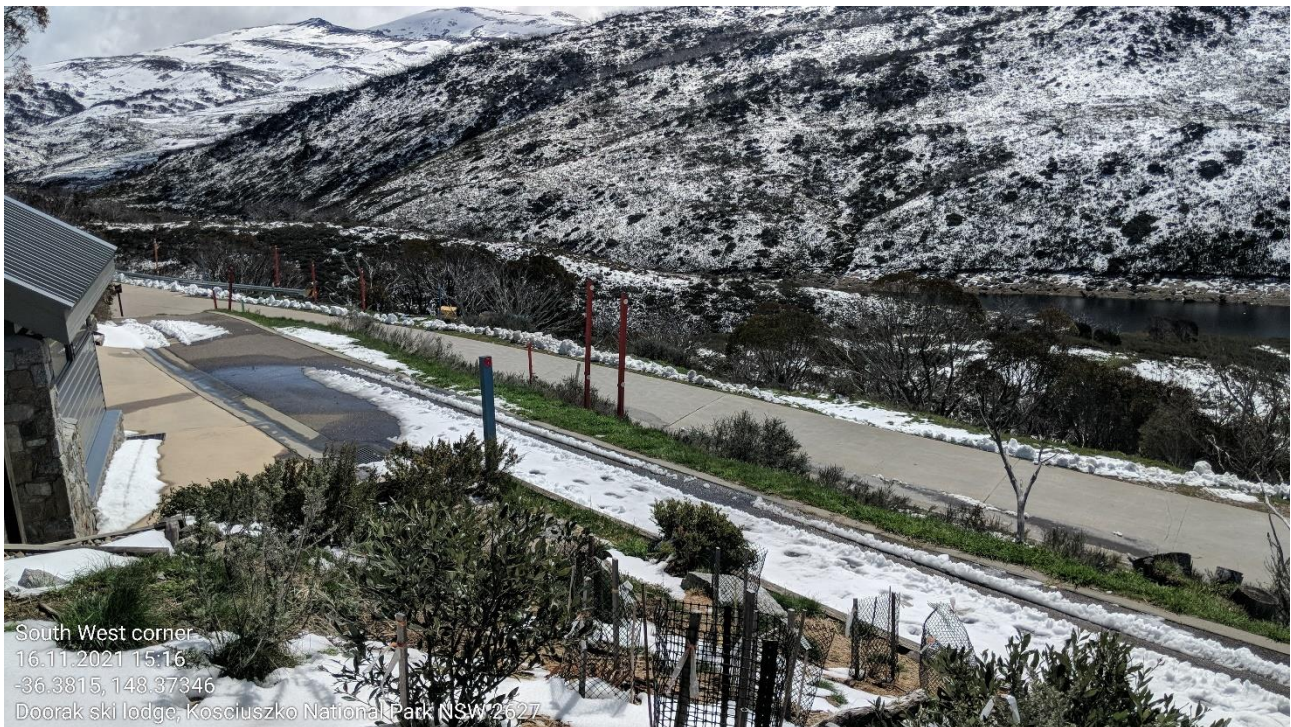
The lease boundary with Turnak is less than 3m from the Doorak front deck fire escape. The Doorak side of the boundary is maintained grassland <200mm in the absence of snow cover. The Turnak side is managed low shrubs and some lopped snow gums. The Southwest aspect is essentially level in the direction of Turnak, with a downslope in the westerly direction contiguous with the northwest aspect described above. The area between Doorak and Turnak is jointly maintained as grassland <100mm height by the two lodges and is considered BAL-29.

View SW from Deck

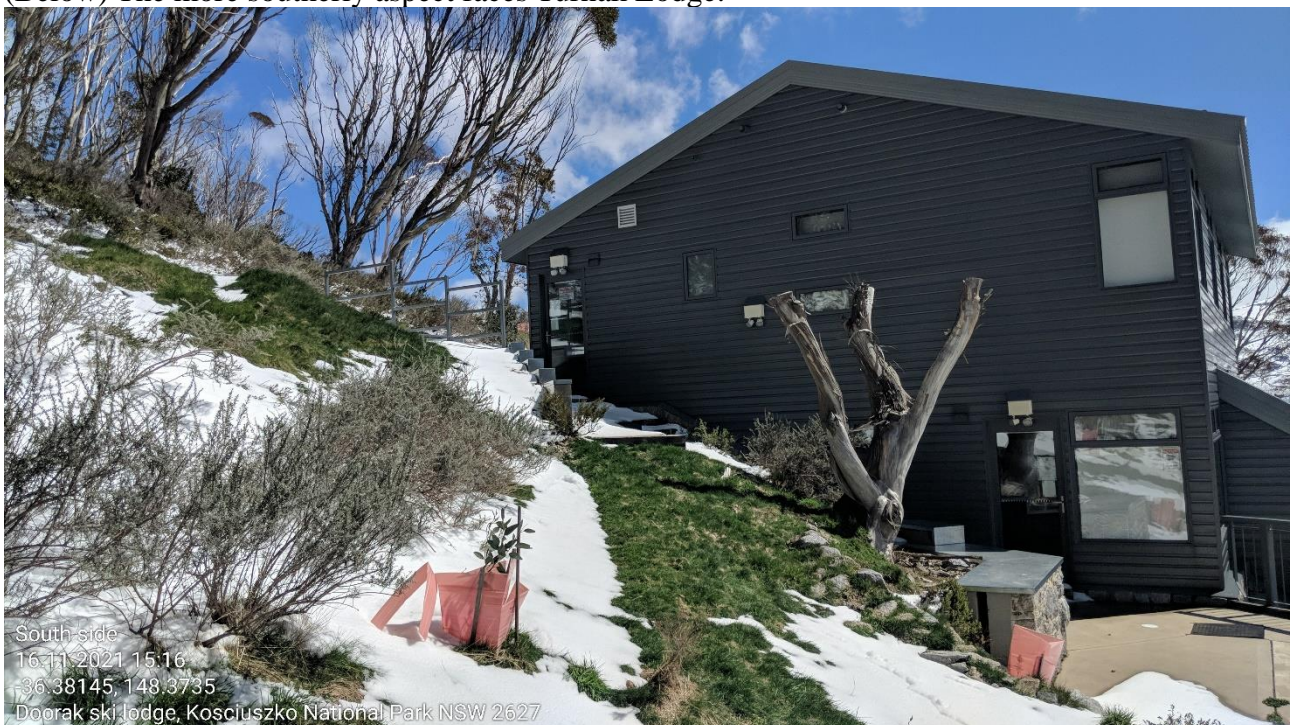
(Below) The more southerly aspect faces Turnak Lodge.

View southwest towards Turnak
