## **Proposed J-bar Ski Lift Perisher NSW**

Geotechnical Investigation

Our ref: 6728-G1 Rev 1  
22 August 2022

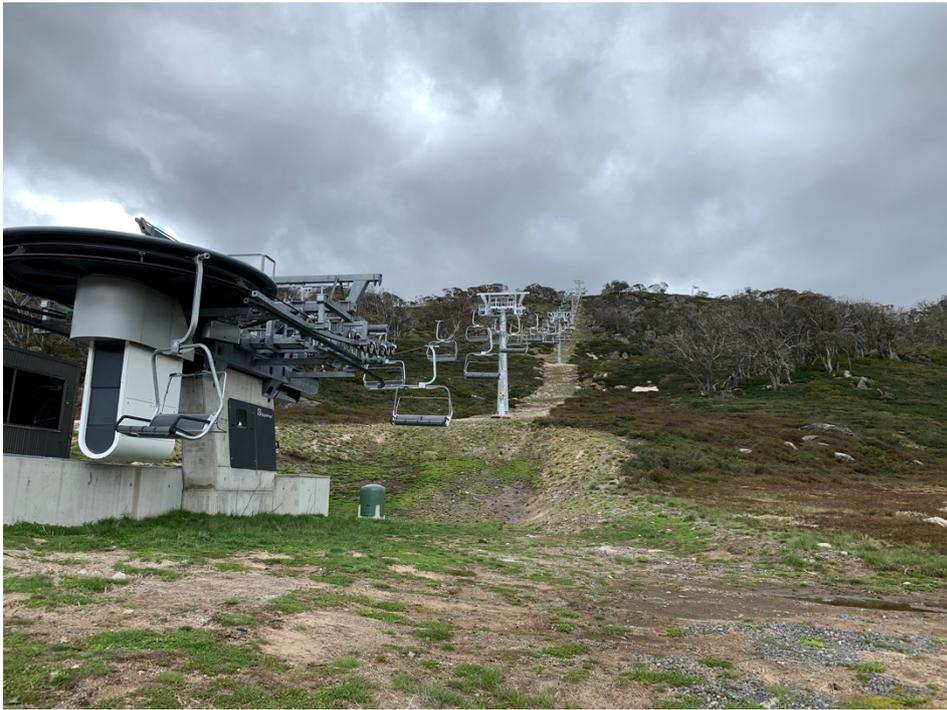
Photos 1 to 2 shows the lower part of the proposed bottom station. Photo 3 shows an area of ponded seepage in the vicinity of the existing bottom station. The existing Leichhardt Chairlift and Home Rope Tow lift bottom stations appeared to be in modest condition.

**Photo 1**  
Overview of the  
proposed ski lift area.

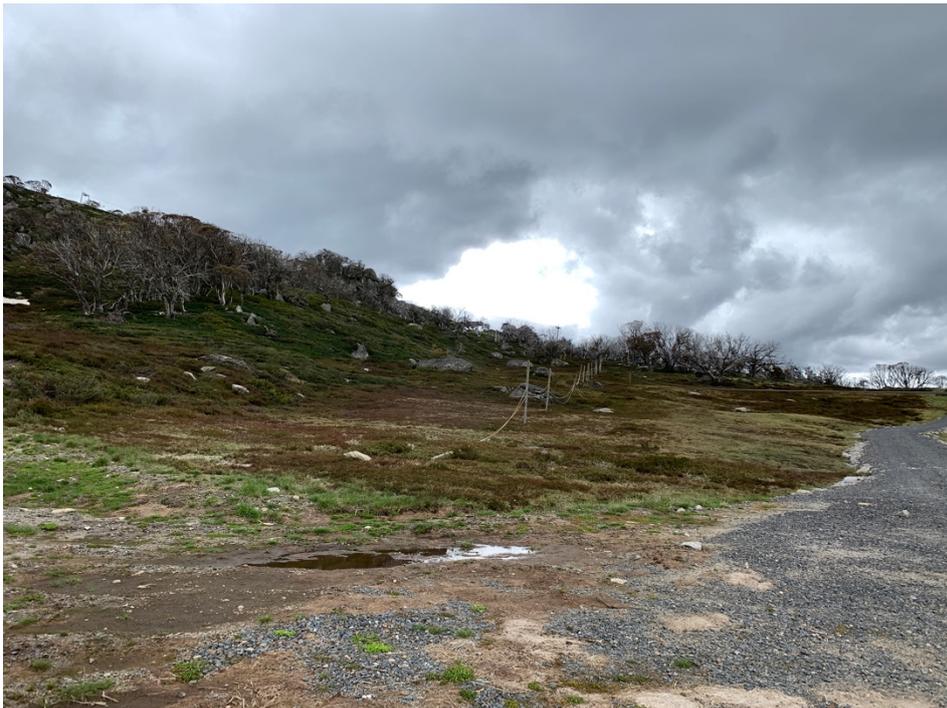
**Photo 2**  
Continuation of Photo  
1

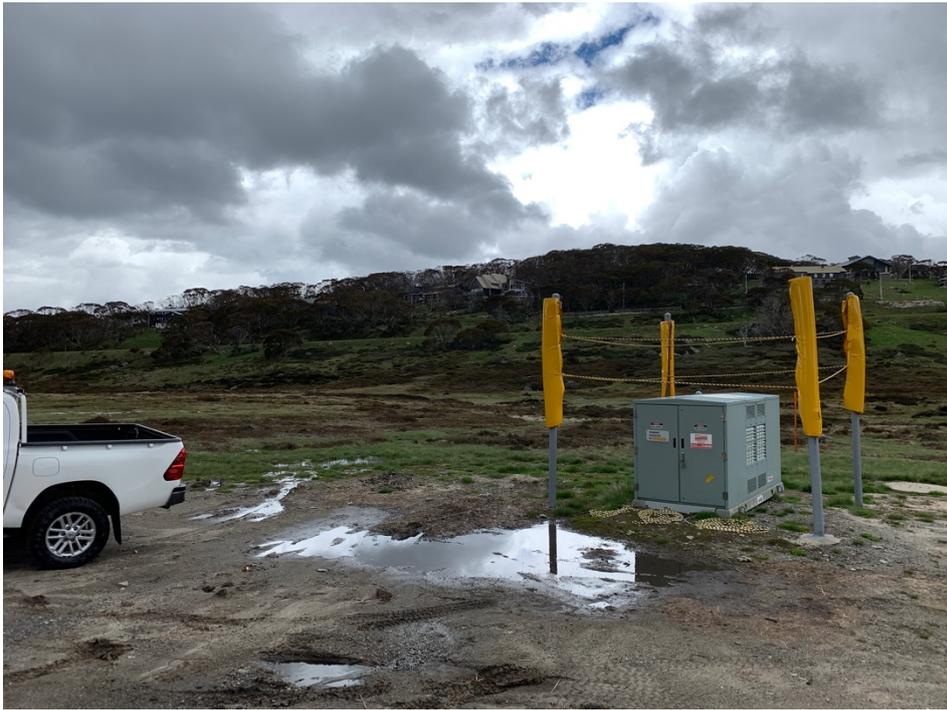
The mid slopes are generally free draining with regards to surface water flows. However, the lower slopes were observed to have areas of waterlogged soils and free surface water at the time of the fieldwork.

**Photo 3**  
Saturated/  
Waterlogged subsoil  
condition at bottom of  
the slope onsite.

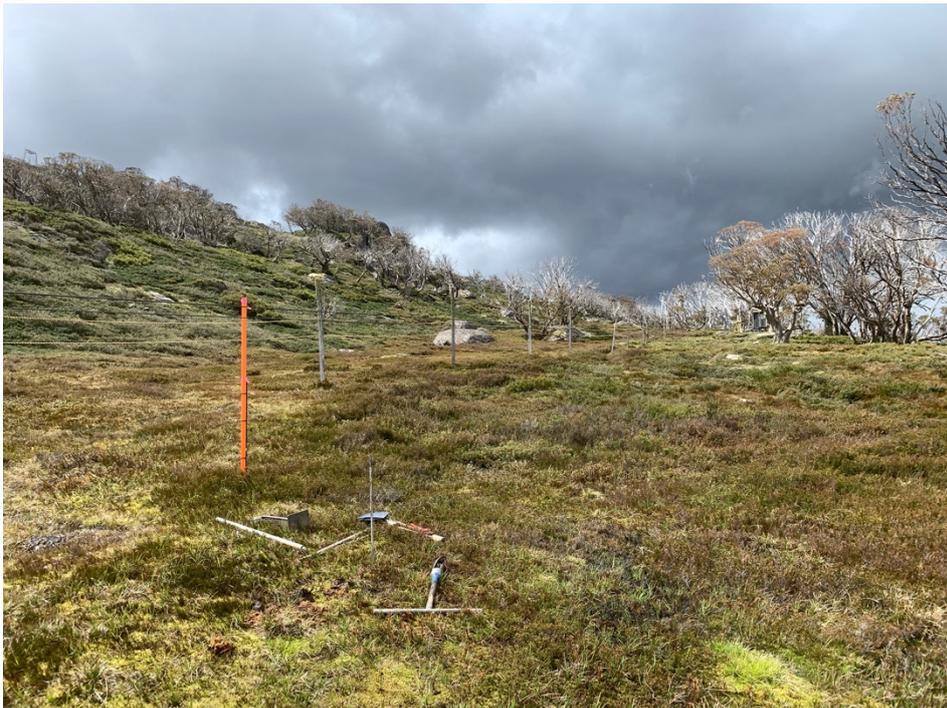
**Photo 4**  
Hand Auger Borehole  
and DCP sounding at  
BH2 location.
