Proposed J-bar Ski Lift Perisher NSW

Geotechnical Investigation

Our ref: 6728-G1 Rev 1 22 August 2022 Department of Planning and Environment

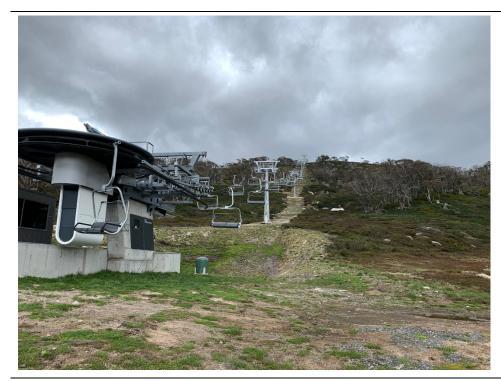
Photos 1 to 2 shows the lower part of the proposed bottom station. Photo 3 shows an area of ponded seepage in the vicinity of the existing bottom station. The existing Leichhardt Chairlift and Home Rope Tow lift bottom stations appeared to be in modest condition.

Photo 1 Overview of the proposed ski lift area.

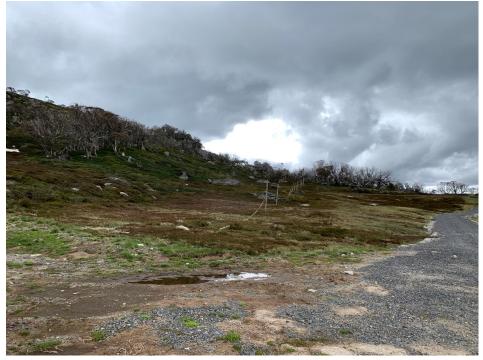
Photo 2 Continuation of Photo 1

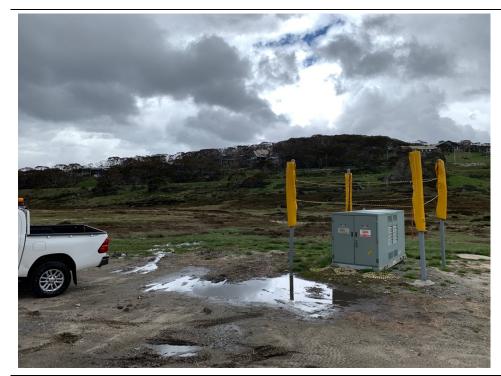
The mid slopes are generally free draining with regards to surface water flows. However, the lower slopes were observed to have areas of waterlogged soils and free surface water at the time of the fieldwork.

Photo 3 Saturated/ Waterlogged subsoil condition at bottom of

the slope onsite.

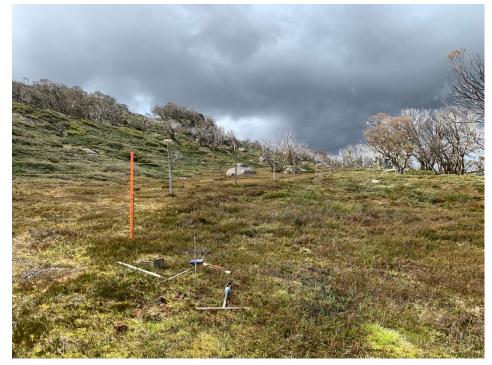
Photo 4

Hand Auger Borehole and DCP sounding at BH2 location.
