16/11/2020

Re: Supplemental Aboriginal Due Diligence Heritage Advice – Mt Selwyn Snow Resort

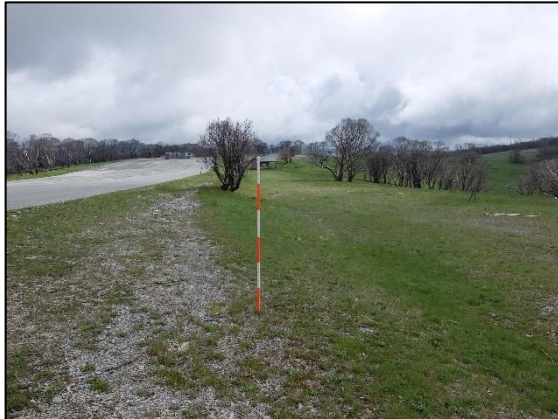
Plate 1. Looking north along road corridor

The alignment for the proposed trenching follows the eastern side of Kings Cross Road, a zone known to have been substantially altered by successive phases of landscape management. Field assessment confirms this observation, with the following specific forms of impact being apparent:

- ❖ Construction of the main sealed road feature;
- ❖ A gravel and earth bund approximately 10 metres wide directly adjacent to the eastern margin of the sealed road;

- ❖ A graded and levelled ancillary vehicle track or service corridor approximately 20 metres wide paralleling the eastern side of the road; and
- ❖ A mechanical push of mixed local soil and imported gravels several metres wide running along the eastern edge of the ancillary track.

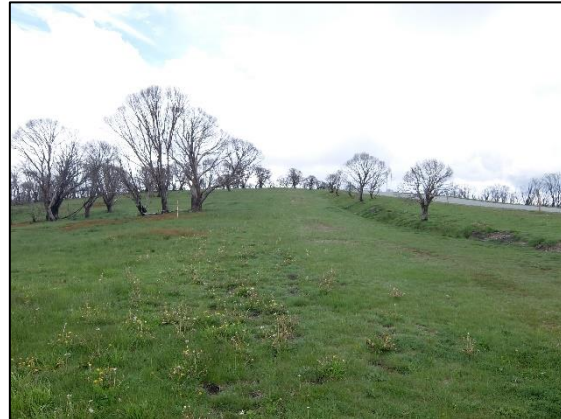
Plate 2. Looking south showing landform disturbance, reshaping

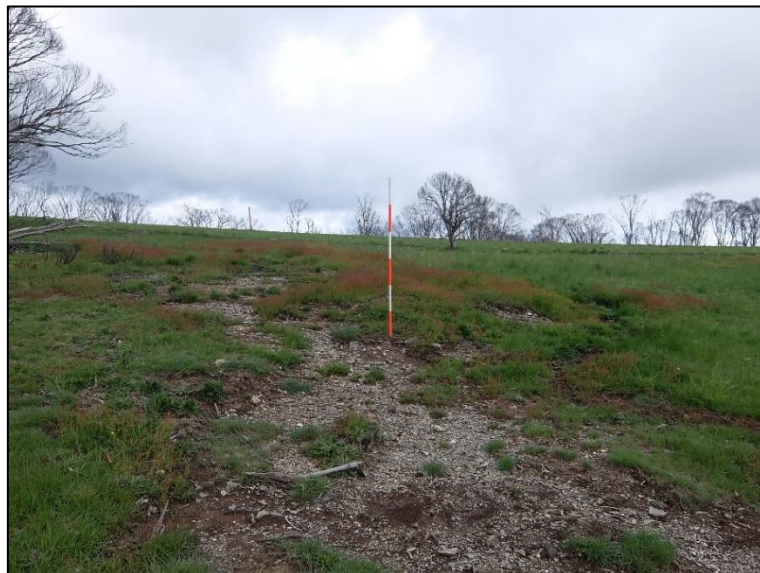
Plate 3. Site location looking south along road alignment.

As noted by Feary in 2010, the location comprises an eroded surface in the upslope vicinity of a natural spring or soak. Landscape position is a low gradient upper slope or ridge side/crest interface. Following the recent bushfire events the surface exposure may be expected to have expanded in extent and during the current inspection was measured at 20m x 5m in area with very high levels of surface visibility. The deposit within the exposure area is a medium to dark brown alpine loam soil of indeterminate depth with a surface lag of locally sourced gravels. Bedrock (likely of metamorphic rock) is apparent in occasional adjacent low outcrops.

The stone artefacts noted by Feary in 2010 were not relocated and no additional archaeological items or features were found during the inspection of the exposure or surrounding landscape surfaces. Given the intervening period between the original artefact recording and the current assessment, it is not surprising that the three stone artefacts apparent at the location in 2010 are no longer visible, particularly considering surficial processes associated with ongoing solifluction, bushfire and bioturbation.

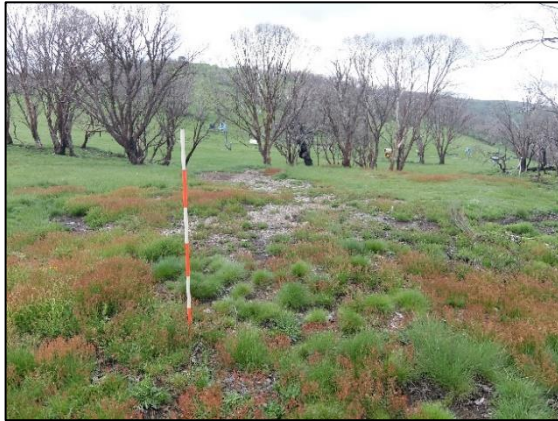
Plate 4. Looking East

The impression gained through field visitation is that the artefact-bearing exposure is a relatively concise feature that indicates the presence of a very low to low density artefact scatter associated with lightly impacted to considerably disturbed deposits directly abutting the substantially altered landscape of the road corridor.

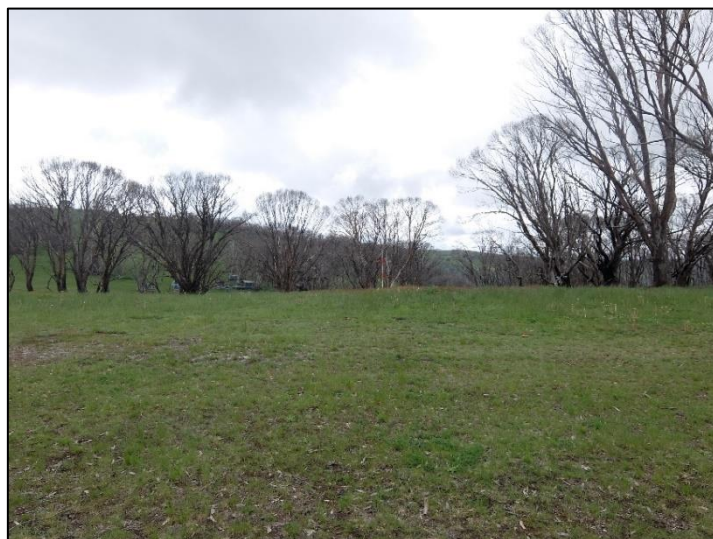
The location of the artefacts and any comparatively undisturbed associated deposits lies approximately 40 metres from the edge of the sealed road surface or 30 metres from the edge of the road bund and is separated from this zone by approximately 20 metres of levelled surface and mixed, redeposited sediments and rock. This intervening area of disturbed soils is shown in Plate 6.

Plate 6. Looking east – Ranging pole marks site exposure – intervening surface heavily disturbed

As a result of the localised nature of the artefact scatter, and the wide intervening area of disturbed landform between the proposed works and the identified site location, no heritage impacts are anticipated from the proposed works.

The placement of the trench adjacent to or within the disturbed areas associated with the road and bund and the containment of construction plant within the levelled ancillary track corridor will ensure that all works are remote to any identified archaeologically sensitive areas.

Recommendation 1: Works to proceed without further heritage assessment.

If any alteration of works is undertaken, which will reduce the intervening distance from the identified heritage site, then protective barrier fencing may be required. In any alteration of footprint, re-assessment of impacts will be required.
