Montessori Academy Group Developments Pty Ltd

Hazardous Materials Survey

Proposed Development at: 427 Burwood Road Belmore NSW 2192 Lot 8 - 12 / - / DP11289 & Lot A / - / DP420721

E2126-1 1st March 2021

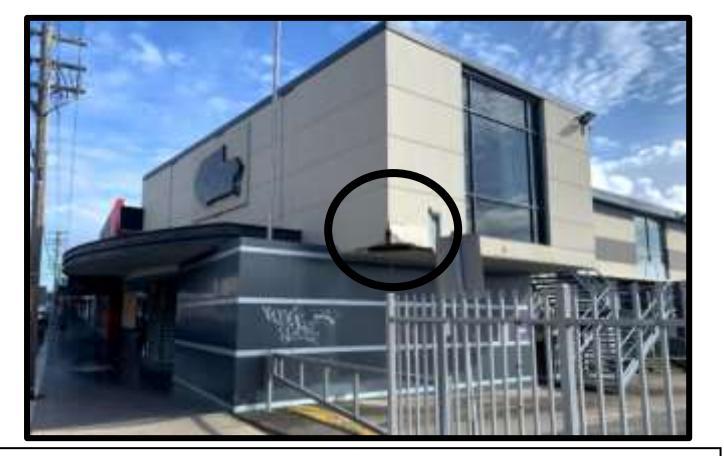
Image 1: Depicts the front view of the site. The site is a twolevel structural dwelling used for commercial purposes. There is a vent coming out of the structure. In addition, there is an area which is eroding (seen from circle).
