ARBORICULTURE IMPACT ASSESSMENT REPORT

Corner Faunce and Young Streets, West Gosford

Prepared for: Urbis

14 December 2022

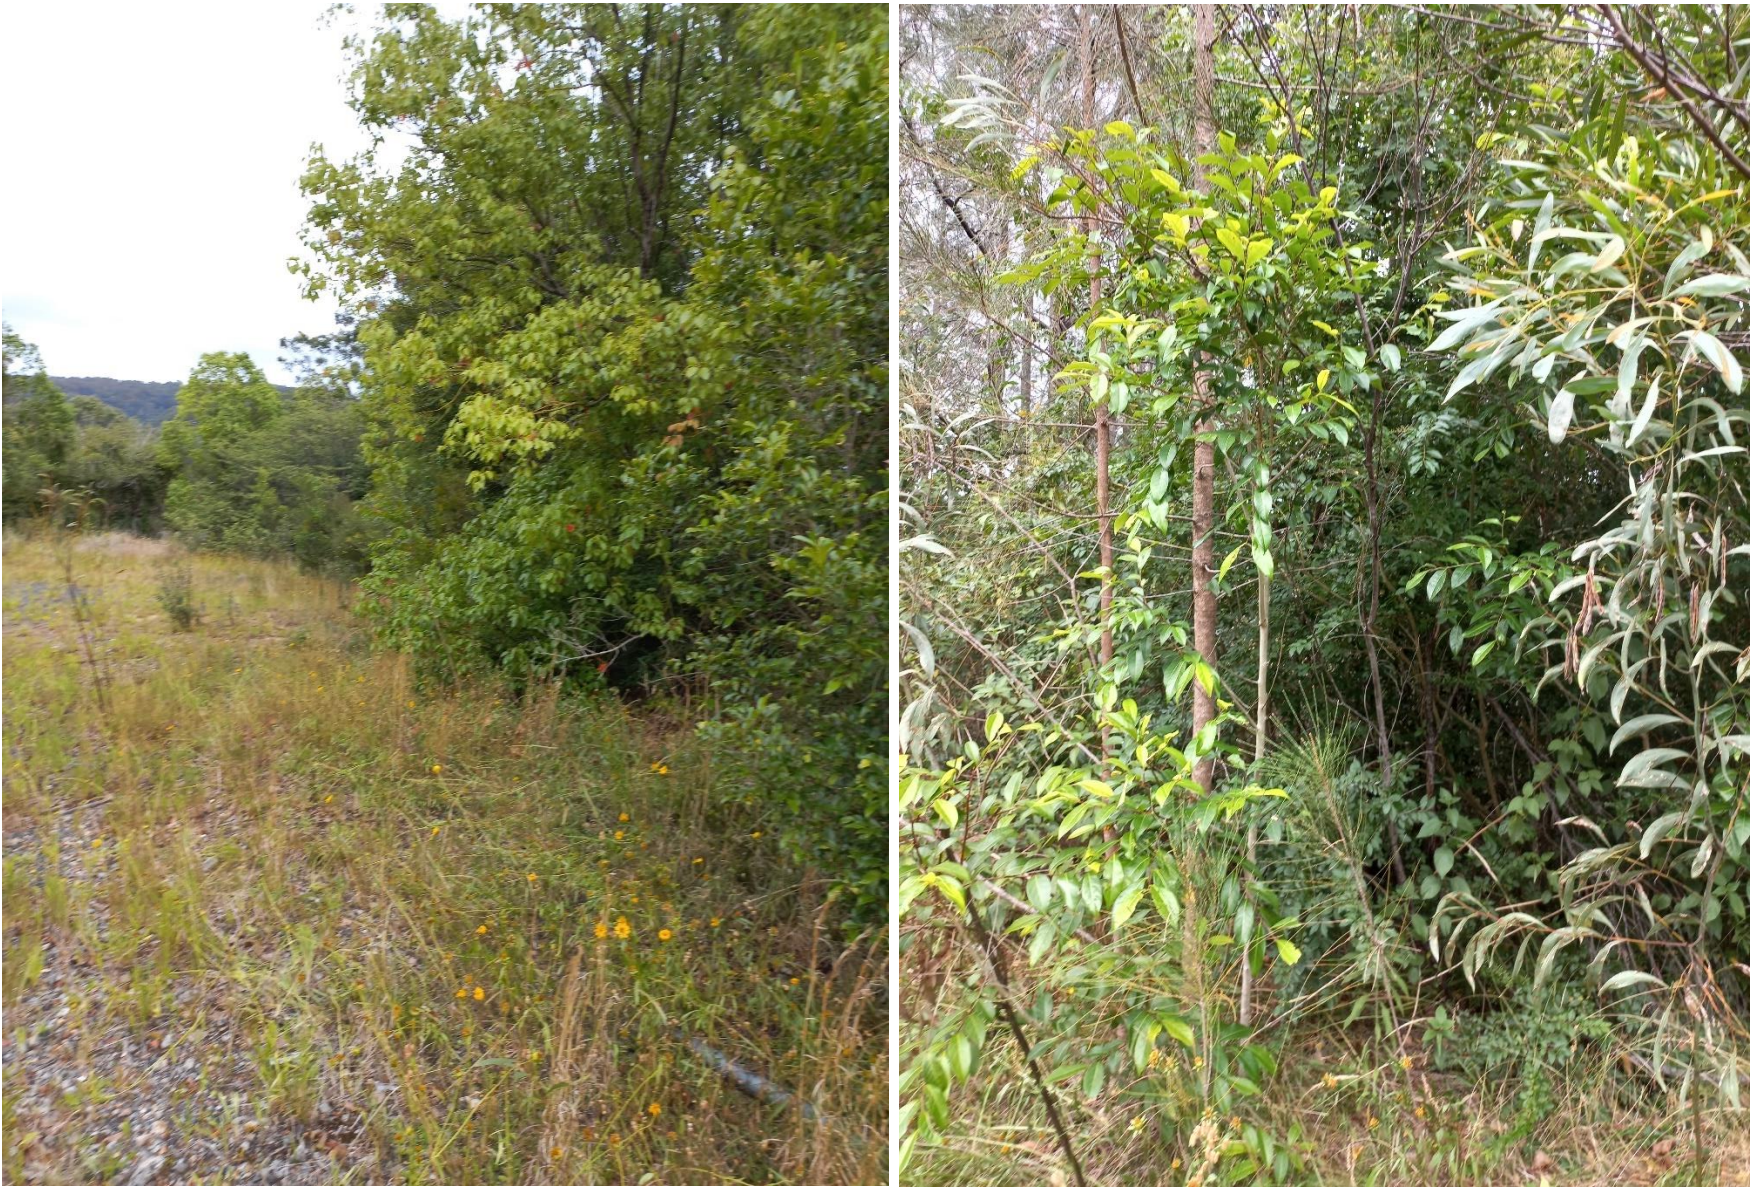
Figure 2 – Overgrown Vegetation

The site is opposite to the Gosford Entertainment complex owned by racing New South Wales. The site is used as a parking ground during events, on a monthly basis. The remaining parts of the site consist of unmaintained heavy shrubs including lantana and black berry, along with saplings of Casuarina glauca and Camphor laurel. The boundary of the site was also covered in over grown vegetation. Along the entrance to the site, there was strong evidence of trees in poor condition being affected by powerlines (See Figure 3).

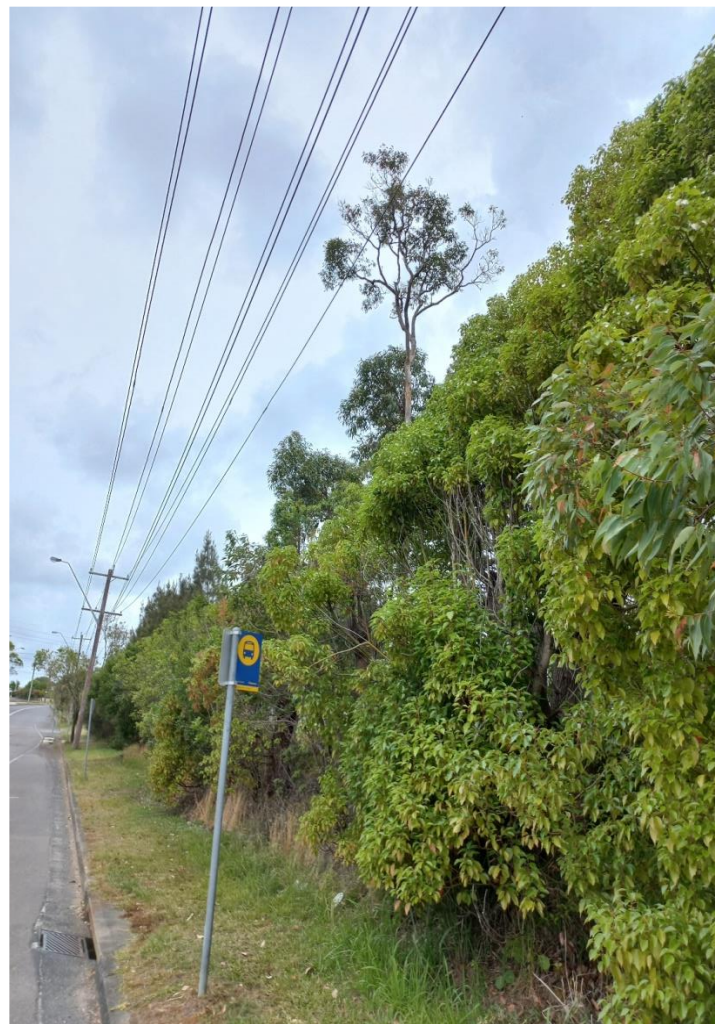
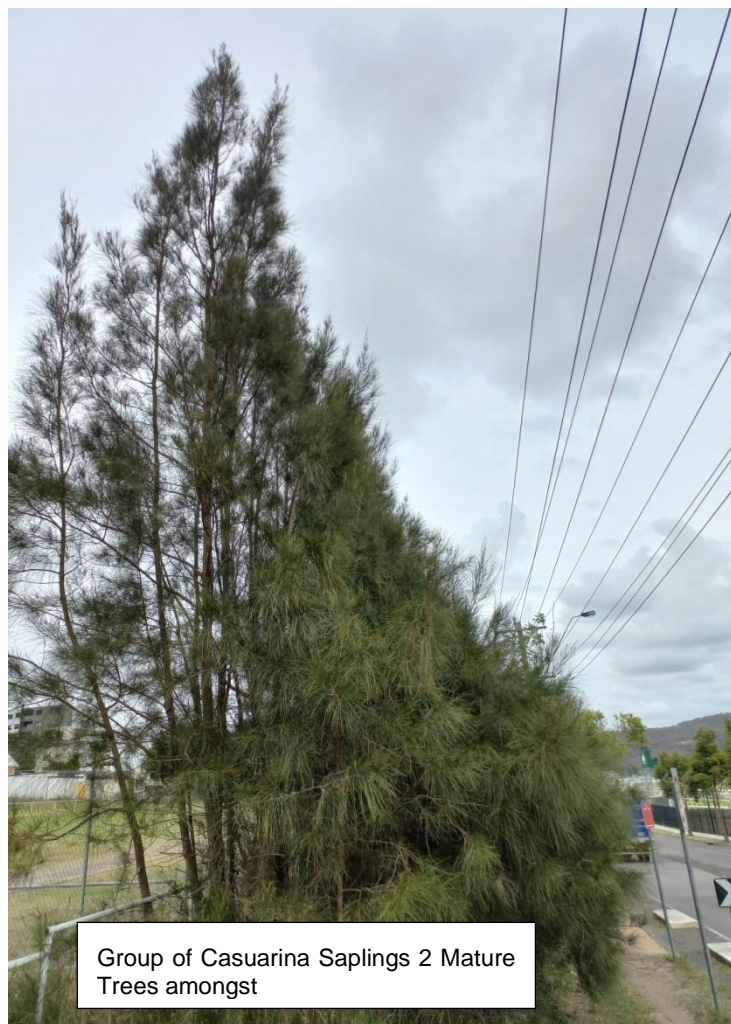
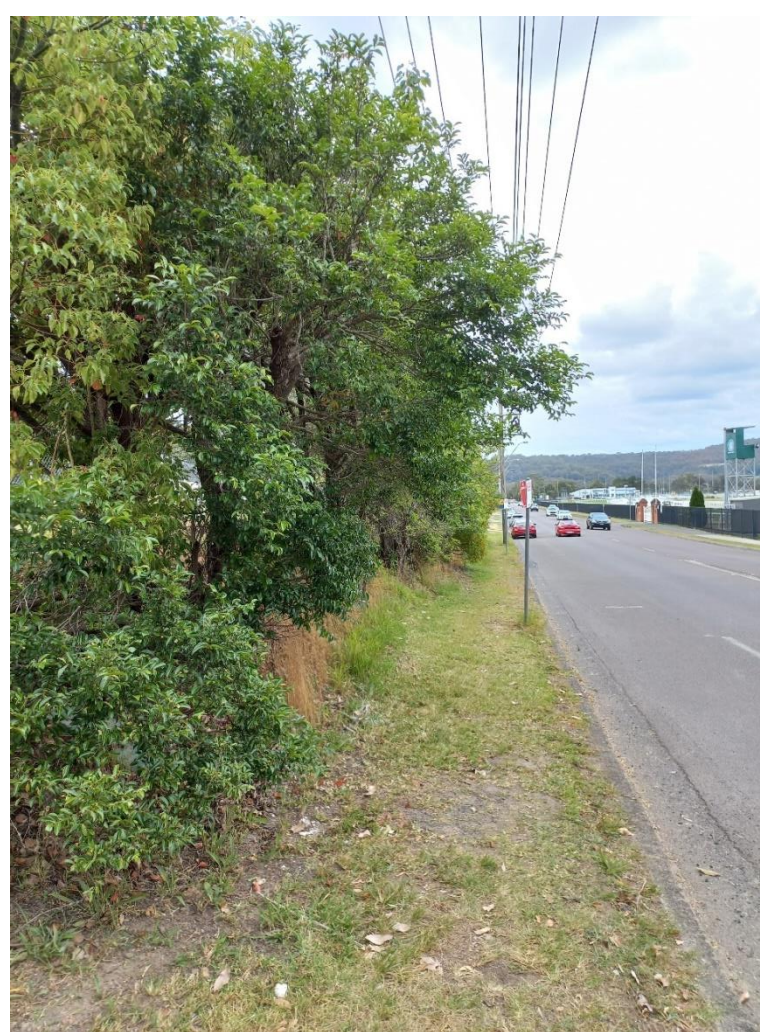
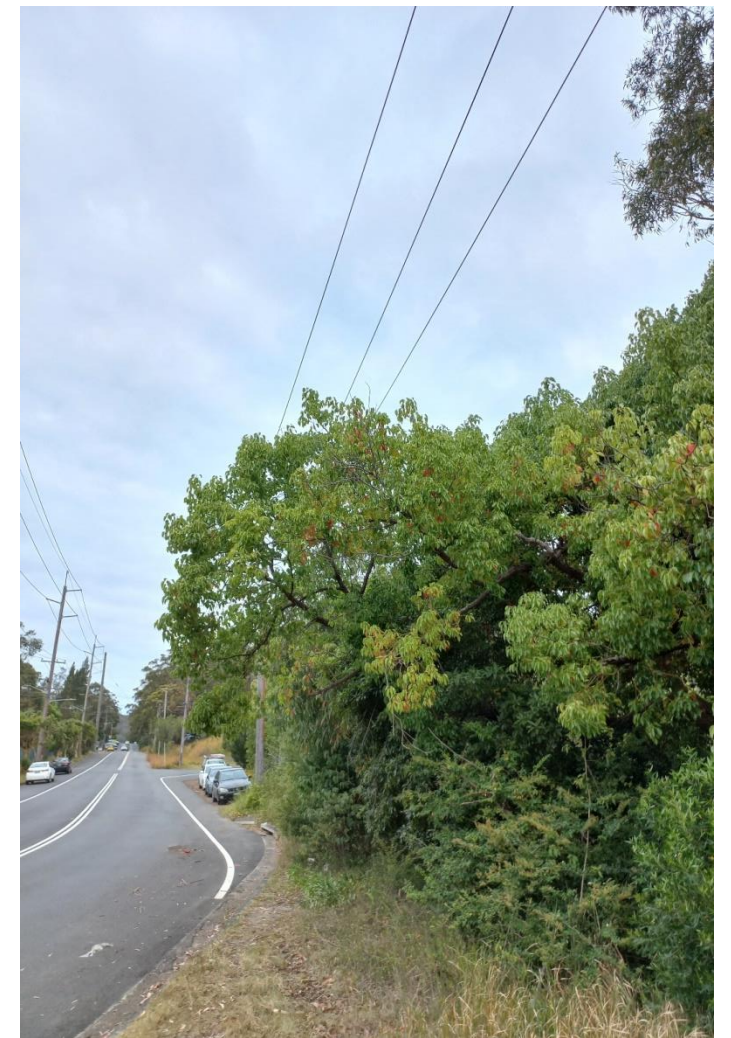
Figure 3 – Power lines outside the site

It is noted that trees 128 and 129 form part of an endangered ecological community where the two mature trees are amongst a group of saplings. The TPZ will be encroached however the species will tolerate encroachment. See photo 2 in Figure 3 – Power lines outside the site.

The majority of the trees on site are of poor quality and retaining trees with poor form and structure would not be viable. It is recommended to retain the trees on the council managed land as they are native casuarina glauca however it is noted that these trees are heavily affected by powerline maintenance.

Trees; 99, 98, 97, 103, 126, 127, 130, 131, 132, 133, 134, 135, 136, 137, 138, 139, 140, 141, 142 and 143 are along Racecourse Road on the Central Coast Council's nature strip are mainly Angophora floribunda trees. These trees are significantly affected by powerline pruning and are of poor condition. It is recommended that these trees be replaced with the same or similar species throughout, suitably sized and included in the landscape design, away from utilities such as power supply.
