# **Proposed Development**

# 2-10 Faunce Street West Gosford

# 18 July 2024 (REF: URB09)

### ARBORICULTURE IMPACT ASSESSMENT REPORT

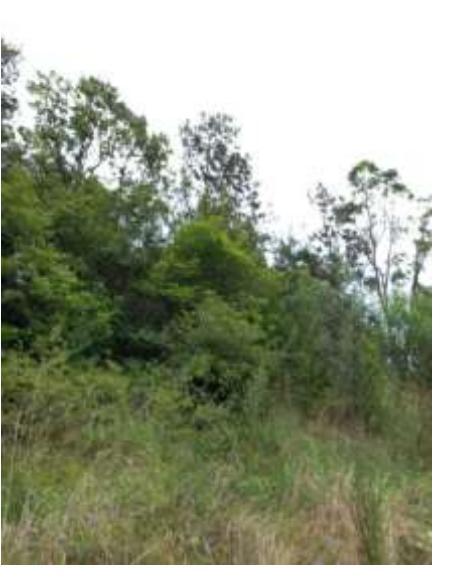
Cinnamomum camphora (Camphor laurel) is in abundance on site.

Figure 3 - Cinnamomum camphora (Camphor laurel) on site

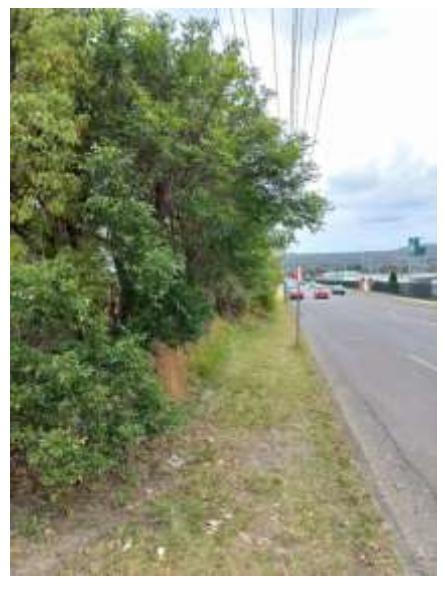
Figure 4 - Cinnamomum camphora (Camphor laurel) on the nature strip of the site.

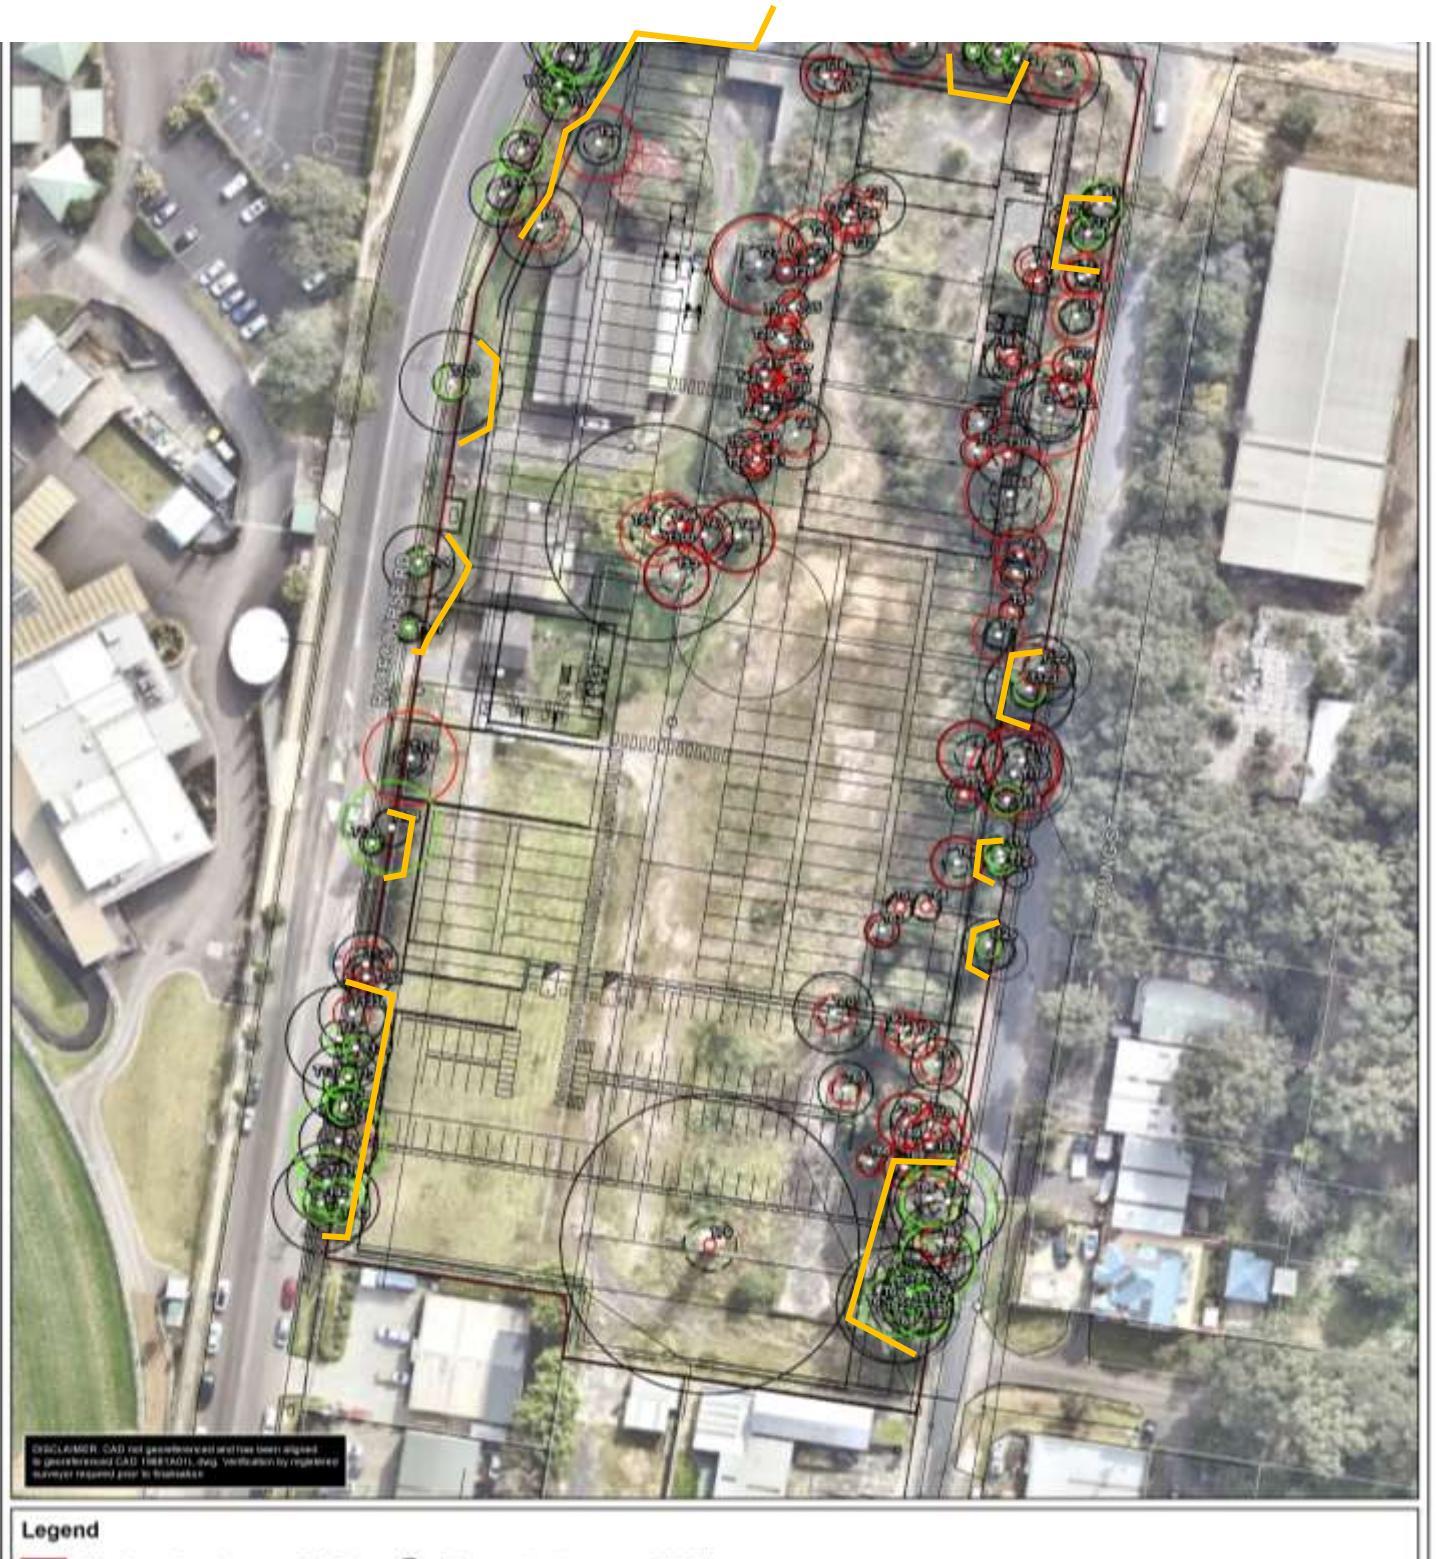
#### Figure 15 - Location of tree protection fencing.

- Site boundary (source:CAD)
- Tree Retain tree (52)
- Remove tree (90)
- Tree protection zone (TPZ)
- Structural root zone (SRZ)
