## VEGETATION ASSESSMENT REPORT

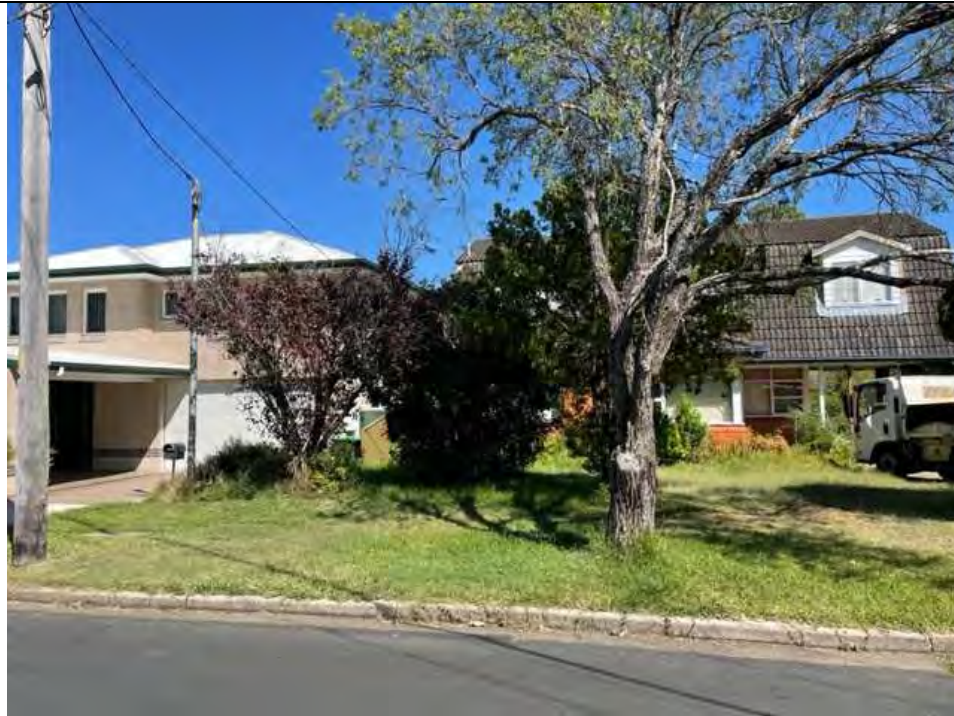
**Fig 1: shrubs (Lemnos Ave)**

**All vegetation inside property are non-native and in poor condition to be removed and to be replaced as shown on the landscaping plan.**

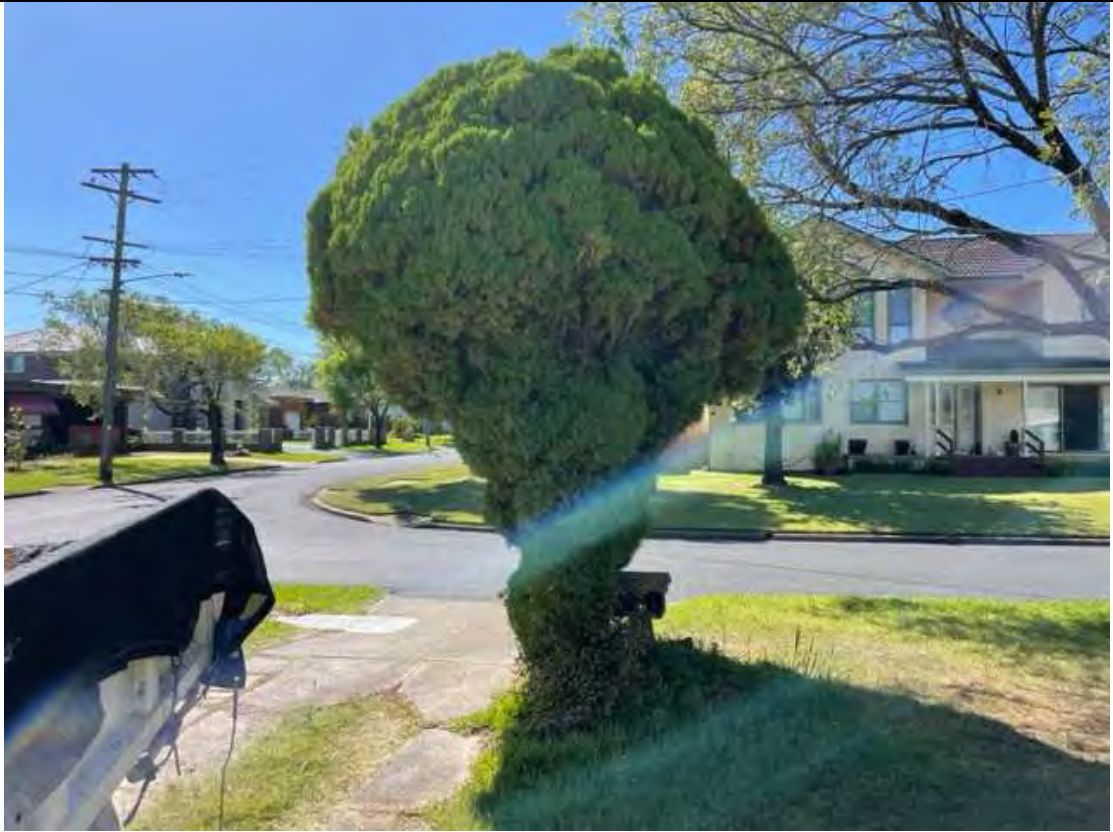
**Fig 2: Conifer (Lemnos Ave)**

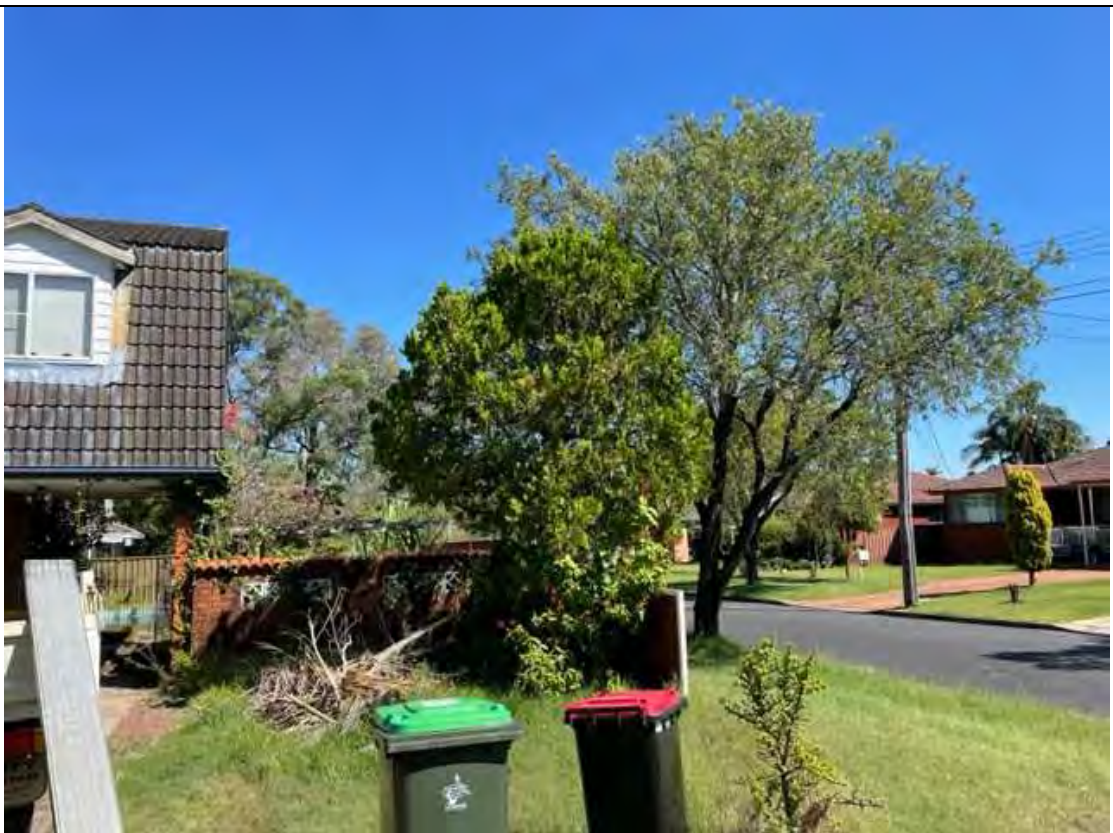
**Fig 3: Shub inside property. (Street tree to remain)**

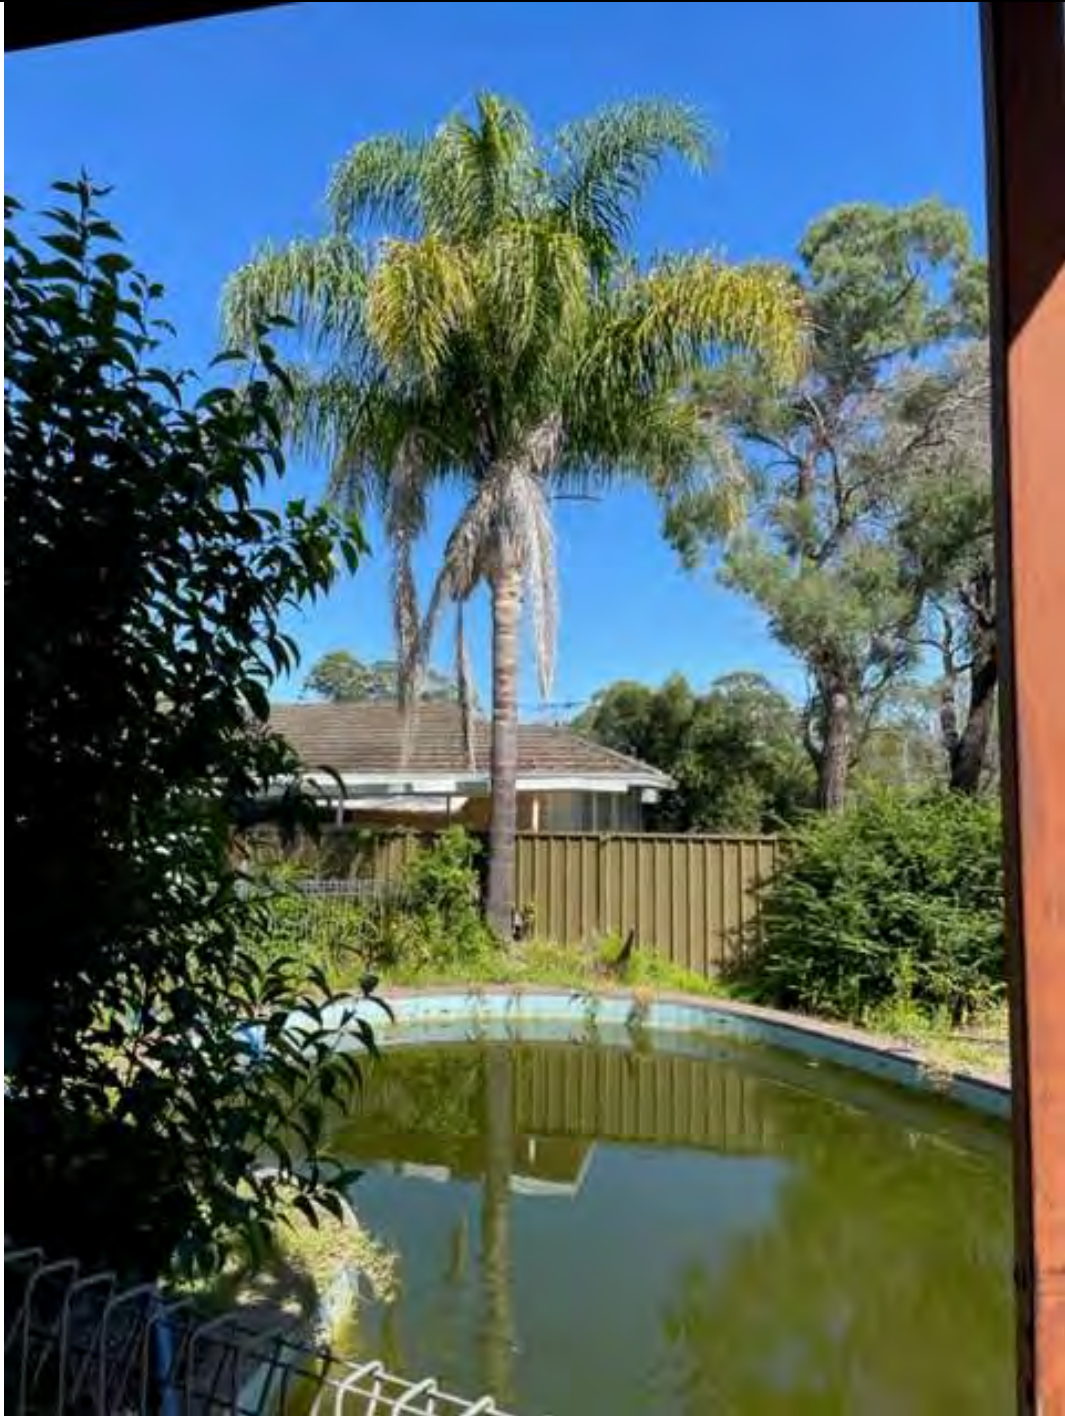
**Fig 4: Palm tree to be removed.**
