Moore Trees
Arboricultural Services

Arboricultural Development Assessment Report

Kogarah War Memorial Pool
Carss Park NSW 2221
September 2020
Final

Prepared for: Georges River Council

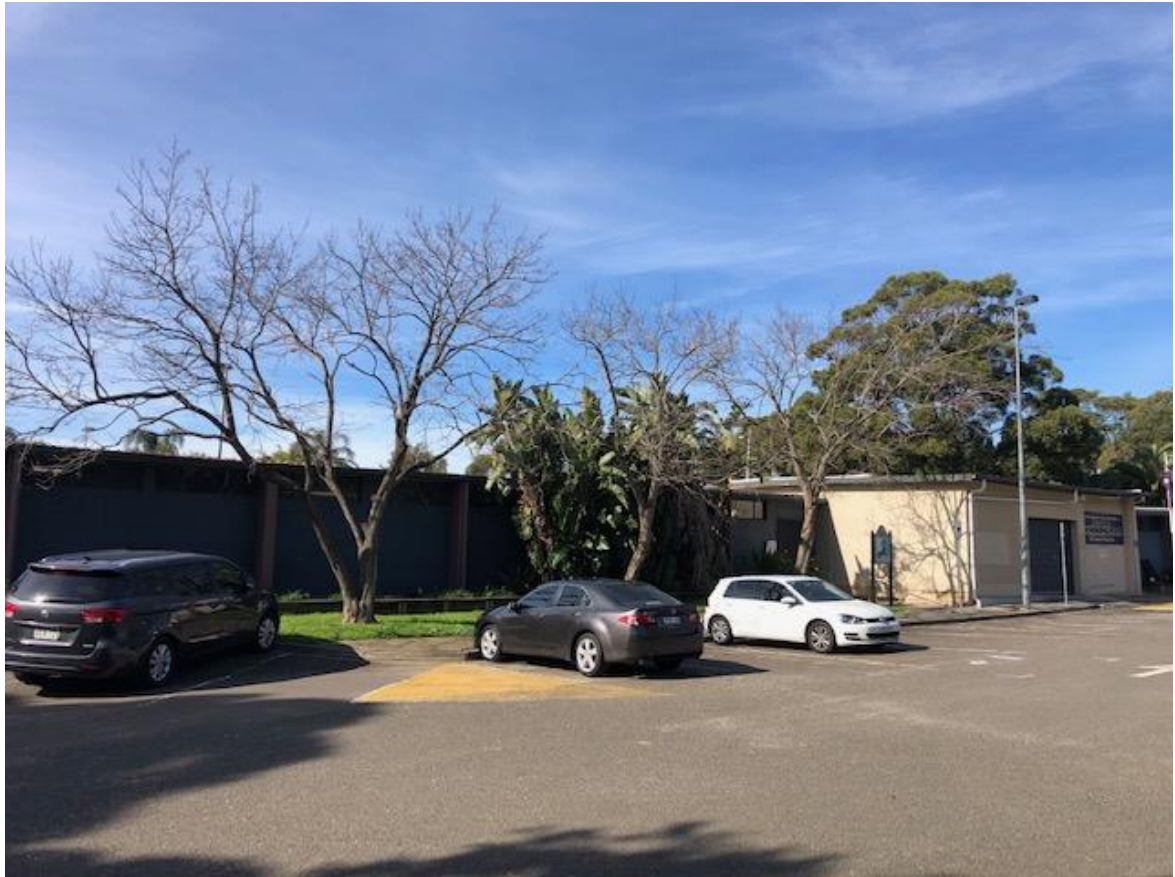
Plate 1: Image showing Trees 14-16 (*Robinia sp.*). P. Vezgoff

- 3.10 Impacts:** Based on the demolition works and soil remediation required Trees required to be removed are numbered as 14-16, 33-62, 74-86, 88-93, 97. The majority of these trees are exotic specimens.

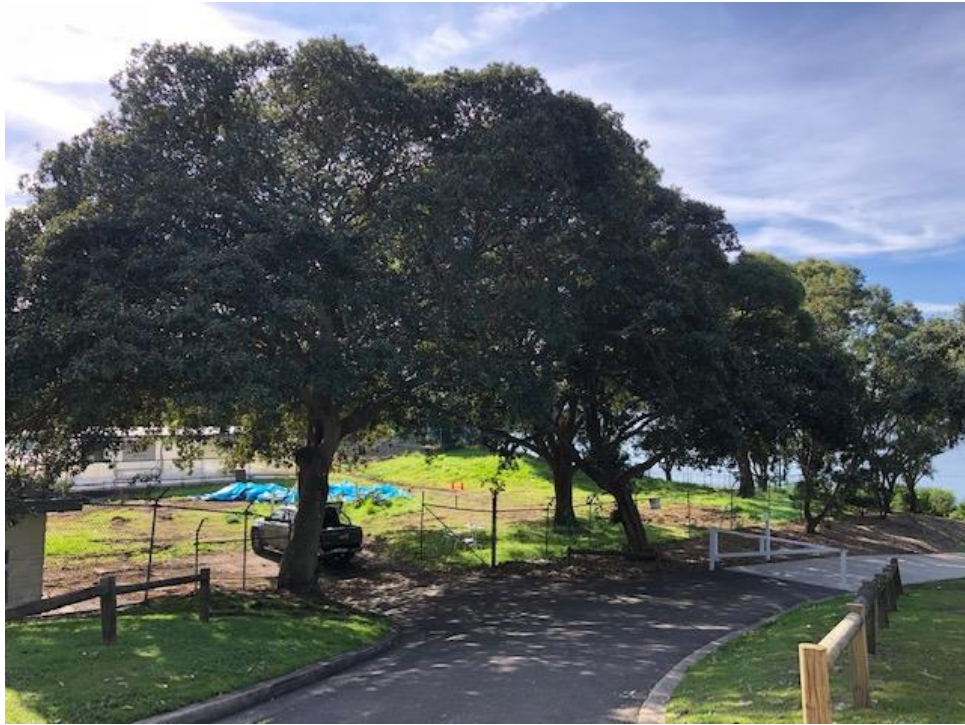
Plate 2: Image showing Port jackson fig (*Ficus rubiginosa*) by the side gate. P. Vezgoff

- 3.11** The larger trees near the demolition works are numbered as 23, 24, 27 and 32. These trees are three (3) Tallowwood (*Eucalyptus microcorys*) and a single Port Jackson fig (*Ficus rubiginosa*) and are in good health and condition. The TPZ varies on these trees and they are located within the remediation area so could potentially be impacted by the works.

- 3.12** Soil remediation techniques can vary and with the roots of these trees growing within the top 900mm of soil profile a site specific tree management process is required. For this project a Geofabric marker layer will extend up to the base of the trunks of the trees to be retained within the remediation area. A layer of 150mm of topsoil and woodchip around the base of the trunk will occur followed the cap increasing to 0.5 m thickness and comprising compacted imported fill with topsoil and a turf or woodchip layer at the surface level. This capping type process will occur to the area below Trees 23, 24, 27 and 32 to the extent of the drip line.

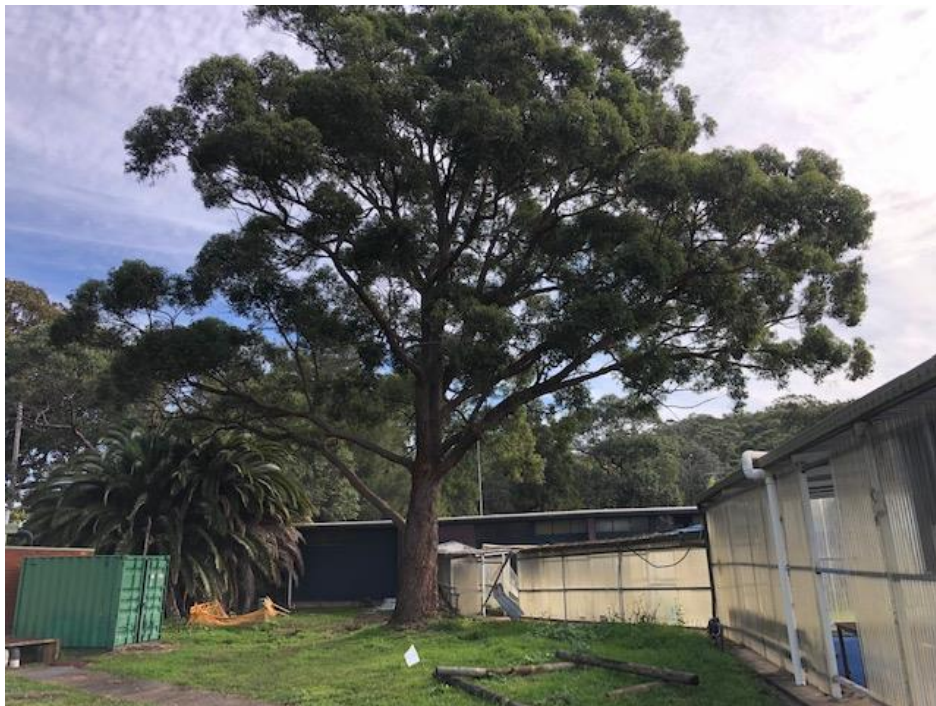
- 3.6** Along the southern vehicle entry to the site are the larger native specimens being Trees 23, 24, 27 and 32. These species consist of Tallowwood (*Eucalyptus microcorys*), Port jackson fig (*Ficus rubiginosa*), Forest Oak (*Allocasurina torulosa*). The Ficus has suffered from mechanical damage over the years however it is worthy of retention (Plate 2). The Tallowwood specimens within the pool grounds are large prominent specimens that are worthy of retaining, provided the soil remediation works do not impact these trees (Plate 3).

Plate 3: Image showing Tree 32. P. Vezgoff

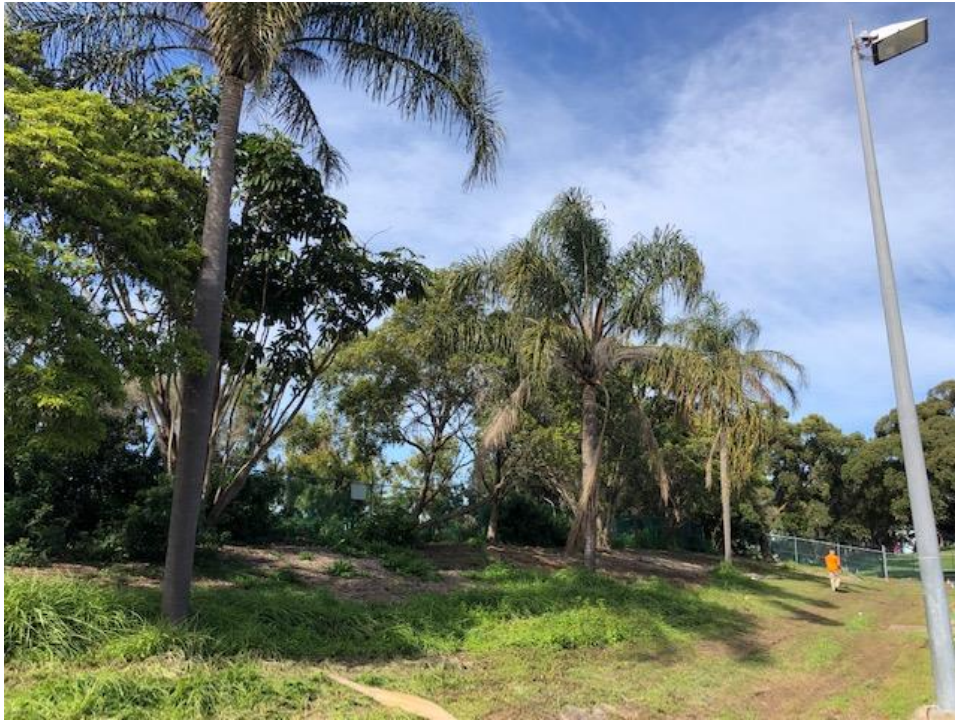
- 3.7** Other trees within the Pool area, that are mostly exotic specimens, consist of Kentia Palm (*Howea fosteriana*), Dypsis decaryi, Hill's weeping fig (*Ficus microcarpa* var. *Hillii*), Native daphne (*Pittosporum undulatum*), Umbrella tree (*Shefflera actinophylla*), Cocos palm (*Syagrus romanzoffiana*), Jacaranda (*Jacaranda mimosifolia*) and a row of several Mexican fan palms (*Washingtonia robusta*).

Plate 4: Image showing some of the many exotic specimens surrounding the pool garden area. P. Vezgoff
