Arboricultural Impact Assessment

Riverlands Development
56 Prescott Parade, Milperra
Shared Cycleway
03/10/2023

Temporal Tree Management Pty Ltd.

Mirvac Homes (NSW) Pty Ltd.

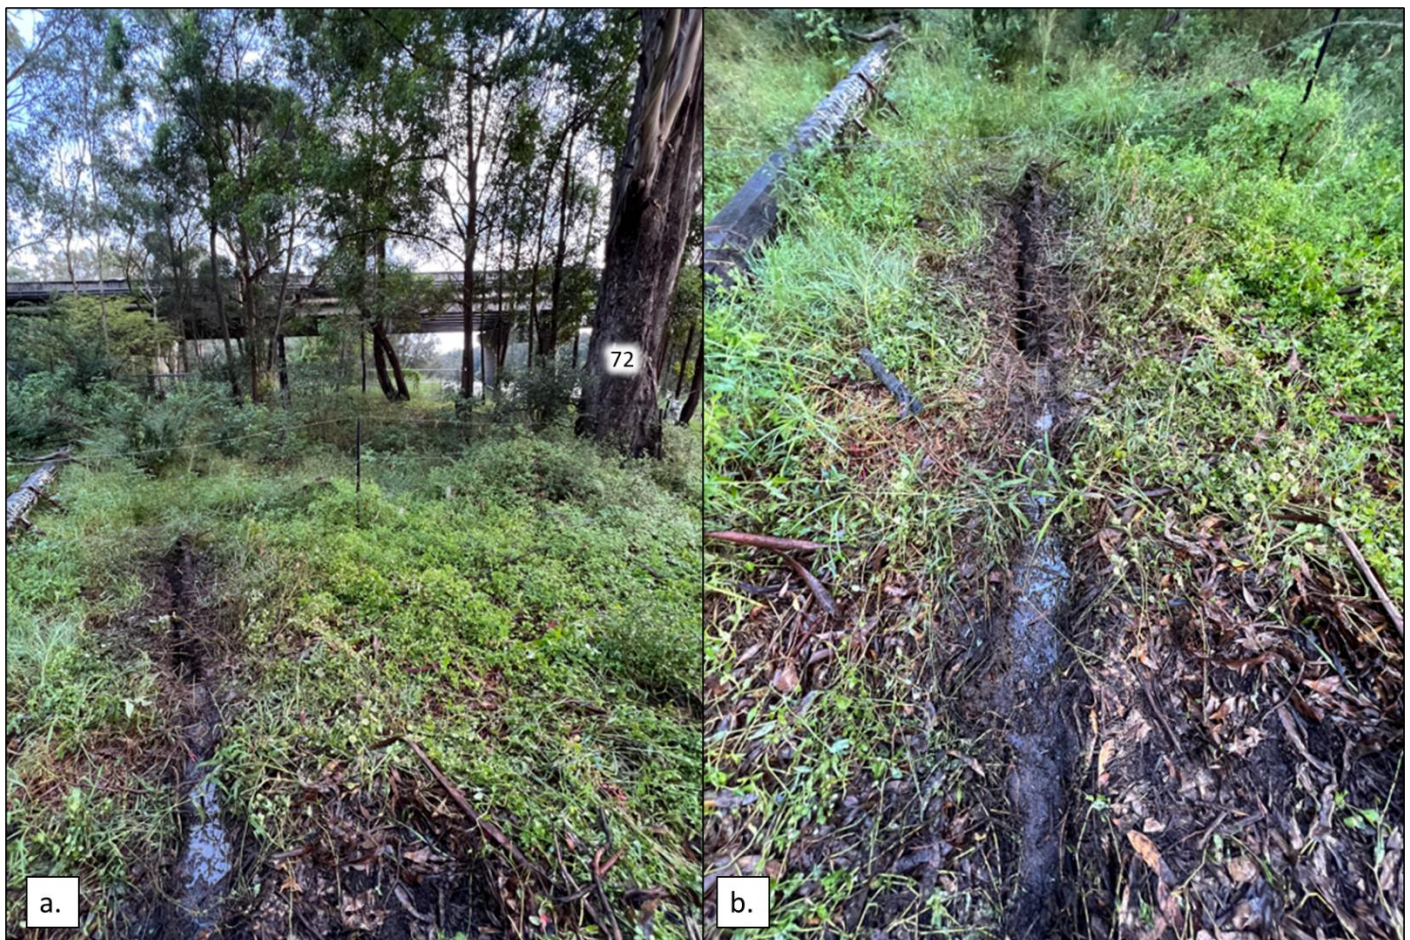
7.3.1. Survey Trench 1

There were no minor roots of 15mm or greater encountered in Survey Trench 1. There were no major tree roots encountered in this survey trench (Figure 7).

Figure 7. No tree roots were encountered in Survey Trench 1.

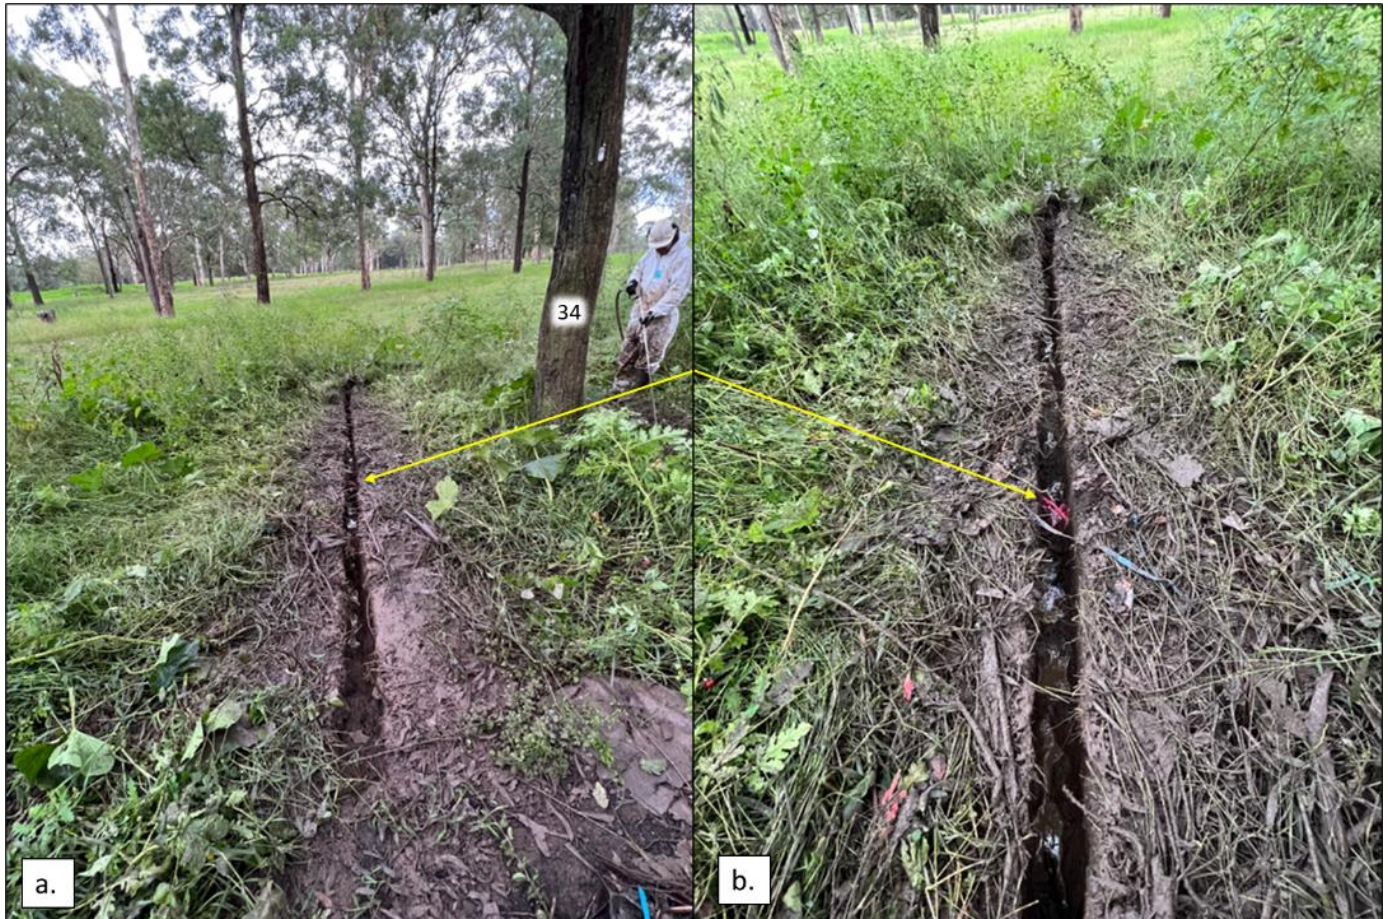
7.3.2. Survey Trench 2

One minor root of 15mm diameter was encountered in Survey Trench 2 (Figure 8). There were no major tree roots encountered in this survey trench. The encountered minor root was pruned during the inspection in compliance with *Section 3.3.3 of AS4970 (2009)*.

Figure 8. One minor root was encountered in Survey Trench 2.

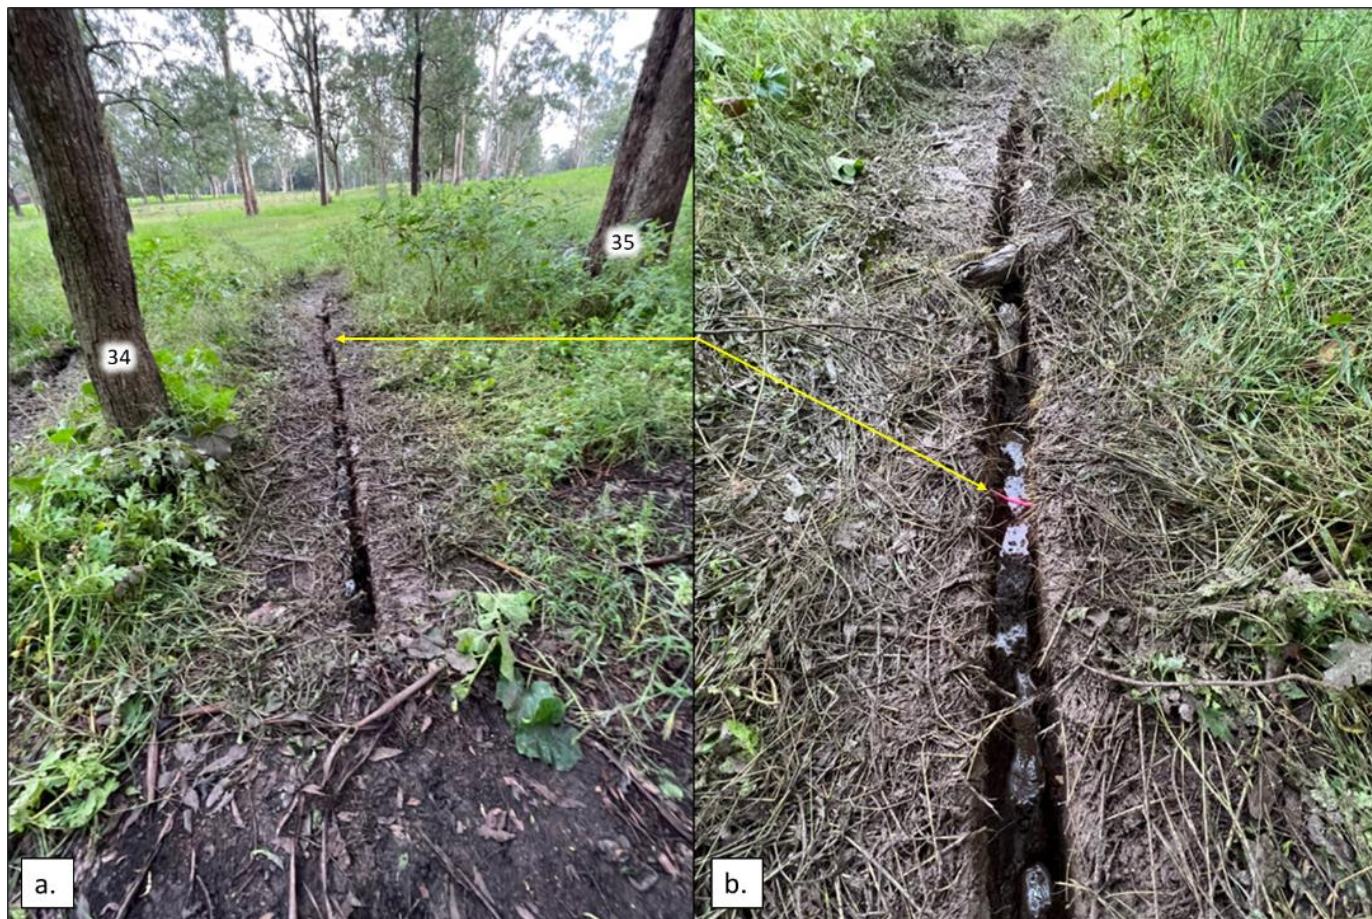
7.3.3. Survey Trench 3

One minor root of 15mm diameter was encountered in Survey Trench 2 (Figure 9). There were no major tree roots encountered in this survey trench. The encountered minor root was pruned during the inspection in compliance with *Section 3.3.3 of AS4970 (2009)*.

Figure 9. One minor root was encountered in Survey Trench 3.

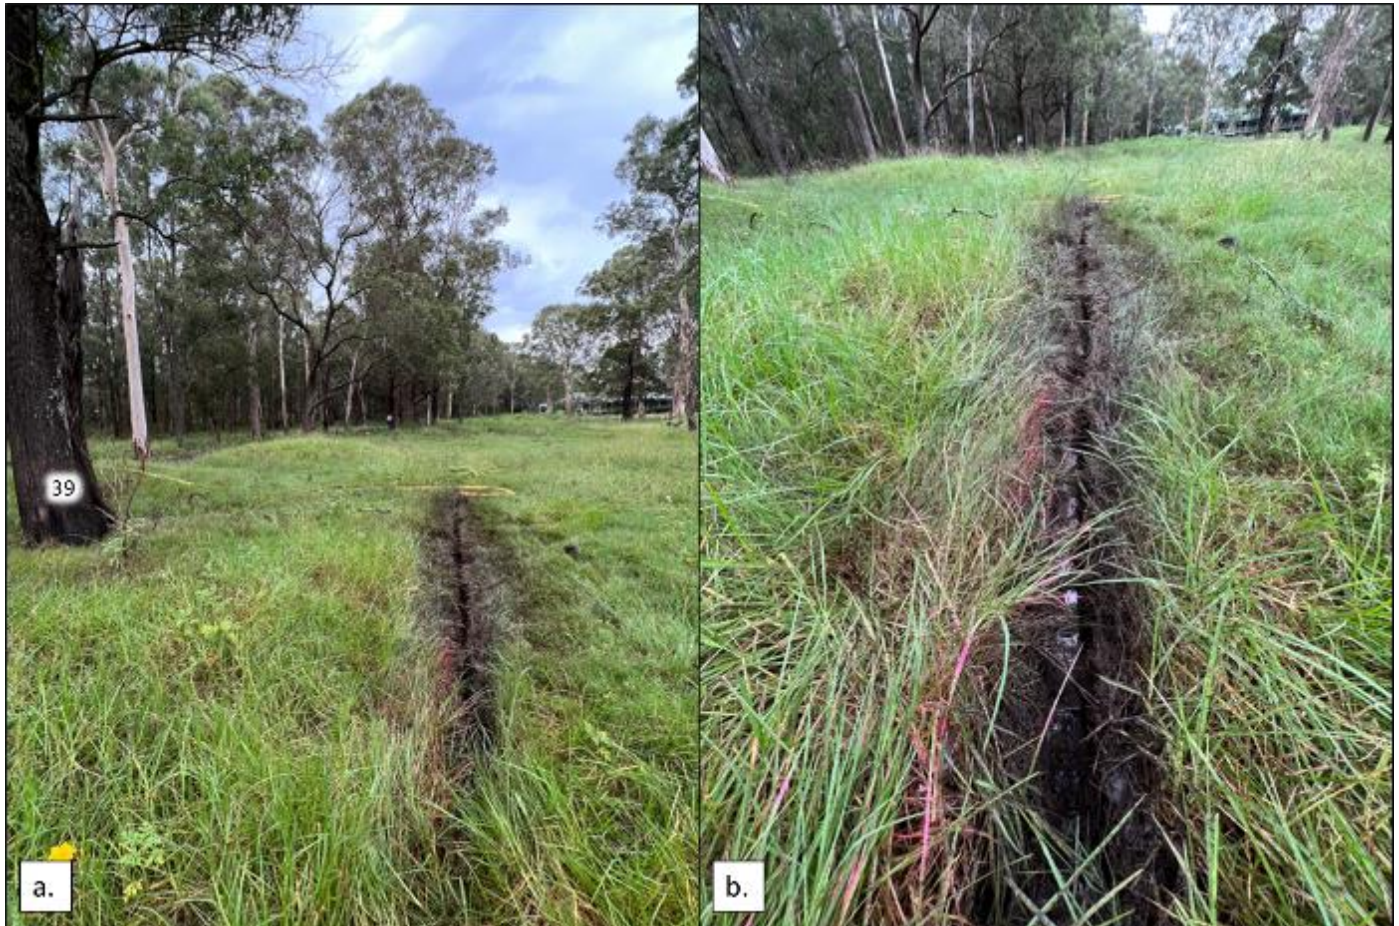
7.3.4. Survey Trench 4

There were no minor roots of 15mm or greater encountered in Survey Trench 4. There were no major tree roots encountered in this survey trench (Figure 10).

Figure 10. No tree roots were encountered in Survey Trench 4.

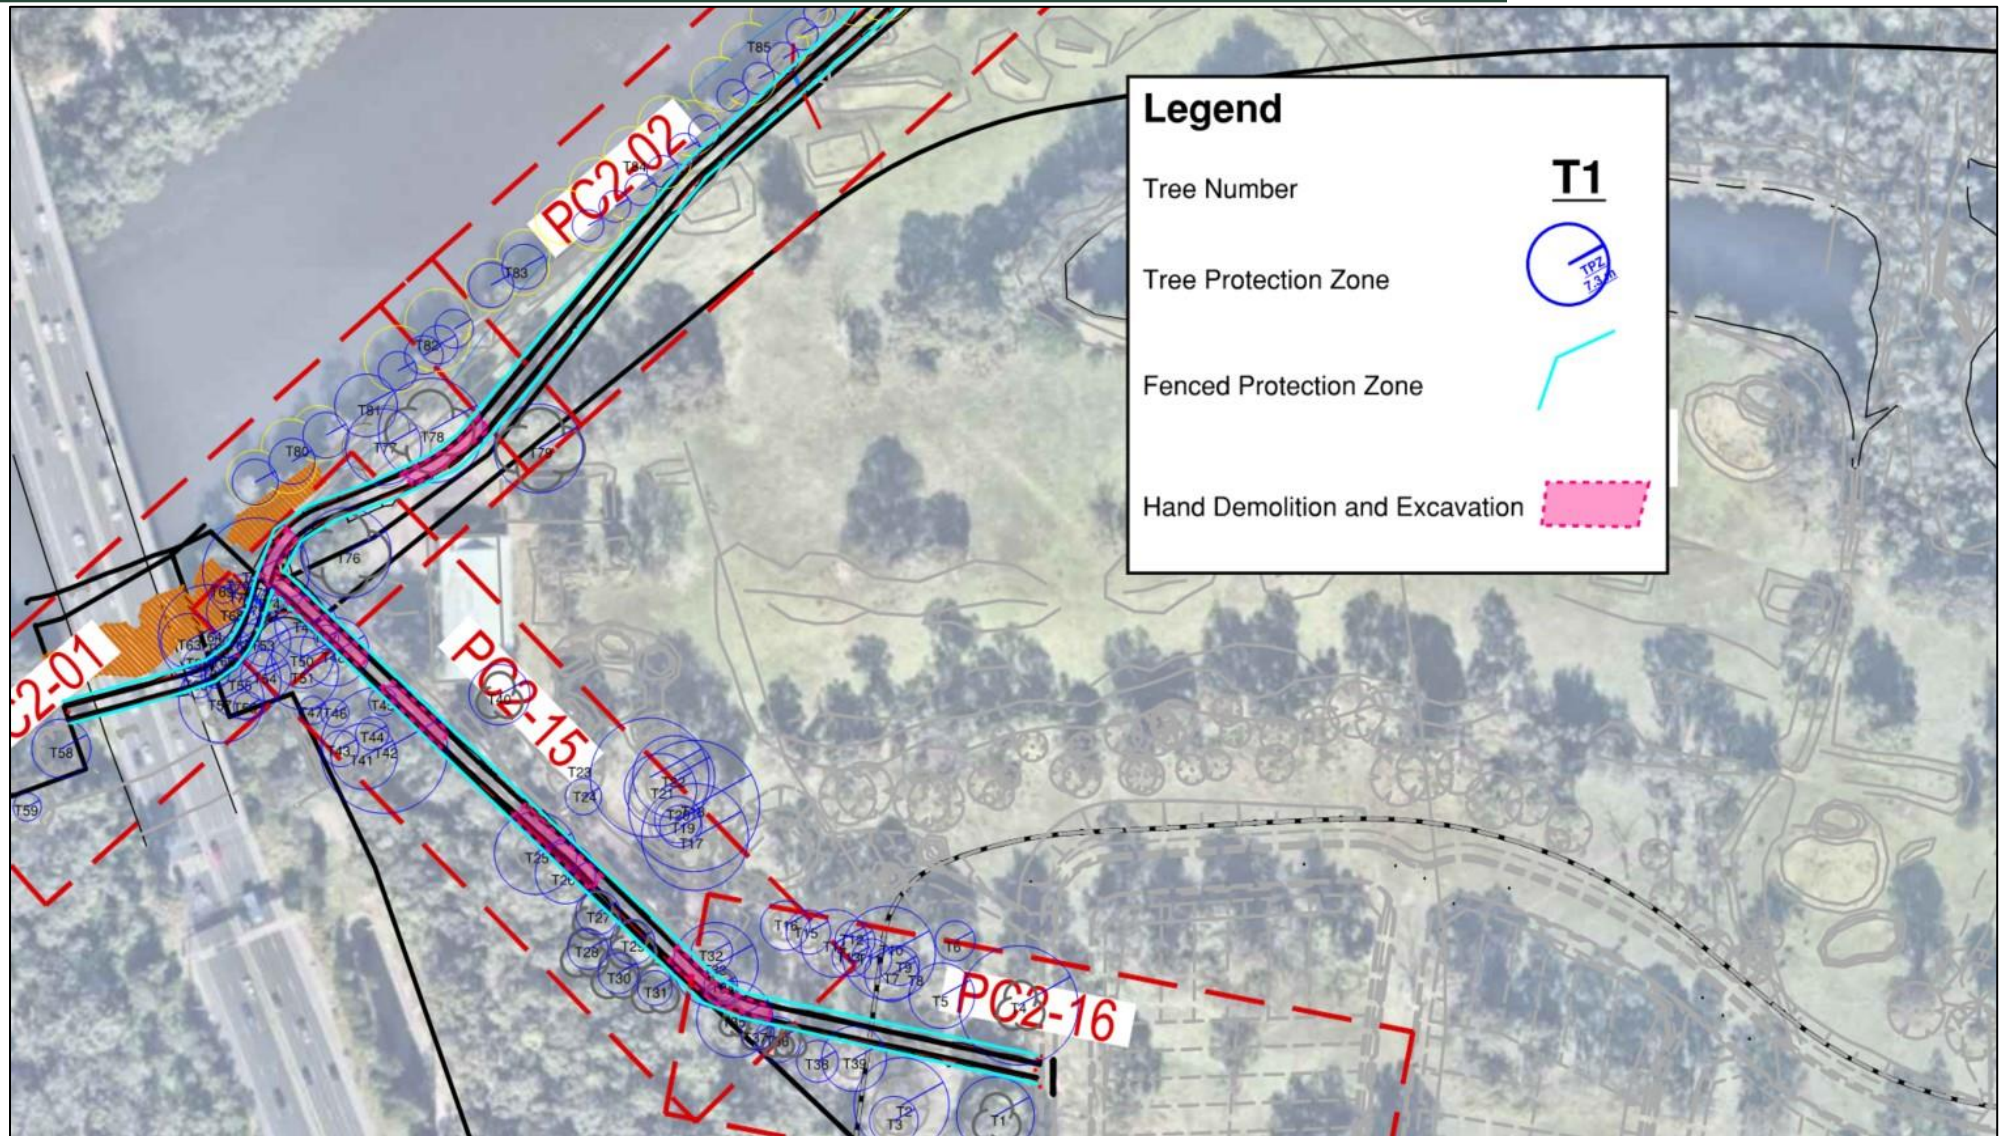
Figure 13. Boundary fencing and supervised excavation requirements within the southern portion of the proposed pathway.

- The impact of the major encroachments with Severe / Major impacts that will be sustained by Trees 25, 26, 33, 35, 39, 42, 45, 48, 49, 72 and 78 will be mitigated by the replacement of the existing asphalt roadway that is within their TPZs and SRZs.

- The High impact these trees may sustain must be mitigated further using sensitive excavation methods. It is recommended that all asphalt demolition and excavation within the R_{TPZs} of Trees 25, 26, 33, 35, 39, 42, 45, 48, 49, 72 and 78 be supervised by the Project Arborist. Hand tools must be used where required to mitigate the potential impact on any encountered tree roots (Figure 13).

- There must be no major root (diameter of 40mm or greater) damage or disturbance during the hand excavation within the TPZs of retained trees.
- Major root pruning of retained trees is only considered to be suitable if design amendments are not possible. All major root cutting must be undertaken by the Project Arborist using a handsaw in compliance with Section 4.5.2 of *AS4970 (2009)*. Documentation of all major root cutting and an ongoing monitoring schedule for all affected trees must be provided by the Project Arborist as part of the final arboricultural checklist.
