COWPASTURE ROAD BOSSLEY PARK NSW - EXISTING ADVERTISING SIGNS

Structural Assessment

Structural Condition Report

21 AUGUST 2023

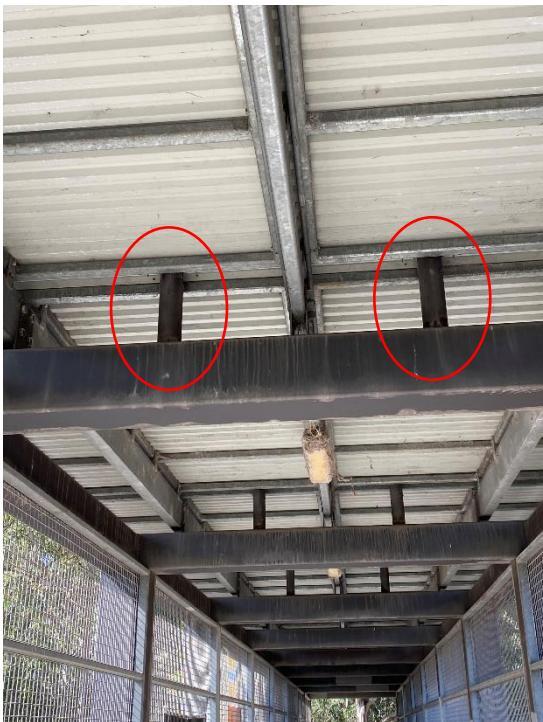
Photo 1 – Signage structure legs welded to bridge superstructure (circled).

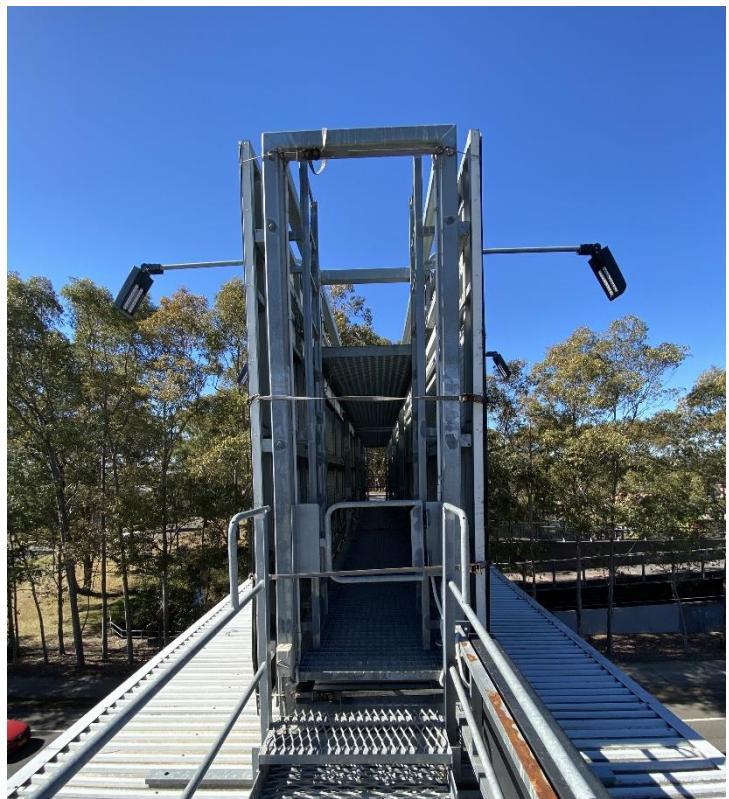
Both catwalks exceed minimum width requirements and are equipped with compliant handrails and kick rails (where required). A permanent fixed ladder located at each end of the catwalk, provides access between the gantry levels. The ends of the upper catwalk are only fitted with safety chains, which does not necessarily provide adequate fall protection.

Photo 2 – General end view of signage structure

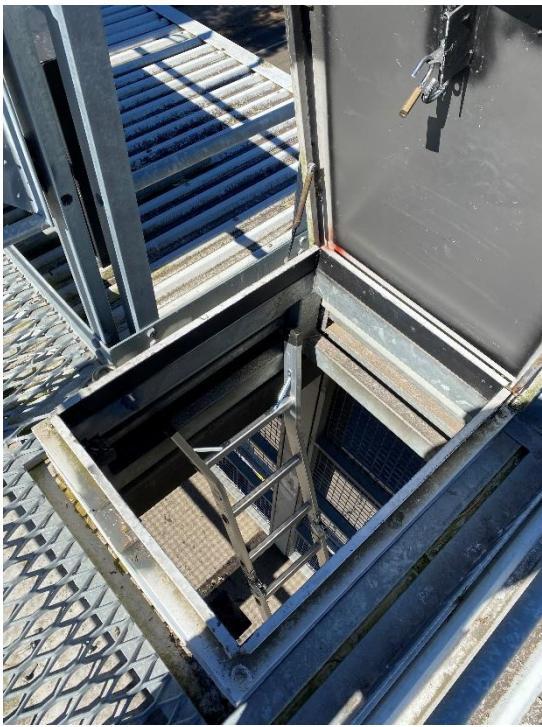
Photo 3 – Secured access hatch in roof of pedestrian bridge.

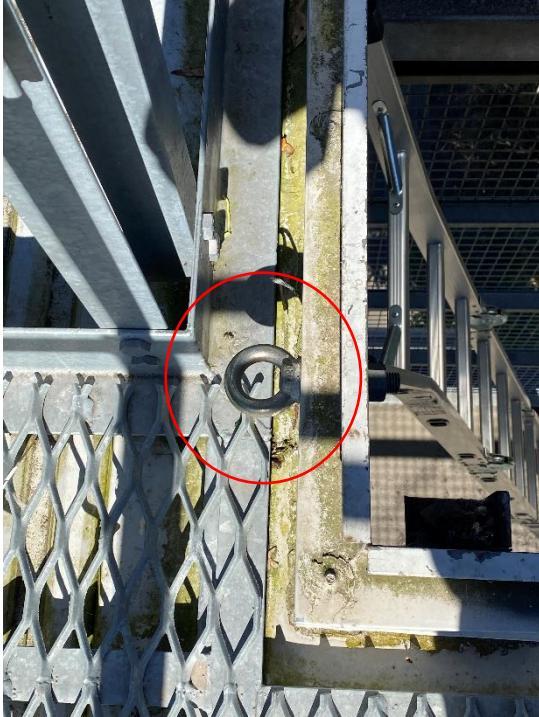
Photo 4 – Lanyard attachment eyebolt (circled)

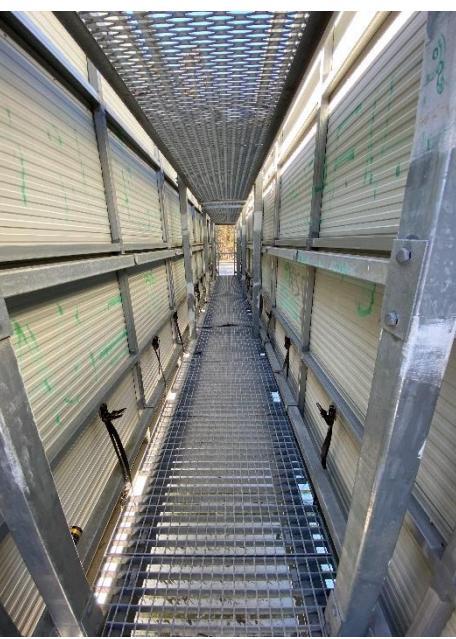
Photo 7 – General view of lower catwalk

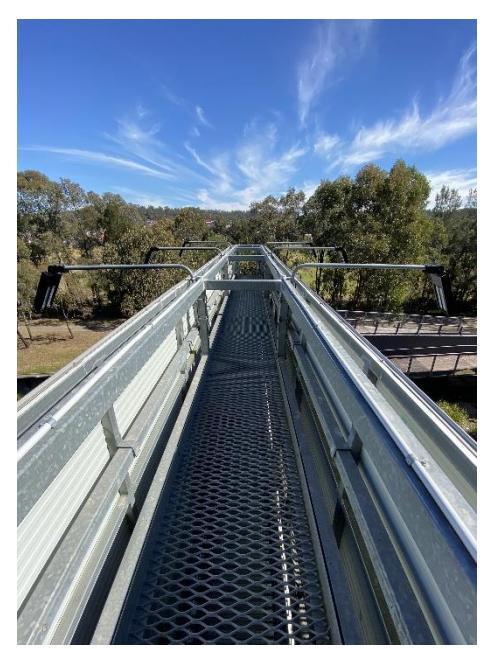
Photo 8 – General view of upper catwalk

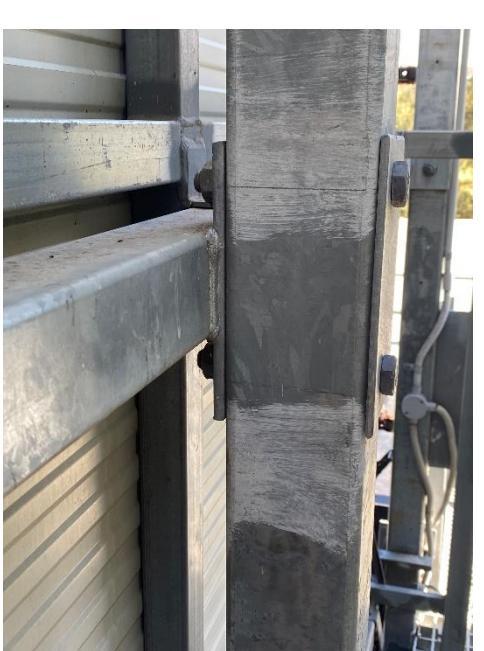
Photo 9 – Typical horizontal rail connection

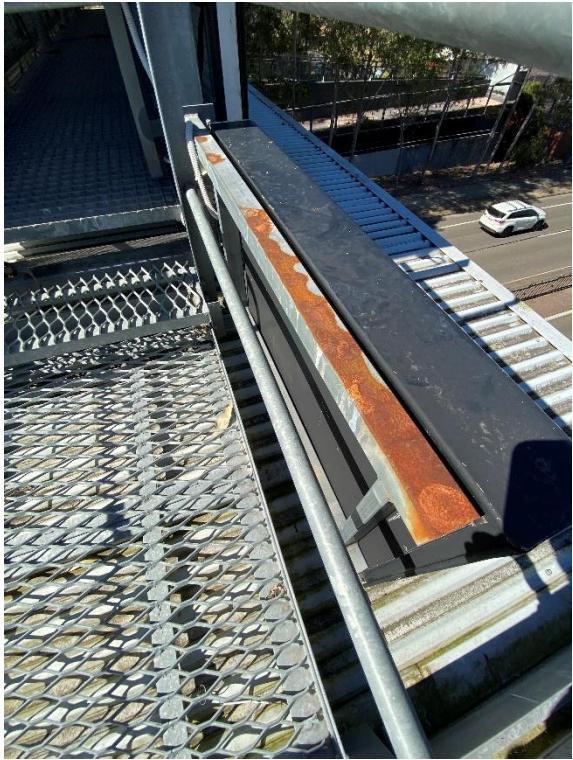
• Minor surface corrosion to logo box support framing (both sides).

Photo 10 – Minor surface logo box support framing (west).

We would recommend that the surface corrosion be wire brush cleaned and treated with a proprietary cold galvanising paint at the next scheduled maintenance programme, to avoid further corrosion developing and potentially more costly remediation. This may involve the complete replacement of nuts and bolts.

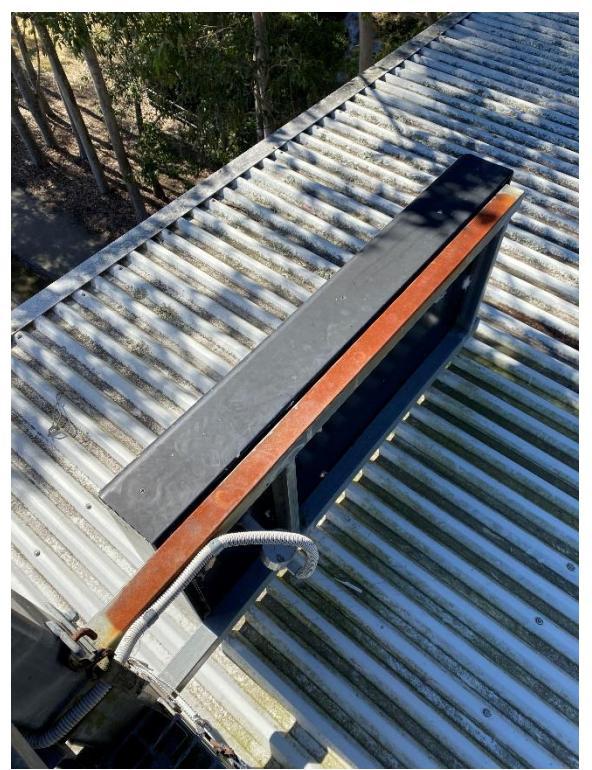
Photo 11 – Minor surface logo box support framing (east).

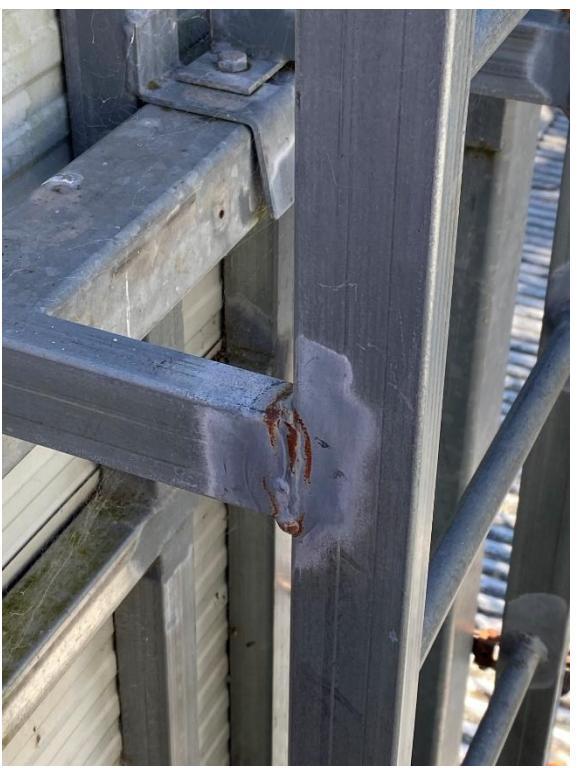
Photo 12 – Minor surface corrosion to vertical ladder support framing.

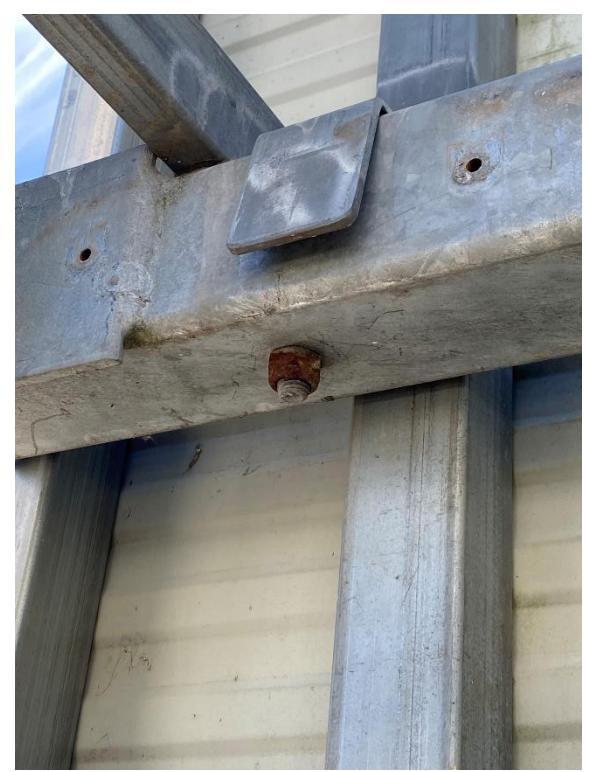
Photo 13 – Corroding nut to vertical ladder support framing.

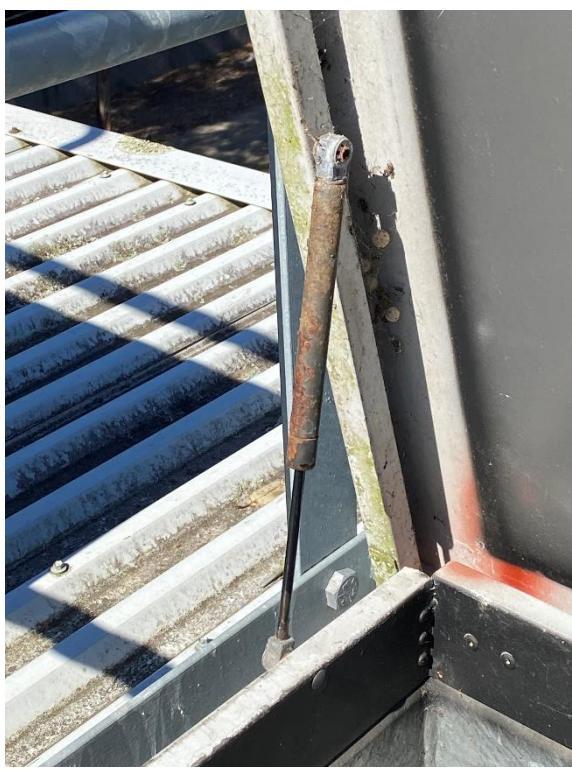
Photo 14 – Deteriorating hatch strut.

The deteriorating hatch struts be replaced.

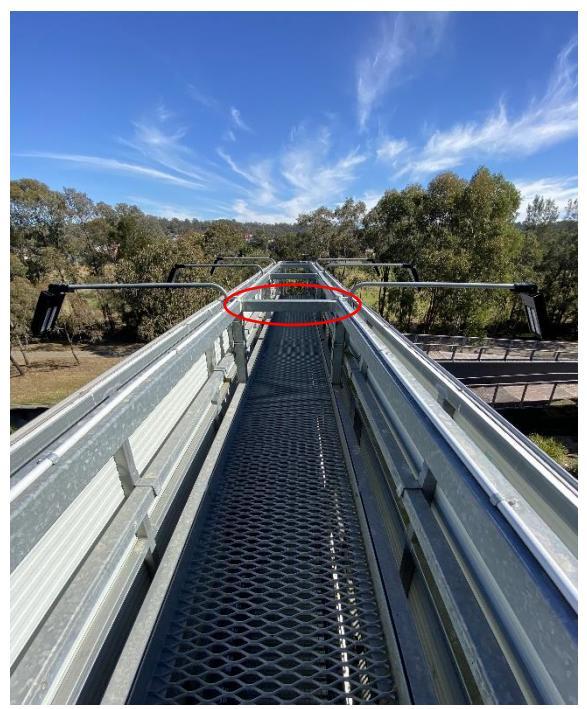
Photo 15 – Trip hazards to top catwalk (circled).

Elimination of the trip hazards would necessitate total redesign and fabrication of the signage structure – a significantly costly exercise. In lieu of replacing the structure, measures such as 'tiger tape' on the trip hazard and warning signs should be instated.
