ARBORICULTURAL IMPACT ASSESSMENT AND TREE MANAGEMENT PLAN

PROPOSED DUAL OCCUPANCY DEVELOPMENT APPLICATION

47 CRAGG STREET CONDELL PARK, NSW

21st November 2023 - Version 1

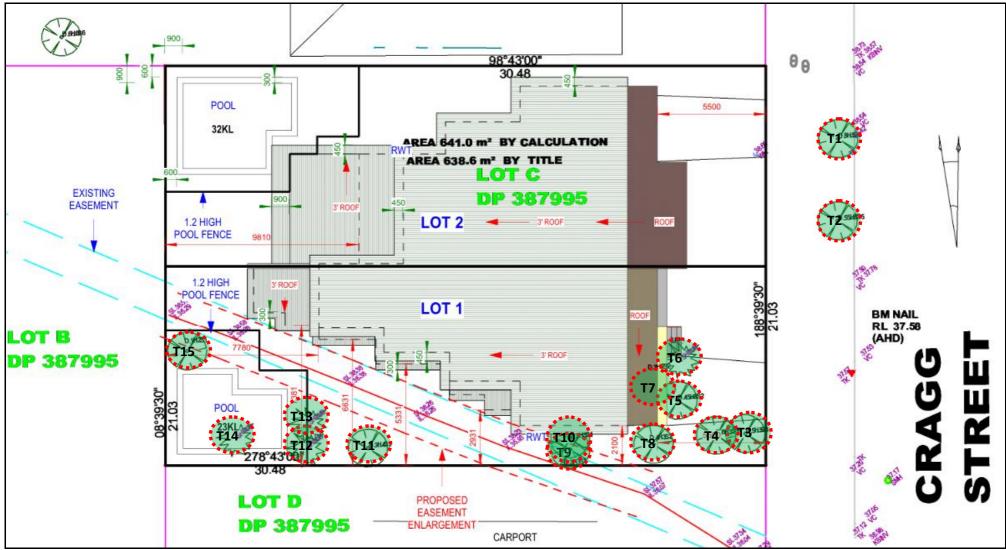
Figure 3 Shows the site and adjoining trees location based on the proposed development layout.

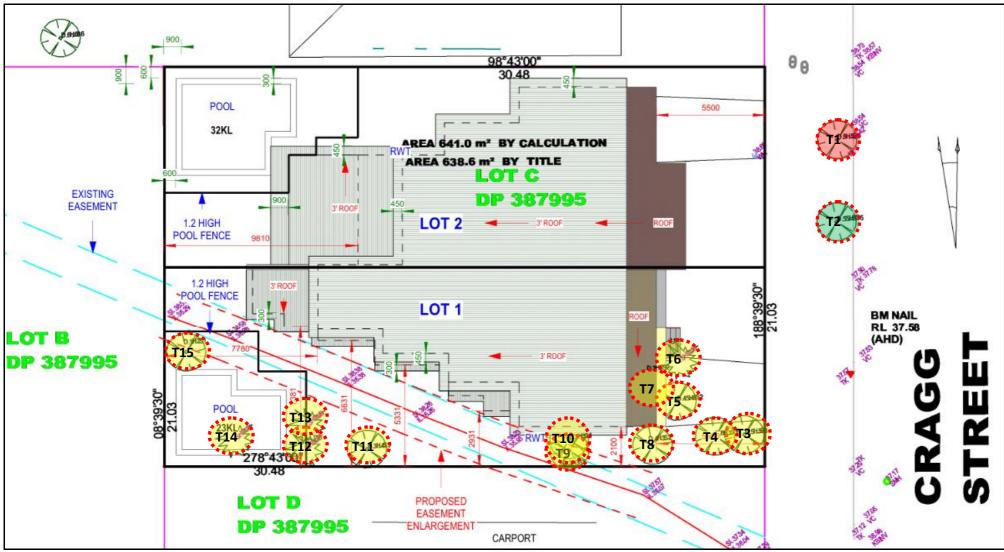
Figure 4 Shows trees in RED and or YELLOW that are TPO Exempt due to height requirements and or species.

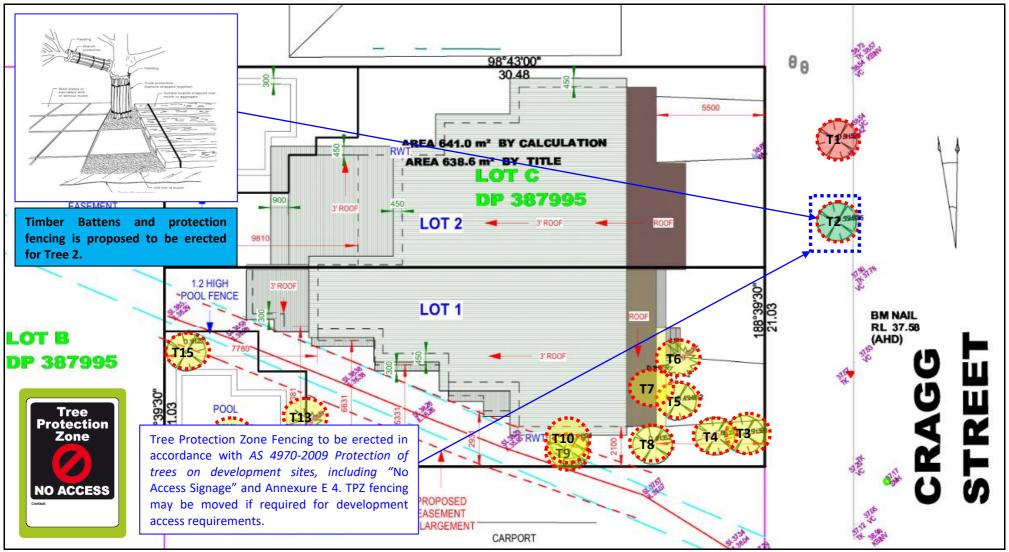
Figure 5 Shows Council Street tree 1 to be retained and protected.

- Tree Numbered 2 is to be retained, protected, and managed on site as per the Tree Management Plan,
- Avoid large changes to the surface structure due to modification of the tree's moisture / surface feeding roots,

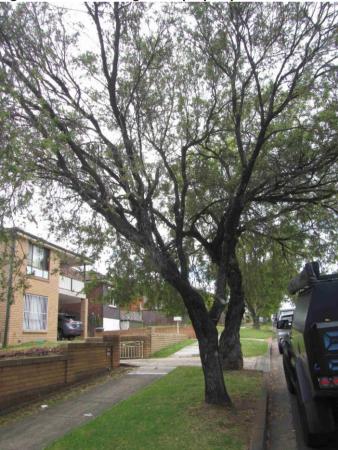
Figure 7 Shows Councils Street Trees 1 and 2 in the Council verge.

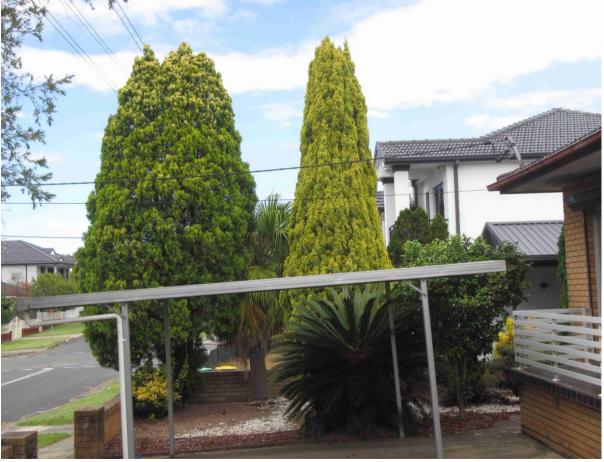
Figure 9 Shows minor TPO Exempt ornamental shrubs 2 to be removed.

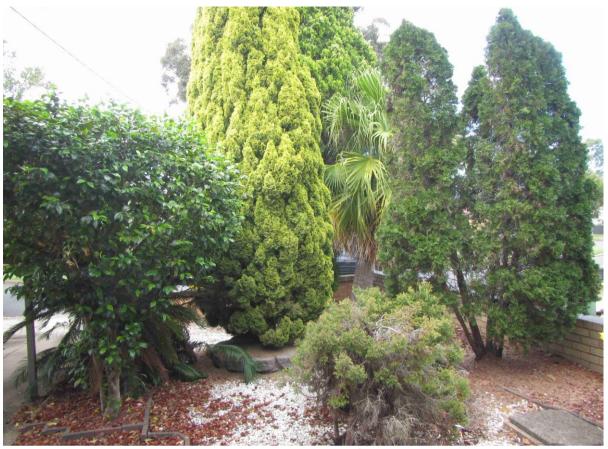
Figure 10 Shows minor TPO Exempt palm, shrubs and conifers that are required to be removed.

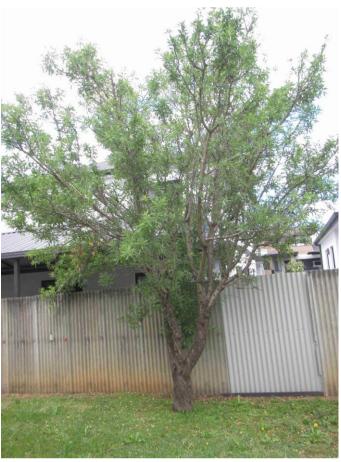
Figure 12 Shows the peach tree that is TPO Exempt to be removed from a distance.

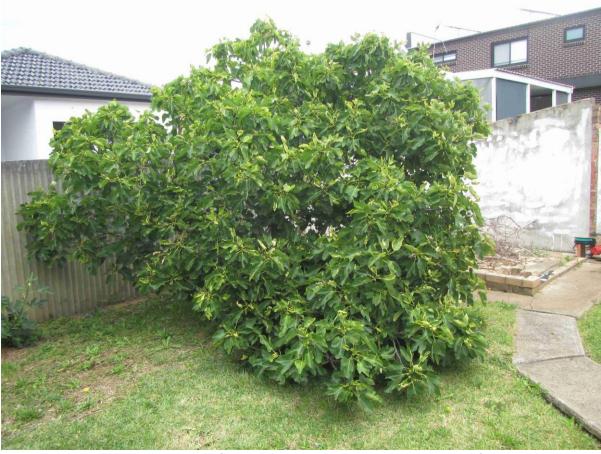
Figure 13 Shows the common table fig tree that is TPO Exempt to be removed from a distance.

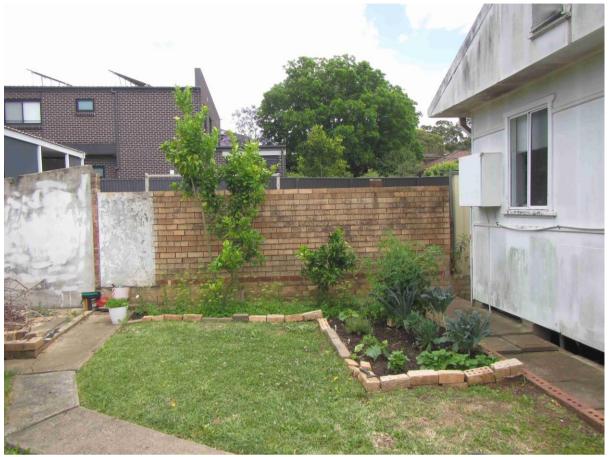
Figure 14 Shows minor planted Lemon tree and vegetables in planter beds.

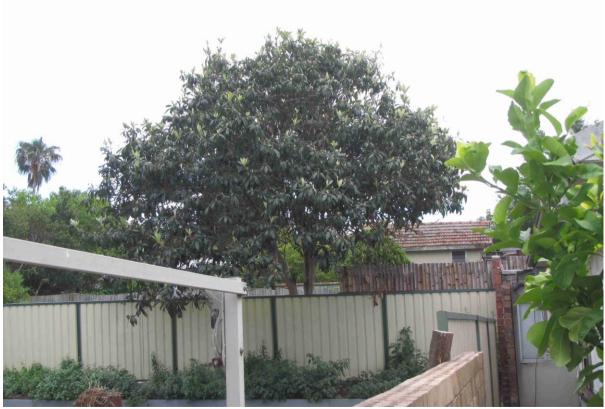
Figure 15 Shows an adjoining Loquat tree with Number 45 that is sufficiently distanced.
