Arboricultural Impact Assessment

14 Victory Street, Belmore
NSW, 2192
3/-/DP347819
16/02/2024

Temporal Tree Management Pty Ltd.

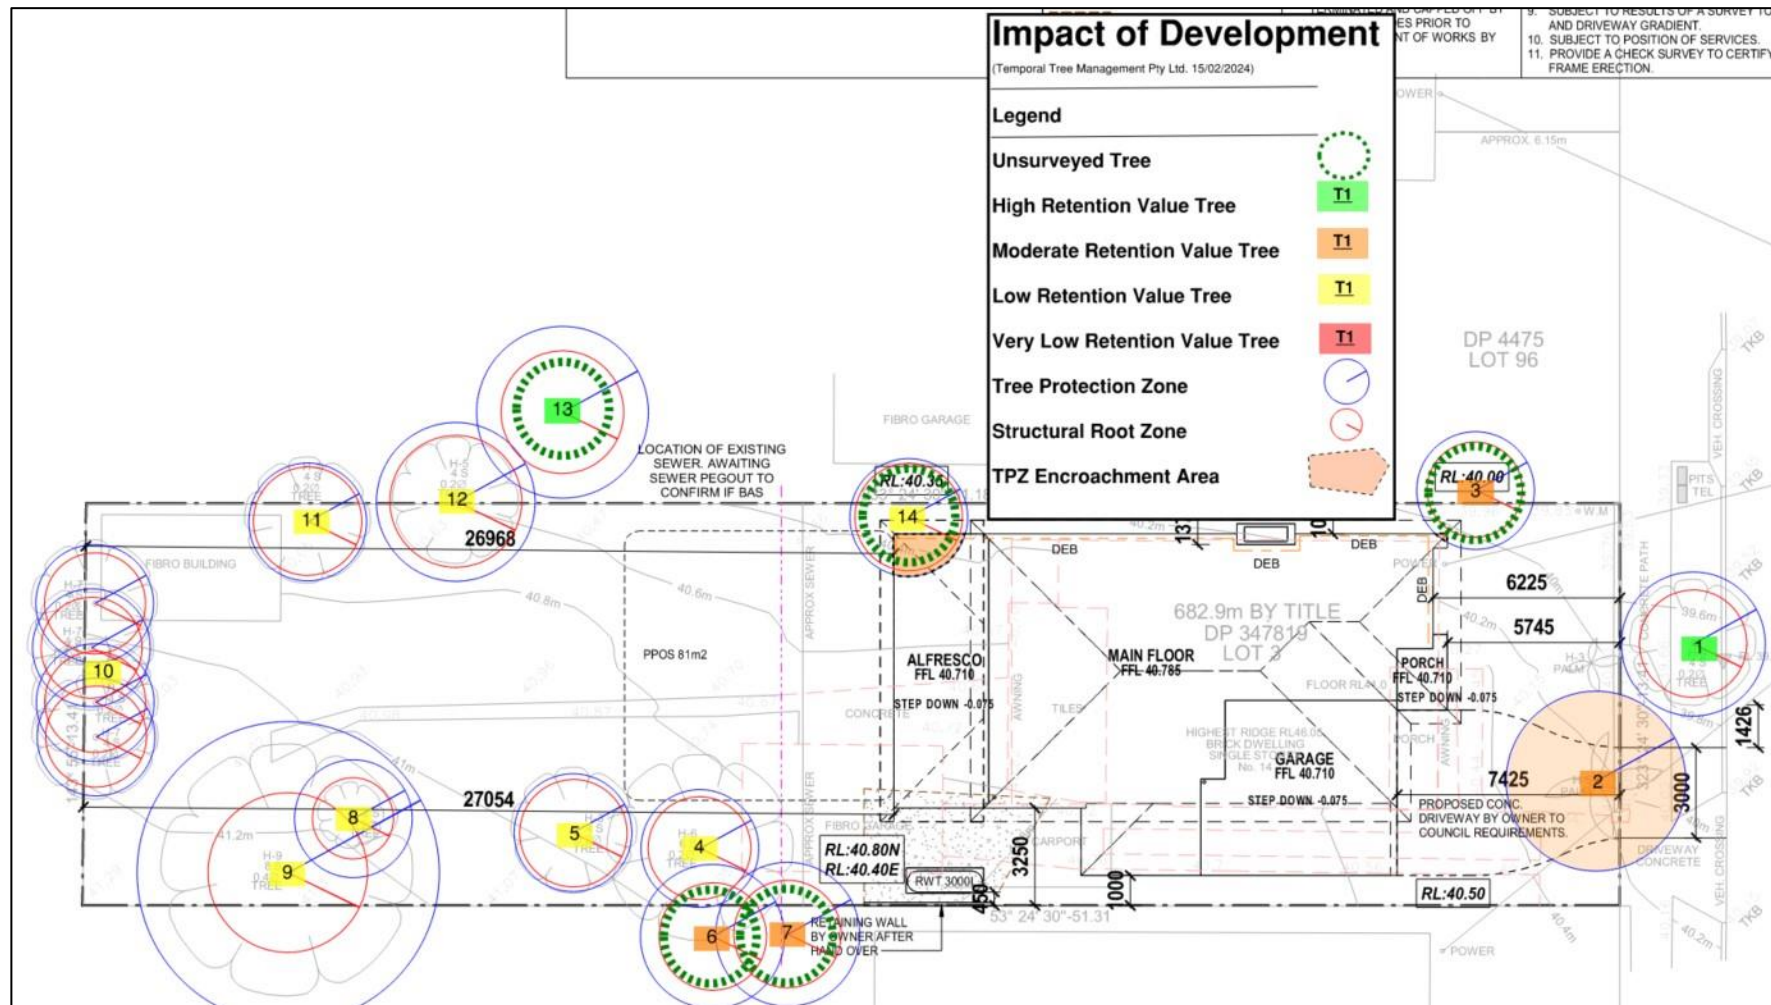
Figure 4. Retention values, TPZs, SRZs and Encroachments for fourteen trees positioned within the subject site. *Proposed Site Plan* as prepared by Masterton, Job No: 2018920, Sheet No. 01.00, Rev. 1, drawn 19.10.2023. Annotated by Temporal Tree Management Pty Ltd. (15.02/2024).

The stem of Tree 2 is within the footprint of the proposed driveway. This palm will require removal to facilitate the proposed development. Tree 14 will sustain an encroachment that will breach its SRZ and is likely to have a severe impact on its viability. It is recommended that Tree 14 is also removed as part of this development. Tree 14 was determined to be of Low retention value in Section 4.2 of this report and is suitable for removal. Tree 2 was determined to be of Moderate retention value in Section 4.2 of this report. The removal of this smaller palm to facilitate the construction of the new driveway is supported in this assessment only if it is suitably replaced as part of the proposed development.

Trees 4, 5, 8, 9, 10, 11 and 12 are trees positioned within the subject site that were determined to be of Low retention value in Section 4.2 of this report. The removal and replacement of these seven trees with specimens of more suitable native species is supported in this assessment.

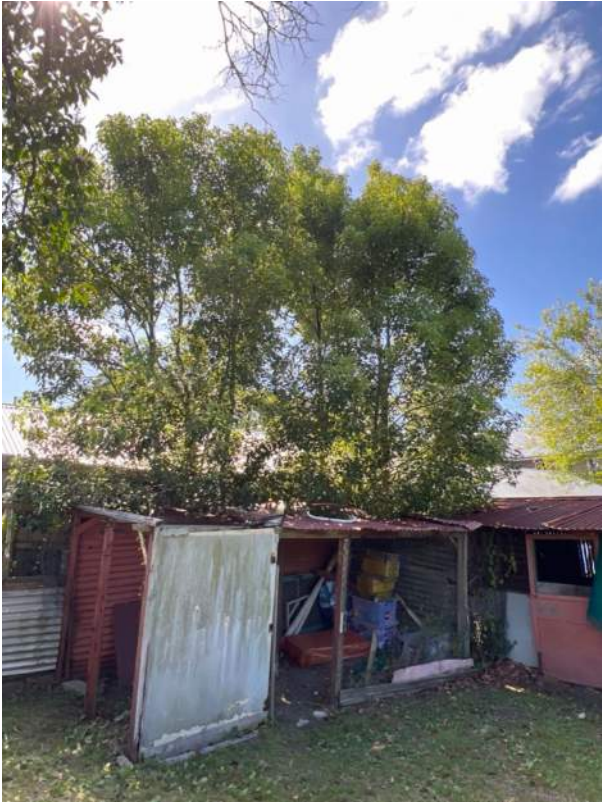
Tree Details	
Tree Id:	9
Scientific Name:	Ligustrum lucidum
Common Name:	Privet
Health:	Poor
DBH [cm]:	42
Tree Height (Estimated) [m]:	8
Risk Rating:	
Priority:	None
Canopy Width (m):	7
Useful Life Expectancy:	1-5 years
Maturity:	Mature
Structure:	Fair
Retention Value:	Low
Tree Work:	
Last Modified:	15/02/2024
Observations:	
Tree Comments:	Large specimen of potentially invasive species. Canopy with signs of dieback. Hazardous deadwood in upper and mid canopy.
