BHM Geotechnical

Geotechnical Investigation

60 & 62-64 Showground Road, Gosford NSW 2250

Document Reference: CHP 2293 – AA Rev.3
BHM Geotechnical Pty Ltd
Email: info@bhmgeo.com.au
ACN: 642 369 739
ABN: 44 642 369 739

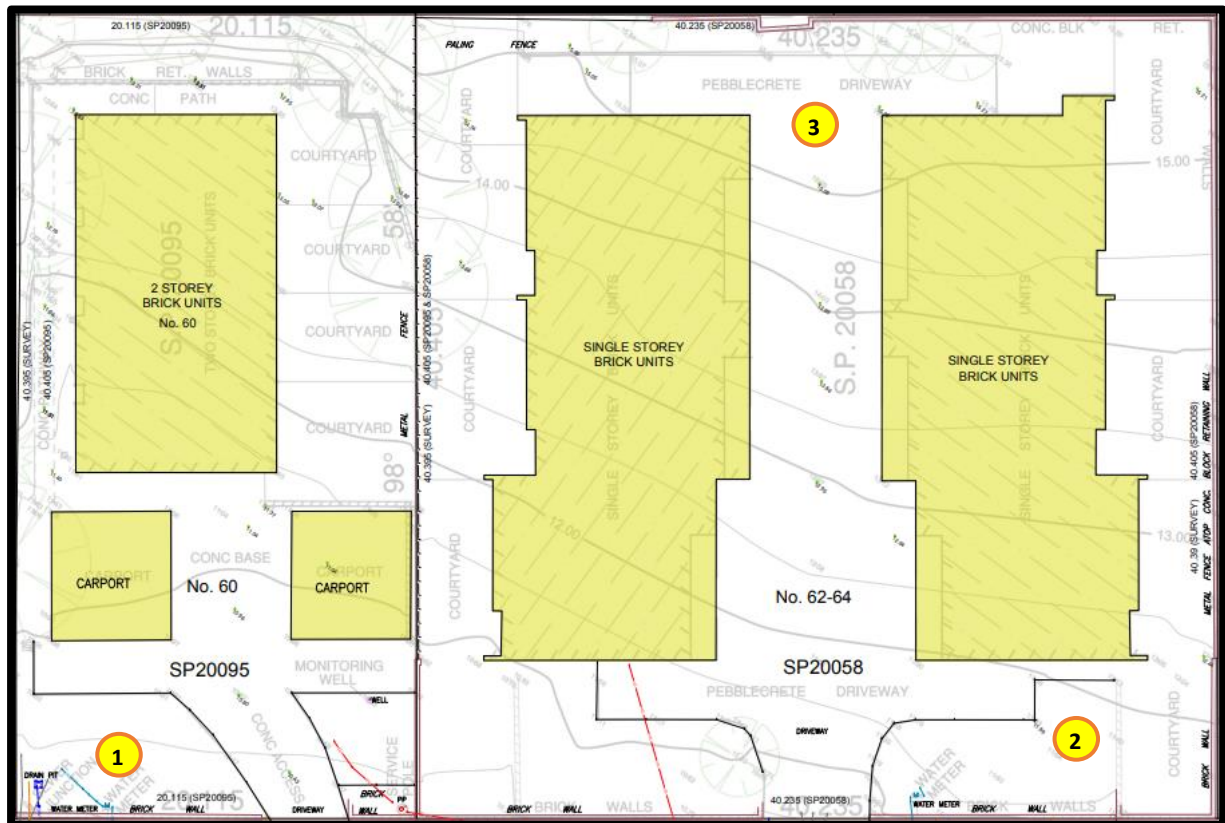
Figure 1 - Borehole & DCP locations

The investigative borehole locations were chosen by our supervising geotechnical engineer based upon the location of the proposed construction works. Their locations are overlaid on the proposed plans of the site in Figure 1 below.

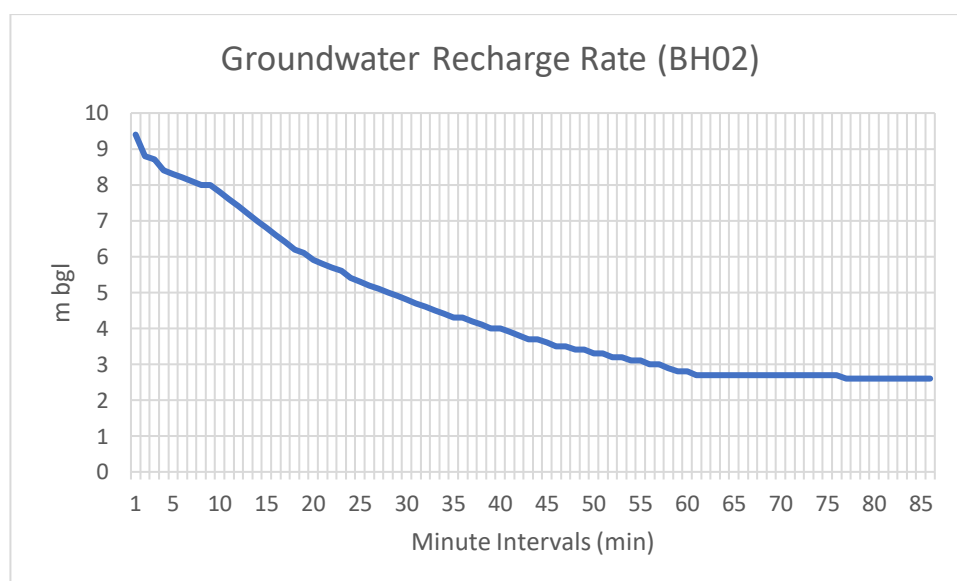
Table 1 - Groundwater Recharge Rate (BH02)

During the excavation of boreholes 01, 02 and 03, groundwater seepage was observed at depths of 5.5 m, 6.5 m and 4 m, respectively. Subsequently, boreholes 02 and 03 were converted into groundwater monitoring wells. The groundwater within the monitoring wells was bailed out on the 31st of August 2023. The screen installed within borehole 02 was constructed to isolate the extremely weathered bedrock. Initial measurements indicated the groundwater level at 1.7 (m bgl) before the water was bailed out. Groundwater extraction was performed until it reached a depth of approximately 9.4 (m bgl). Water bailing was terminated due to the presence of sludge at greater depths.

Groundwater recharge results have been tabulated in a graph and presented within tables 1 & 2.

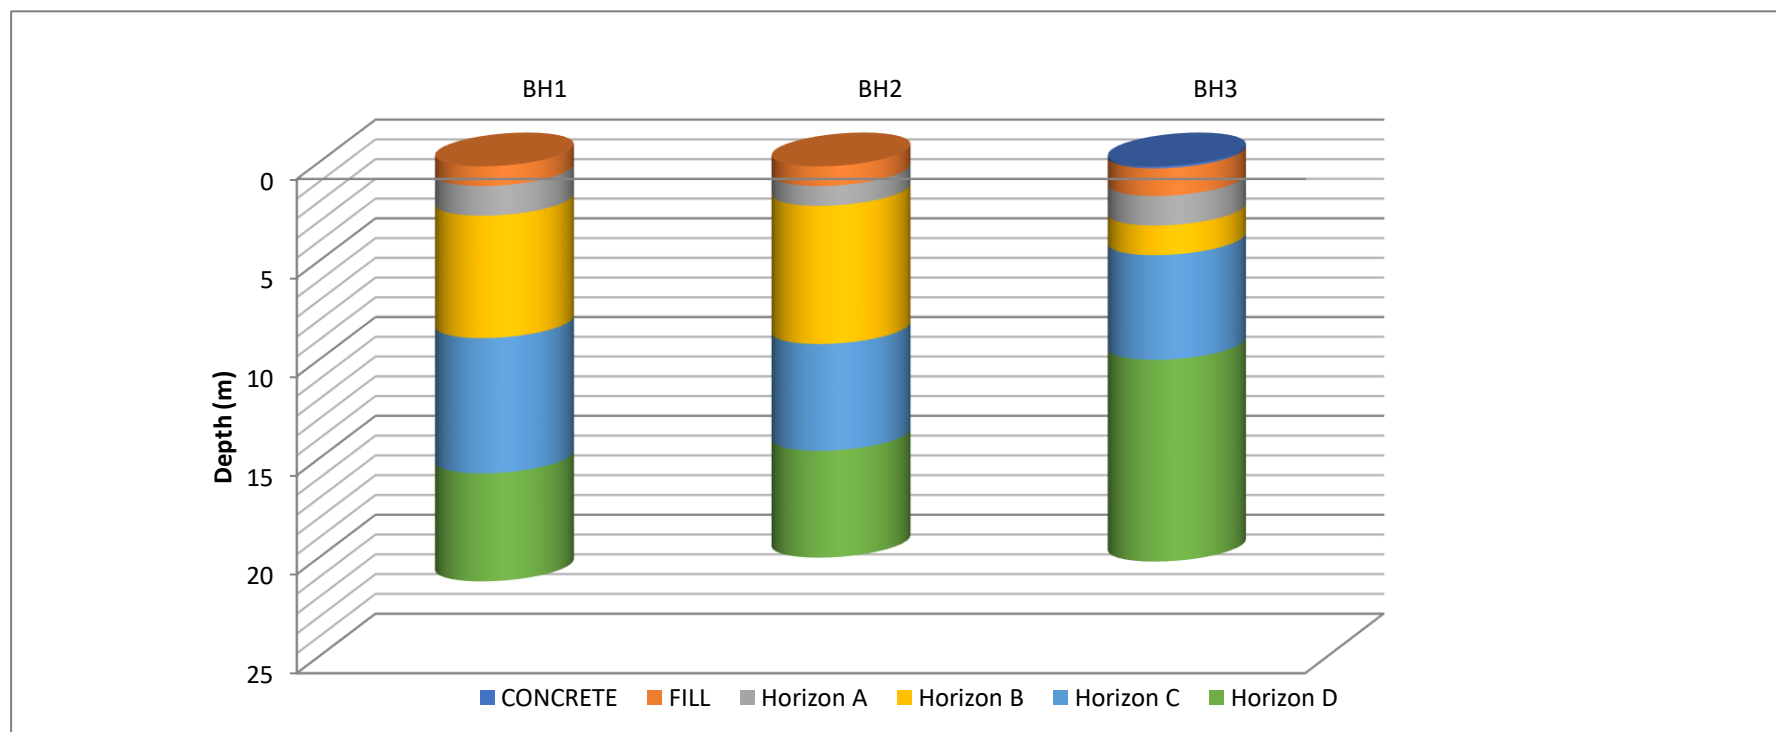
Figure 5 - Geotechnical Model

Assessment of the ground conditions at the specified area has been undertaken to develop a geotechnical model of the site. A summary of the subsurface horizons is presented below, borehole logs can be found within Appendix A of this report for a more detailed description.

Fill material mainly consisted of brown, low to medium plastic clay mixtures between depths of 0 – 1.5 m. Moisture content throughout the fill profile was equal to the plastic limit. Fill profile was poorly compacted at the tested locations and is considered to be uncontrolled fill.

The soil profile encountered predominately comprised of alluvial soils with depths ranging between 1.0 – 2.0 m. The majority of this unit consisted of brown, low to medium plasticity sandy clay with moisture content equal to the plastic limit. The consistency at the tested locations were assessed to be stiff to very stiff.

The soil profile encountered predominately comprised of residual with depths ranging between 2.0 – 9.0 m. The majority of this unit consisted of red mottled grey, low to medium plastic clay with moisture content greater than the liquid limit. The consistency at the tested locations were assessed to be very stiff to hard.

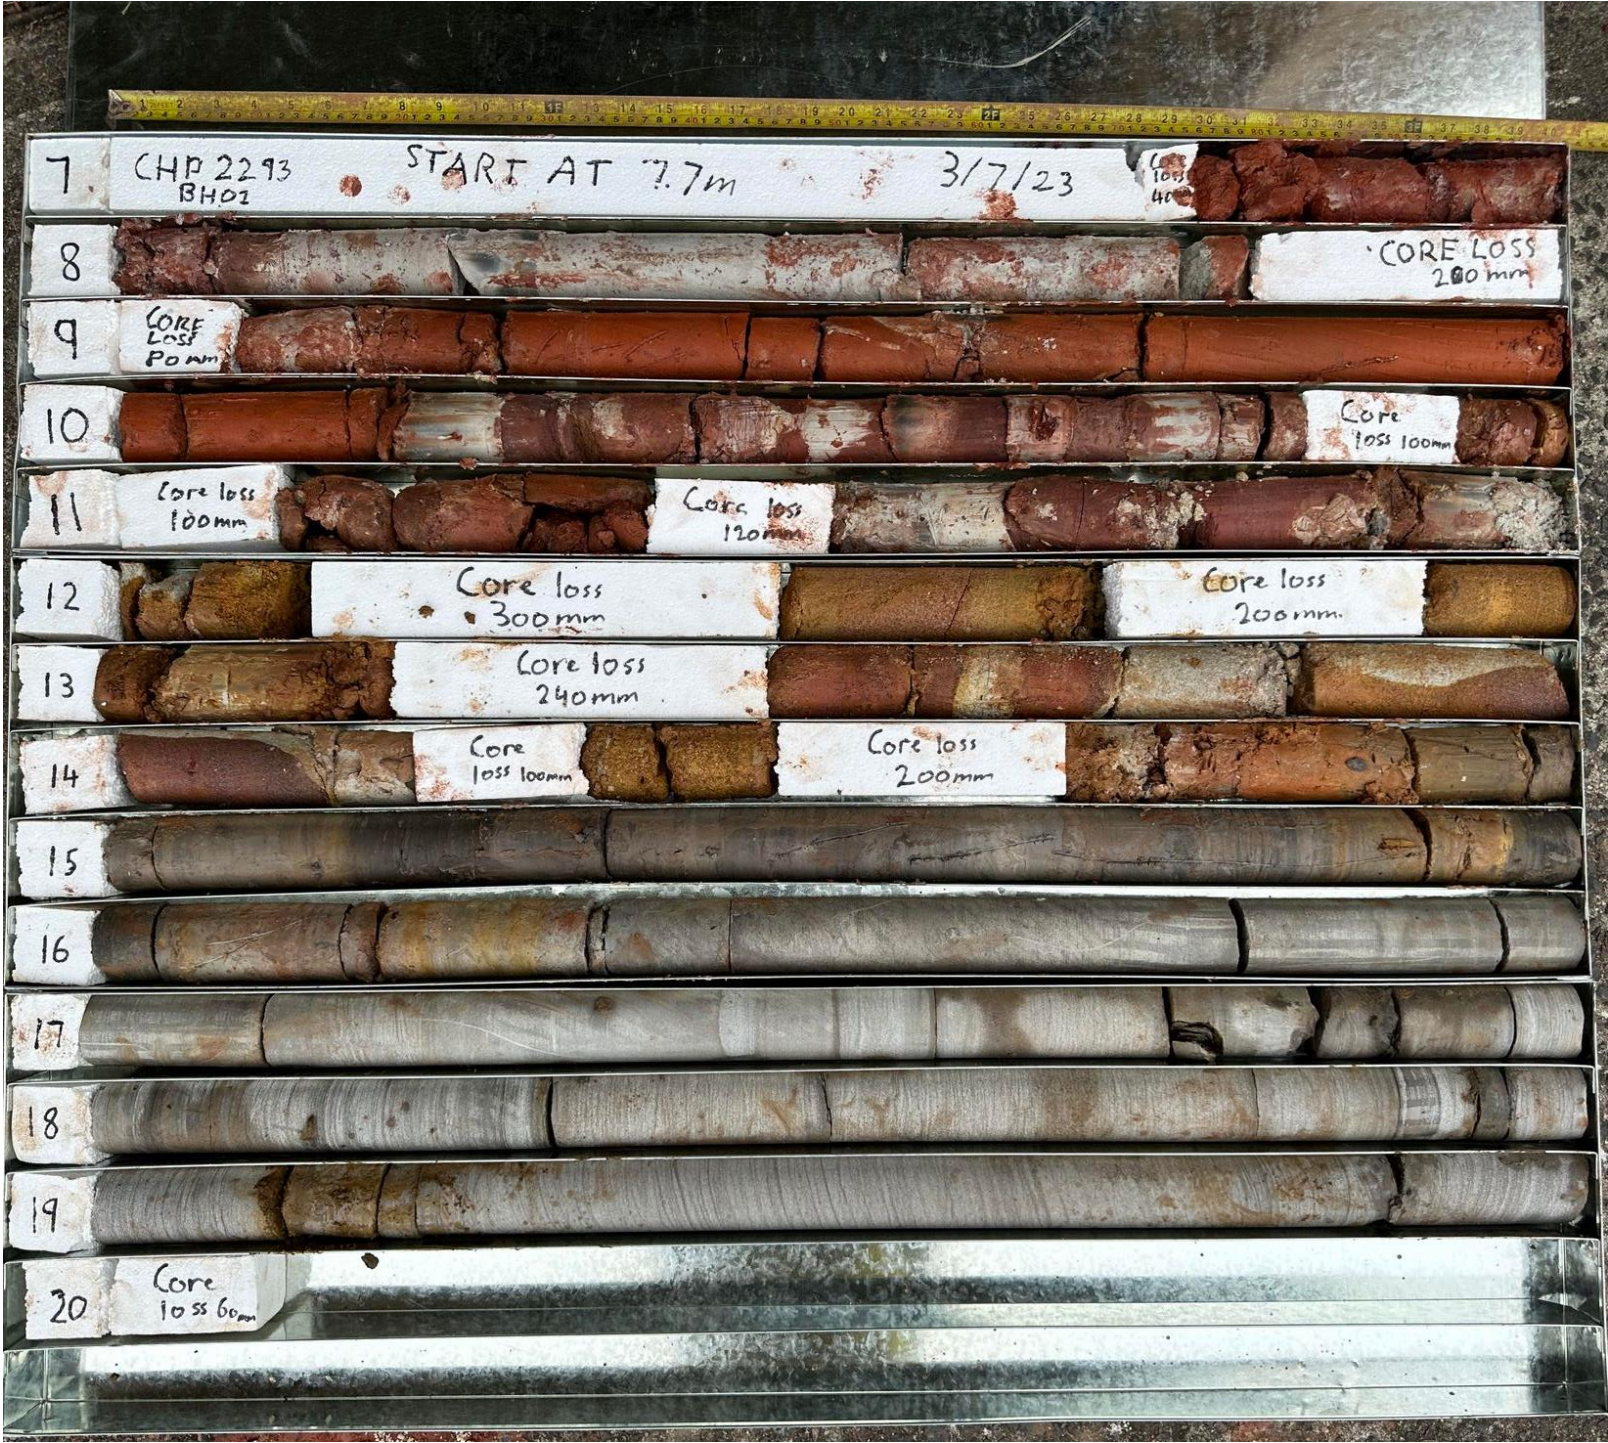
BH01 rock core
7.7 m – 20 m

thereafter Class III sandstone within borehole 1 to 16.7 m, class II shale was encountered at the depths specified within tables 4 and 5 based on our investigated locations. The classification of shale and sandstone requires 3 criteria to be met, this includes strength, defect spacing and allowable seams. The current classification was predominantly governed by the allowable seams and defect spacings. Diagrams of the investigative boreholes undertaken are presented within Appendix D of this report.
