Our ref: 7471-R1 Rev2 14 September 2024

Proposed Playground Upgrade, Thredbo Village NSW Geotechnical Assessment

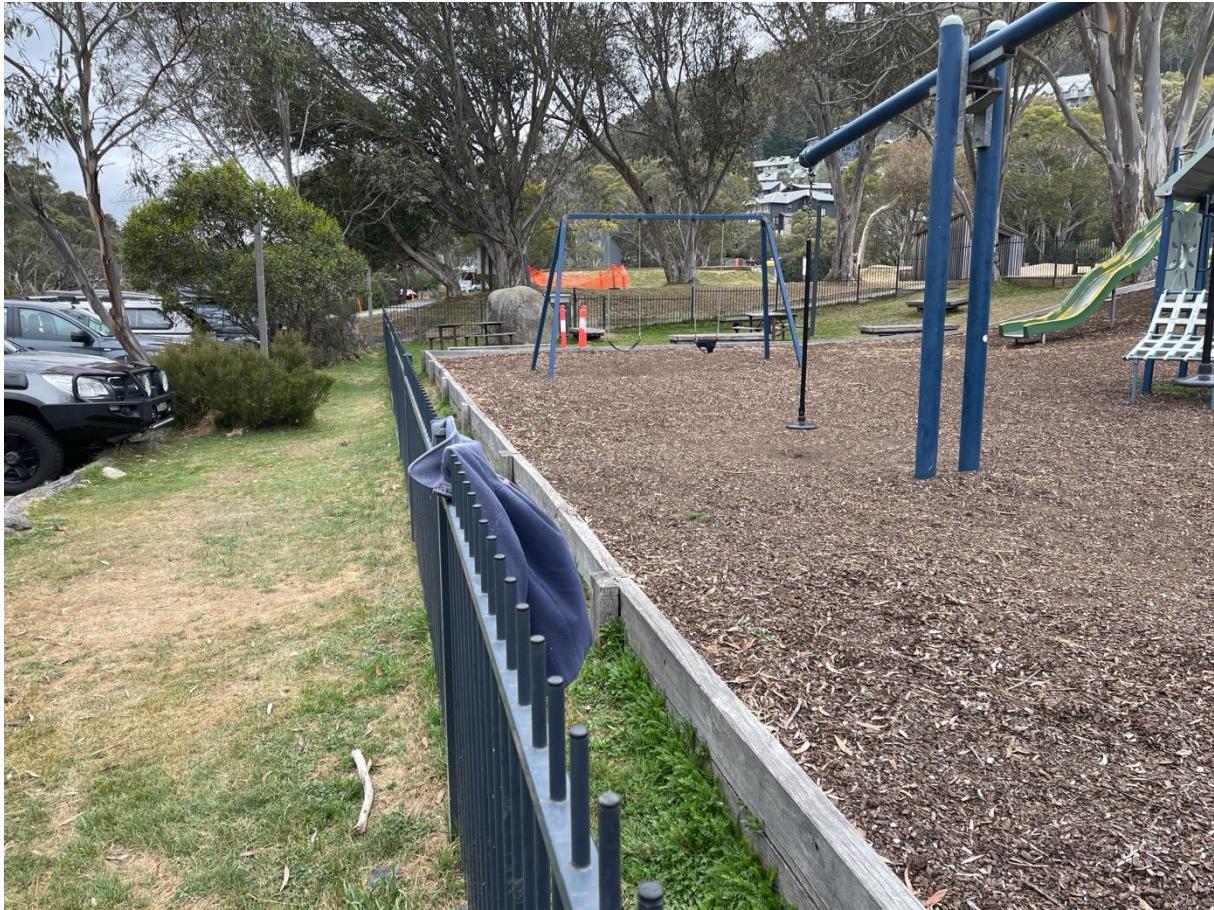
Photo 1: View of northern side of existing playground, looking northeast.

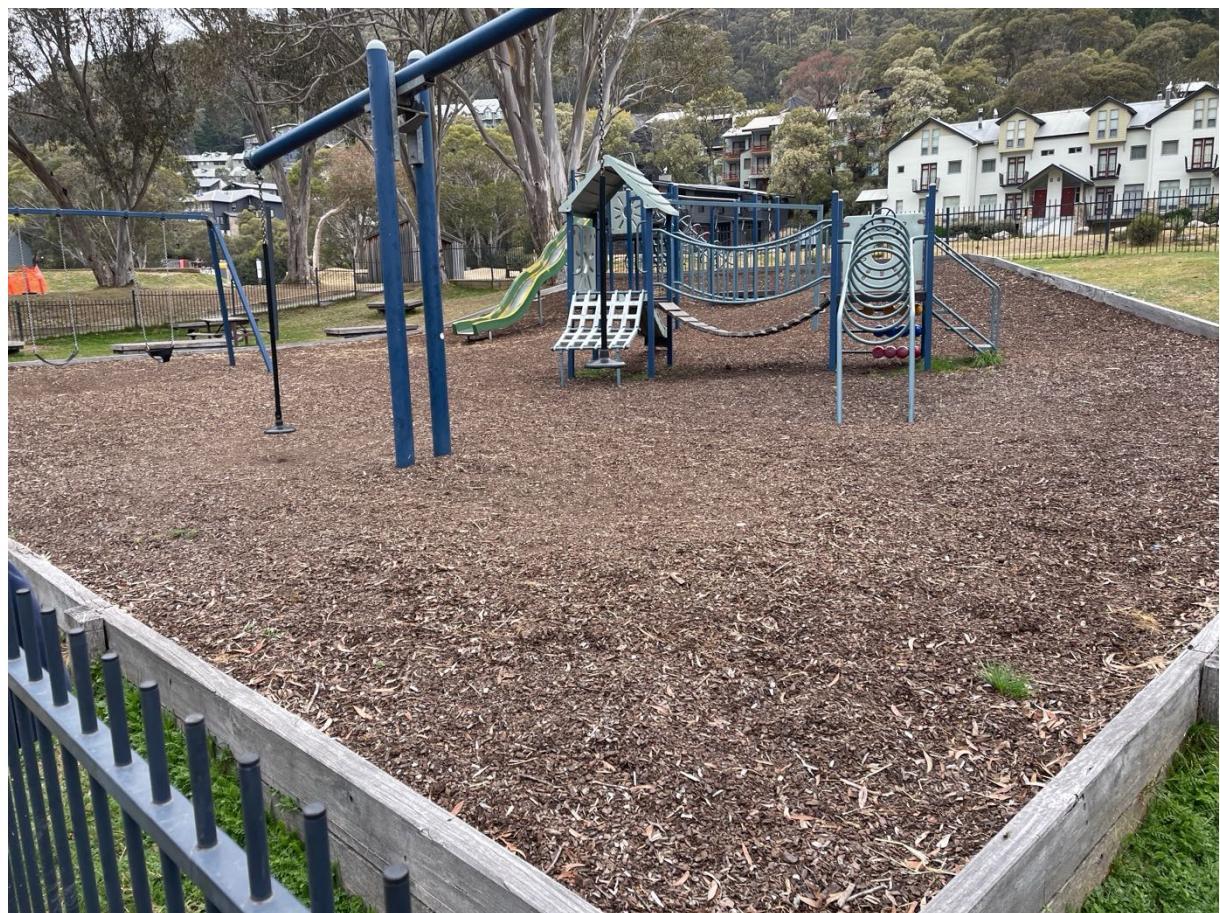
Photo 2: View of existing playground, looking southeast.

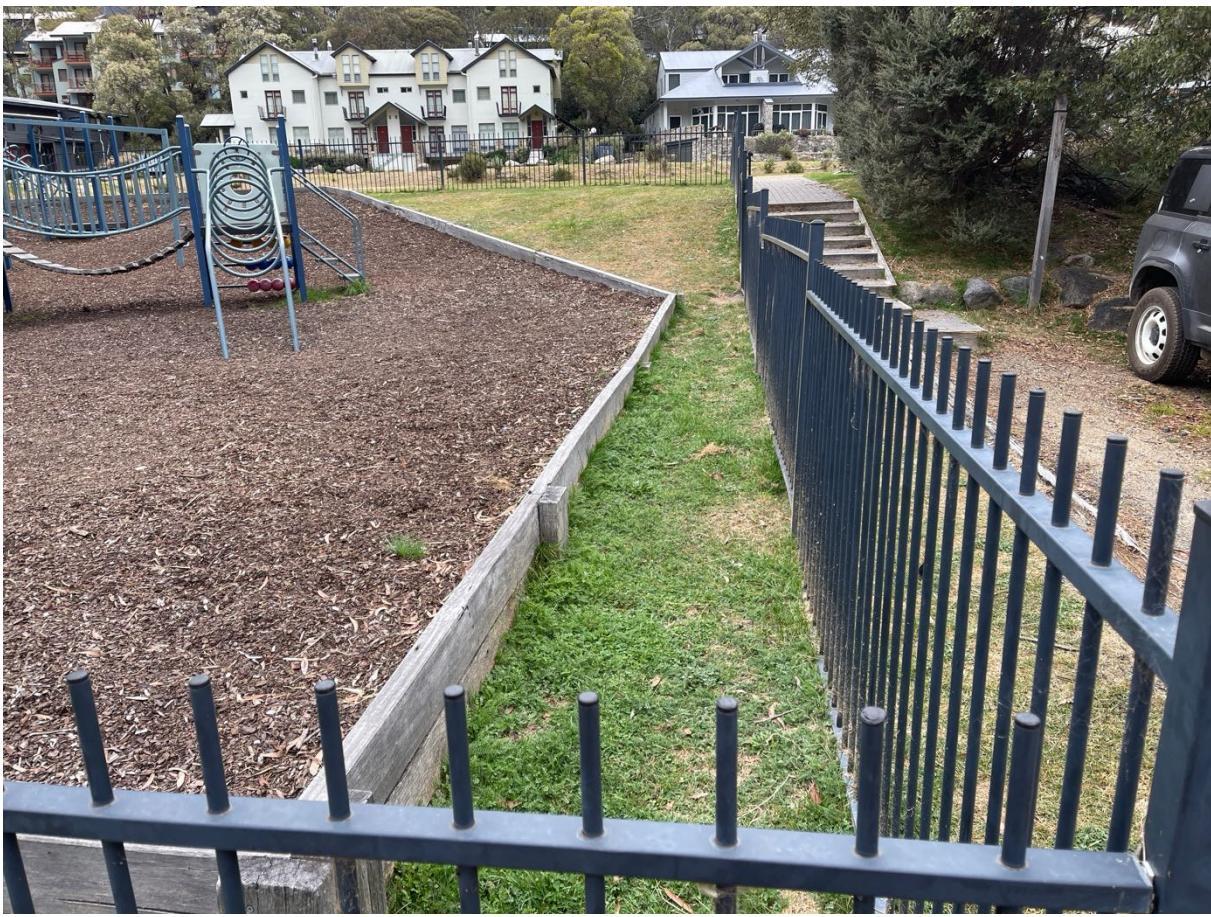
Photo 3: View of existing playground, looking south.

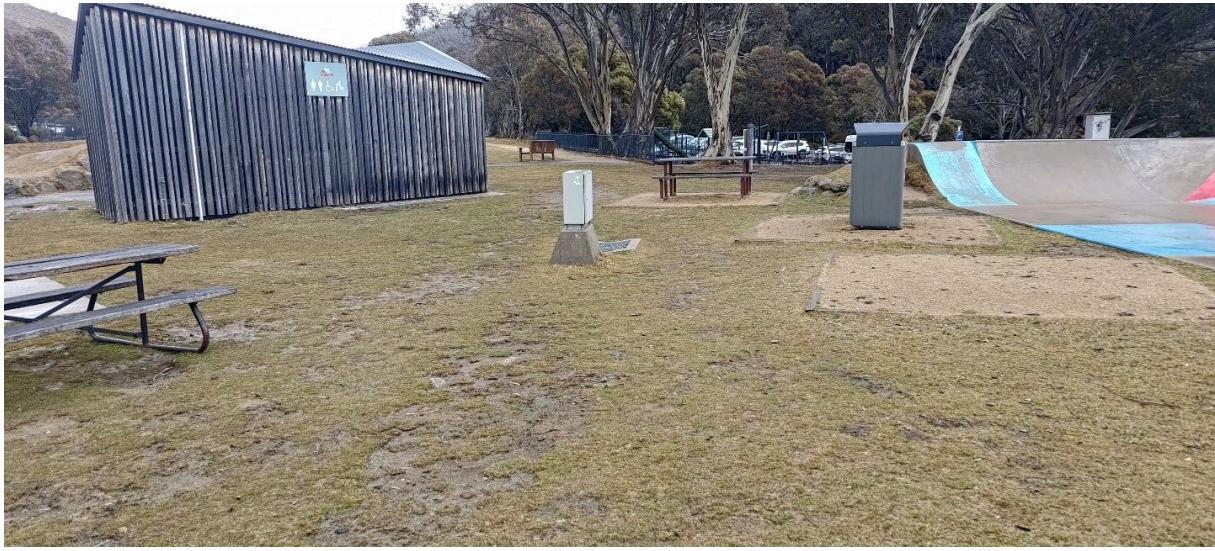
Photo 4: Existing Plaza Area, looking south. Source: Kosciuszko Thredbo Pty Ltd.

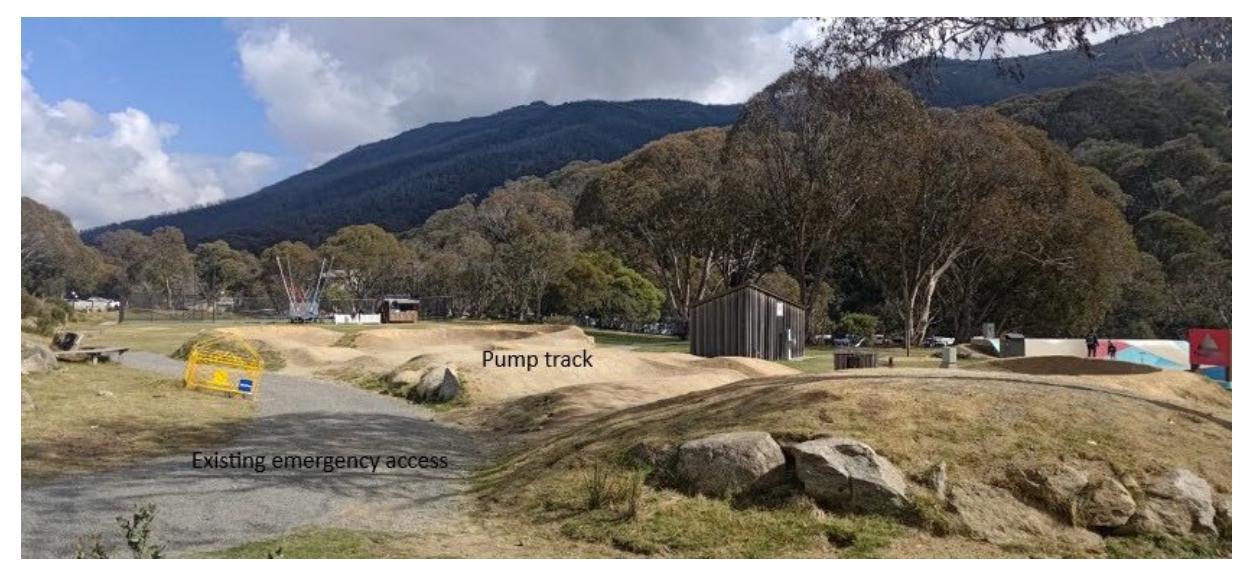
Photo 5: Existing Pump track Area, looking west. Source: Kosciuszko Thredbo Pty Ltd.

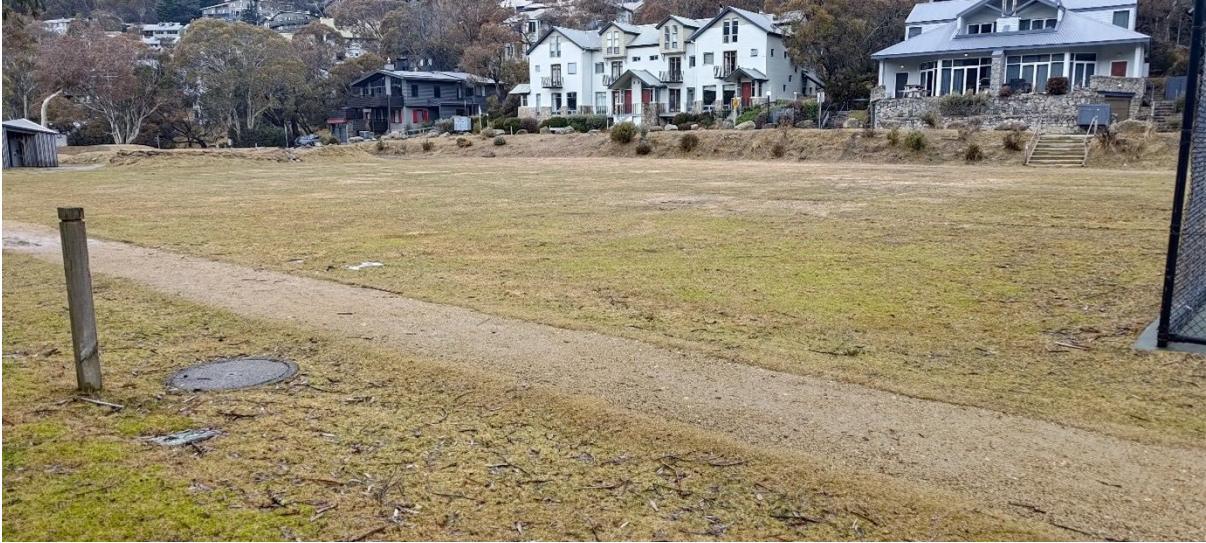
Photo 6: Existing Water Main and Emergency access area, looking east. Source: Kosciuszko Thredbo Pty Ltd.
