Our ref: 7407-R1 Rev2
8 March 2025

Proposed New Water & Sewer Services Installation, Lots 793, 794 & 795, Diggins Terrace, Thredbo Village NSW Geotechnical Assessment

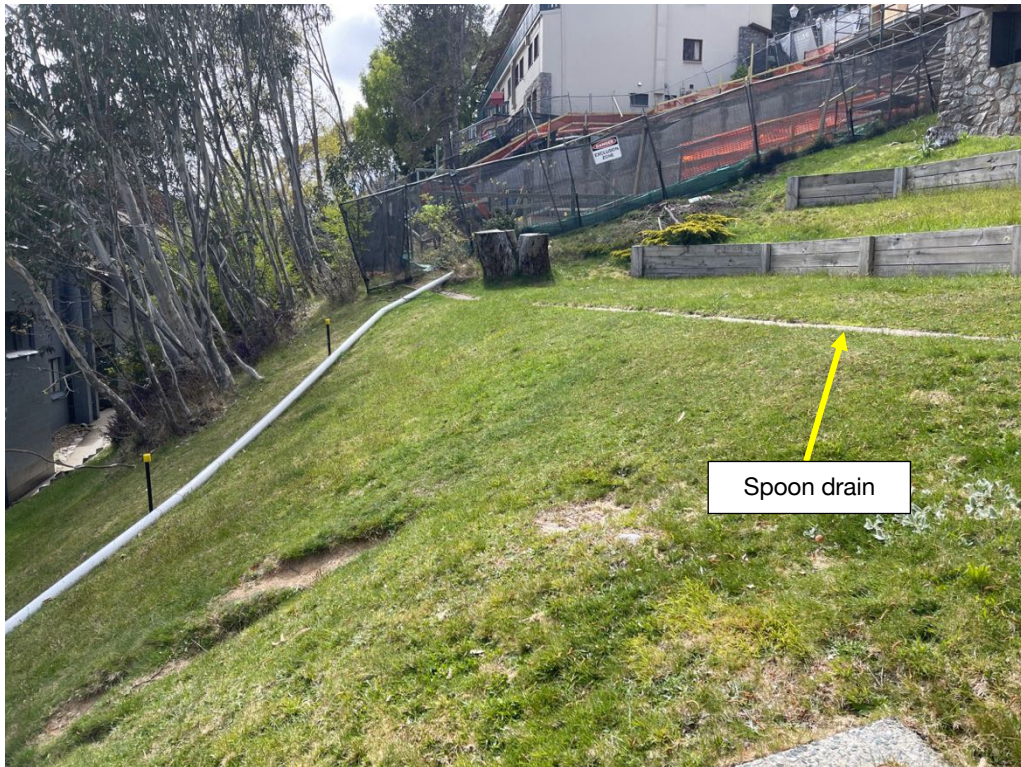
Photo 1 – View towards Blackbear Inn (being re-developed) – Sashas Apartments in foreground.

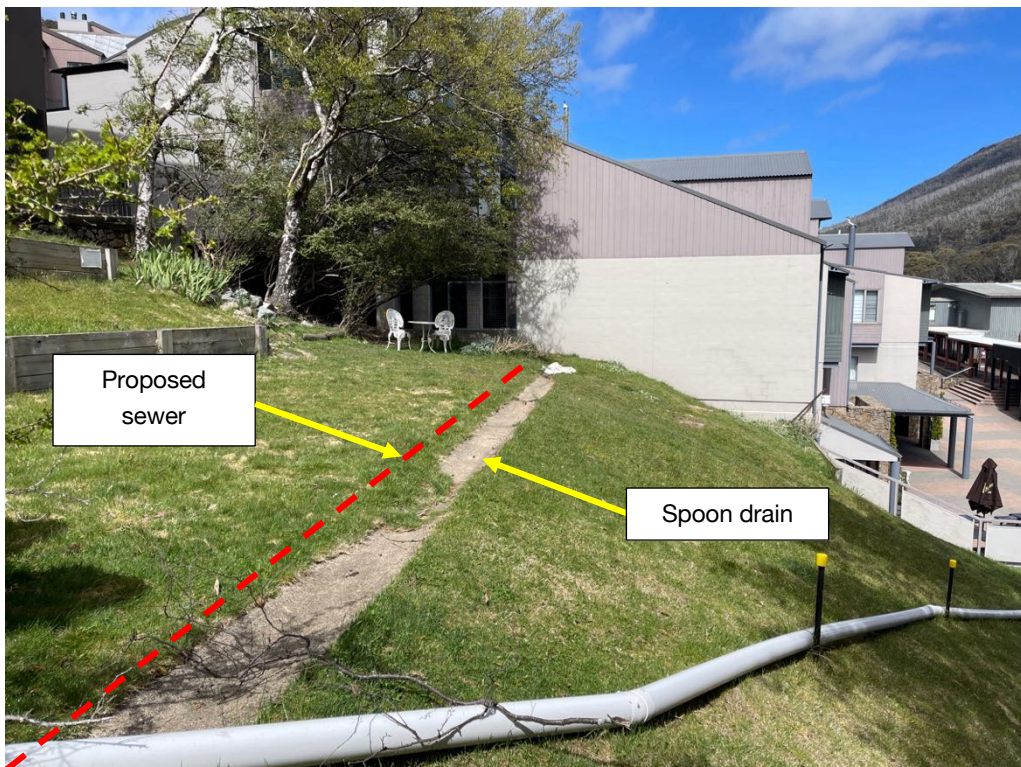
Photo 2 – View of rear of Sashas Apartments showing existing spoon drain and proposed sewer and stormwater.
