Ref: 24197

23rd October 2024

RE: Supersite Monopole On the M4 Near Clunies Ross St, Prospect, NSW DA For Continued Signage Use, Structural Feasibility and Safety Report

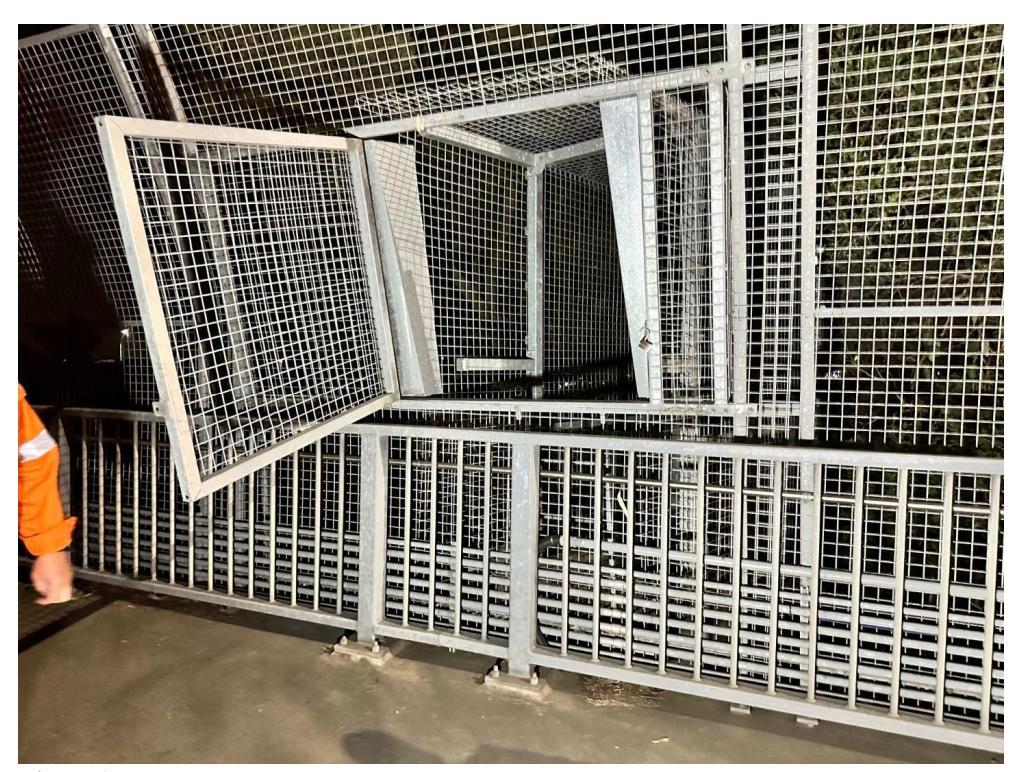
The lower walkway is accessed by a steel gantry that runs from the adjacent Clunies Ross St bridge. There is a hatch in the safety screen of the bridge to access the gantry. Refer to photos 1 to 4.

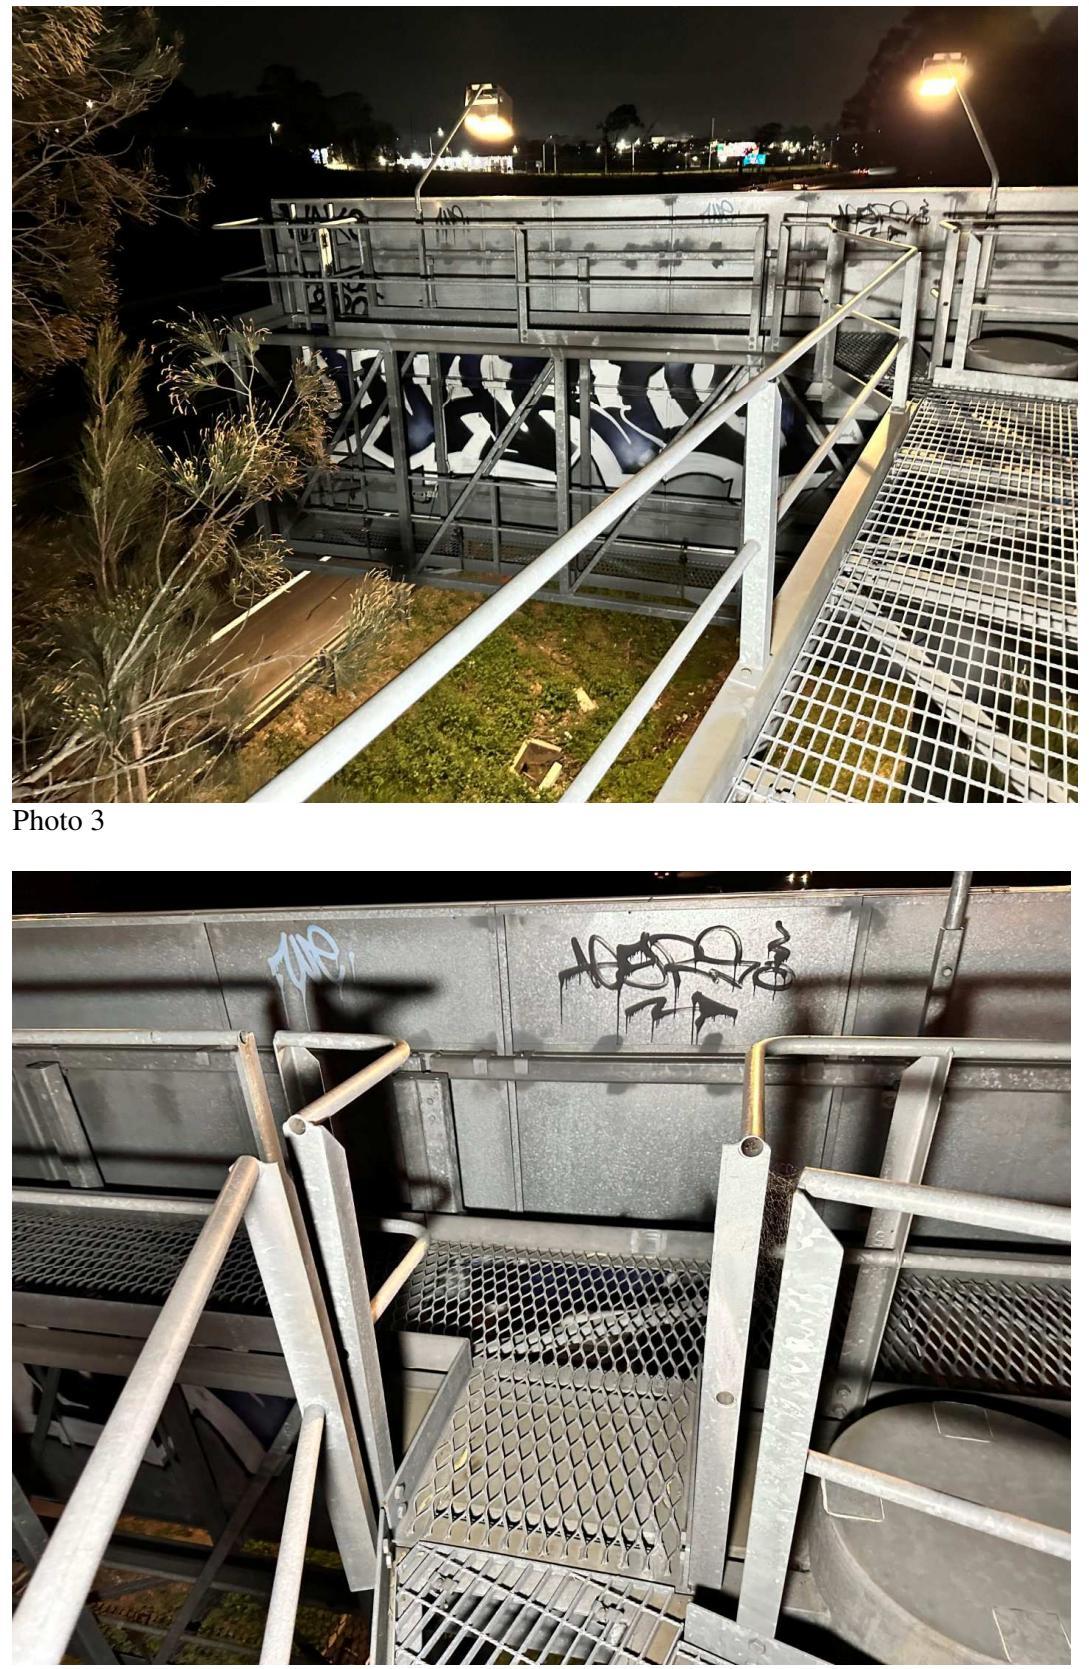
There are two walkways in the 3D steel frame behind the panel, near the base of the panel and one metre from the top of the panel. The walkways enable the banners to be changed when required. There are propriety balustrades on the back and sides of the walkways with the panel in front acting as a barrier to prevent falls. Refer to photos 3 to 6.

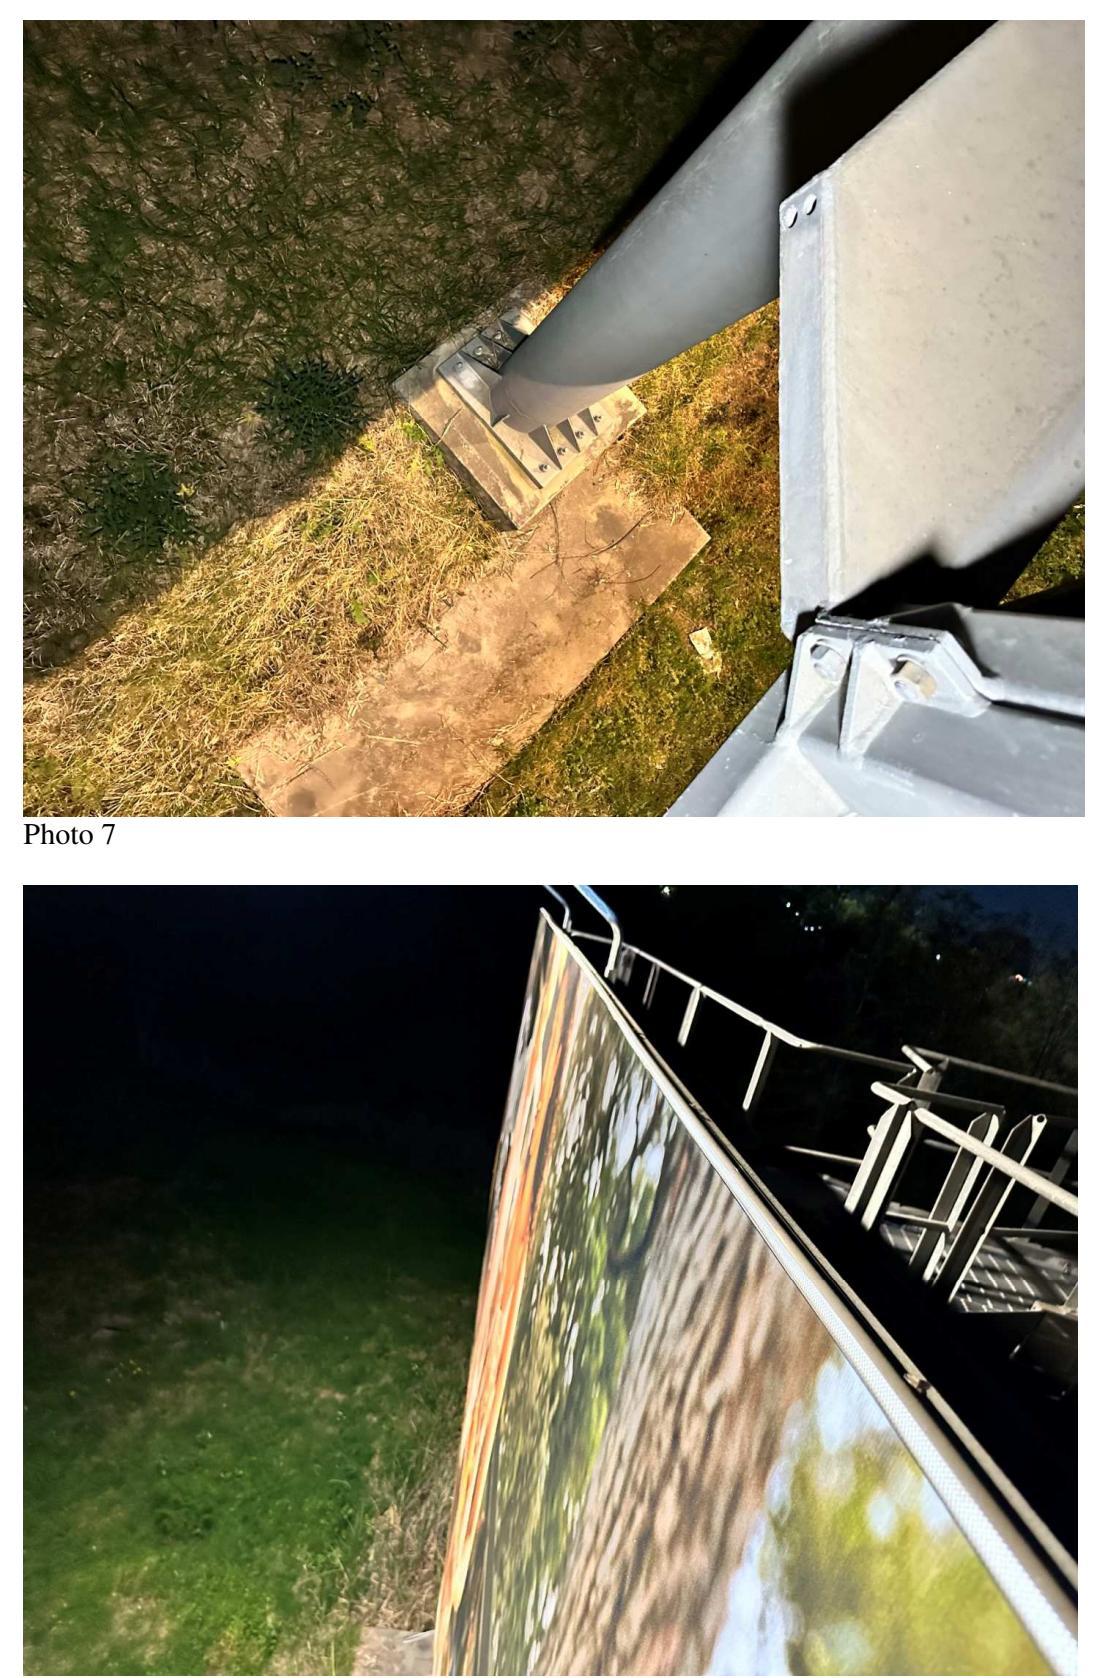
Photo 8

The existing sign is a front lit supersite sign on a monopole. The sign consists of a banner which is placed against a steel panel and is tensioned both horizontally and vertically. The panel is fixed to a three-dimensional (3D) steel frame that is supported off a steel pole. The steel pole is supported off a concrete footing. Refer to photos 7 to 9.
